### Tension and compression behavior of corroded steel beams rehabilitated with BFRP

# **Tension and compression behavior of corroded steel beams rehabilitated with BFRP**

Submitted to the Faculty of Graduate Studies  
through the Department of Civil and Environmental Engineering  
in Partial Fulfillment of the Requirements for  
the Degree of Master of Applied Science  
at the University of Windsor

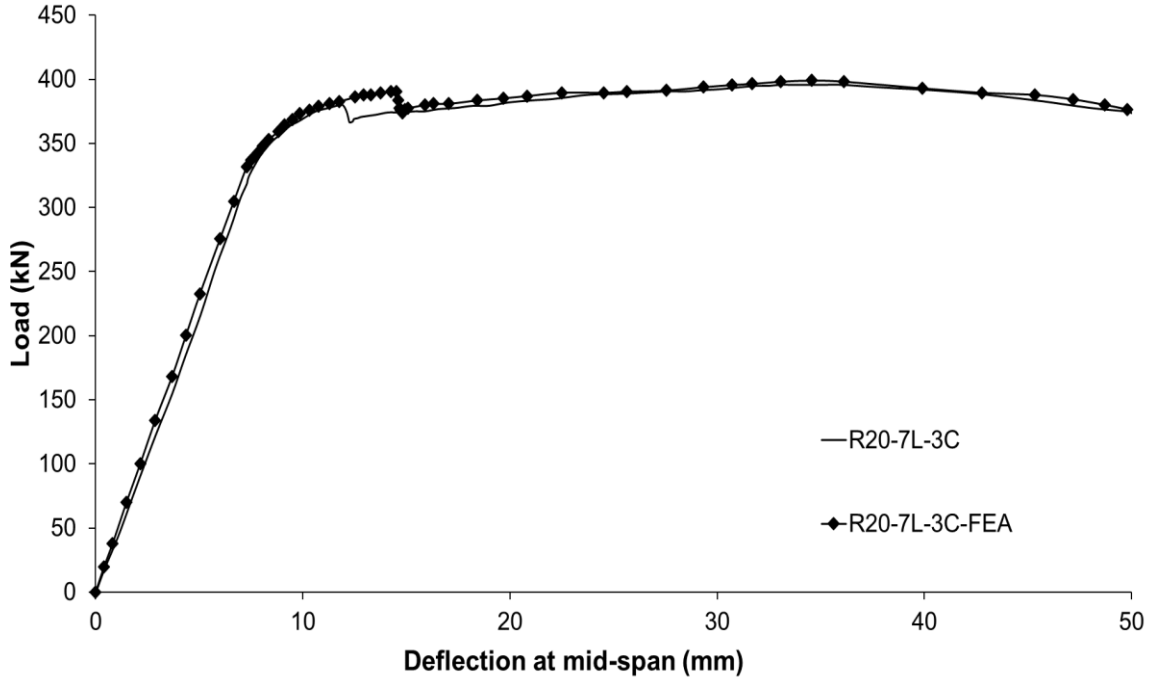
Figure 3.23: Validation of models for R20-7L-3C beam

Figure 3.23 compares the load-deflection data of the steel beam with 20% corrosion defect and rehabilitated with 7 layers of BFRP fabric obtained from the test and FE model. A good agreement between the load-deflection data obtained from the test and the FEM model can be observed for this

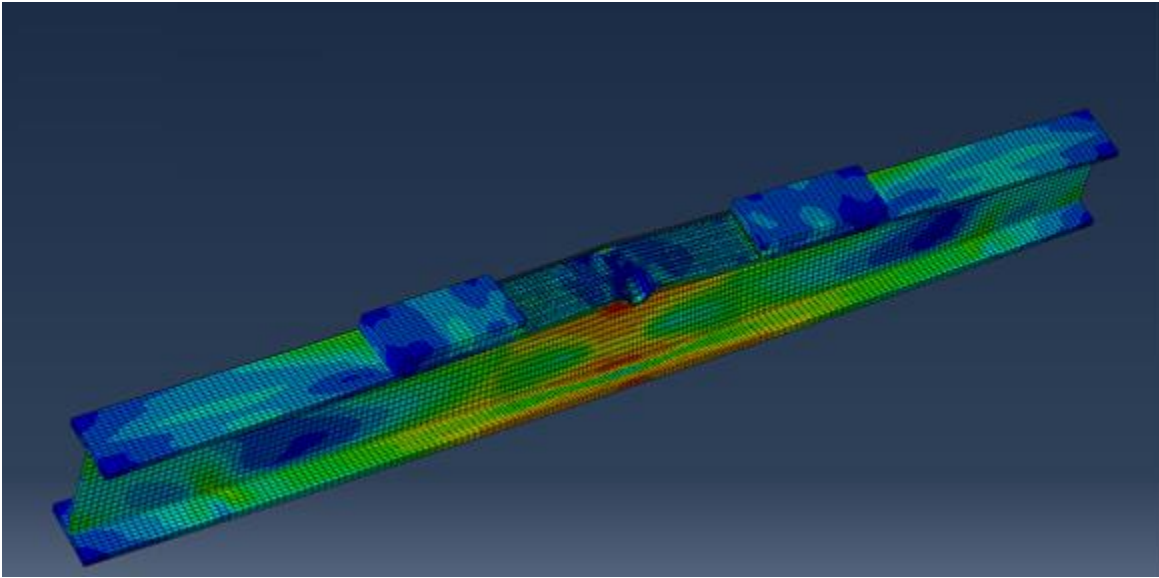
Figure 3.24: Failure mode obtained in the FEA model for R40-10L-3C specimen

The failure mode obtained from FE model for specimen R40-10L-3C is shown in Figure 3.24. The damage of the composite fabric from the FE model beyond ultimate load and at 50 mm mid-span deflection for specimen R40-10L-3C is shown in Figure 3.25. The other FEM models for the rehabilitated specimens showed similar behavior (Appendix A Figures A.9 -A.14).

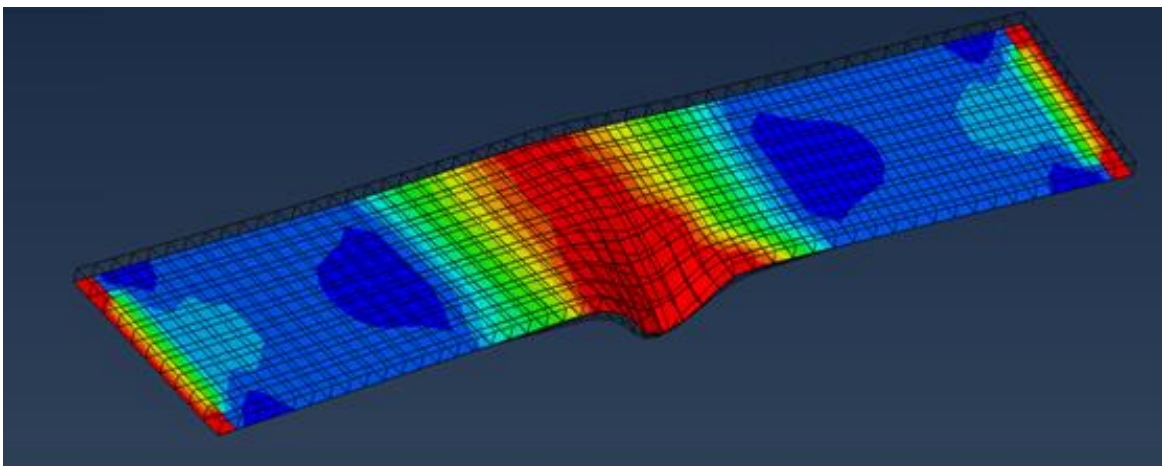
Figure 3.25: Damage in BFRP modelled using Hashin Criteria for R40-10L-3C specimen

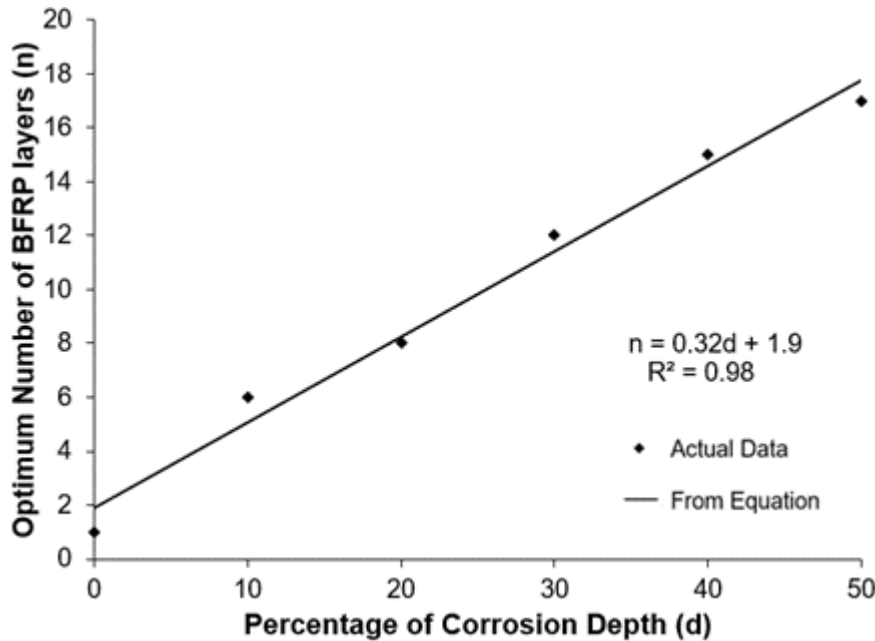
Figure 3.26: Relationship between percentage of corrosion and number of BFRP layers

varied to determine the optimum number of BFRP fabric for each corrosion depth. Figure 3,26 shows the optimum number of BFRP fabric layers required to restore the ultimate strength of the corroded specimens to the level of uncorroded corrosion (virgin) specimen, UB for various corrosion depths. The optimum number of layers refers to the minimum number of BFRP fabrics layers required for restoring the ultimate load capacity of the rehabilitated specimens to level of the uncorroded control (virgin) specimen, UB.

Based on this data, Equation 3.8 is developed which can be used for determining the optimum numbers of BFRP fabrics layers required to rehabilitate a beam with corrosion defect in the compression flange.

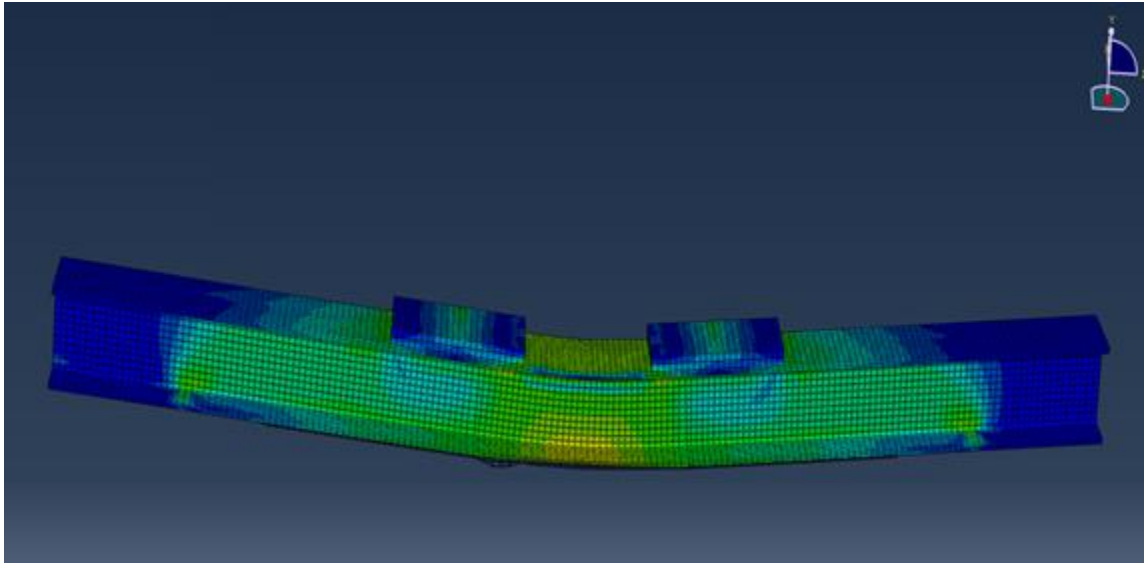
Figure A.1: Final Deflected shape in the FEM model for specimen R400\_7L

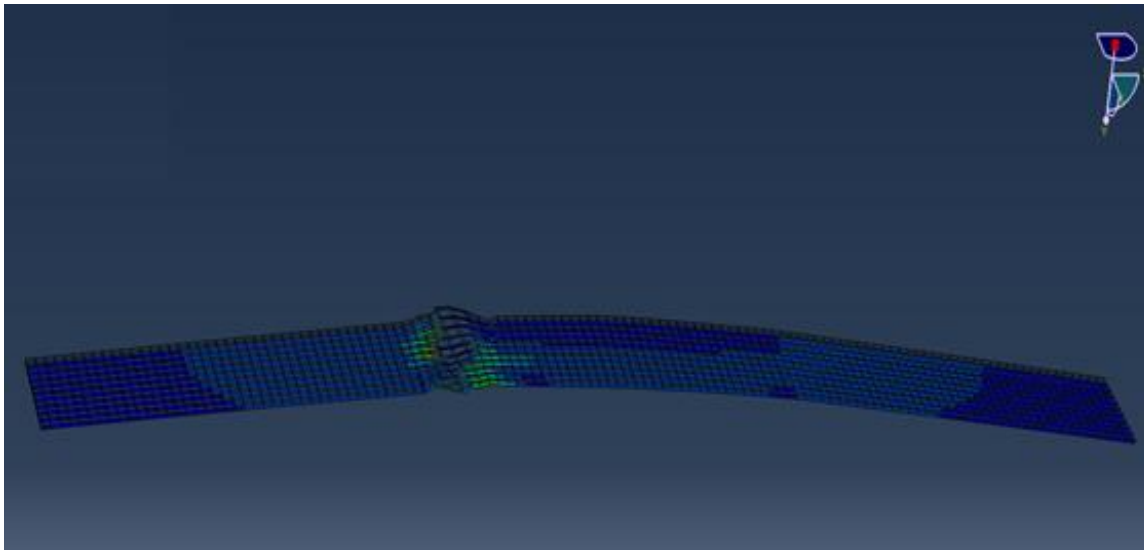
Figure A.2: Shape of the BFRP laminate after rupture point for specimen R400\_7L

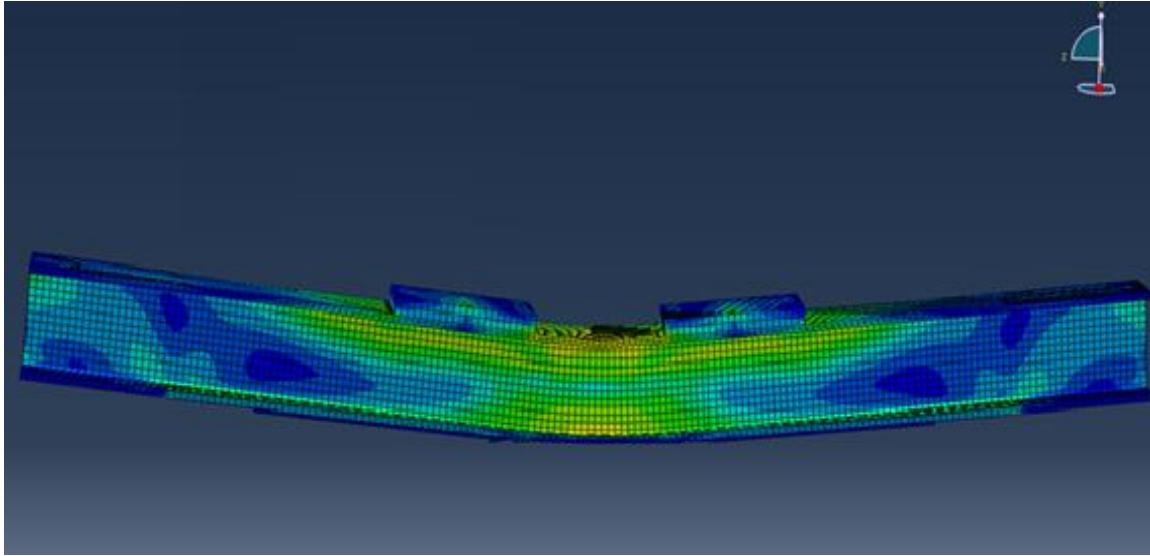
Figure A.3: Final Deflected shape in the FEM model for specimen R400\_10L

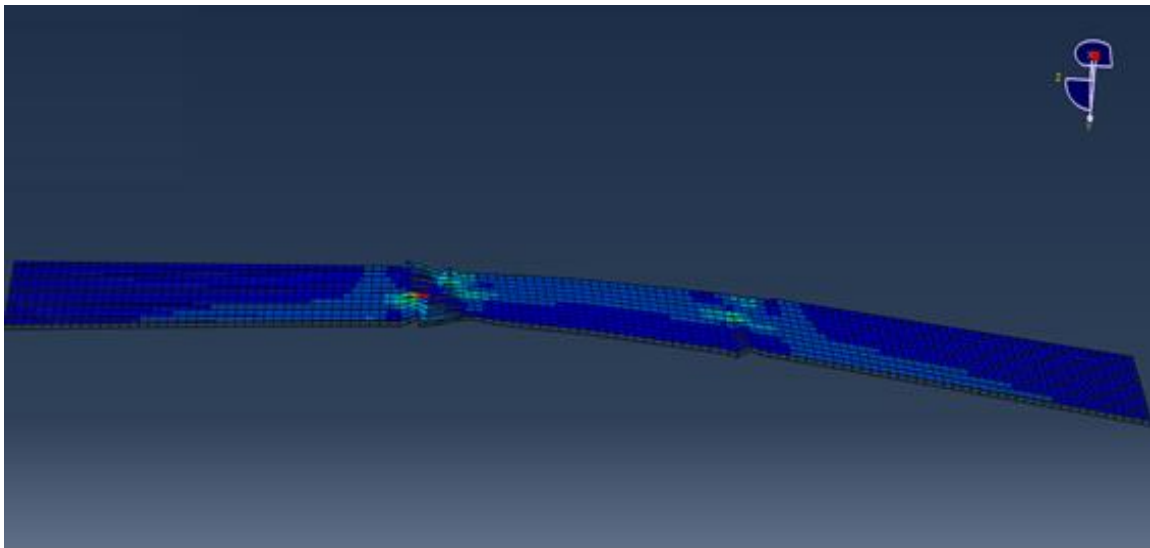
Figure A.4: Shape of the BFRP laminate after rupture point for specimen R400\_10L

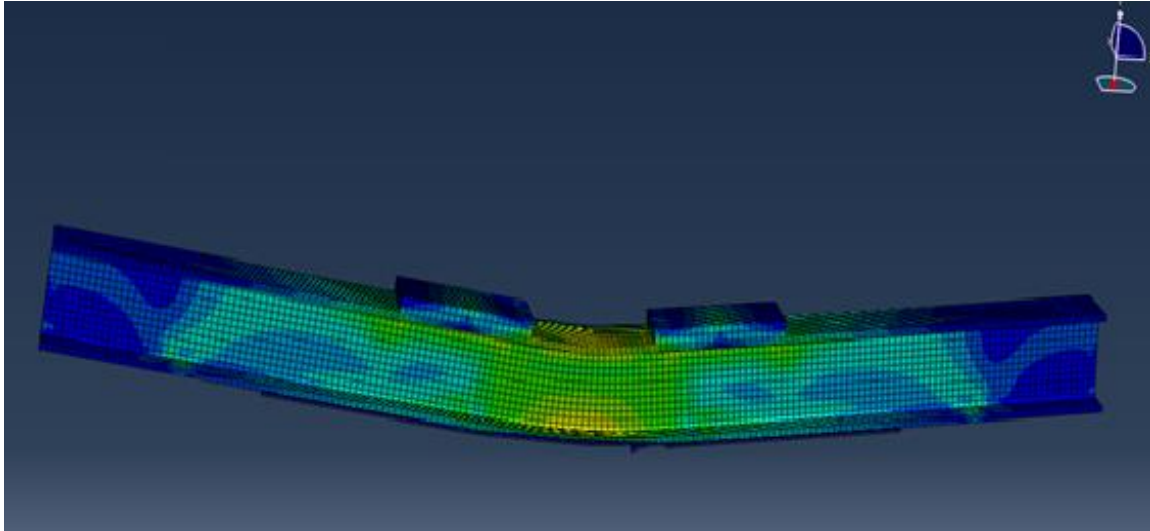
Figure A.5: Final Deflected shape in the FEM model for specimen R400\_15L

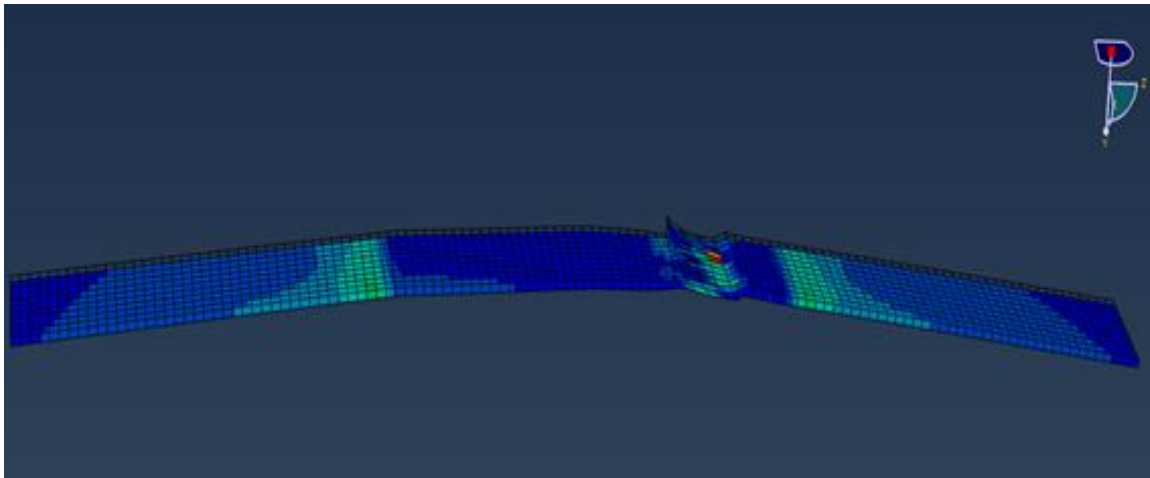
Figure A.6: Shape of the BFRP laminate after rupture point for specimen R400\_15L

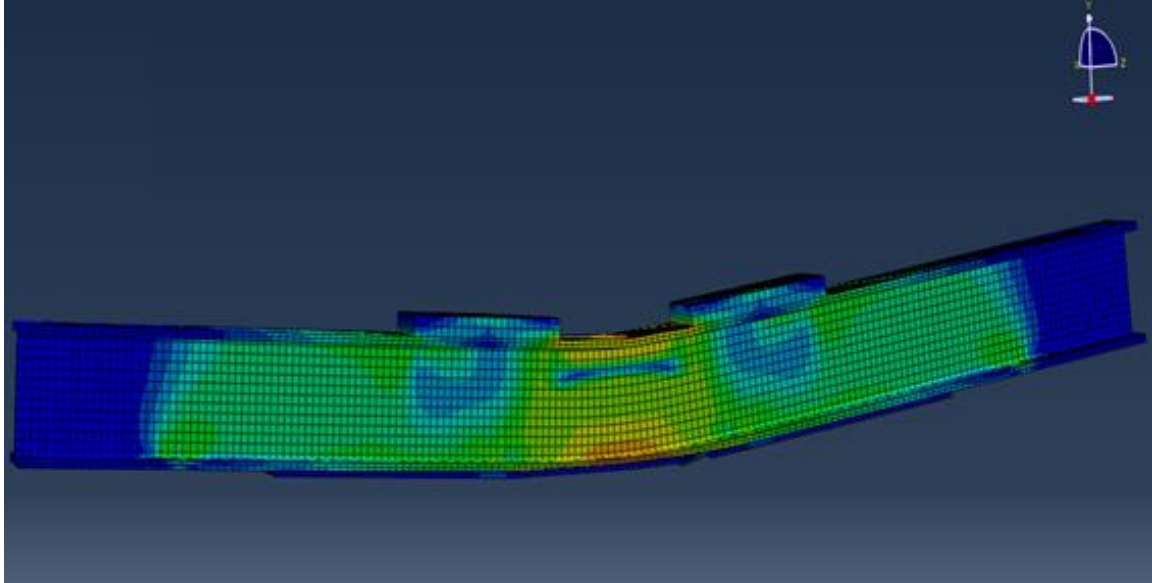
Figure A.7: Final Deflected shape in the FEM model for specimen R100\_7L

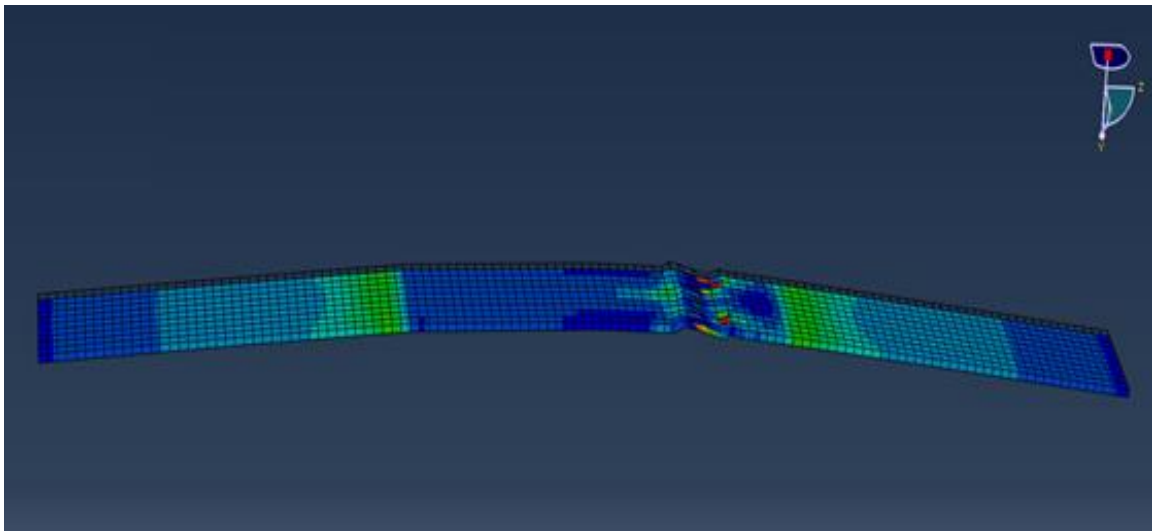
Figure A.8: Shape of the BFRP laminate after rupture point for specimen R100\_7L

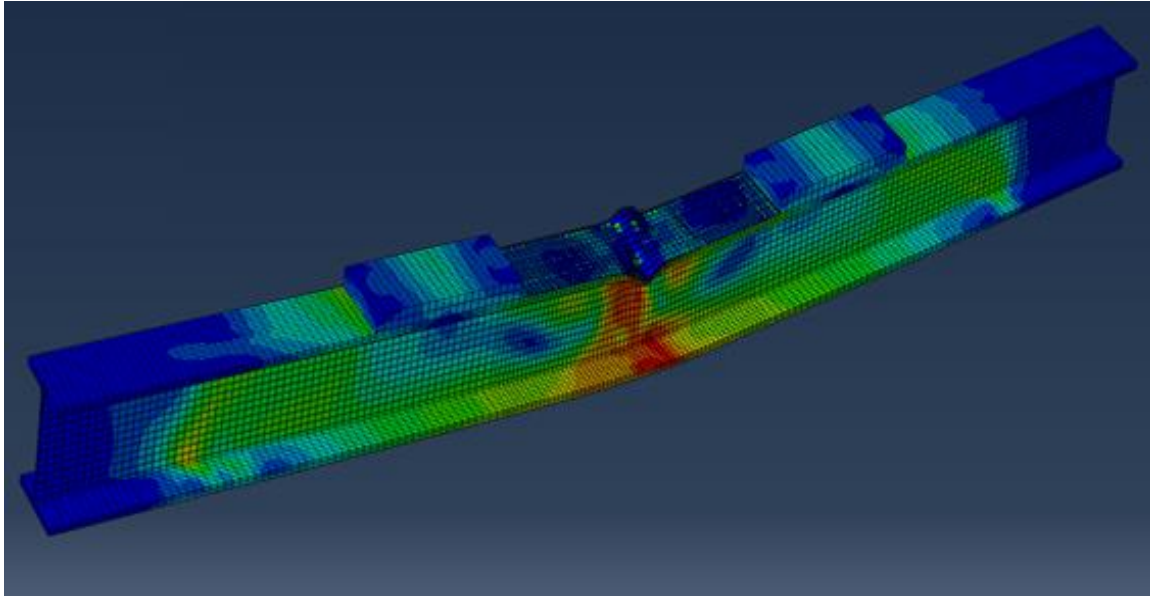
Figure A.9: Failure mode obtained in the FEA model for R40-7L-3C specimen

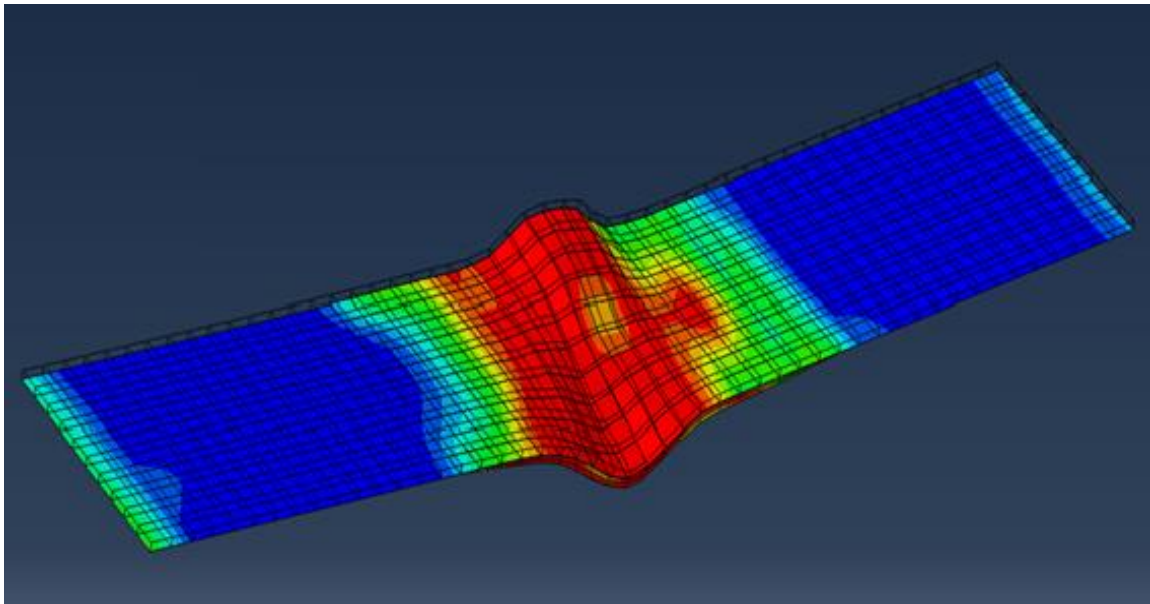
Figure A.10: Damage in BFRP modelled using Hashin Criteria for R40-7L-3C

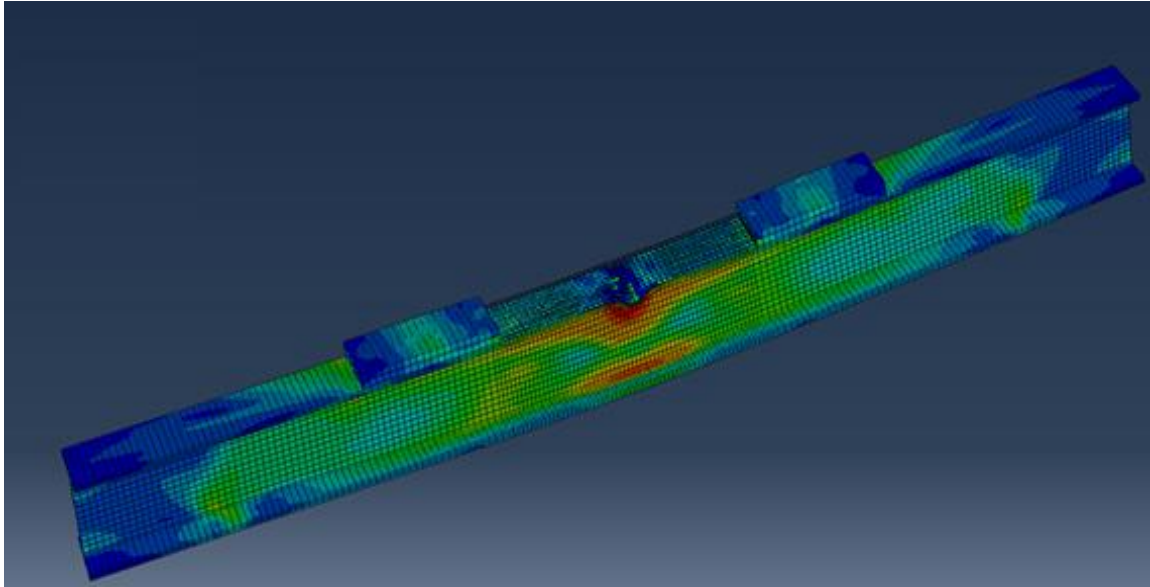
Figure A.11: Failure mode obtained in the FEA model for R40-15L-3C specimen

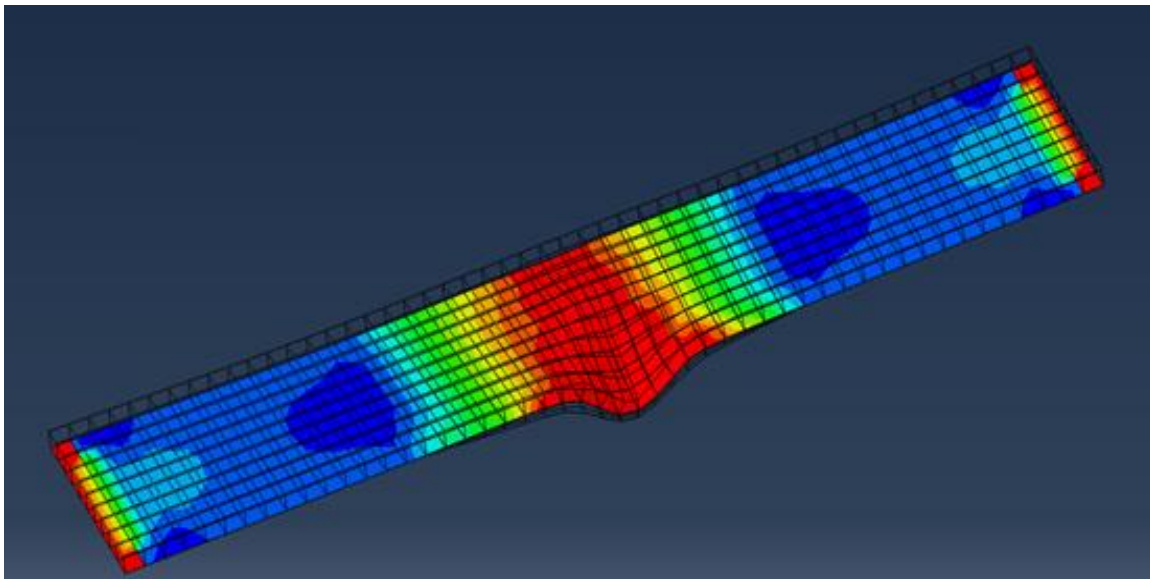
Figure A.12: Damage in BFRP modelled using Hashin Criteria for R40-15L-3C

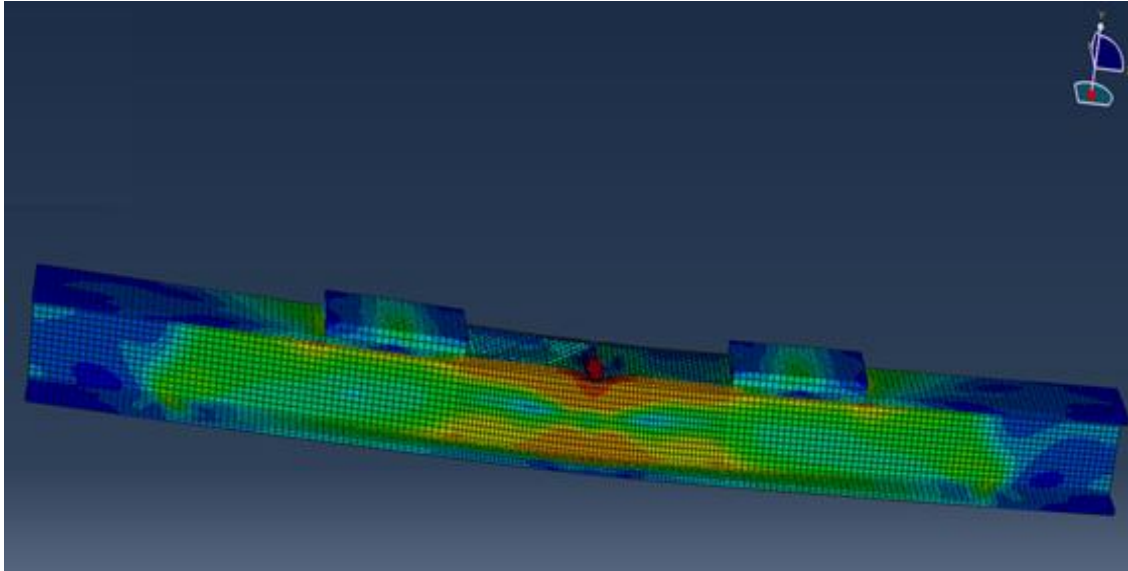
Figure A.13: Failure mode obtained in the FEA model for R20-7L-3C specimen

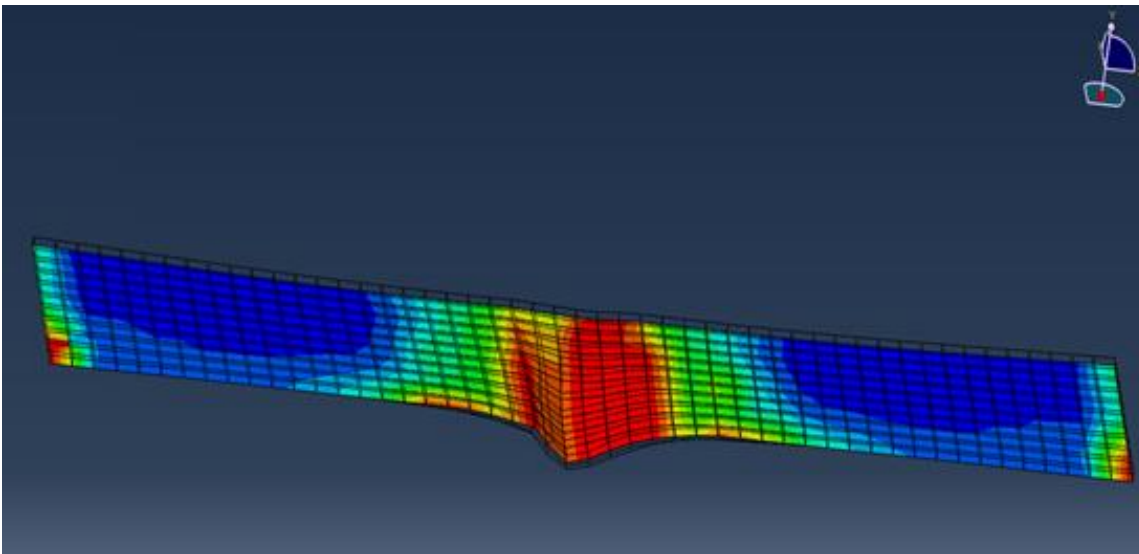
Figure A.14: Damage in BFRP modelled using Hashin Criteria for R20-7L-3C
