TITLE: PROBABILISTIC RISK ASSESSMENT FOR THE
LOS ALAMOS MESON PHYSICS FACILITY WORST-CASE
DESIGN-BASIS ACCIDENT

AUTHOR(S): M. Sharirli
J. M. Butner
J. L. Rand
R. J. Macek
S. J. McKinney
M. L. Roush

SUBMITTED TO: Probabilistic Safety Assessment International Topical Meeting
January 26-29, 1993
Clearwater Beach, FL

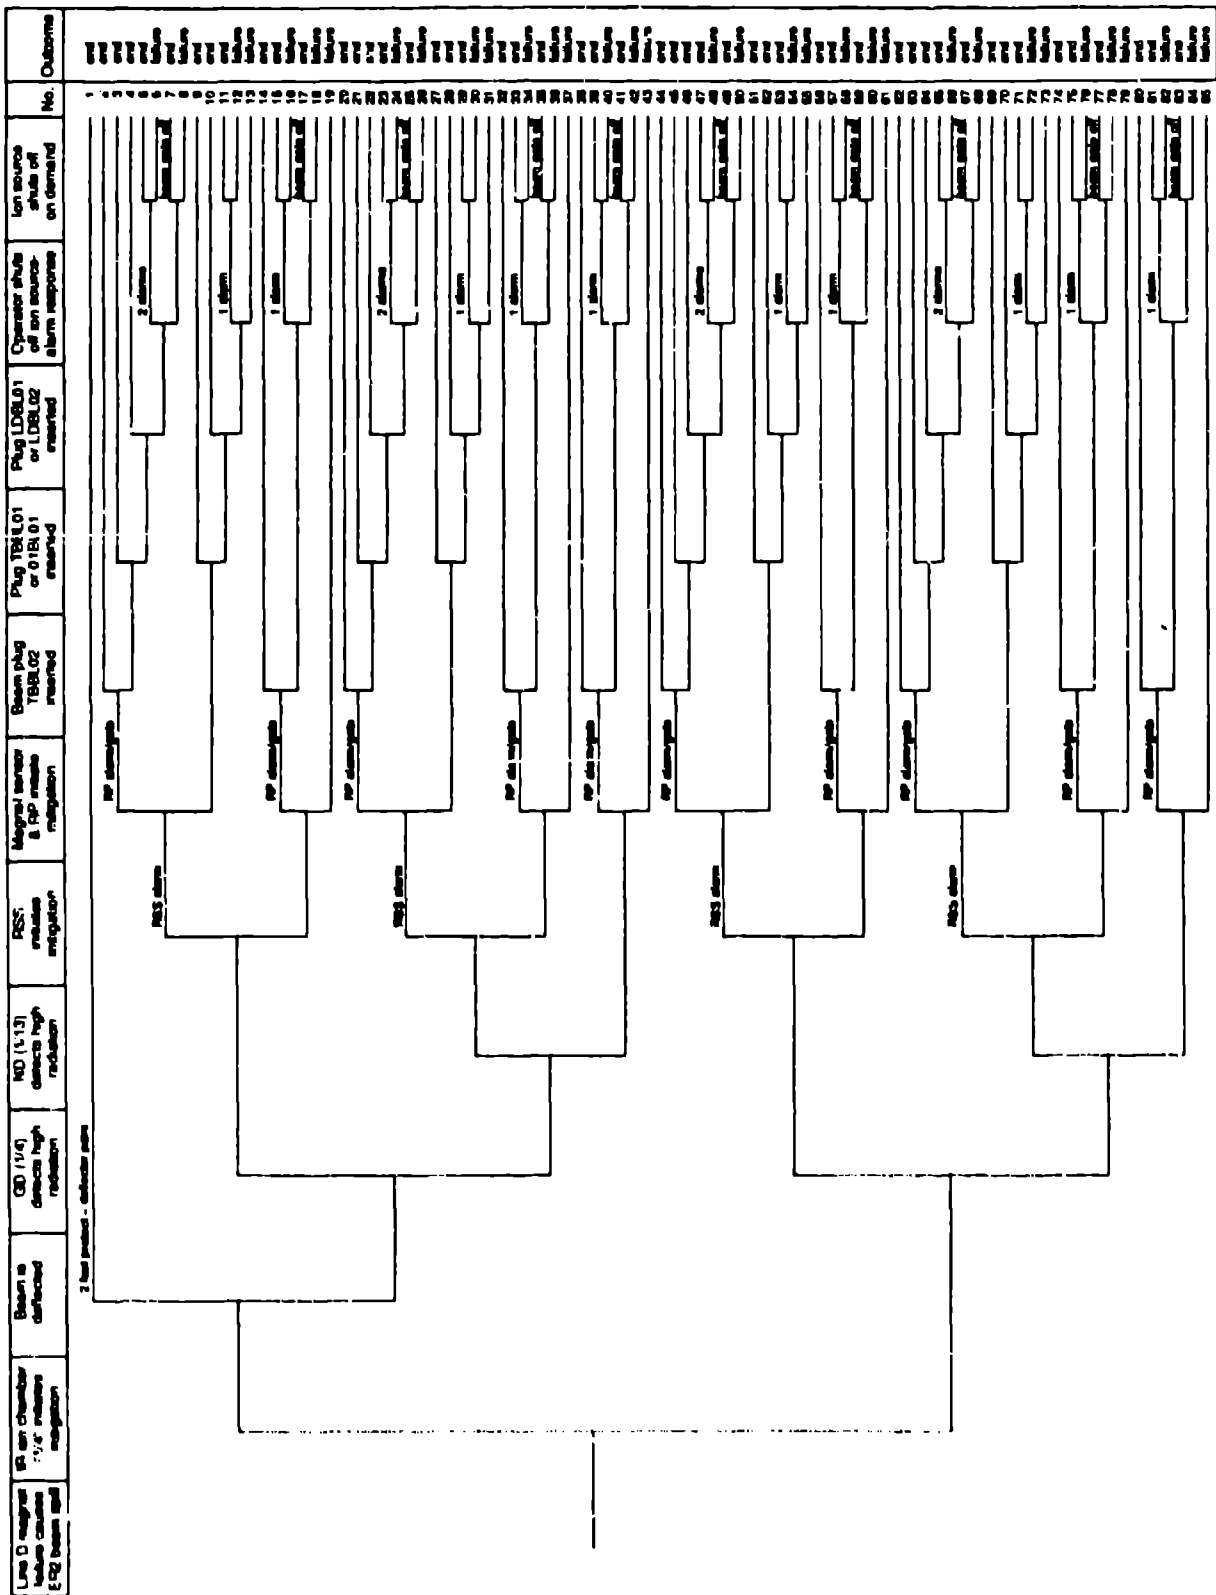
FIGURE 1 EVENT TREE FOR ANALYSIS SCENARIO

The accident-sequence event tree for the LAMPF accelerator 1L beam spill initiated by a 1LMP01 90° beam-steering magnet failure is shown in Fig. 1. For this analysis, several systems, such as the two FP electronics and their associated deflectors, were consolidated into single event tops in order to minimize the number of sequences. The following section discusses the general procedures used to quantify event-tree branch probabilities.

Referring to Fig. 1, there are 11 system responses to the 1LMP01 90° beam-steering magnet initiator design-basis accident (DBA). These responding mitigating systems can be grouped into four categories: sensors and analog electronic mon-

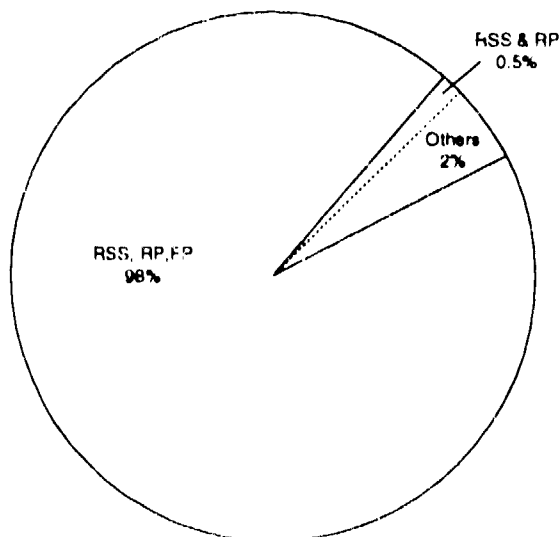
FIGURE 2 ACCIDENT EXPOSURE FREQUENCY CONTRIBUTION RESULTING FROM THE LOSS OF FUNCTION ON RSS, RP, AND FP SYSTEMS

As seen in Fig. 2, which illustrates the percentages of total exposure-frequency resulting from three classes of accidents, the dominant accident sequences involve simultaneous failures of the FP, the RSS, and the RP systems. The high unreliability of the FP is the largest contributor to these dominant sequences, whereas RSS and RP reliabilities are reasonable for safety-grade systems. A reduction in the point value of the FP system to a value comparable to the other radiation protection systems lowers the total accident sequence frequency by approximately 95%.
