# Repair of Wood Piles with Fiber Reinforced Composites

# **REPAIR OF WOOD PILES WITH FIBER REINFORCED COMPOSITES**

A THESIS

Master of Science

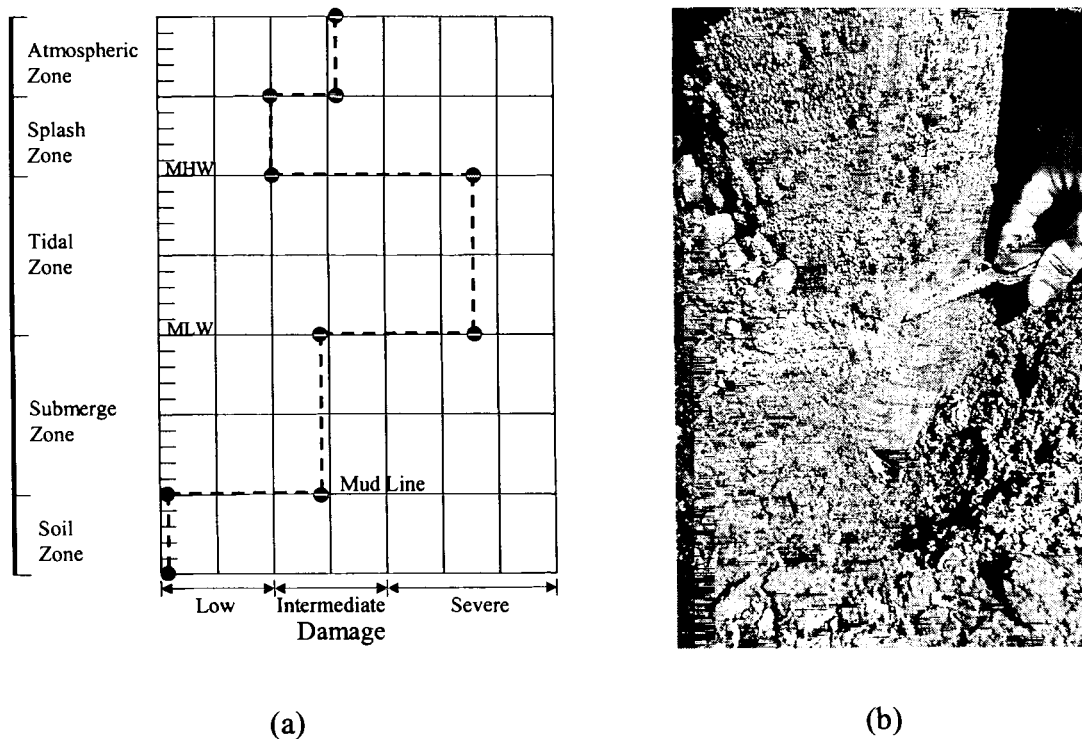
Figure 2.7 - (a) Typical Damage Profile of a Wood Pile; (b) Wood Pile at Mudline in Portland Harbor, Maine.

This exposure variation affects the type and the extent of damage produced by marine organisms. A typical damage profile in the different zones of a wood pile is illustrated in Figure 2.7(a). Similar to the case of corroded steel piles in marine structures (Coburn 2000), inspection of marine wood piles indicate the presence of five different zones: Atmospheric, splash, tidal, continuously submerged, and soil. Wood pile damage due to marine organisms in each zone is assessed.

The soil zone is the zone below the mudline. In general, this zone does not require maintenance. In this zone there is no oxygen available, which prevents the survival of marine borers. For this reason, wood piles below the mud line are generally in good condition. In Figure 2.7(b) it can be observed that above the mud line some reduction in cross sectional area occurred, but below the mudline there is no visible reduction.

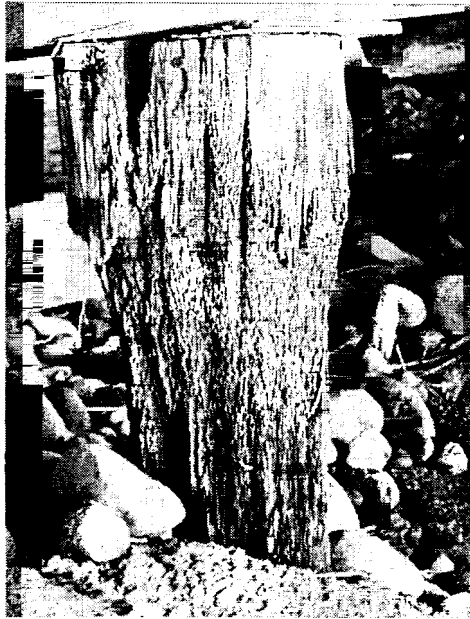
Figure 2.13 - (a) Damage by Gribble, Portland, Maine; (b) Damage by Fungi, Portland, Maine

Damage was observed at the Portland pier in several wood piles, as shown in Figure 2.13. In some cases, a loss of cross section (necking) up to 70 percent was observed. It was

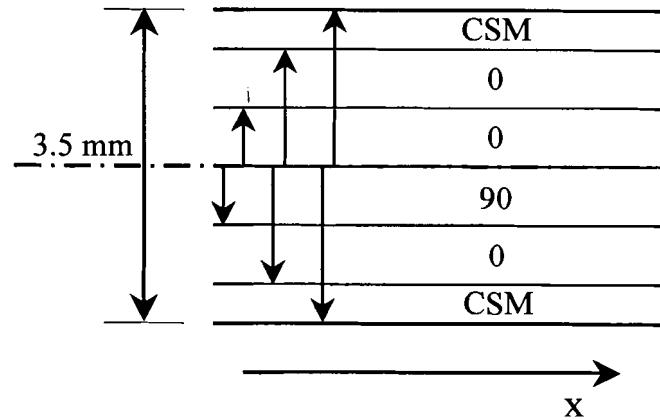
The fiber architecture design is based on maximizing fiber reinforcement in the axial direction with a minimum amount of fibers oriented in the hoop direction. Axial fiber reinforcement contributes to both bending and axial stiffness and strength of the shell, which is required to splice the damage portion of the wood pile. Hoop fiber reinforcement provides adequate integrity to the flexible shell with the required shear strength and mechanical fastener support. One CSM layer was placed on each face of the shell laminate to provide improved bonding to the substrate and to develop a resin rich area for environmental protection. The resulting laminate lay-up of the FRP composite shell is [CSM, 0, 90, 0, 0, CSM] (See Figure 3.8).

Figure 3.8 - FRP Composite Shell Laminate Lay-Up

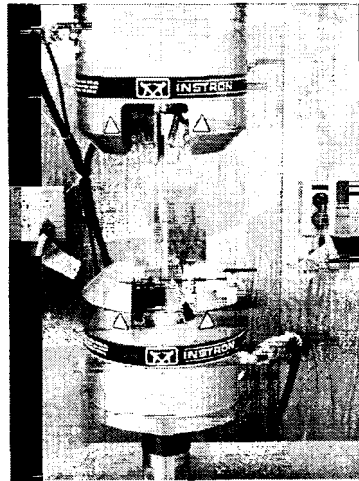
The lap shear tests were conducted using a 100 kN servo-hydraulic loading frame (Instron 1998) in a controlled ambient environment with a temperature of 22°C and a relative humidity of 45% (See Figure 4.8). A total of 18 specimens were tested, 9 control and 9 exposed to freeze-thaw cycles. The specimens were loaded in tension in the displacement controlled mode at a rate of 13 mm per minute. The maximum applied load and the mode of failure were recorded.

Figure 4.8 - Lap Shear Test Setup

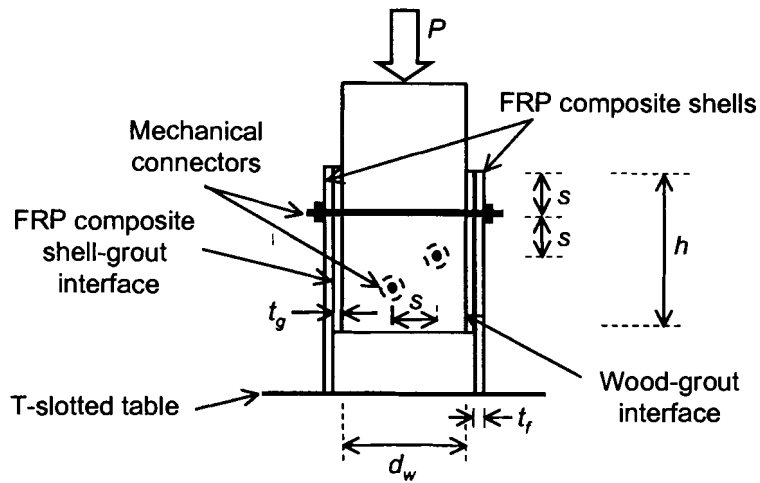
A schematic applicable to both repair systems C and D is shown in Figure 5.8.

Figure 5.8 - Schematic of Test Set-Up for Repair Systems C and D

The compression load was applied to the wood pile, and it was transferred to the grouting material and the FRP composite shield through shear stresses at the interfaces and shear force, depending on the repair set-up, at the connectors (See Figure 5.3, Figure

spacing,  $s$ , as shown in Figure 5.8. The end distance adopted was equal to the rod spacing ( $s = 102$  mm) (See Figure 5.8).

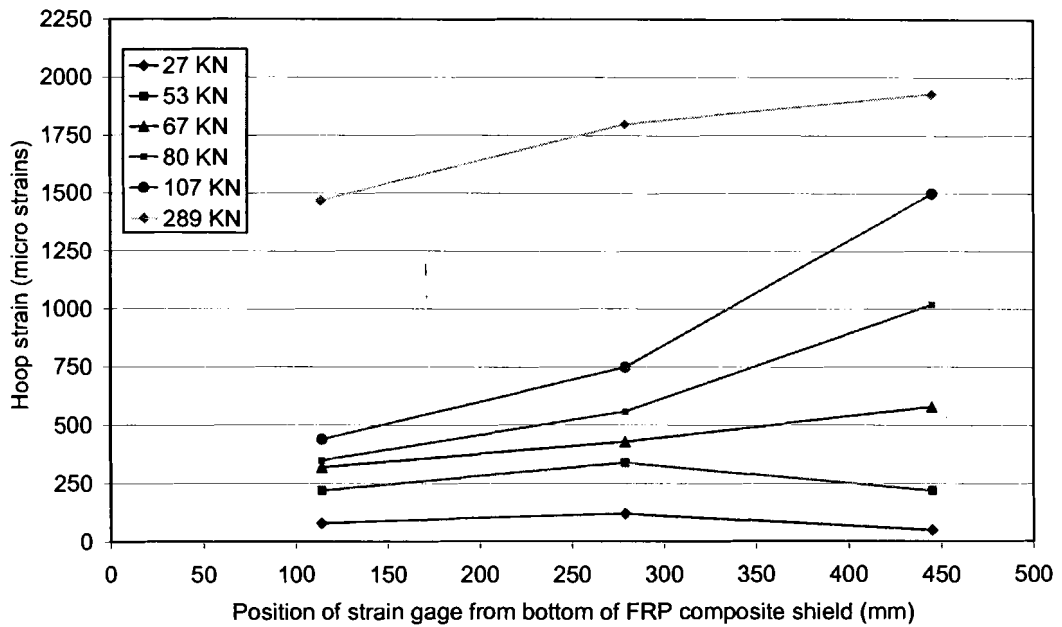
Figure 5.20 – Hoop Strain Distribution on outer FRP Composite Shell for Different Load Levels for Repair System A (Specimen A1)

The strain profiles for repair system A (specimen A1) and B (specimen B2) are depicted in Figure 5.20 and Figure 5.21, respectively.

In the case of specimen A1 (undamaged wood pile), an almost uniform strain distribution was observed for initial loading (See Figure 5.20). When slip developed at the interface between the grout and the innermost FRP composite shell, hoop strains increased markedly with the height (i.e., the upper portion of the shell was subjected to greater hoop strain). By correlating the center strain gages at opposite circumferential locations, strain gages 2 and 4, a strain difference that was attributed to unavoidable load eccentricity was observed (See Figure 5.22).

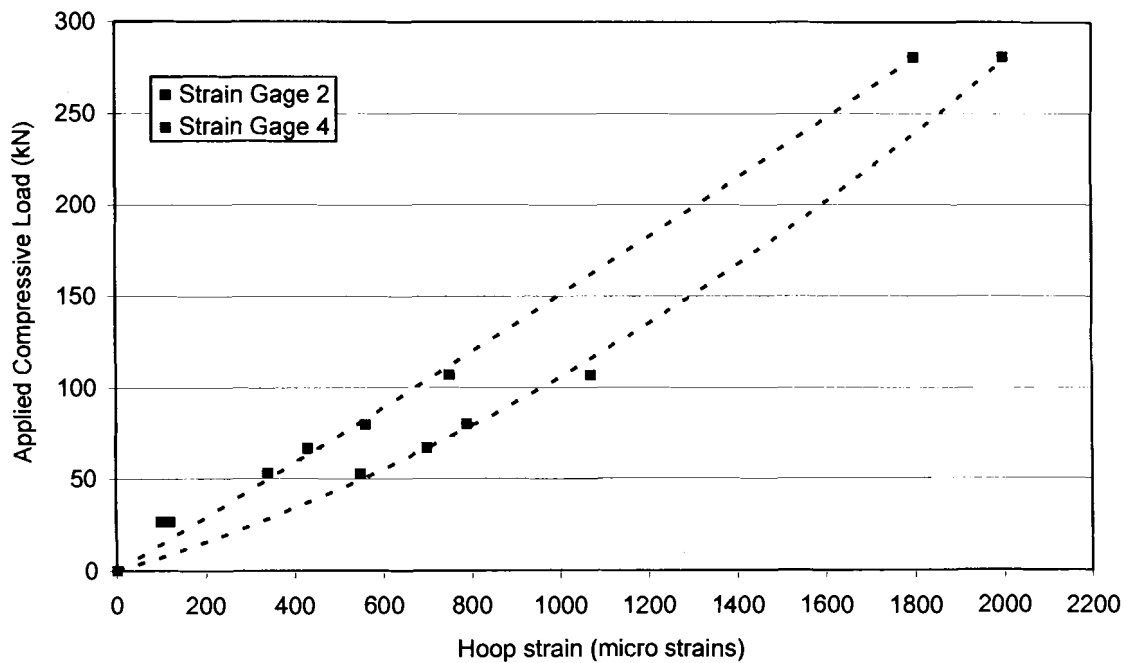
Figure 5.22 – Hoop Strain versus Applied Compressive Load at Opposite Circumferential Locations for Specimen A1

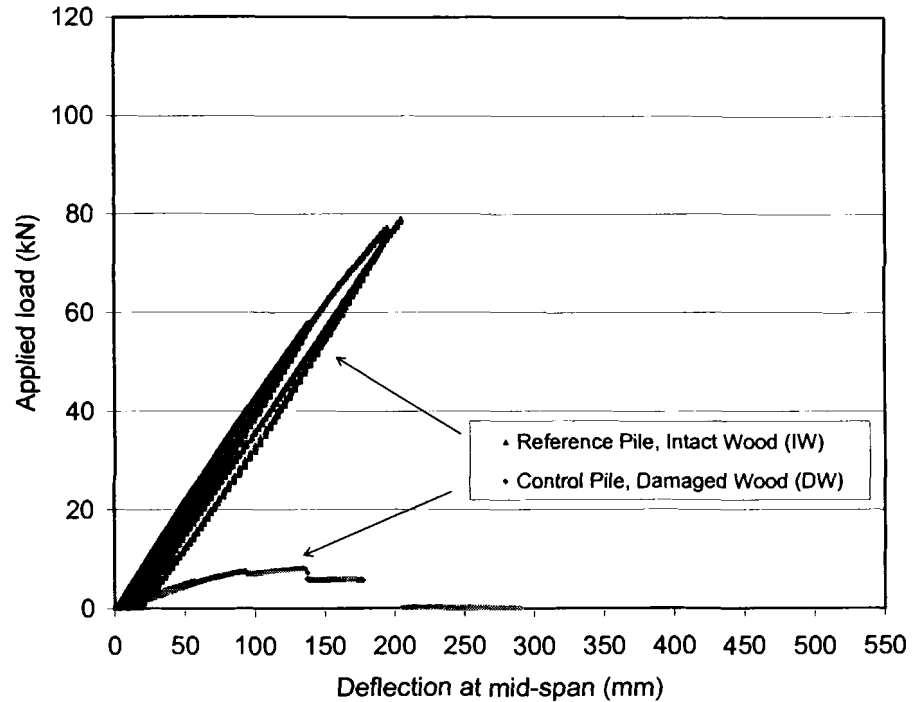
Figure 6.6 Load-deflection response for intact reference pile (IW) and damaged control pile (DW).

The reference wood pile, IW, was tested intact to provide the baseline response. The load-deflection response of the reference pile was linear to failure, as shown in Figure 6.6. The peak load reached by the reference pile was 79 kN. The wood pile under bending failed in tension at the mid span location where the load was applied. After failure, re-loading was not possible for the reference pile.

The control pile, DW, was pre-damaged with its cross sectional area reduced by 63%. This pile was tested to characterize the behavior of a damaged wood pile. The load-deflection response of the control pile is shown in Figure 6.6. The peak load corresponding to the control pile was 8.2 kN. The 63% reduction in cross sectional area diminished the wood pile bending capacity to one-sixth of the intact reference pile (IW) value. Under bending, the damaged control pile failed in tension at the damaged section. After failure, re-loading was not possible for the control pile.

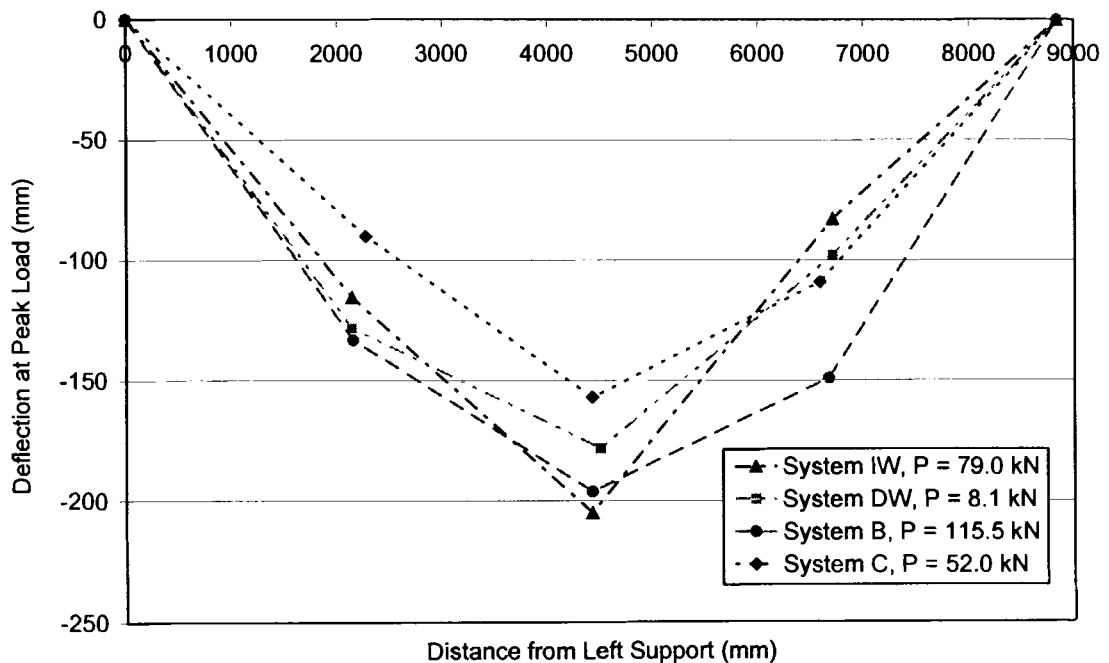
The deflected profiles at peak load for all pile systems are depicted in Figure 6.12. It was found that the repair system B with the cement-based grout resulted in a maximum mid-span deflection of 196 mm, which is similar to the corresponding value for the reference intact wood pile IW, 205 mm. The repair system B resulted in a decrease in curvature in the maximum bending moment region compared to the reference and control piles (i.e., smoother change in deflection slope along the pile axis). This is a consequence of the increase in bending stiffness over the repaired length of the pile.

Figure 6.12 Deflected shape at peak load for all pile systems.

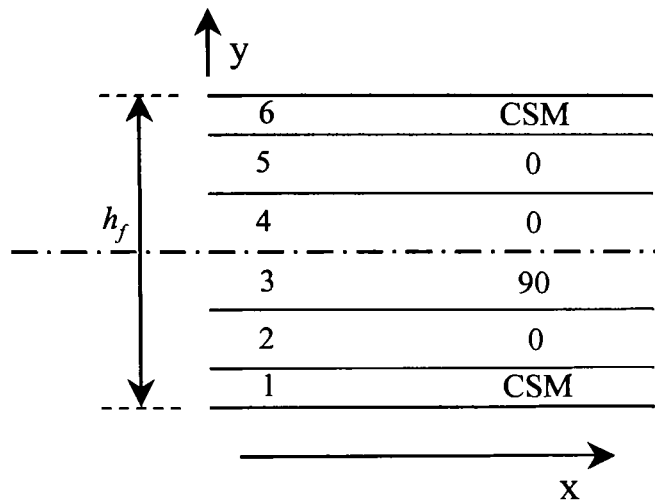
strength and mechanical fastener support. One CSM layer was placed on each surface of the shell laminate to provide improved bonding to the substrate and to develop a resin rich area for environmental protection. The resulting laminate lay-up of the FRP composite shell is [CSM, 0, 90, 0, 0, CSM] (See Figure 7.2). An epoxy-based vinyl ester resin, Derakane 411-C50, was selected as the matrix for the composite shells (Dow Chemical 1999). This resin has a viscosity of 0.15 Pa.s and is well suited for SCRIMP™ processing.

Figure 7.2 - FRP Composite Shell Laminate Lay-Up
