AN ANALYSIS OF CURRENT INTERRUPTION UPON THE BEHAVIOR OF
LIGHT BULB FILAMENT DURING INITIAL AIRCRAFT IMPACT IN SUPPORT
OF AIRCRAFT ACCIDENT INVESTIGATIONS

A thesis submitted to the
Faculty of the Department of Aeronautical Science
in partial fulfillment of the requirements
for the degree of
Master of Aeronautical Science

Embry-Riddle Aeronautical University

November 21, 1997

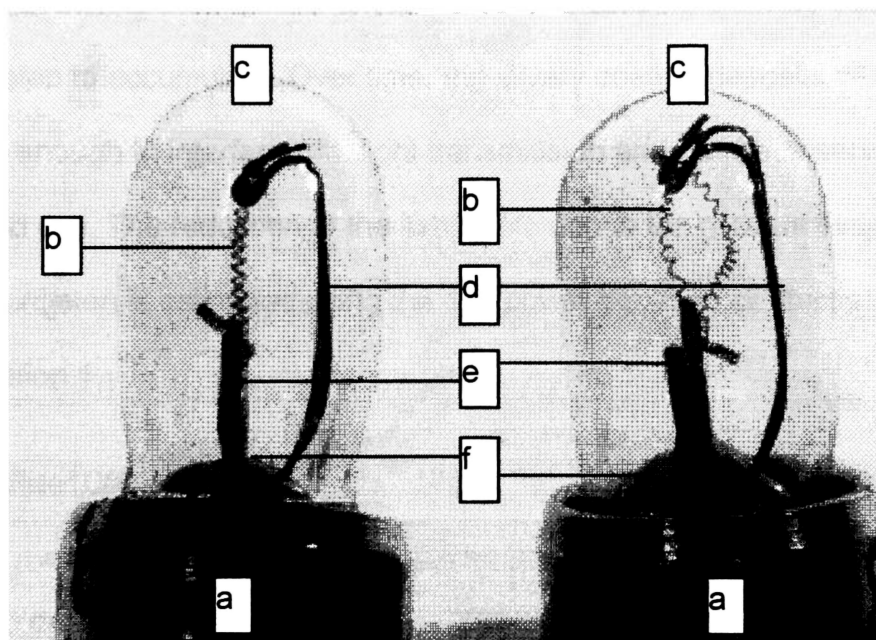
The typical aircraft light bulb is composed of eight basic components that are identified as: (a) the base, (b) the tungsten filament, (c) the glass envelope, (d) the support posts, (e) the contact posts, (f) the mounting lugs or bead, (g) the external contacts, and (h) the insulator. Figure 17 shows the locations of six of the eight basic components of a sub-miniature lamp; not shown are the external contacts and insulator.

Figure 17 Basic components of a #6839 sub-miniature lamp
(Provided by the Canadian Aviation Safety Board)

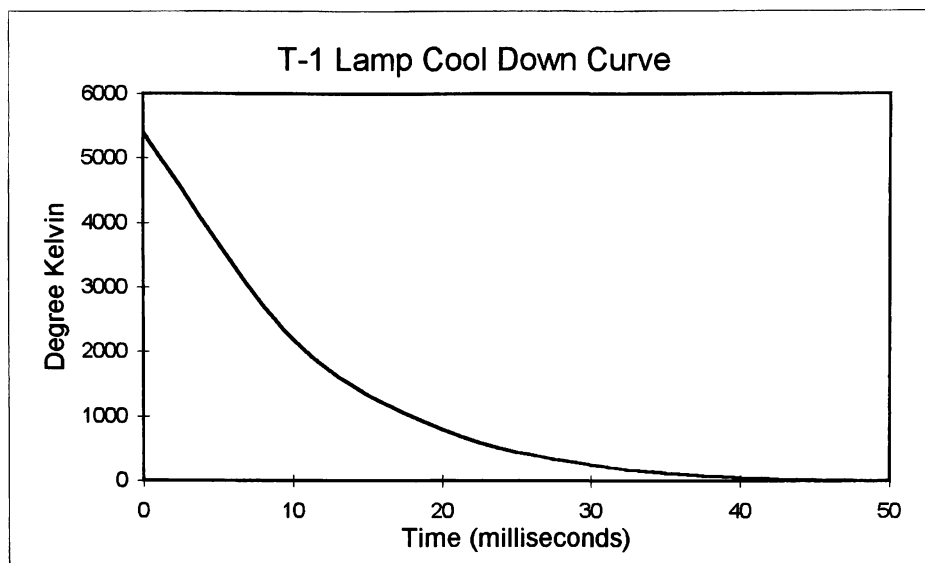
The Lamptronix Company provided the illumination and cool down times for the T-1 lamps used in this study. Both lamps require 48 to 50 milliseconds to reach complete illumination and cool down states. The cool down time depends on color temperature and not lamp voltage. Figure 20 demonstrate the rate of cool down of the T-1 lamp.

Figure 20. Cool down time curve for the T-1 lamps.

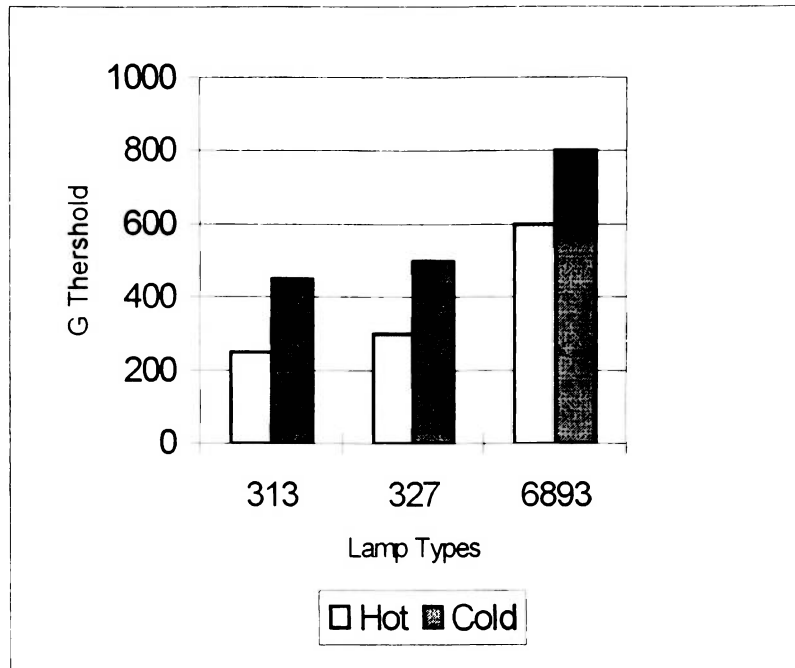
The nature and severity of the accident sequence are the primary mechanisms governing the filament's behavior. In a crash, the kinetic energy of the aircraft is reduced to zero by converting the energy into G forces of several milliseconds to several seconds. The deceleration forces can reach peaks of several hundred to several thousands Gs. The behavior of the filament is partly governed by the lamp's G threshold. Each type of lamp: T-1, T-1¼, T-1¾ has an on and "off" G level threshold. When deceleration forces exceeded the filament's threshold, deformation is expected to occur. The thresholds depend on the size of the lamp and its state at the time of impact. A cold lamp's G threshold will be greater than a hot lamp's G threshold. Figure 21 shows the thresholds for several types of lamps (Canadian Aviation Safety Board, 1985; Heaslip, Poole, & Vermij, 1985).

Figure 21. G thresholds for the #313, #327, and #6839 lamps. (Galler, Glover, & Kusko, 1994)

As the diameter of the lamp become smaller, the G level thresholds becomes greater. A T-1 lamp, cold, can withstand approximately 800 g's as compared to 500 g's for a T-1¼ lamp.

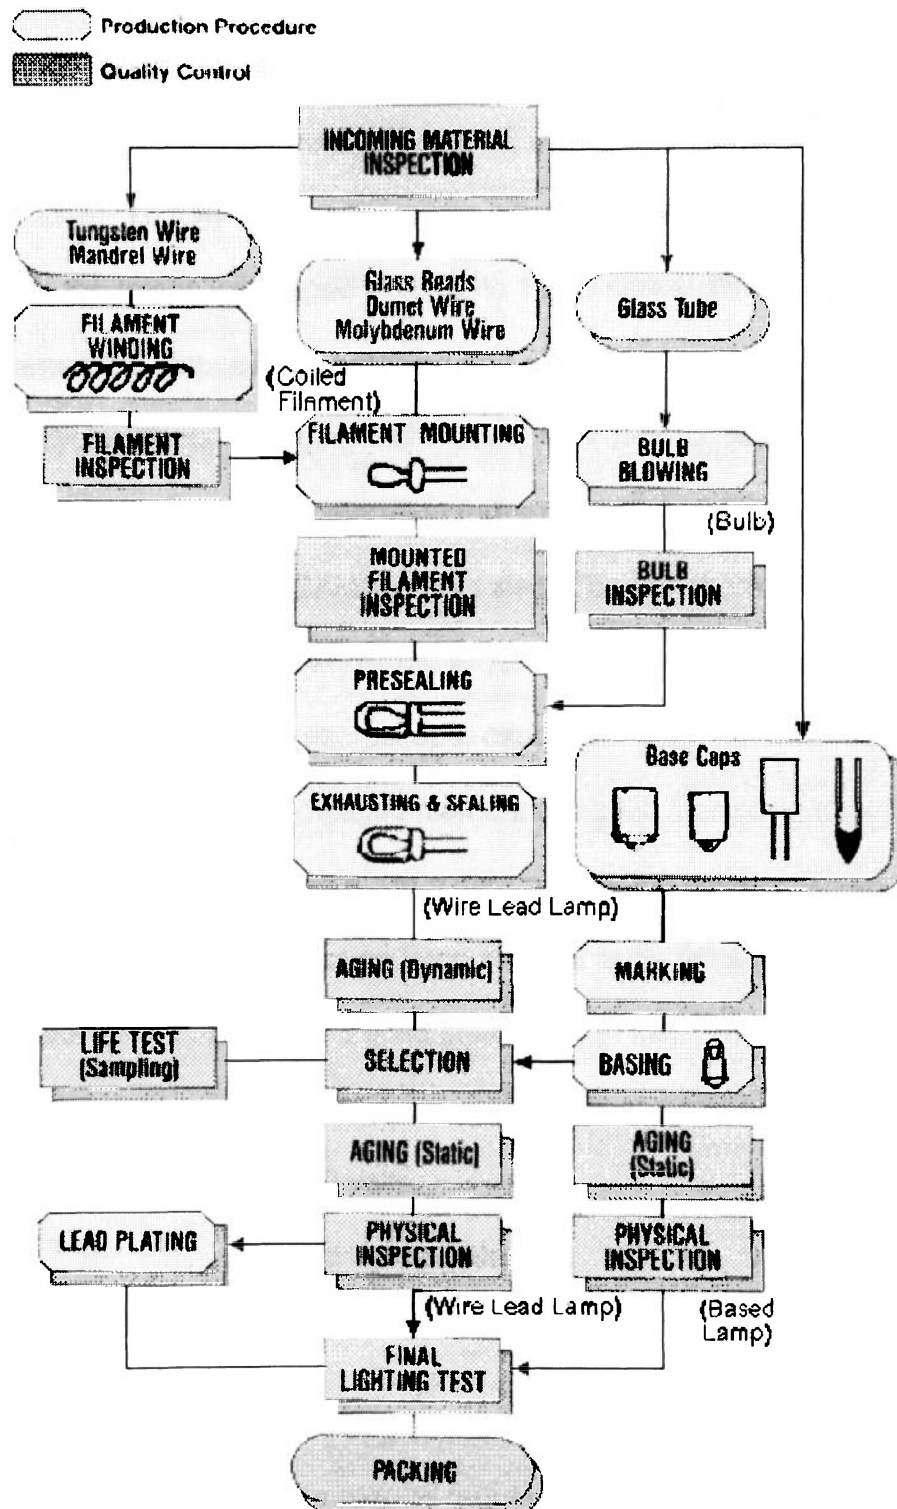
Figure 42. Production and quality control flow chart of lamps.
 (Oshino lamp catalog & technical manual, 1997)

The subjects of this study were 120 commercially available T-1 five volt and another 120 T-1 twenty-eight volt aircraft bulbs. There was no necessity for random sampling because the materials used were already inspected and the production lamps use a computer-controlled manufacturing processes to ensure quality control. Figure 42 illustrates the quality control exercised during the manufacturing process. The bulbs arrived at Embry-Riddle Aeronautical University, Daytona Beach, Florida, via common carrier. No human subjects were involved in the study.

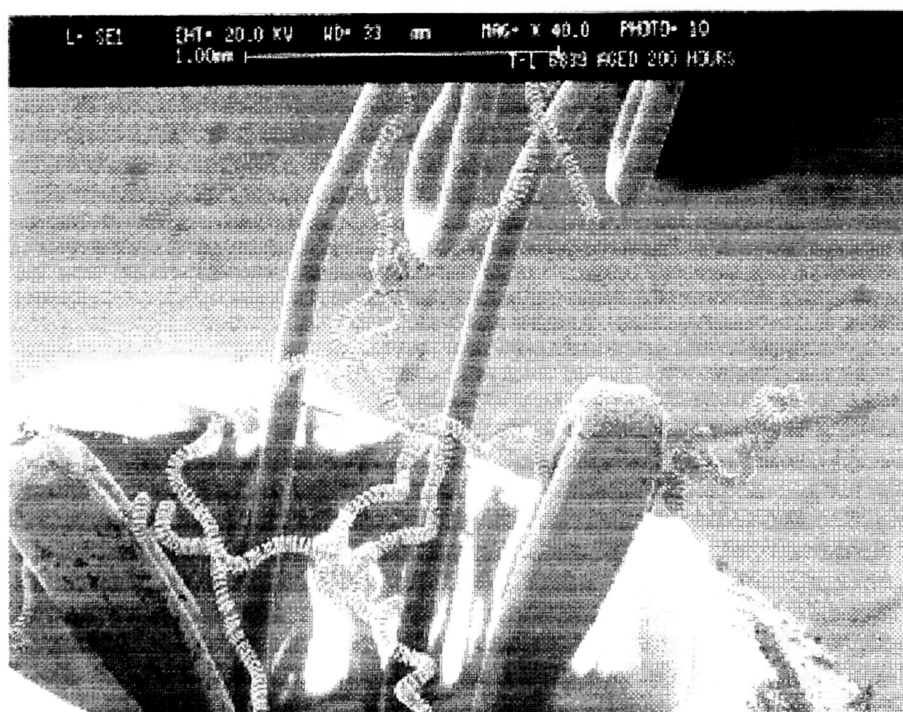
Figure 60. 36839 lamp at 50X, age 200 hours

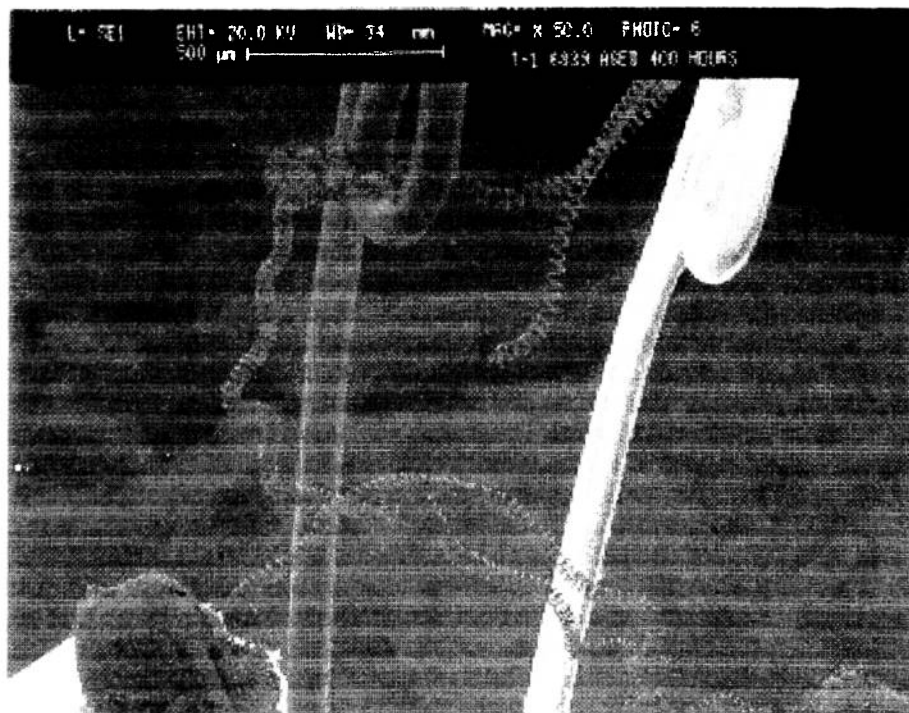
Figure 62. #6839 lamp at 50X, age 400 hours

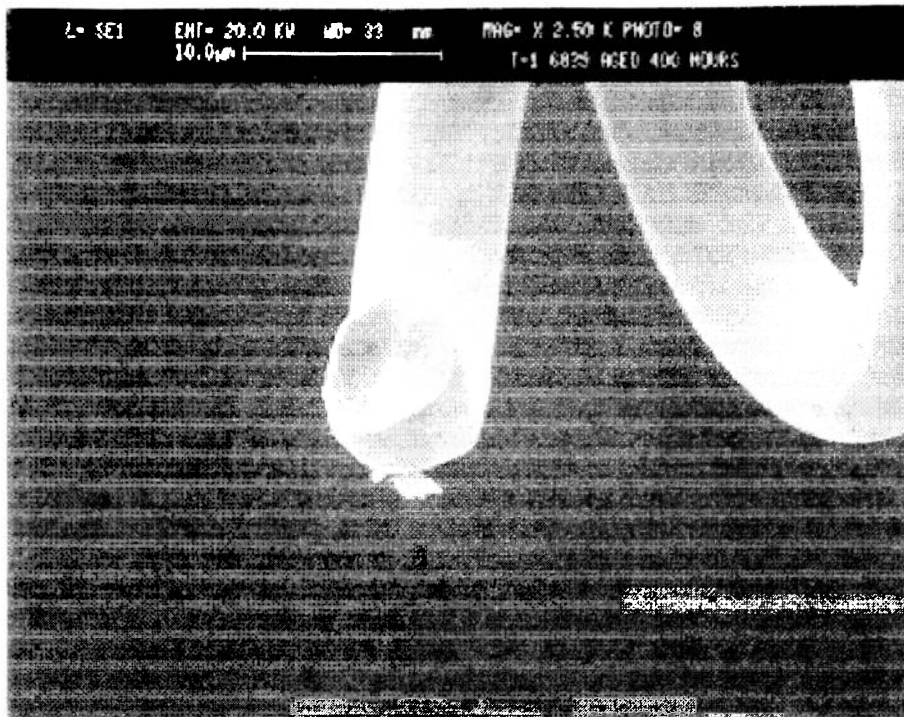
Figure 63. The fracture surface of the 400 hour age group, 2,500X

The detailed examination of the #6839 filaments revealed the fractures to be brittle in nature. The fractured surfaces displayed classic brittle indications. Magnified 2,500 times, the surfaces show sharp, cleaved edges, a smooth interior surface and no evidence of the tungsten necking down. The combination of the deformation sustained during the early portion of the impact, and the aging effects, decreased the filament's G force threshold. With the filament weakened, the modest G force exceeds the new lowered G force threshold. The fractures probably occurred when the filament was cooler and the G forces were severe enough to cause the brittle fractures.

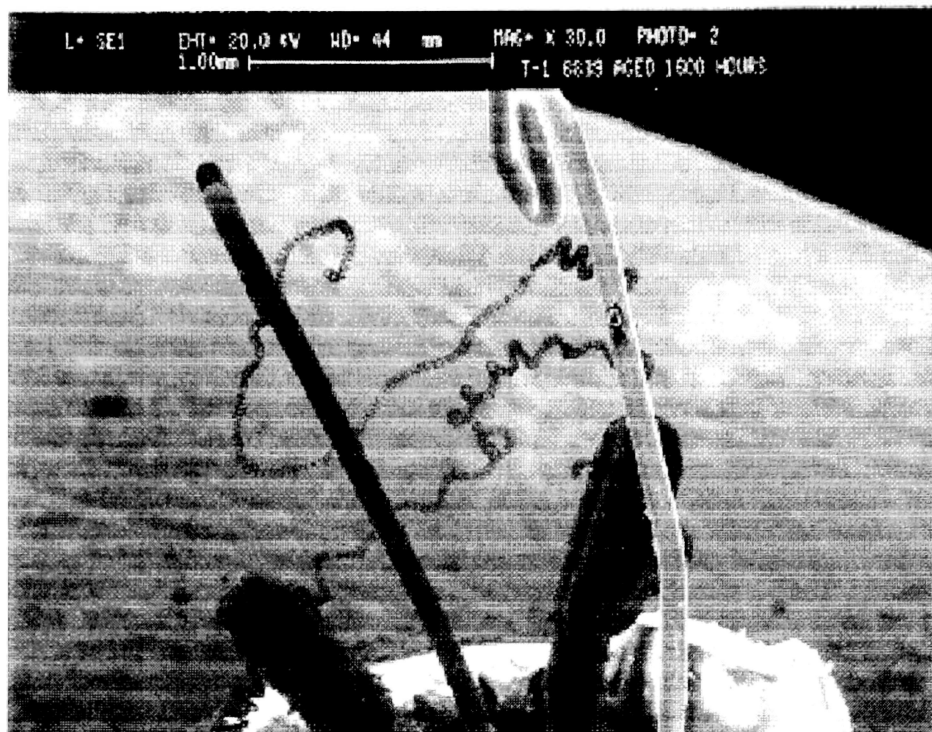
Figure 65. #6839 lamp at 50X, age 1,600 hours
