Low-velocity Impact Analysis of Composite Repair Patches of Different Shapes

A Thesis

Master of Science in Aerospace Engineering

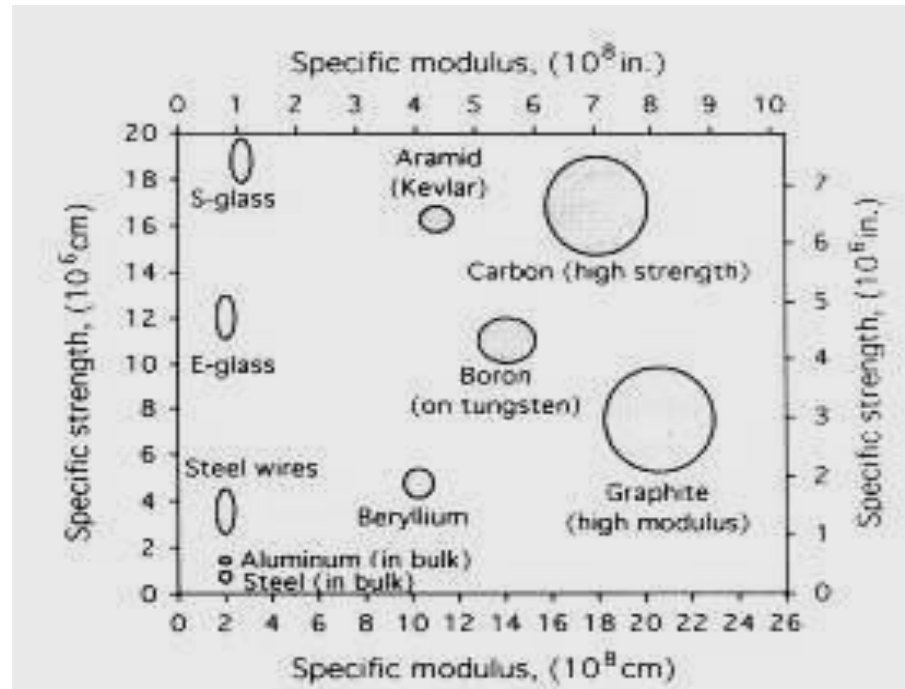
The most common form of reinforcement used is fiber. Generally most of the materials are stronger and stiffer in fibrous form as compared to any other form. Fibers have high stiffness and low density. Glass fiber, carbon fiber and boron fiber are the most common types of fiber materials used in composites. Comparison of various fibers is shown in figure 2.2.

Figure 2.3 Mechanical properties of different fiber

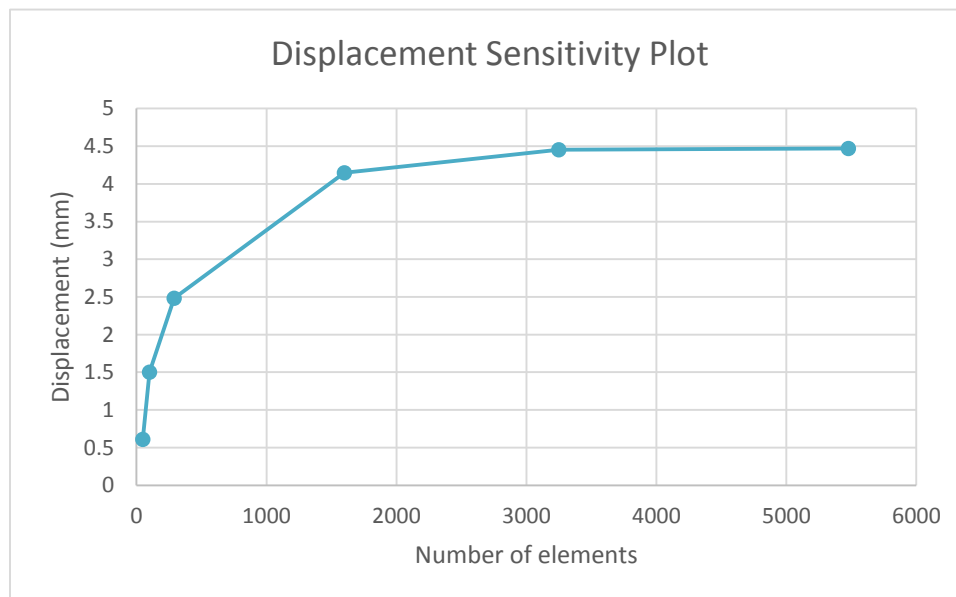
Figure 4. 5 Displacement sensitivity plot

Figure 4.7 is the plot between displacement and number of elements and figure 4.8 is a plot between Von-Mises stress and number of elements. It can be observed from the plots that the graph of displacement and Von-Mises stress converges when the number of elements are 49284.

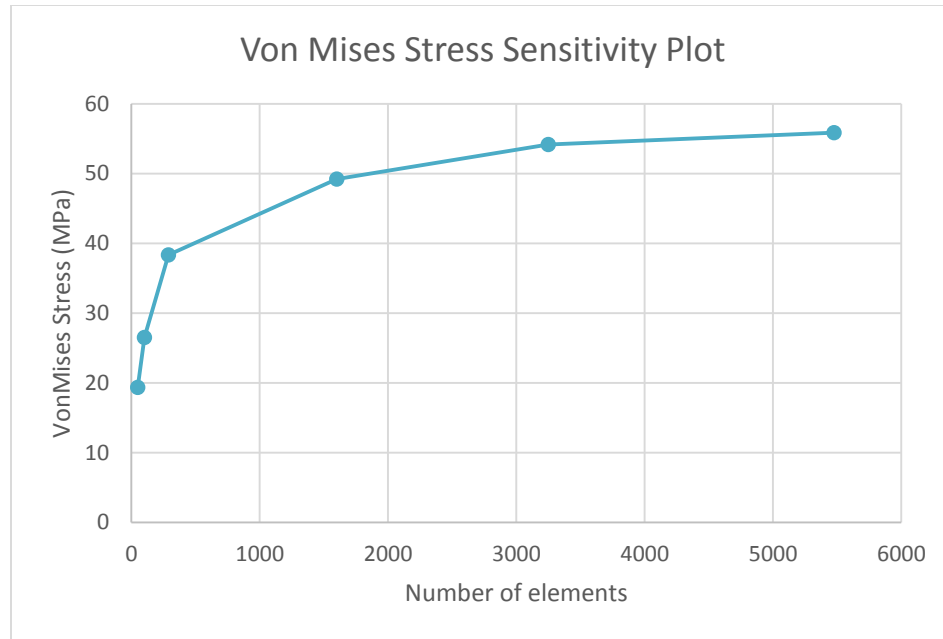
Figure 4. 6 Von-Mises stress sensitivity plot

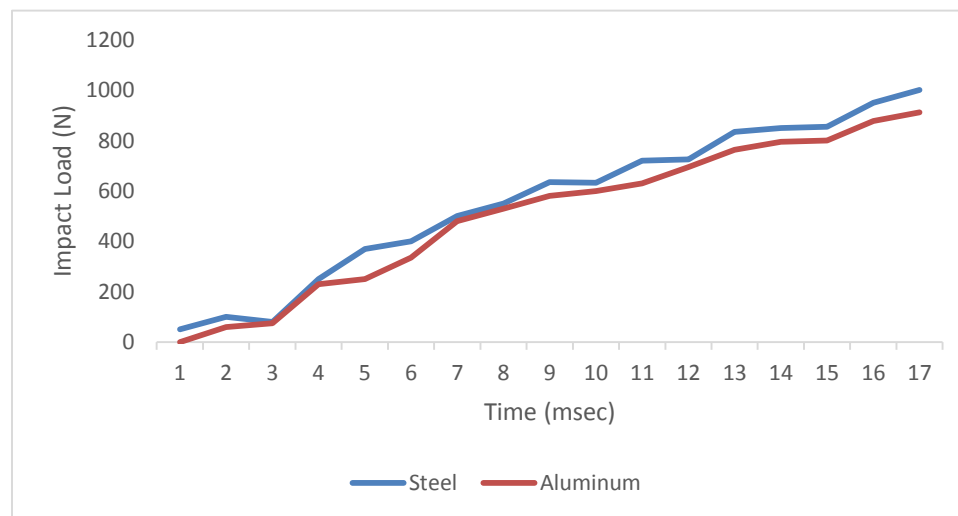
Steel and aluminum projectile were used for parametric study of impactor material. The impactor diameter and velocity were kept the same as that used in the tests. This study was specifically to see the effect of changing material of the impactor on the impact damage. There were differences observed in the impact force with the change in materials. Having the same impact velocity, aluminum and steel had the kinetic energy in a similar ratio. The maximum impact force of steel was found to be 1000.5 N and that of aluminum was 912 N. Figure 7.1 shows a plot of impact force vs time for both aluminum and steel impactor materials.

Figure 7. 1 Steel and aluminum impact comparison
