# Fire protection onboard : enhance fire safety by design

Shangchun Zhang  
*World Maritime University*

# **FIRE PROTECTION ONBOARD**

Enhance Fire Safety by Design

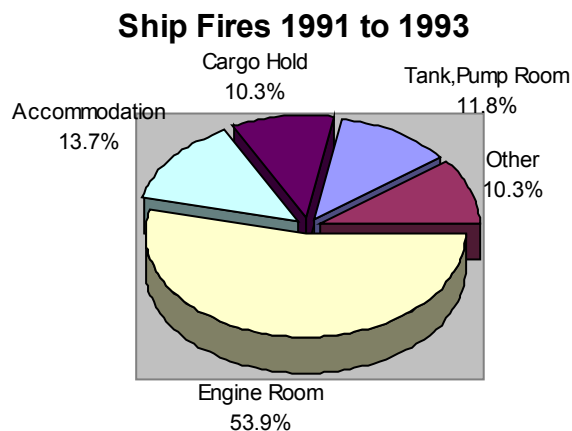
Figure 7.1

Continuing to the analysis of ship fires in Chapter 2, it was recognized that engine room fires got the highest rank sorted by location. A detailed analysis has been undertaken of fires in engine rooms which occurred during the period 1991 to 1993. Figure 7.1\* shows engine room fires accounted for almost 54% of all fires occurring between 1991 and 1993. The study of these incidents reveal that they were often initiated by explosion, or result from an uncontrolled release of flammable vapours or fuel into the engine room.

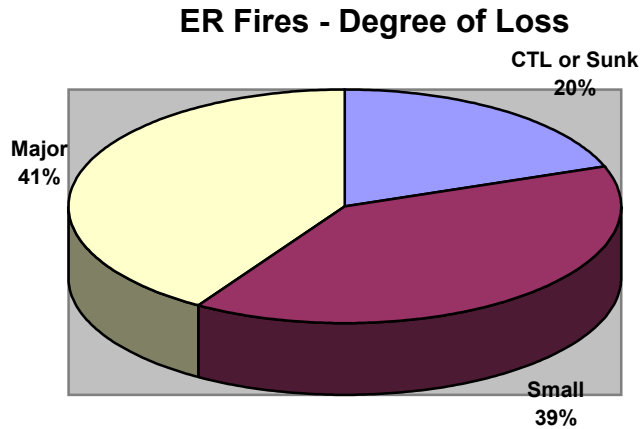
Figure 7.2 shows the degree of loss which resulted from engine room fires in the period, grouped by sinking or constructive total loss (CTL), major fires and small incidents. Over 60% of the engine room fires cause major damage to the ship.
