# Tanker accidents : double hull is not the only viable alternative

**TANKER ACCIDENTS: DOUBL HULL IS NOT  
THE ONLY VIABLE ALTERNATIVE**

**MUKKADAYIL PAILY JOHN**  
India

**MARITIME AFFAIRS**  
**(Maritime Safety and Environmental Protection)**

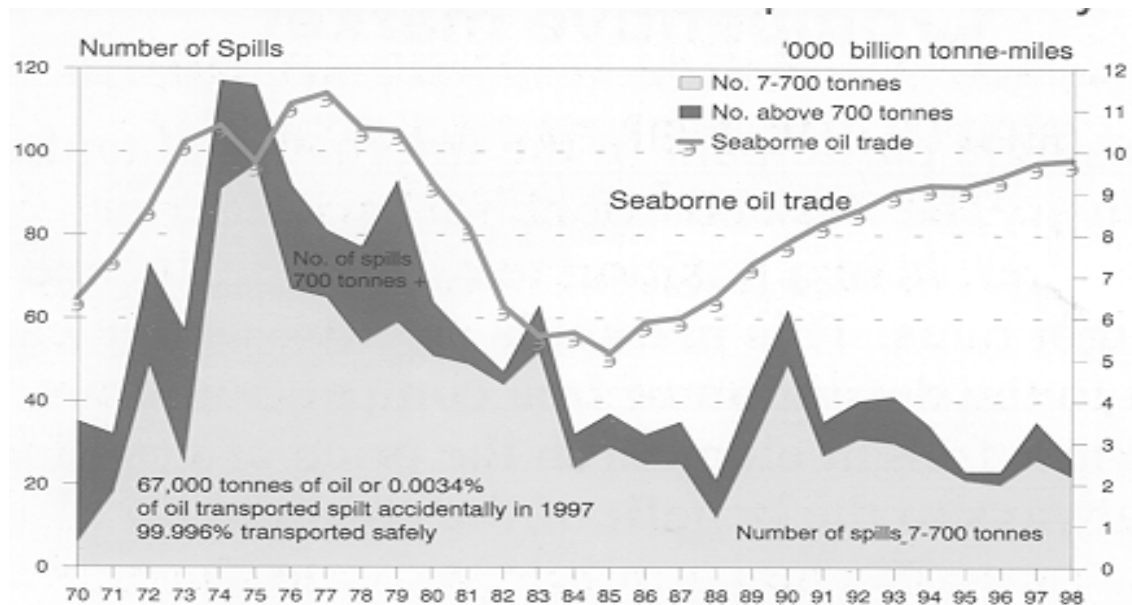
Fig.1. 99.996% of world oil transported safely

Between 1970 and 1984 oil tankers spilled about 3,824,000 tons of oil worldwide. During the next 14-year period, from 1985 to 1998, the quantity of oil spilled was reduced to 1,535,000 tons; a 60% reduction despite an 80% increase in tanker activity ('Strong improvement', 1999, p.5). (See Fig.1). The main causes for tanker accidents that have led to large oil spills include groundings on reefs, collisions with other vessels, and fires and explosions emanating from cargo. Statistics from ITOPF (2001, pp.1-3) show that the number of oil spills per year during the periods 1970-'79, 1980-'89 and 1990-'99 were 24.1, 8.8 and 7.3, respectively, and that the maximum of 34 spills were in the year 1979. Patin (1999, p.2) states that the quantity of oil spilled by tanker accidents in 1989 and 1990 were 114,000 and 45,000 tons, respectively, whereas the average volume of oil pollution caused by marine oil transportation was 500,000 tons per year.

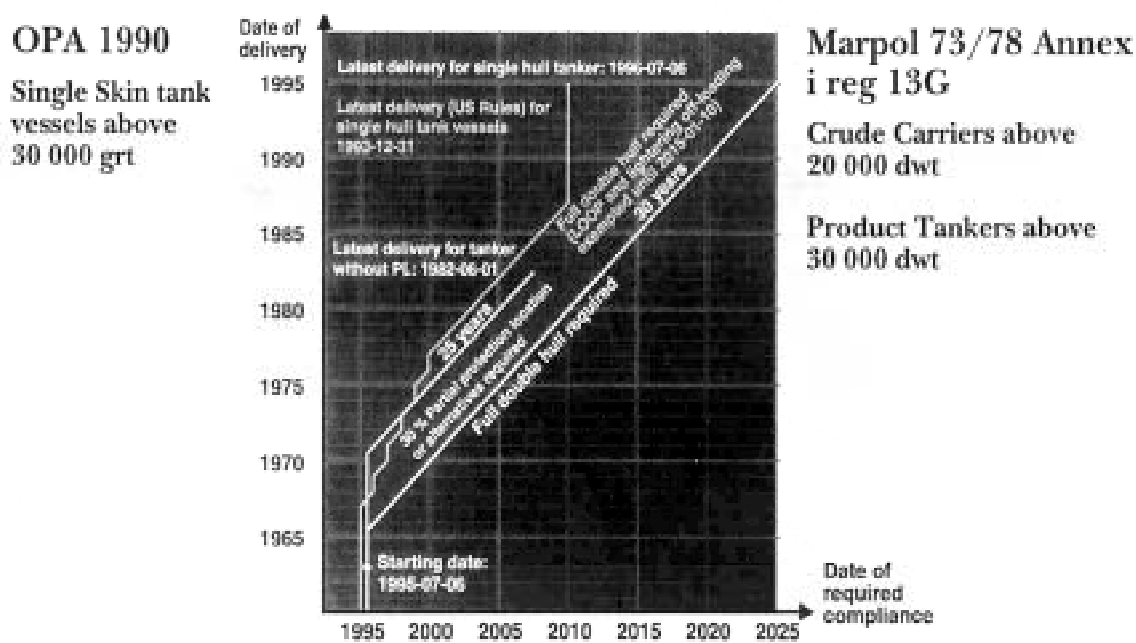
Fig. 2. Phasing out of single hull tankers under OPA 90 and MARPOL 73/78

Section 4115 of OPA 90 contains the double hull requirements and a phase out schedule for single hull tank vessels operating in US waters. According to this provision, all newly constructed tank ships must meet the double hull requirements. The phase-out dates for single hull tank ships of 5,000 GT and above are specified as a function of two variables with different dates. They are size groups with either double bottom or double hull construction. The size groups are: 5,000 – 15,000 GT, 15,000 – 30,000 GT, and 30,000 GT and above. In the present phase-out period single hull vessels up to 40 years of age are permitted for the two small sizes, with an additional five years for either double-hull or double-bottom. But a single hull vessel may not operate in US waters after January 1, 2010 and a vessel with only double bottom or double sides after January 1, 2015. (See Fig. 2). The double hull requirements do not apply to foreign vessels engaged in innocent passage.

Regulation 13G, containing the IMO phase-out requirements for existing crude oil tankers of 20,000 tons dwt and above and product carriers of 30,000 tons dwt and above, took effect from July 6, 1995. It does not apply to tankers complying with regulation 13F. (See Fig. 2). The main provisions of regulation 13G are as follows:

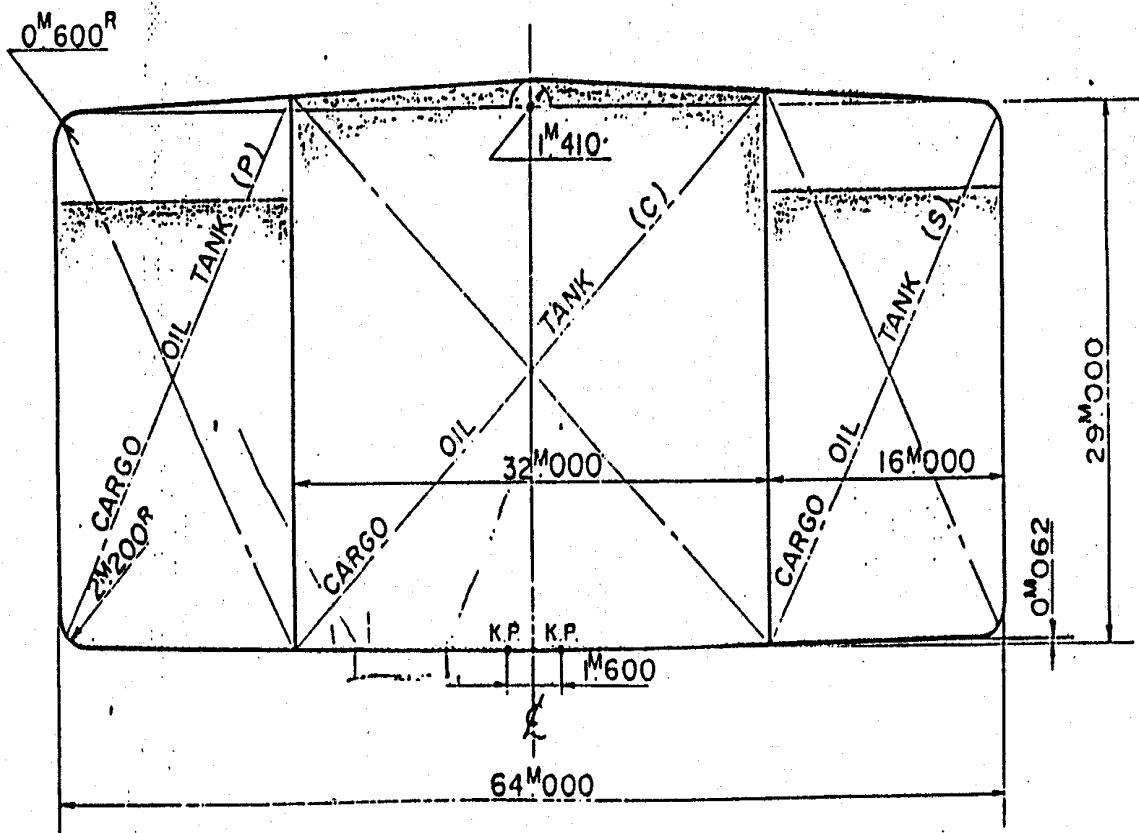
Fig. 3. Hydrostatically Balanced Loading

HBL is based on the principle that the hydrostatic pressure at the cargo tank bottom of the cargo oil column plus the ullage space inert gas overpressure remains equal to or less than the hydrostatic pressure of the outside water column, thereby mitigating the outflow of the oil in case of bottom damage. When grounded, the high pressure of the seawater pushes it into the tank forcing the cargo upwards and forming a seawater layer in the lower part of the tank. (See Fig. 3). Acceptance of this method by the administrations is based on the guidelines of IMO resolution MEPC 64(36). According to Gray (1997, p.4), the National Research Council report “ Tanker Spills: Prevention by design” speaks in a guarded way about HBL and expresses cautions. The report states that -

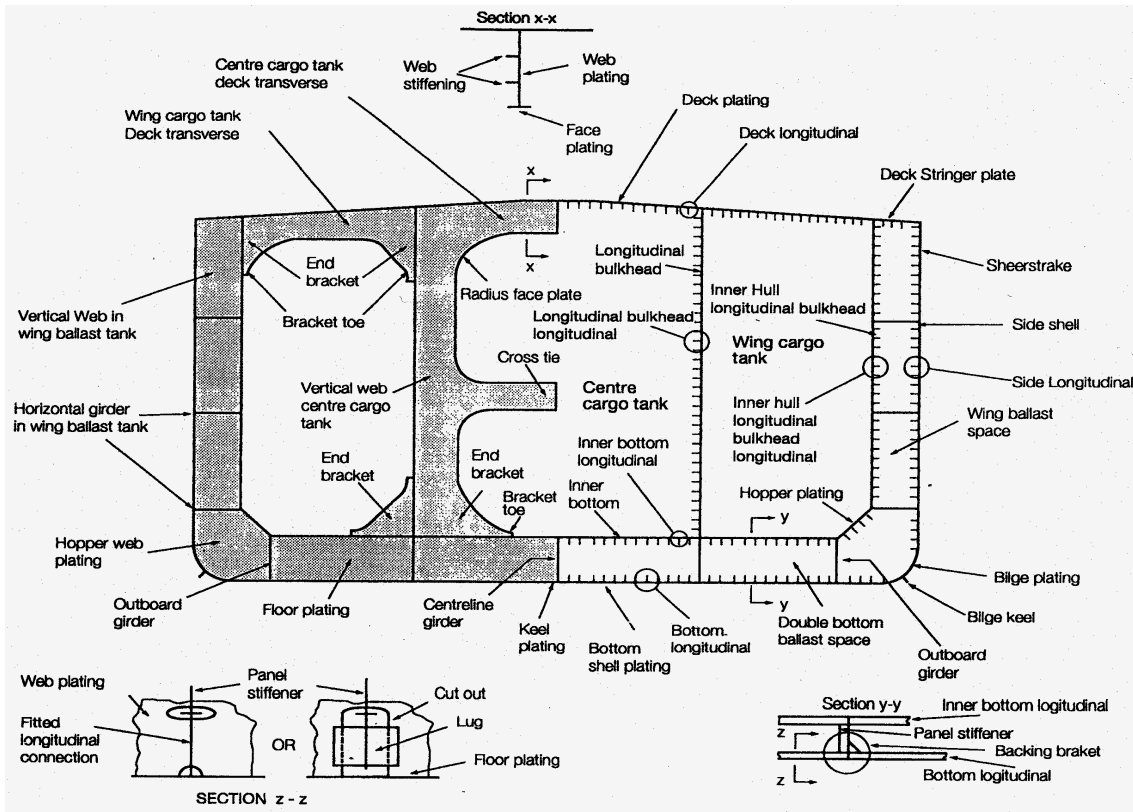
Fig. 4. Typical double hull midship section nomenclature

The double hull concept simply means that the cargo oil tanks are separated from the outer hull by means of a space large enough to absorb low-speed impacts. Fig 4 shows midship section with nomenclature of a typical double hull tanker. Björkman (1992, p.321) says that the most obvious structural solution to this requirement is to build the double hull of sandwich panels. The sandwich panels mean that the webs and stiffeners of inner and outer shells will be inside the double hull.

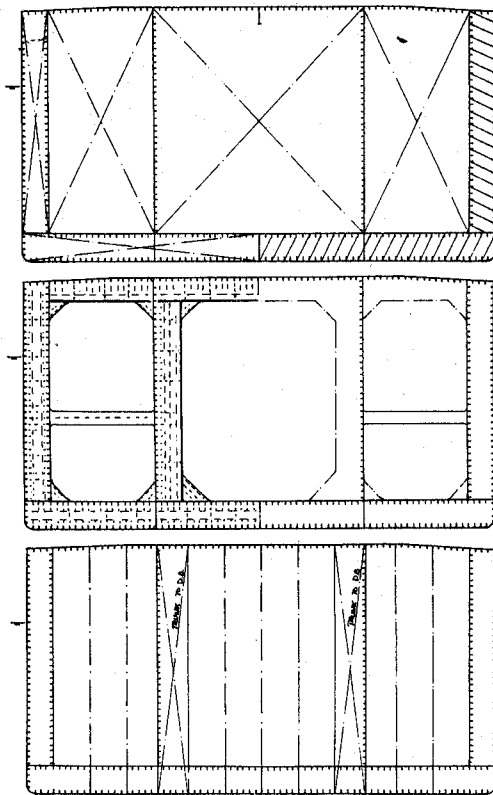
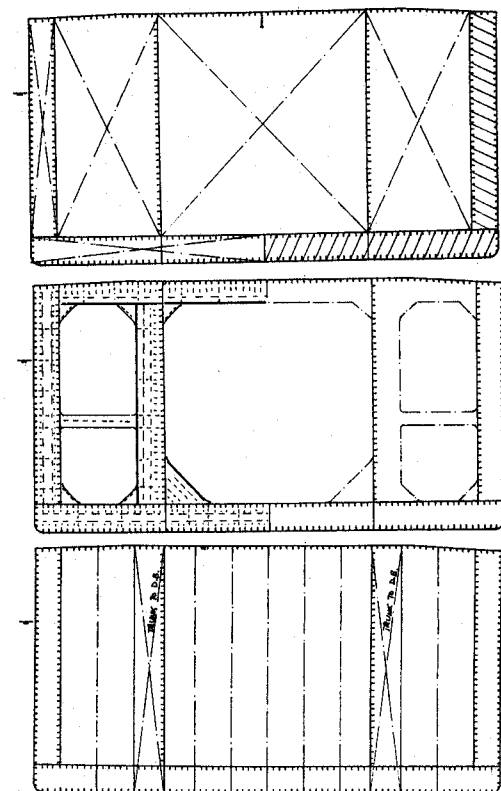
Fig. 5. Alternative A1

Fig. 6. Alternative A2

Figs. 5 and 6 are two alternatives A1 and A2, where the double hull spaces at sides and bottom have a uniform distance between inner and outer skins of 3.5 m. There are four pairs of side and double bottom ballast tanks. The main difference between A1 and A2 is in the web fitting of the longitudinal bulkhead separating centre and side cargo tanks. In A1, the web is fitted at the centre cargo tank side, whereas in A2 it is at the side cargo tank side. The access to the double bottom tank is via trunks incorporated in a vertical web on the transverse bulkhead and a longitudinal bulkhead web. The inner and outer side shell stiffeners are located inside the double skin space. These designs incorporate all the four problems, described earlier.

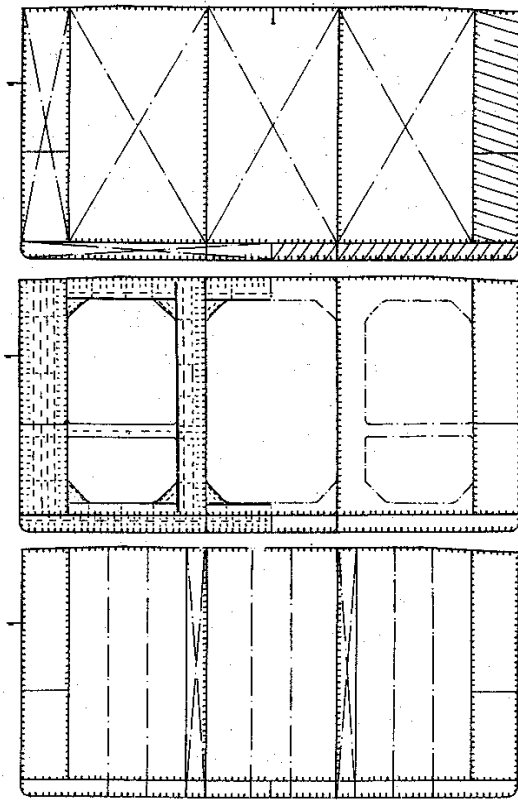
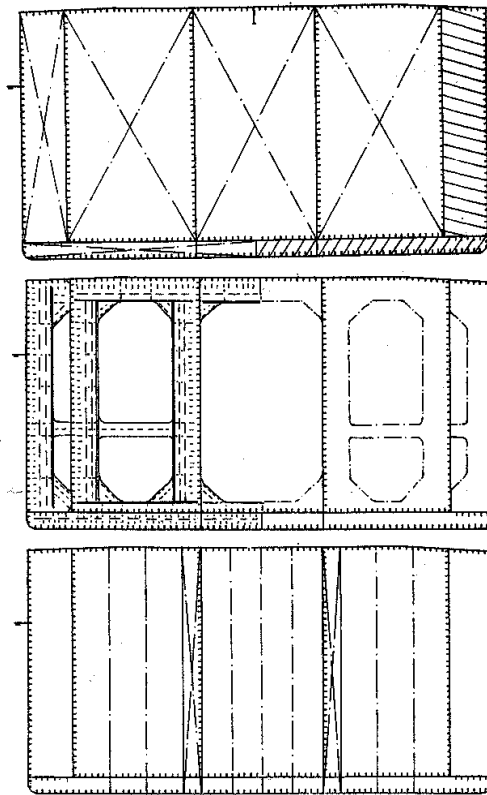
Fig. 7. Alternative B1

Fig. 8. Alternative B2

Figs. 7 and 8 show alternatives B1 and B2, which have 2 m deep double bottom tanks and 5 m wide side tanks. The inner bottom longitudinals are fitted in the cargo tanks. As the double bottom is not a sandwich construction, carrying out assembly welding in this space is easier. Further, welding inside the space is limited to upside welding of the web and vertical stiffeners to the inner bottom shell. The inner bottom plate is subject to less transverse stresses because its position is close to the neutral axis of the bottom web. The bottom web flanges take the maximum stresses. Access to the double bottom space is similar to A1 and A2.

Although in B1 the inner side shell stiffeners are located in the ballast tanks, they are not sandwich panels as there is sufficient width between inner and outer shells and the two panels are joined at the web. In B2 the inner side shell stiffeners are located in the side cargo tank. The conventional web beams support the inner and outer shells and the quantity of steel structure in ballast tanks is reduced.

In B1 and B2 the side ballast tanks can carry about 70% of the ballast. As these tanks are wider in construction, they can be easily cleaned and ventilated. The double bottom tanks may need to carry less quantity of ballast water as peak tanks can also be used for ballast. This facilitates filling of double bottom ballast tanks in the open clean sea and avoids ballast sediments collecting in the tanks.

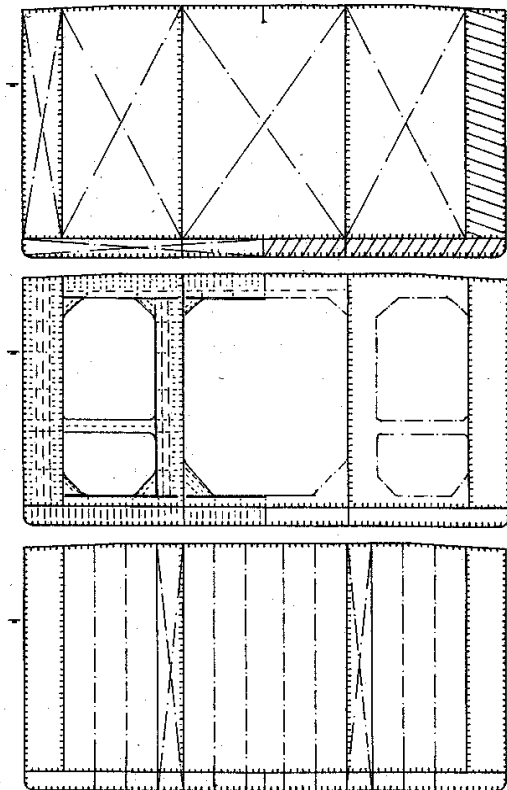
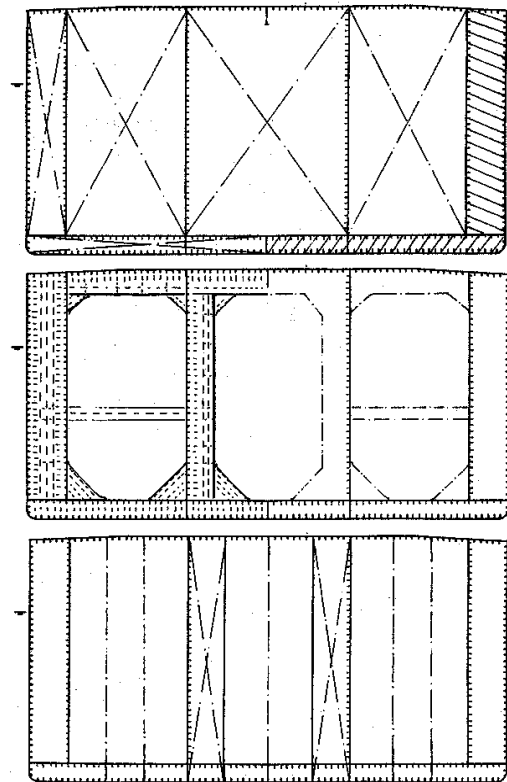
Fig. 9. Alternative C1

Fig. 10. Alternative C2

Figures 9 and 10 show alternatives C1 and C2, where the double bottom tanks are 2.33 meters deep and the double side tanks are 4.66 meters wide. The difference between C1 and C2 is in the location of longitudinal bulkhead web between the side and central cargo tanks and the construction of double bottom. In C1, web fitting of the longitudinal bulkhead is in the side cargo tank, whereas in C2 it is in the central cargo tank. Similarly, the inner bottom longitudinals are fitted in the cargo tanks side in C1, whereas it is fitted in double bottom in C2.

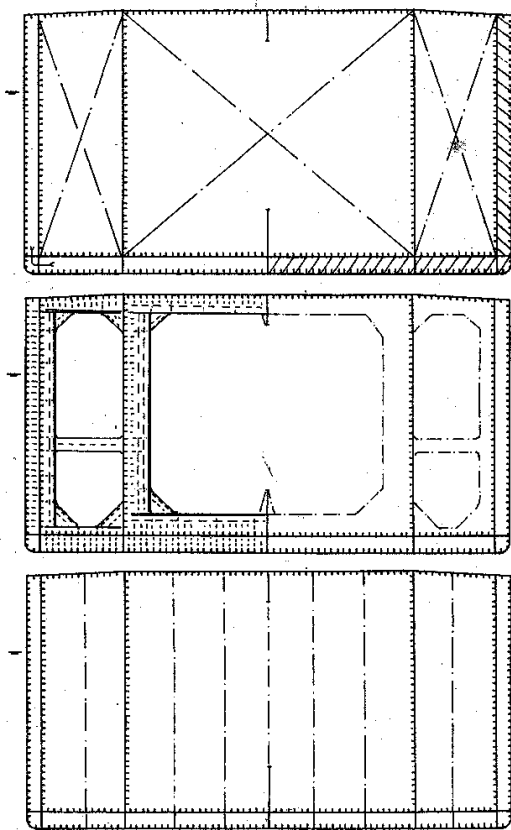
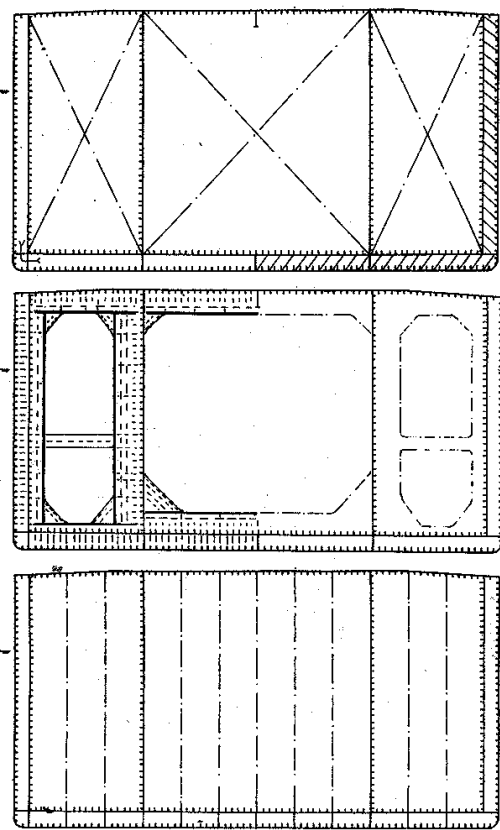
Fig. 11. Alternative D1

Fig. 12. Alternative D2

Figures 11 and 12 show alternatives D1 and D2. The alternatives have 2m wide double hull with inner shell stiffened in the cargo tanks. The double bottom is not of a sandwich construction, but with two panels fitted on top of each other, similar to B1 and B2, with the inner shell plate located close to the transverse web frame neutral axis. As the double hull space used for carrying ballast water has only 2m widths, this space alone cannot carry adequate quantity of ballast water to meet the MARPOL requirements. Either one centre tank or a pair of side tanks must be allocated for ballast purposes. Further, it may be possible to arrange four U-shaped ballast tanks in the double hull cargo body, meeting the requirements of regulation I/25A. Such an arrangement can facilitate easy ventilation of these tanks from one side to other.

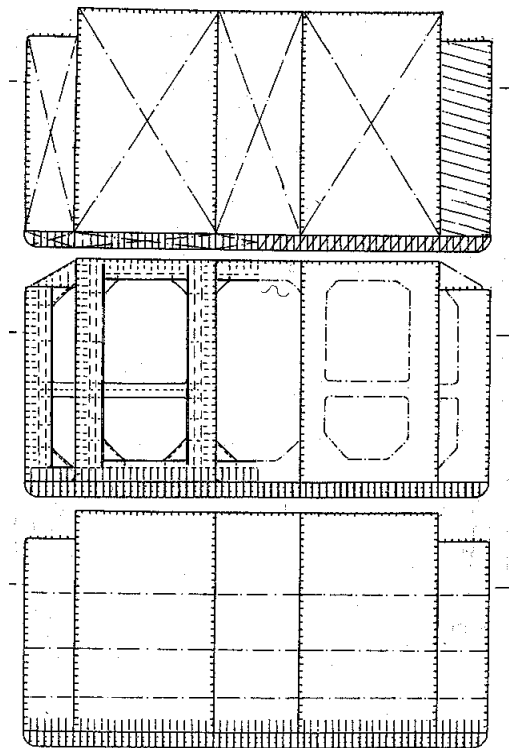
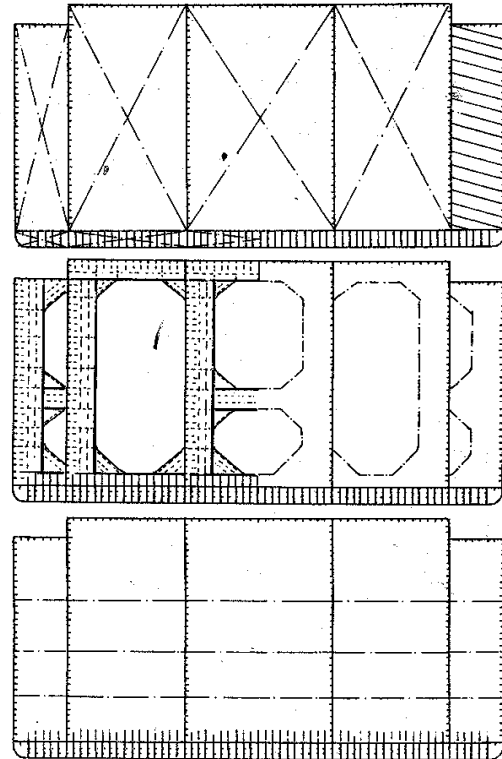
Fig. 13. Alternative E1

Fig. 14. Alternative E2

Figures 13 and 14 show alternatives E1 and E2. The main difference between E1 and E2, and other alternatives is in the design of the double bottom tanks. Other alternatives have transverse webs inside double bottom supporting the outer shell longitudinals. In E1 and E2, one longitudinal girder with two longitudinal stiffeners replaces the inner and outer shell bottom longitudinals. The unidirectional stiffened double bottom has no transverse webs inside the double bottom. The transverse webs inside the cargo tanks support the longitudinal girders. The difference between alternative E1 and E2 is that in the former the longitudinal bulkhead web is in the wing tanks and in the latter it is in the centre tank.

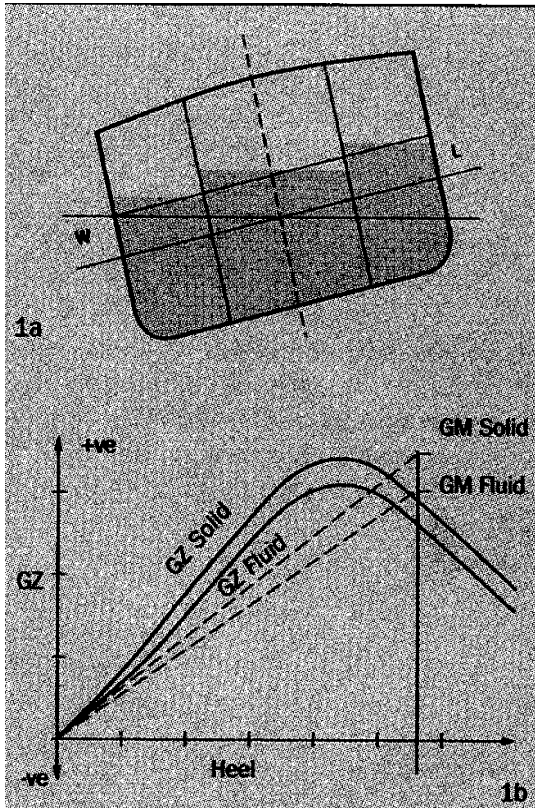
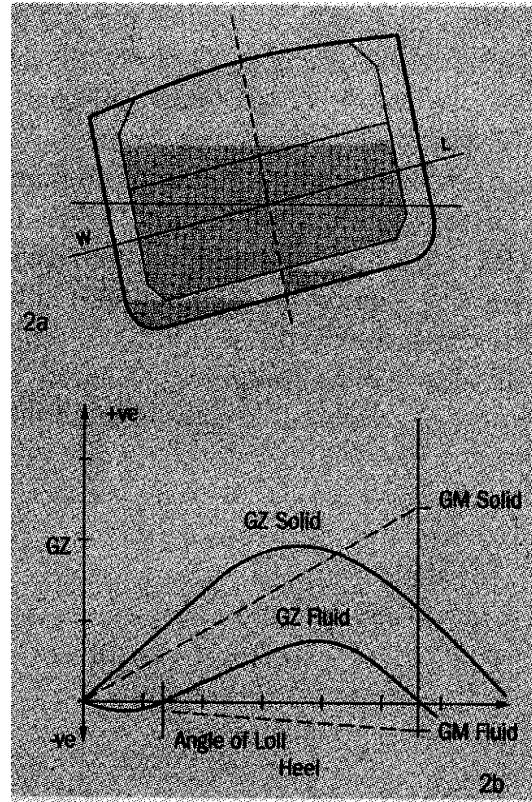
Fig.15. Diagrammatic section of a single hull tanker and its stability curve.

Fig. 16. Diagrammatic section of a double hull tanker and its stability curve.

The diagrammatic sections with stability righting lever curves of a single hull tanker and a double hull tanker in fig.15 and fig. 16, respectively, illustrate the essential differences in free surface effects in tankers with and without longitudinal subdivision of the cargo tanks ('Double-hull concerns', 2000, p.18). Comparing the stability curves<sup>4</sup> it can be observed that a single hull tanker with longitudinal subdivision has high initial GM,

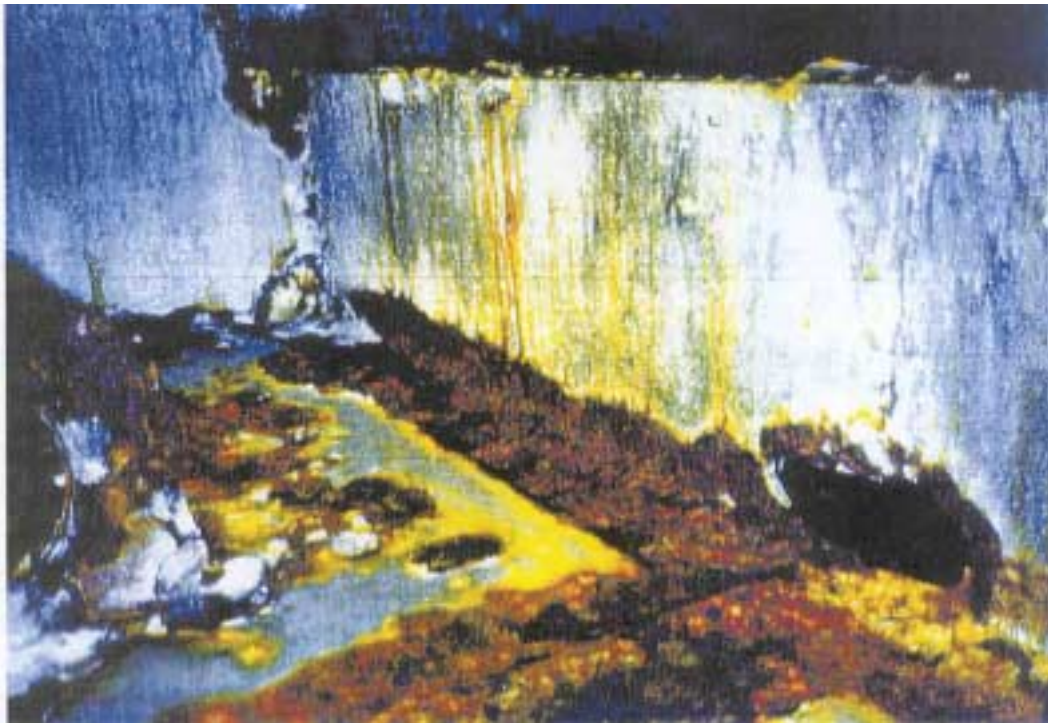
Fig. 17. Grooving corrosion in a stiffener connection (Source: DNV paper series No.2000-P008. p.11)

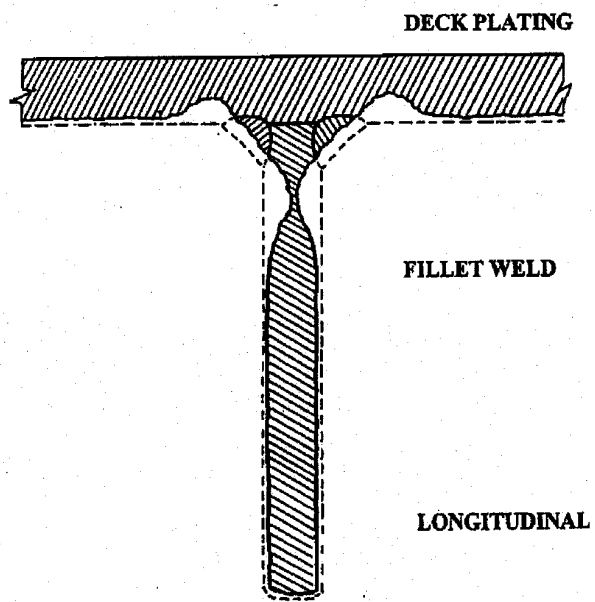
Fig. 18. Typical grooving corrosion in stiffener connection

Pitting is a form of local corrosion within limited areas (Magelssen, 2000b, pp. 10-12). According to the Oil Companies International Marine Forum (OCIMF), excessive pitting corrosion of up to 2 mm per year was observed in the uncoated bottom plating in cargo tanks in new single and double hull tankers. In addition, indication of general corrosion up to 0.24 mm per year has been found in vapour spaces. Magelssen explains that severe pitting occurring in the bottom of cargo and ballast tanks or other horizontal surfaces may tend to merge to form a long groove or scabies of wide patches with resemblance of general corrosion. Fig. 17 shows a typical grooving corrosion in a stiffener connection. The average corrosion rate in pits and grooves can be very high. When grooves occur close to a weld between a longitudinal bulkhead and the deck, it may create a higher deformation of the stiffener resulting in an accelerated corrosion rate in the groove. This condition, at times, introduces a 'necking effect'. Fig. 18 shows a typical grooving corrosion in stiffener connection.

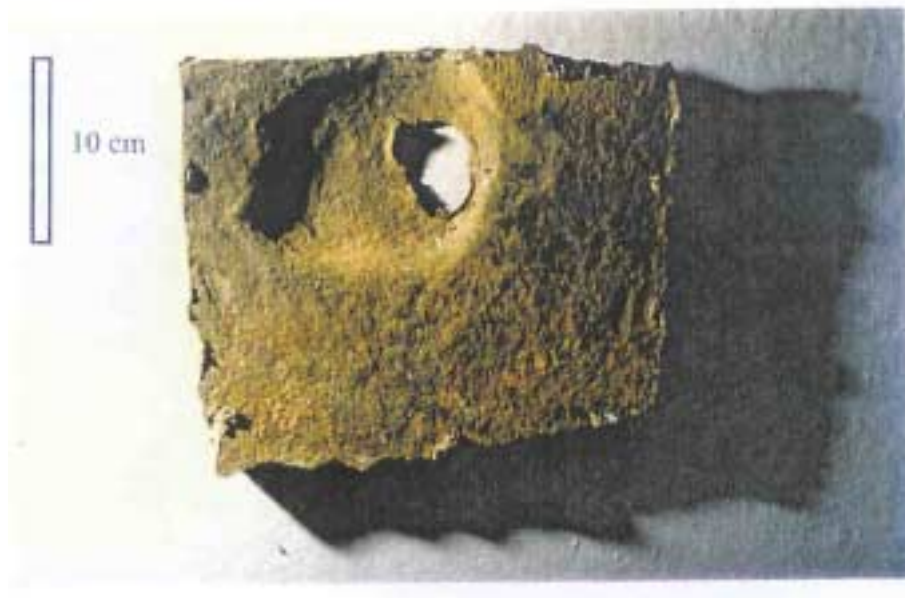
Fig. 19. Severe pitting corrosion in the bottom plate in a combined oil/water ballast tank

relatively new double hull crude oil tankers. This evidence suggests that corrosion rates for under deck plating in uncoated cargo tanks of double hull tankers can be two to three times the normal anticipated rate. There are several reports of severe pitting corrosion, to a depth of 3 to 4 mm, in the inner bottom plating of cargo tanks, which can be attributed to the collection of water where there has been a breakdown of natural oil film coatings formed from cargo ('Double hull concerns', 2000, p.18). Fig. 19 shows severe pitting corrosion in the bottom plate of a combined oil/water ballast tank.

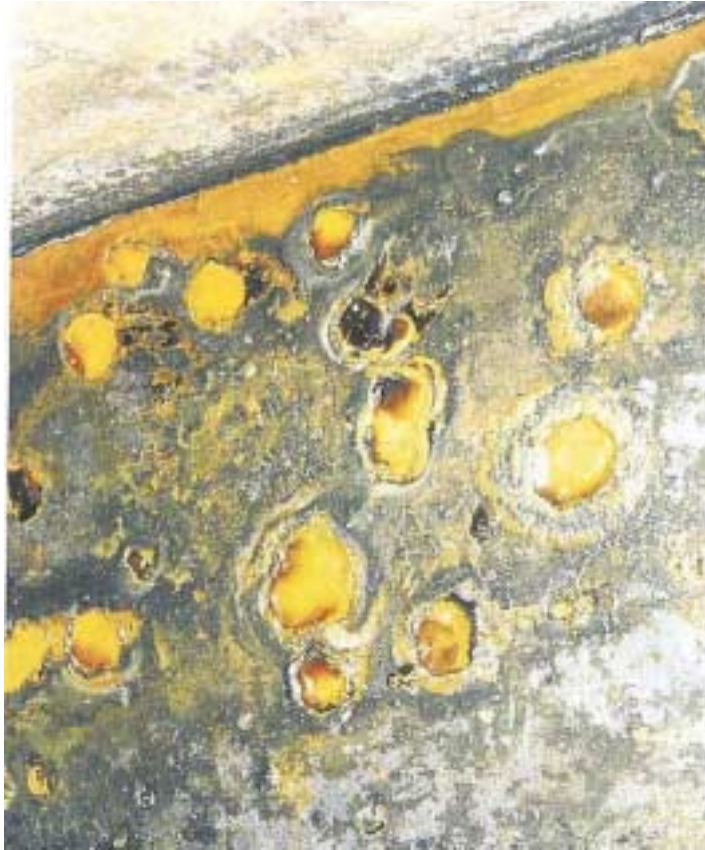
Fig. 20. Bacterial corrosion (Source: DNV paper series No.2000-P008. p.15)

Microbial induced corrosion (MIC) associated with the corrosion of steel is from sulphate reducing bacteria (SRB) and sulphur oxidizing bacteria (SOB). Acid is the result of a chemical process, and consequently, pitting corrosion at an extreme rate may occur. Double hull tankers are more prone to this corrosion due to the 'thermos bottle effect'. On the loaded passage, the ballast tanks provide a buffer between the cargo and the sea, acting almost as a thermos flask. The cargoes retain their heat and bacterial growth has been shown to increase dramatically with temperature as crude oil routinely has small water content ('First fire', 2001, p.27). Fig. 20 is a typical example of bacterial corrosion. Experience indicates that bacterial corrosion occurs at a temperature range of 20°C to 50°C with a longer time duration, which explains the reason why long trade VLCC are much more exposed to this type of corrosion than other tankers on shorter runs (Magelssen, 2000b, p.14).

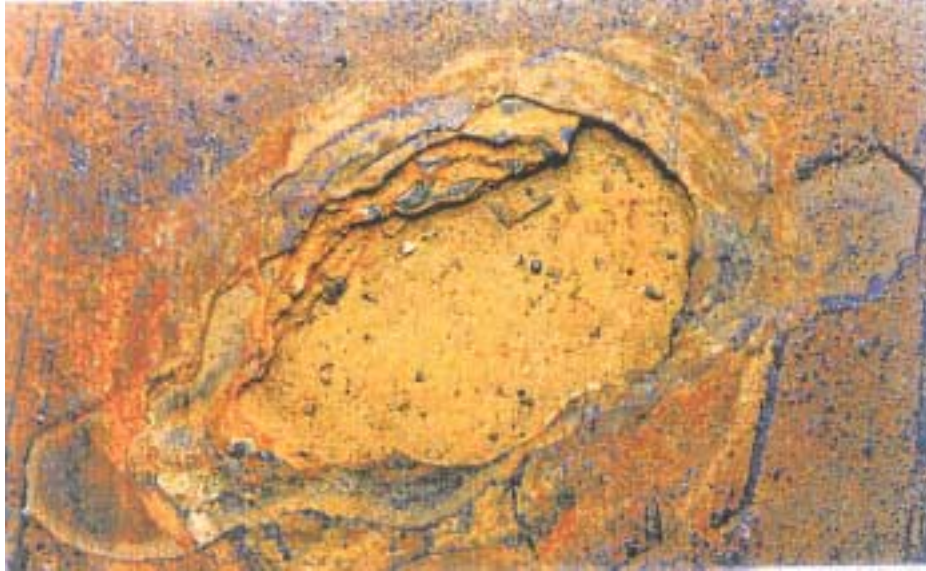
Fig. 21. Pitting corrosion with build up of scale rust in the bottom plate of a ballast tank (Source: DNV paper series No.2000-P008. Appendix 1)

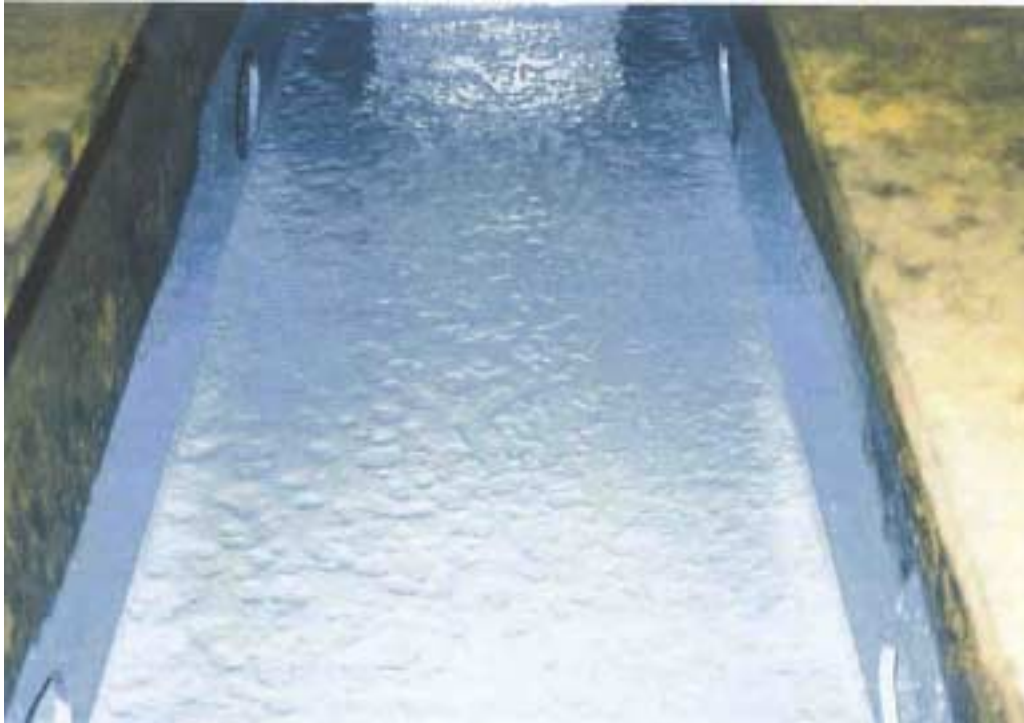
Fig. 22. Coating is the best solution when pitting occurs (Source: DNV paper series No.2000-P008. p.21)

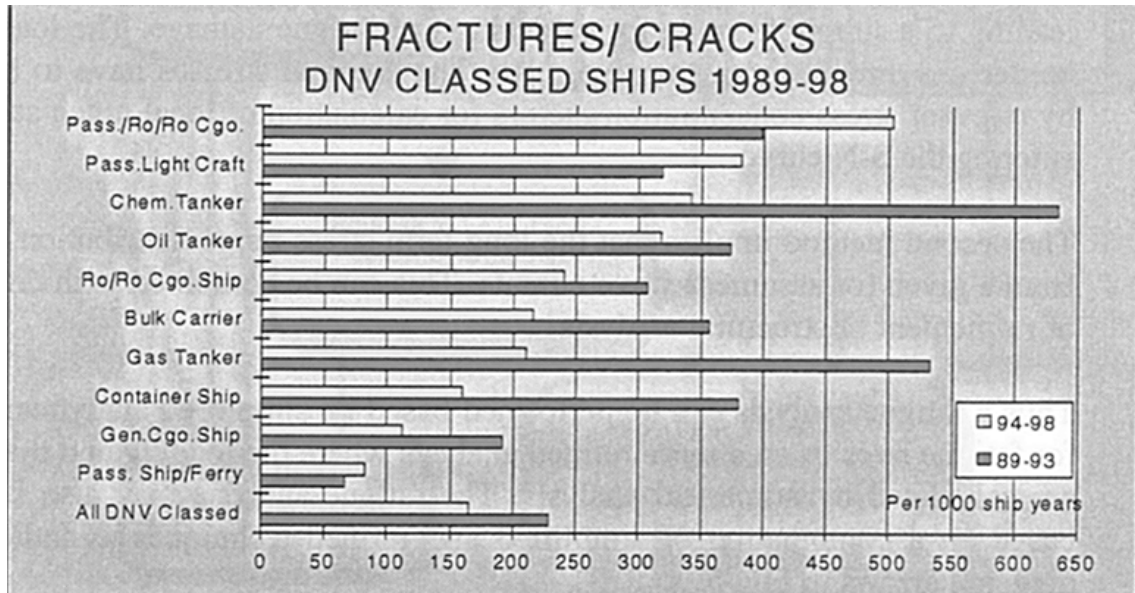
Fig. 23. Fractures/ Cracks statistics. (Source: DNV paper series No. 2000-P0004, p.5)

Hull damage may be categorised as damage due to deformation, corrosion/surface defects, and fractures/cracks. Deformation damage has been recorded for less than 10%, whereas, corrosion damage accounts for approximately 45% and fracture/crack damage for about 40%. Some damages reported are unspecified (Magelssen, 2000a, pp.1-3). Fig. 23 shows fractures/cracks in DNV classed ships during 1989-98. From this statistics, it can be observed that the share of cracks as a fraction of all hull damage for the ship types tanker for oil, bulk carrier and container carrier has increased from approximately 40% to 50%.

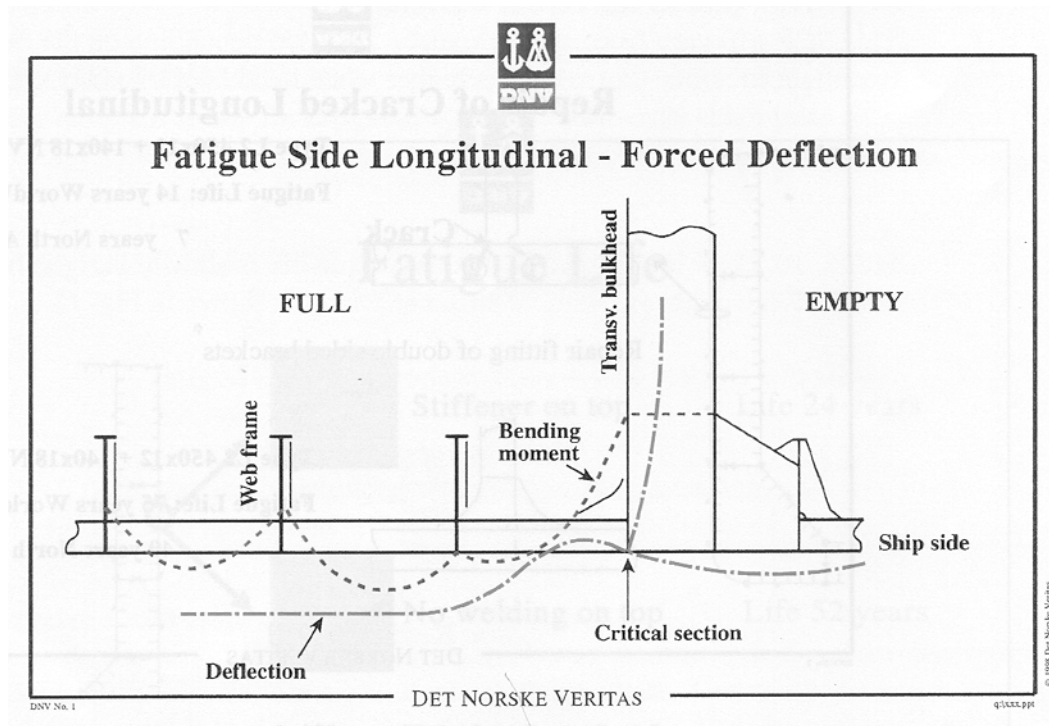
Fig. 24. Forced deflection

Loads in general for ship design are based on a 20-year return period in the North-Atlantic. But when fatigue criteria were introduced, the fatigue load was based on a worldwide ship trading. Fig. 24 illustrates stresses due to forced deflection. Referring to the figure, the bending moment (BM) has a peak at the transverse bulkhead, where the BM caused by relative deflection and local bending combines to create a peak stress. The BM from relative deflection is highly dependent on the flexibility of the web frame aft of the transverse bulkhead. The fatigue life for all the longitudinals and stiffeners is

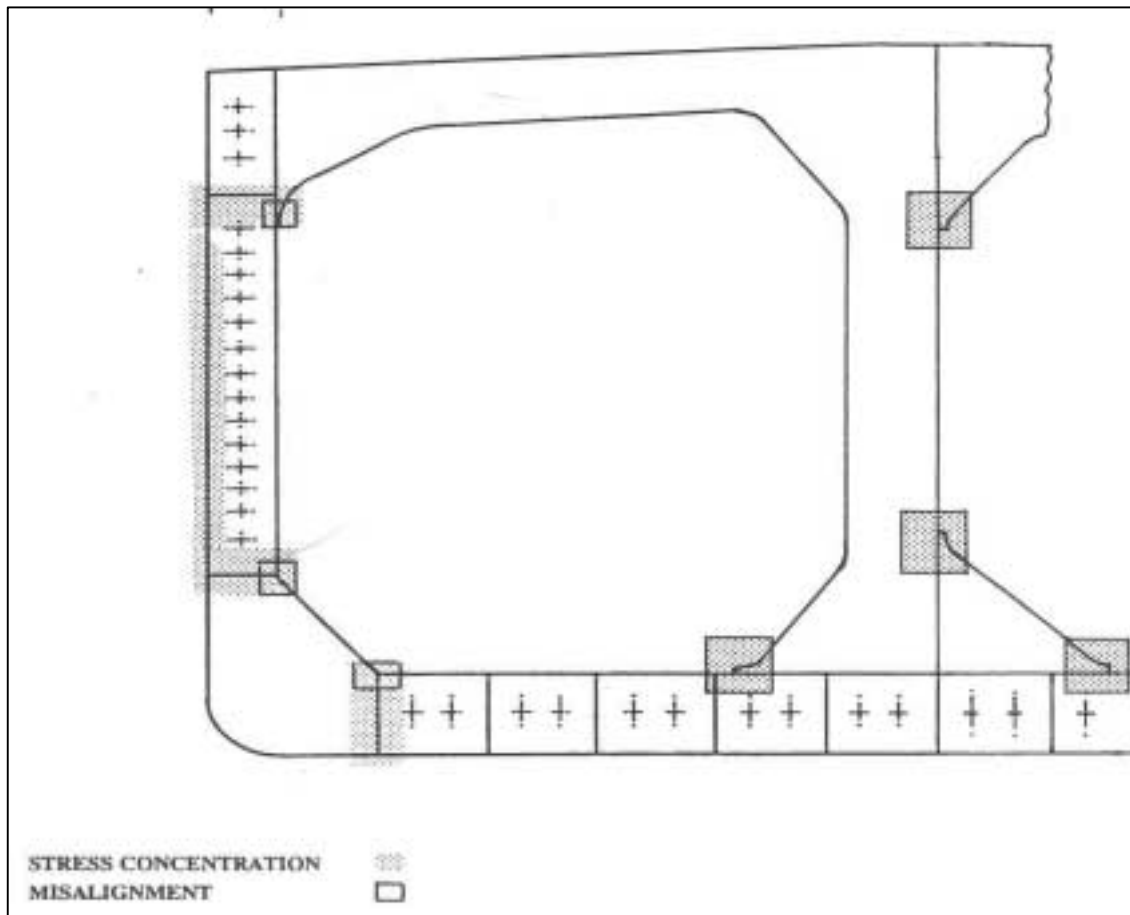
Fig. 25. Areas susceptible to stress concentration and misalignment on midship of a typical large double hull tanker (Source: Tank Structure Co-operative Forum, 1995 )

Fracture/cracks are caused mainly by stress concentrations, which occur at locations within primary structure due to specific design configurations or detailed secondary design. The Tanker Structure Co-operative Forum (TSCF) (1995, pp. 1-89) has reported many structural failures due to stress concentration in double hull tankers of various sizes, based on the information received from surveyors of classification societies. They have categorized the failures on the basis of the size and design of the tankers and demarcated the areas of stress concentration. Figs. 25 and 26 indicate the areas within the double hull tank structure of a typical large double hull tanker at which higher magnitudes of stress will occur on midship sections and transverse bulkheads, respectively.

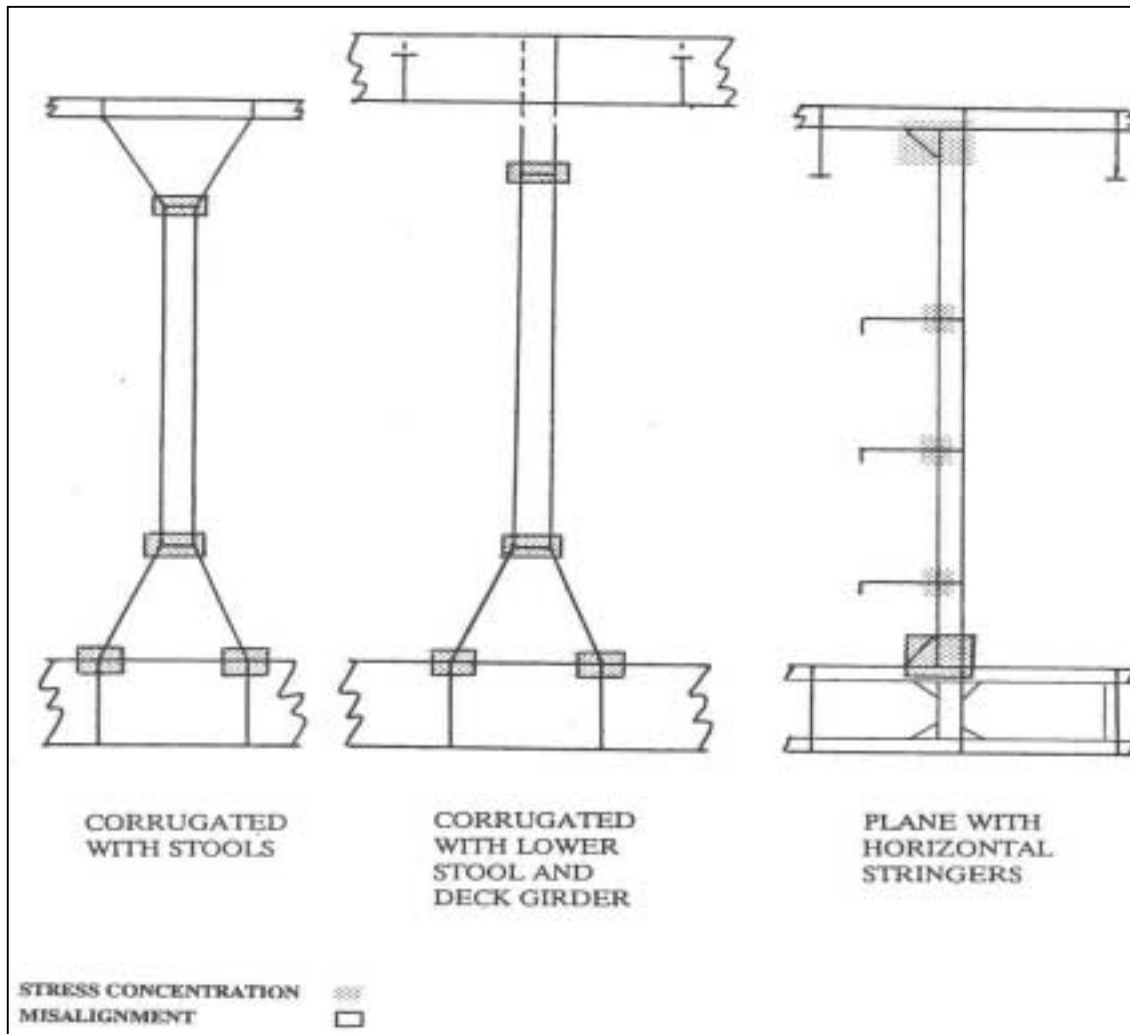
Fig. 26. Areas susceptible to stress concentration and misalignment on transverse bulkheads of a typical large double hull tanker

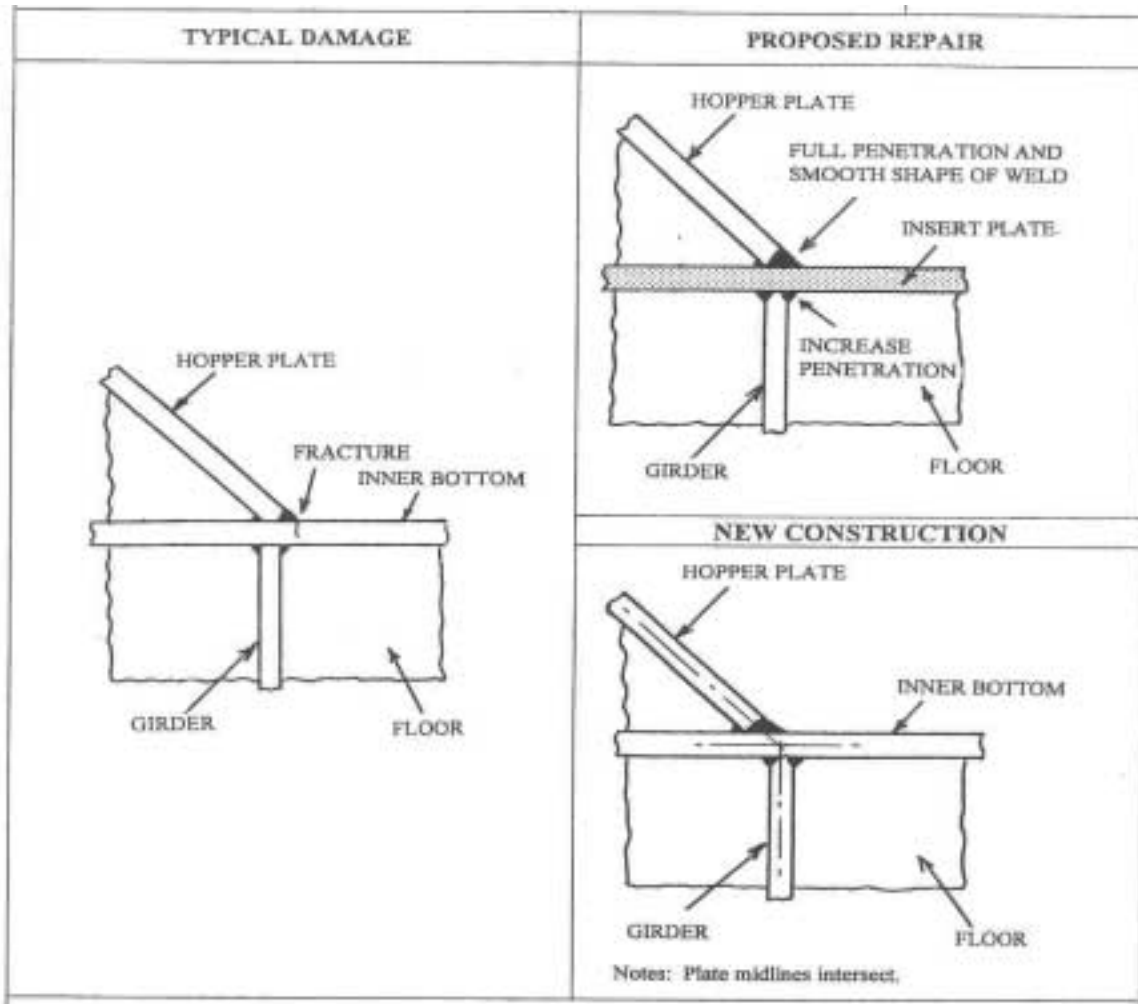
Fig. 27. Bilge hopper: Connection of hopper plate to inner bottom

Some typical damages in the tank structure of double hull tankers, reported by TSCF along with their proposed repairs, are reproduced below with sketches. Fig. 27 shows a fracture of an inner bottom plate at the weld connection of the bilge hopper plate. According to them, contributing factors for the damage are stress concentration at juncture of hopper plate to inner bottom shell plate, insufficient welding connection and misalignment between the hopper plate, inner bottom and girder.

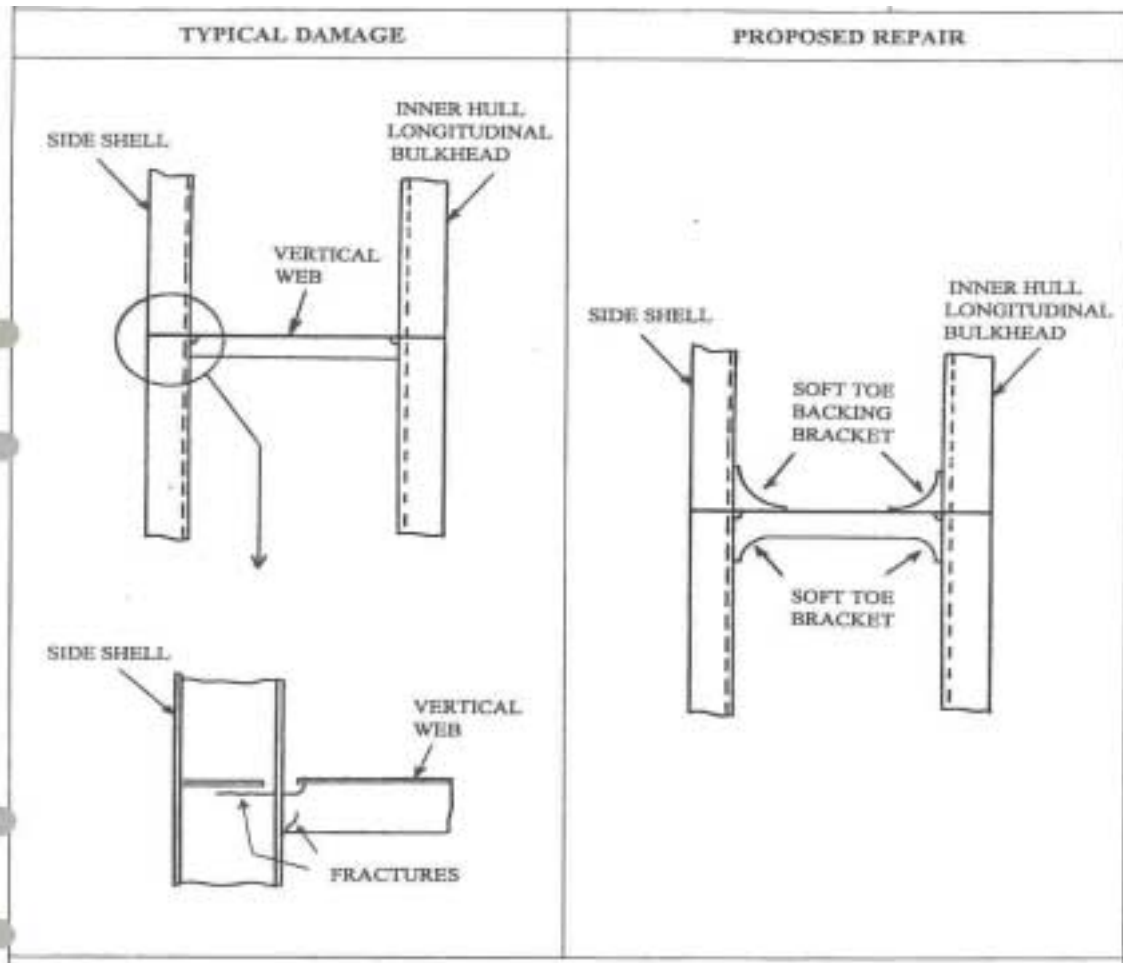
Fig. 28 shows fracture at the connection of longitudinals to transverse webs in a wing ballast tank of a double hull tanker. The causes for the damage are concluded to be the asymmetrical connection of the flat bar stiffener resulting in high peak stresses at the heel of the stiffener, insufficient area of connection of the longitudinal to the web, high bending stresses in the longitudinal, additional torsion stress due to the symmetry of the

longitudinal, and stress concentrations at the square angles at heel and toe of the connections.

Fig. 28. Wing ballast tank: Connection of longitudinals to transverse webs
