# Tanker accidents : double hull is not the only viable alternative

**TANKER ACCIDENTS: DOUBL HULL IS NOT  
THE ONLY VIABLE ALTERNATIVE**

**MUKKADAYIL PAILY JOHN**  
India

**MARITIME AFFAIRS**  
**(Maritime Safety and Environmental Protection)**

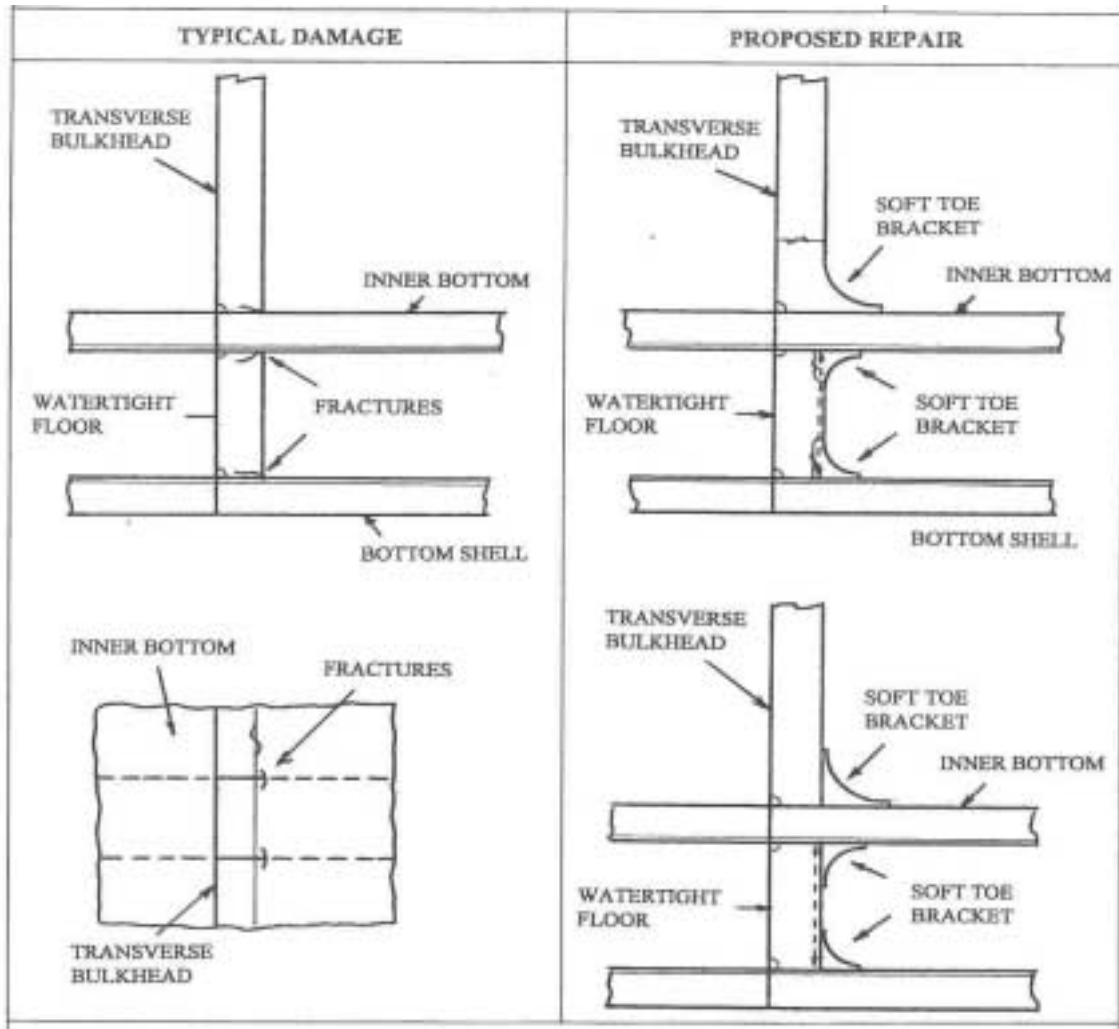
Fig. 29 shows a typical fracture damage of the stiffener connection of a transverse bulkhead to the inner bottom shell and the outer bottom shell in a double bottom ballast tank. Contributing factors to the damage are considered to be the misalignment between bulkhead stiffener and inner bottom longitudinal, and high stress concentration at the points of fractures.

Fig. 29. Connection of transverse bulkhead: Stiffener to inner bottom and bottom shell

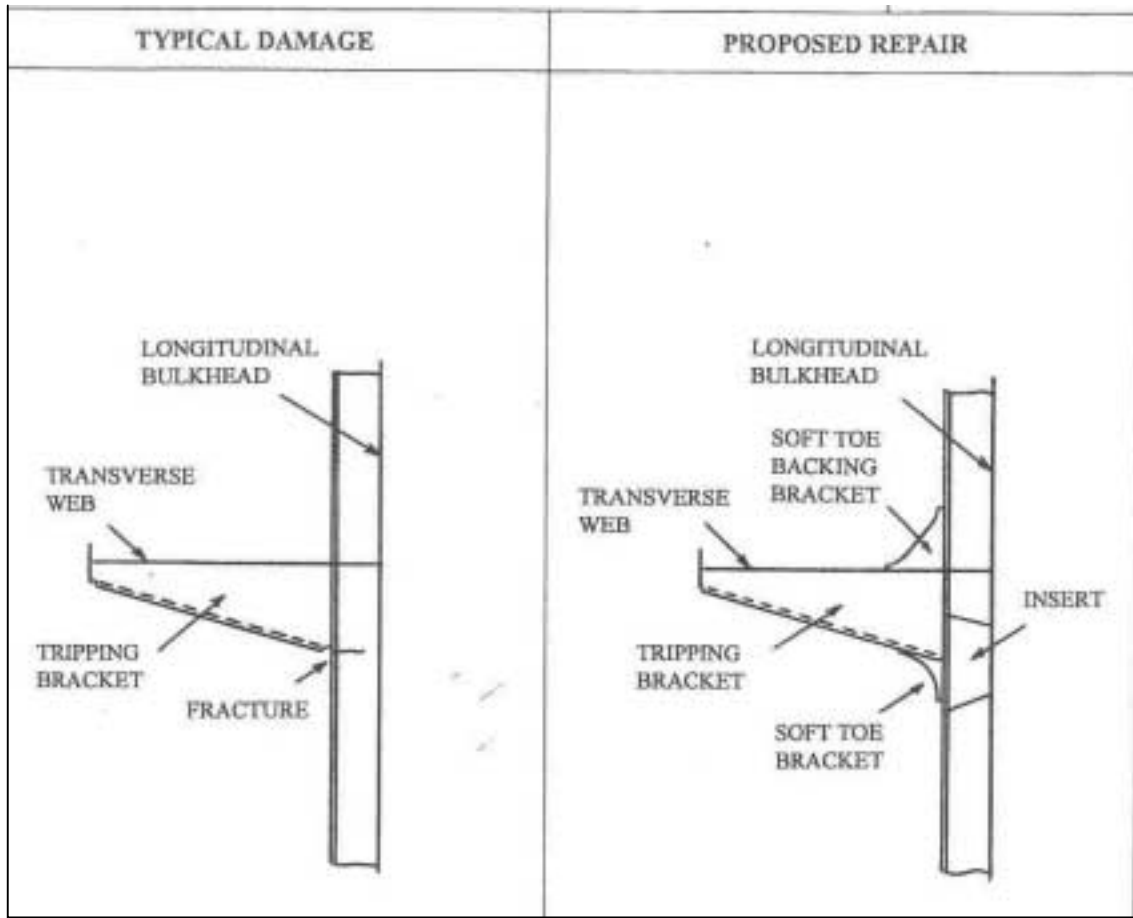
Fig. 30 indicates the fracture caused at the connection of a tripping bracket with the longitudinal bulkhead web in the cargo oil tank. The causes for the damage are concluded as stress concentrations at the toe bracket and high stress in the longitudinal. The modification suggested is welding soft toe brackets with longitudinal web and tripping bracket as shown in the figure, in addition to fitting an insert.

Fig. 30. Web frame in cargo tank: Tripping brackets

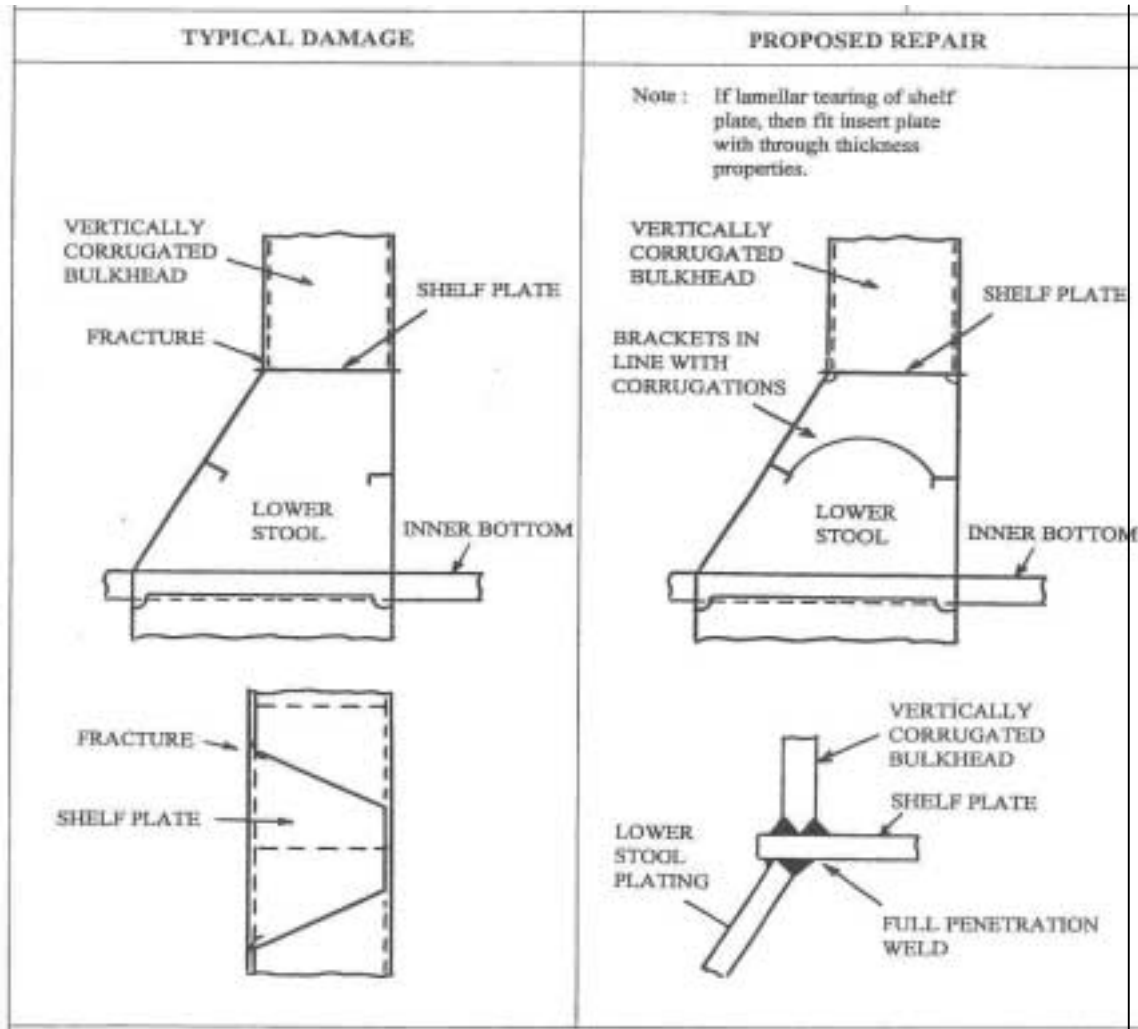
Fig. 32 indicates damages to the vertical corrugated transverse bulkhead with stools in a cargo tank. The factors contributing to the damage are stress concentration due to unsupported corrugation web, high through thickness stress, lamellar tearing, weld details and dimensions, misalignment, and insufficient thickness of stool side plating in relation to corrugated flange thickness. The proposed repair is bracket in line with corrugations of the bulkhead, full penetration welding of lower stool plating and vertical corrugated bulkhead with shelf plate, as shown in the figure.

Fig. 32. Vertically corrugated transverse bulkhead stools

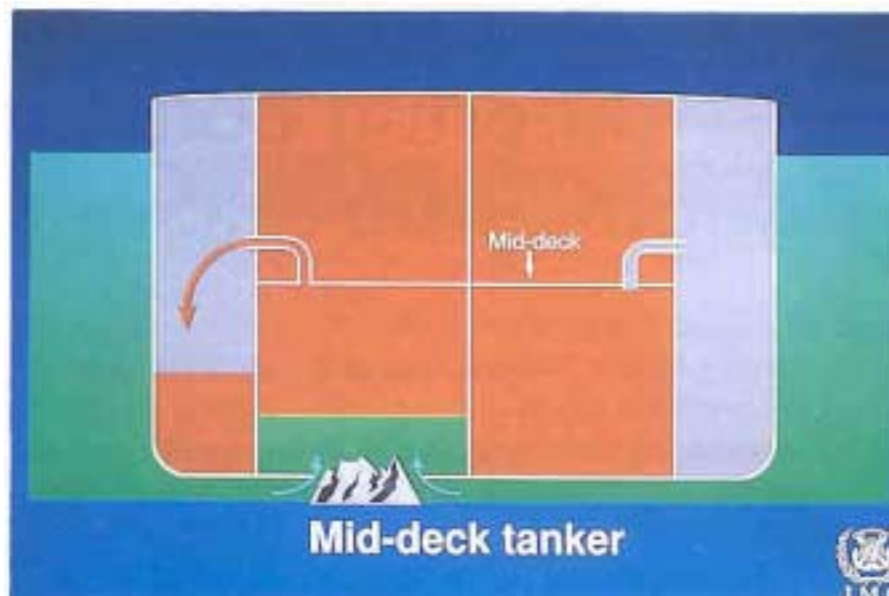
Fig. 33. General tank layout of a mid-deck tanker

In March 1992, the IMO adopted mid-deck and double hull tanker designs as the international requirement for tanker new buildings ('Mid-deck design', 1993, p.21). Fig.33 shows the general tank layout of a mid-deck tanker. Based on the probabilistic oil

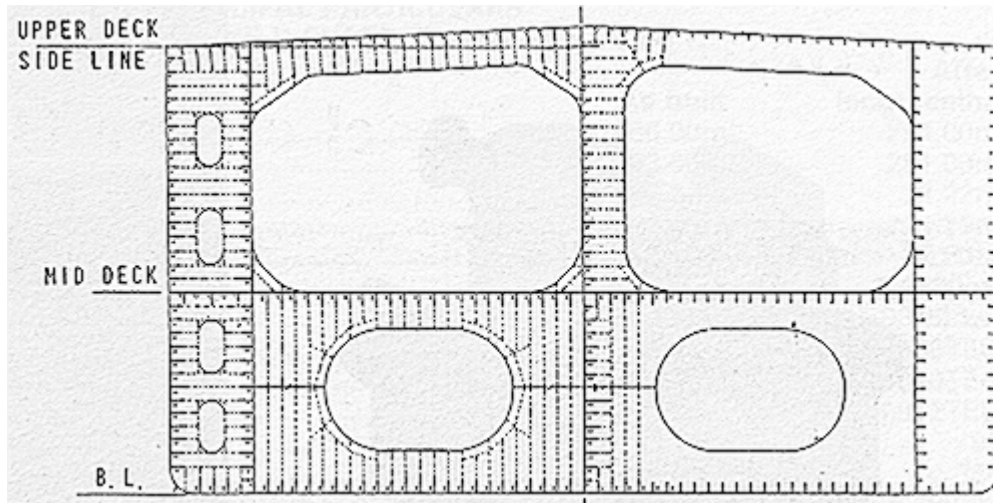
Fig. 34. Hull section for a Mitsubishi proposed 280,000 dwt mid-deck tanker.

The upper cargo tank fittings are essentially similar to conventional oil tankers except for the cargo main pipeline. Situated in the lower cargo tank are cargo oil lines, cargo vent and inert gas lines, access trunks, level gauges and fixed tank cleaning machines. A piping system as in conventional tankers for the lower tank is installed on the bottom of the tank with branch lines for both upper and lower spaces. Cargo oil vent and inert gas trunks are led from the top of the lower cargo oil tanks to upper deck and are connected to the cargo oil tank vent and inert gas main line on the upper deck. Access trunks from upper deck lead to each lower tank forward and aft and are fitted with ladders, while the level gauges measure levels through out the tank height. The access trunks can be used for various fittings and services, eliminating the need to pass through the upper tank ('The mid-deck supertanker', 1991, p.445). Fig. 34 shows the hull section of a Mitsubishi 280,000 dwt mid-deck tanker.

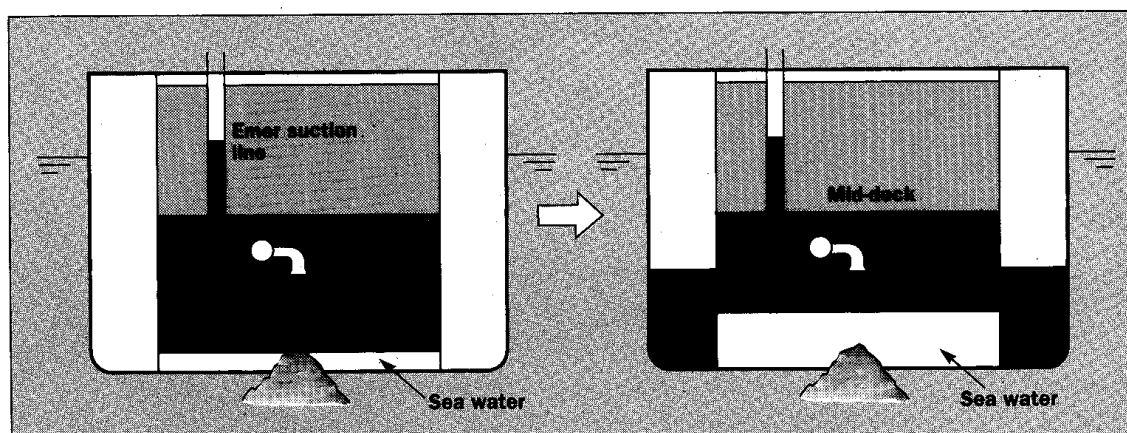
Fig. 35. An emergency suction line below the mid-deck on MHI's design.

supervision of an IMO Steering Committee, quantified that the secondary oil outflow and initial exchange loss represented only 1-2% of the cargo tank capacity. To provide a deep layer of seawater in the damaged tank bottom, an emergency suction line can be connected to the ballast line allowing the emergency transfer of oil into the ballast water tanks. Fig. 35 shows such an arrangement on the design of the MHI.

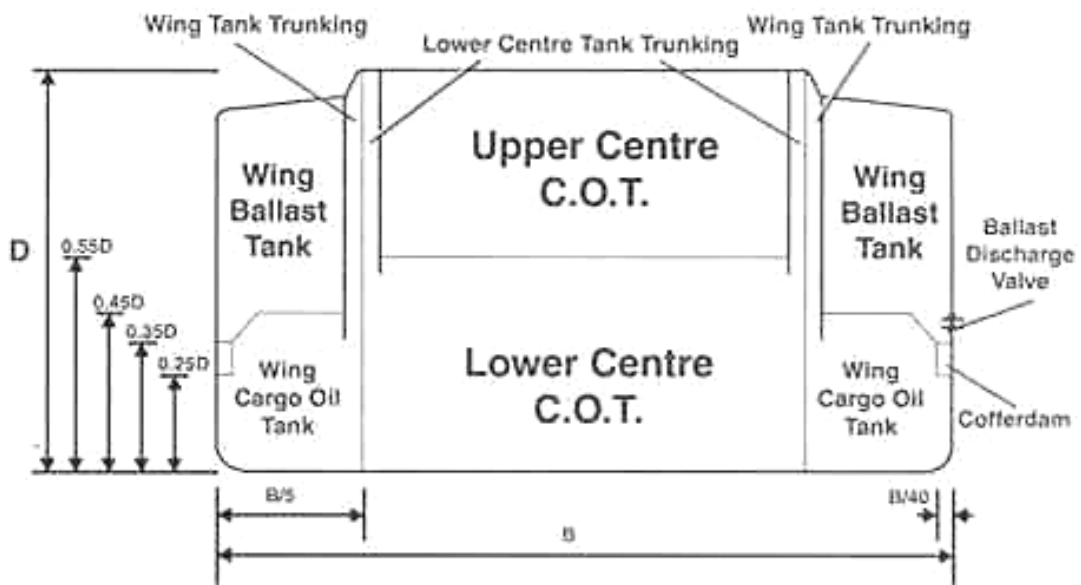
Fig. 36. General layout of a Coulombi Egg tanker

The Coulombi Egg tanker design follows the single hull technology as much as possible and introduces some new features developed over the past few years. The bow and stern designs are similar to the conventional single hull tanker with forepeak tank, after peak tank, collision bulkhead, pump room, and engine room. The basic difference is in the cargo and ballast space designs. The general layout and mid-ship cross section of a Coulombi Egg tanker are shown in fig. 36 and fig. 37 respectively.

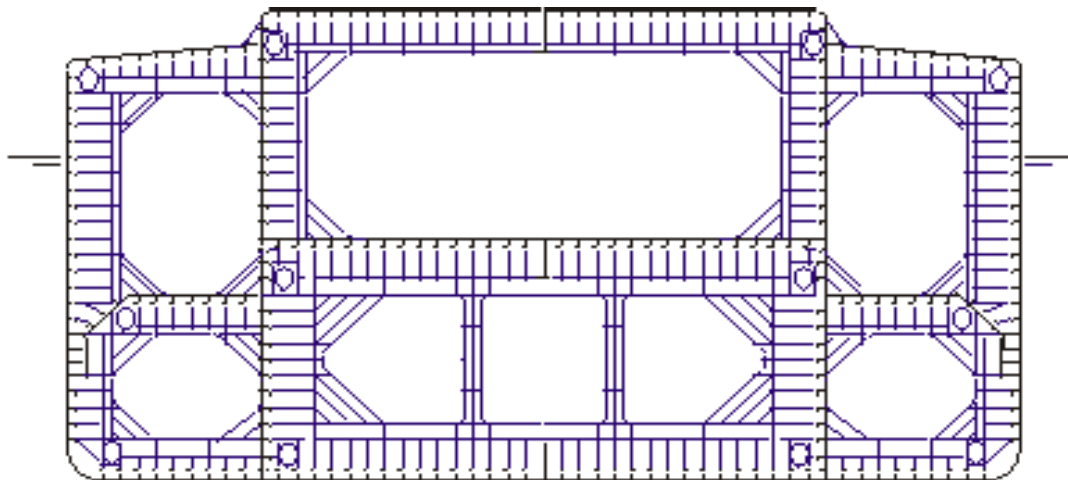
Fig. 37. Midship section of a Coulombi Egg design.

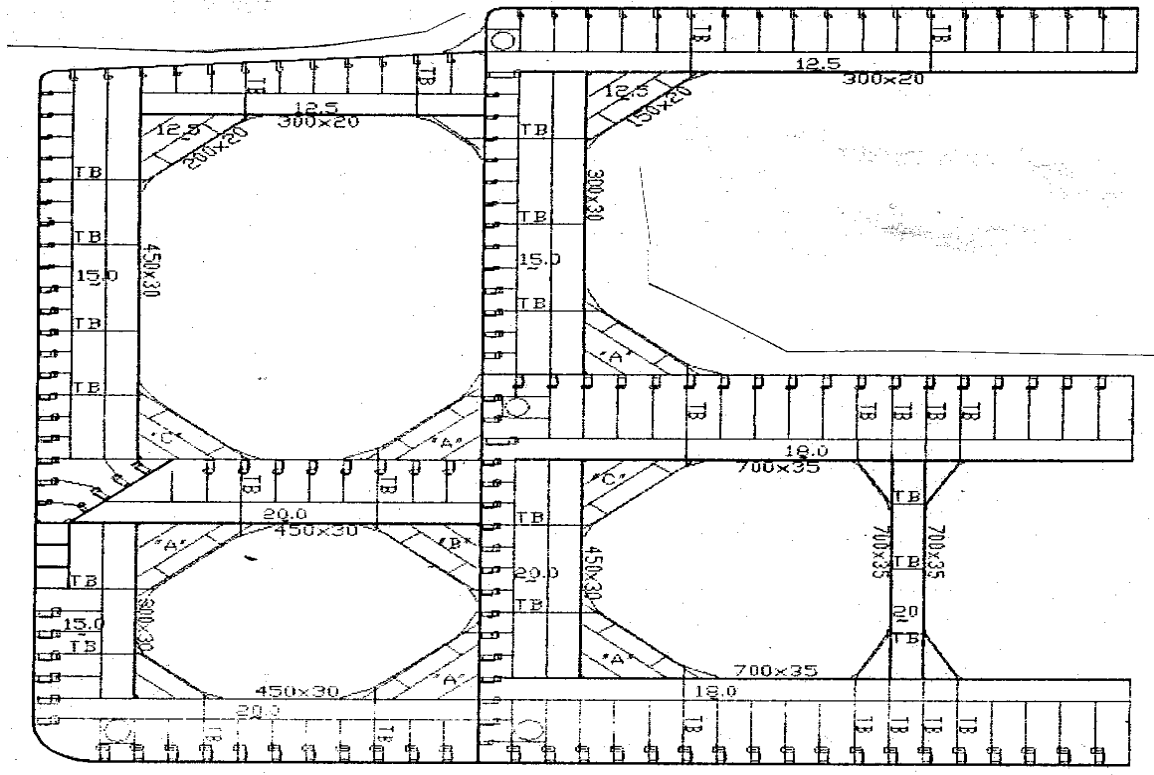
Fig. 38. Transverse web frame construction for a 280,000 dwt Coulombi Egg design

Fig. 38 shows a typical transverse web frame of a 280,000 dwt Coulombi Egg design. The advantages claimed in this design are easy for fabrication as the construction is in mild steel and easy for cleaning of lower centre tanks. The side webs are supported by

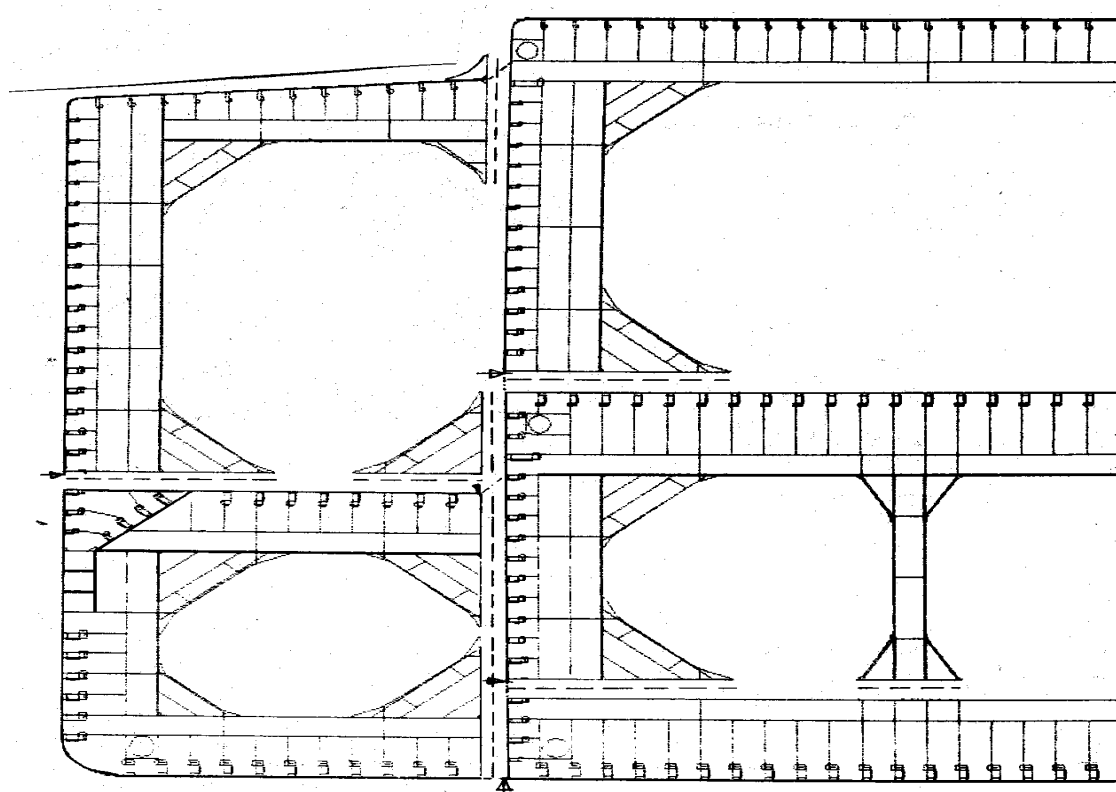
Fig. 39. A 280,000 dwt Coulombi Egg tanker proposal for building block fabrication

The tank body can be fabricated in different blocks and assembled at the building yard. Fig. 39 shows a proposed split up of a half mid ship section into four blocks during

fabrication. Each block consists of flat plate panels with stiffeners and rectangular open webs adapted for fully automatic fabrication and welding in panel and web lines. Corner brackets are fabricated in separate lines. Welding and dimensional control along the full width mid deck is easy. Application of coating to the ballast tanks can be carried out during block assembly or even after assembly (Björkman, 1993, p.295).

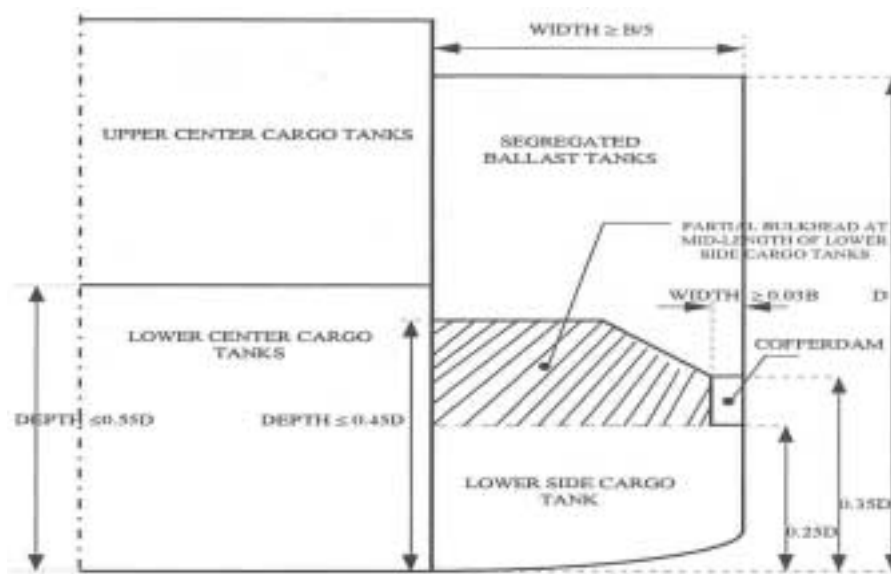
Fig. 40 Midship section showing the partial bulkhead

as emergency receivers for cargo if the lower cargo tanks are punctured. In case of collision, the deep penetration of the side is frequently seen to occur above the water line. As the Coulombi Egg tanker has B/5 wide wing tanks, it can absorb a substantial amount of collision energy and hence provide more structural protection. The ballast tanks and cofferdams operate as crush zones absorbing the impact while preventing any breach of cargo tanks. The partial transverse bulkhead subdividing each lower wing tank at its half-length is welded to the mid deck bulkhead and extends down to the height of bottom edge of cofferdam. These bulkheads restrict the outflow of oil from the tanks trapping it in the deckhouse space<sup>4</sup> as shown in Fig. 40 ('Breaking,' 1996, pp. 38-39).

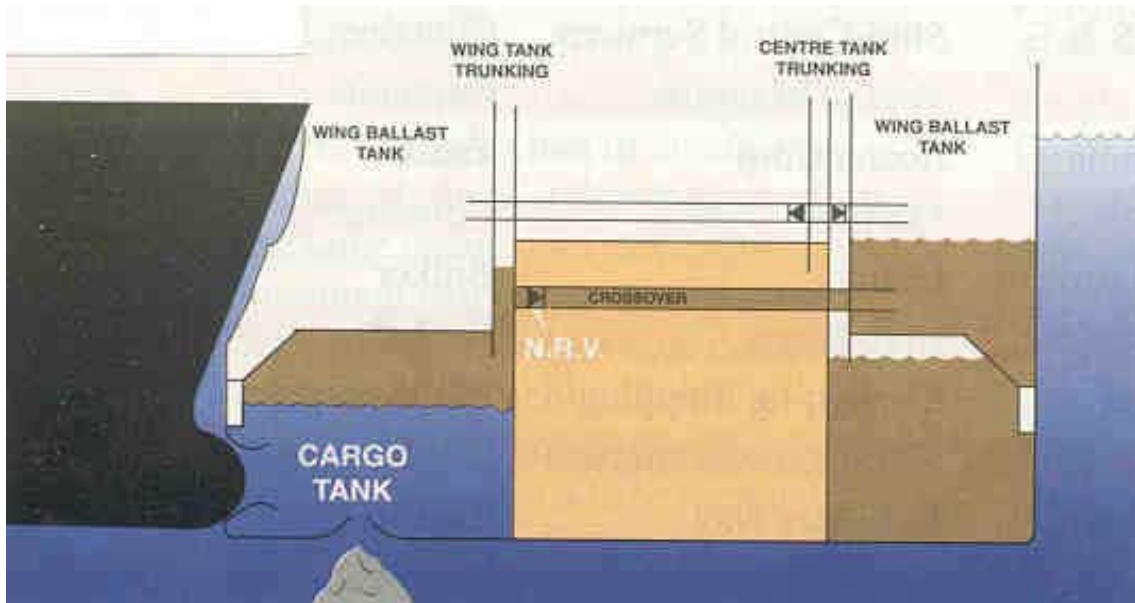
Fig. 41. Breach of wing cargo tank allows inflow of water under hydrostatic pressure forcing oil via the crossover to the ballast tank (Source: Fairplay, 1996, May 9, p.39)

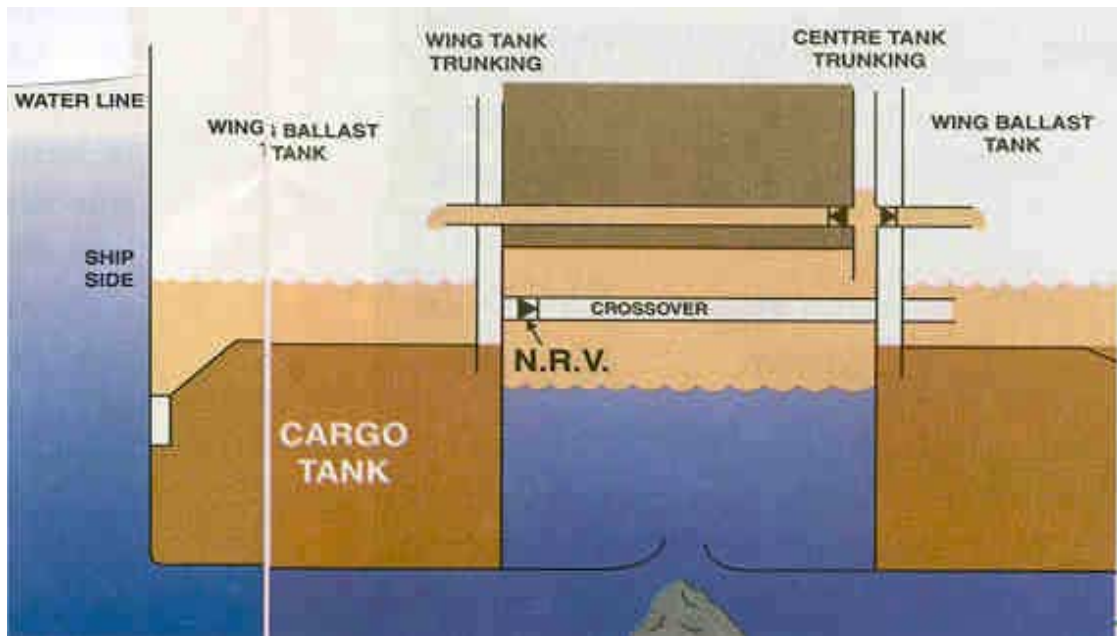
Fig. 42. Breach of lower centre tank forces oil to both wing tanks.

illustrated in Fig. 42 ('Breaking with', 1996, p.39). The system works well as long as the inflow of water caused by the damage in the side tank does not exceed the capacity of evacuation system (Björkman, 1997b, pp. 1-3).

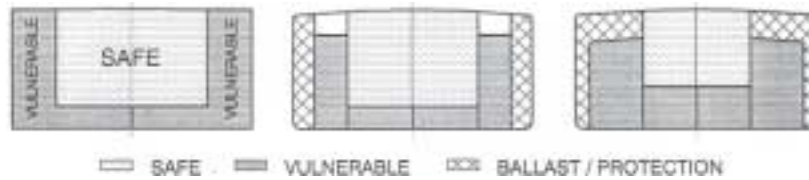
Fig. 43. Objective of tank size and location

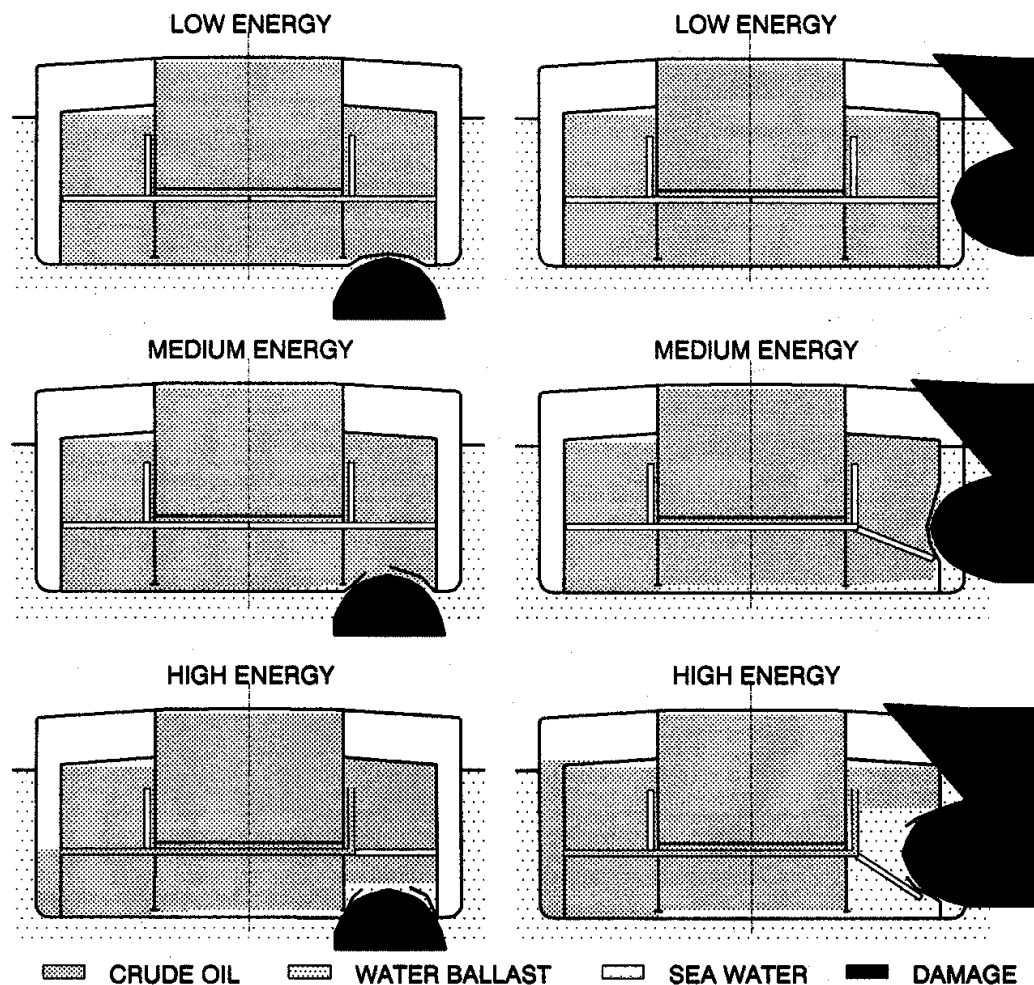
Fig. 44. Small outflow after side and bottom damage in the COBO design

The Combination Of Basic Objectives (COBO) design is based on the principle of protected small hydrostatically balanced cargo tanks in the vulnerable zone and large cargo tanks in the safe zone. However, the minimum size of the cargo tanks is restricted by operational requirements (Laan, 1995b, pp. 358-359). Fig. 43 shows the objectives of tank size and location. Fig. 44 shows small outflow after side and bottom damage. Laan explains the features of the this design as follows:

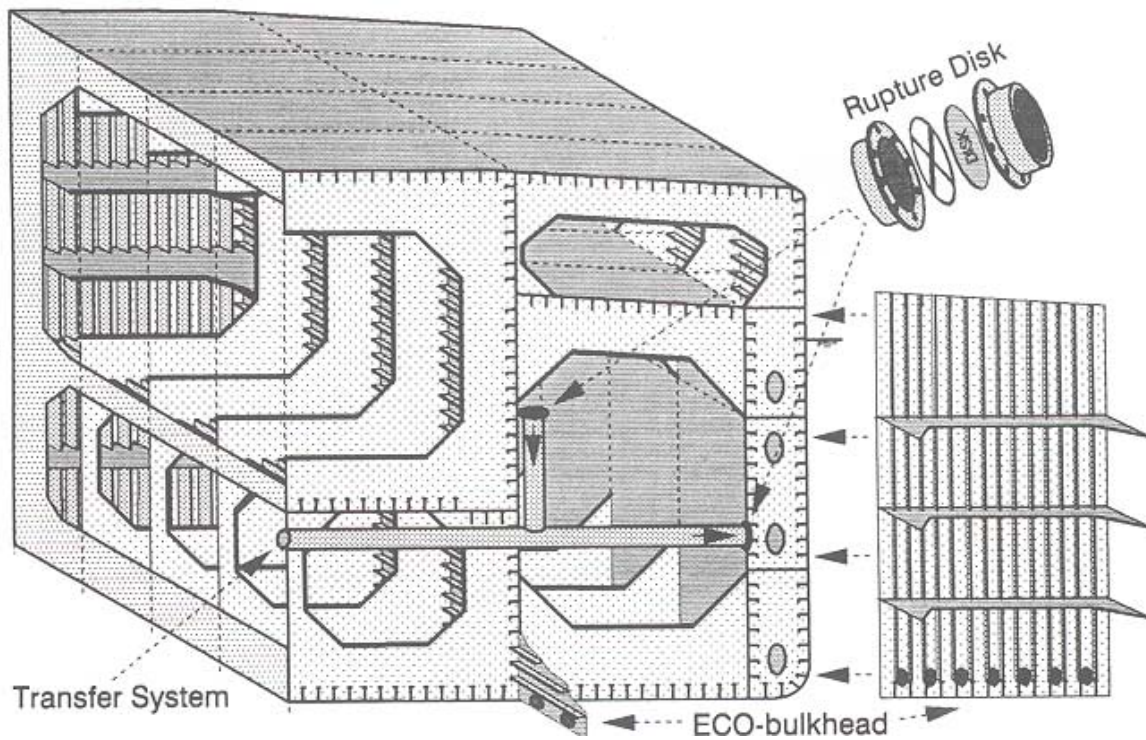
Fig. 45. The COBO midship section in three dimensions

4. Reduced width and height of cargo tanks by specific arrangement of longitudinal bulkheads and horizontal decks. Reduced effective length of the tank for reducing the oil outflow by intermediate transverse ECO-bulkheads<sup>5</sup>. (Fig. 45).
5. Prevention of initial outflow by hydrostatic balance. Reduction of secondary outflow by safety margin in hydrostatic balance caused by dynamic and tidal effects; emergency cargo transfer system with rupture discs, which rupture automatically during collision and allow part cargo transfer to opposite ballast tanks.

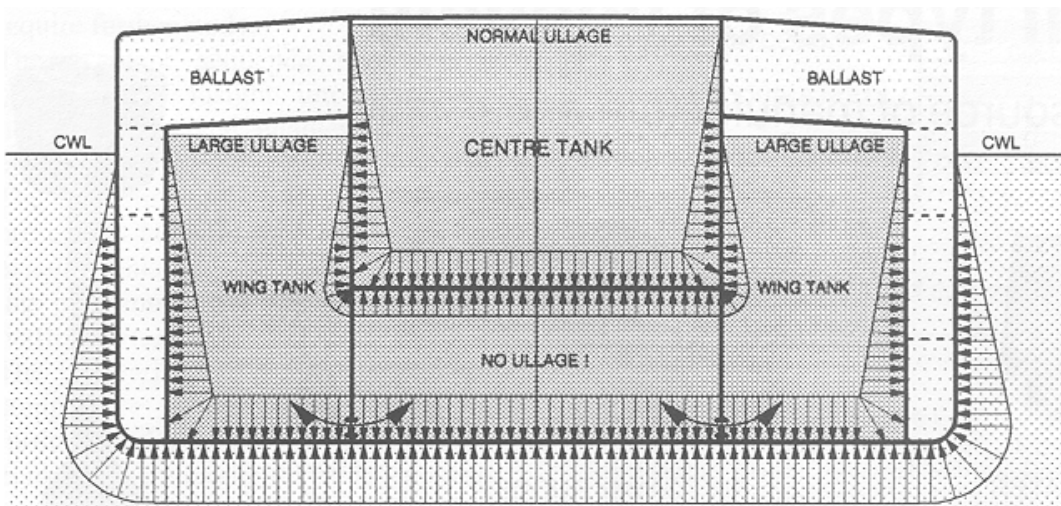
Fig. 46. Small structural loads of COBO in laden conditions

with the counter-acting pressure of cargo from the lower tanks and the absence of an ullage space with large dynamic sloshing loads, which is achieved by connecting the bottom cargo tank to both side bottom tanks by ECO-bulkheads. (See fig. 46). Efficient positioning of longitudinals and transverses reduces coating area approximately by 40% as compared to double hull and includes less material loss due to corrosion. The slope of the wing tank horizontal deck shifts the ballast sediments into the narrow double side. It is claimed that all these factors contribute to a reduction of the building cost by 5% compared to a standard double hull tanker.

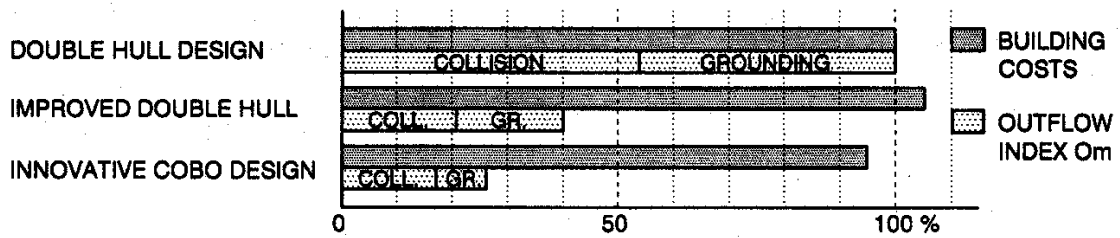
Fig. 47. An economical and ecological comparison

The COBO concept features many advantages over a standard double hull tanker. Major advantages claimed are building cost reduction by 5% and oil outflow reduction by 73% (Fig. 47). Other advantages are - less area is exposed to corrosion requiring less tank coating, improved tank cleaning, purging and venting of bottom cargo tanks, less fatigue and sloshing loads, etc.
