An empirical study on the need for anchor operation education and training

**AN EMPIRICAL STUDY ON THE NEED FOR
ANCHOR OPERATION
EDUCATION AND TRAINING**

MASASHI SUGOMORI

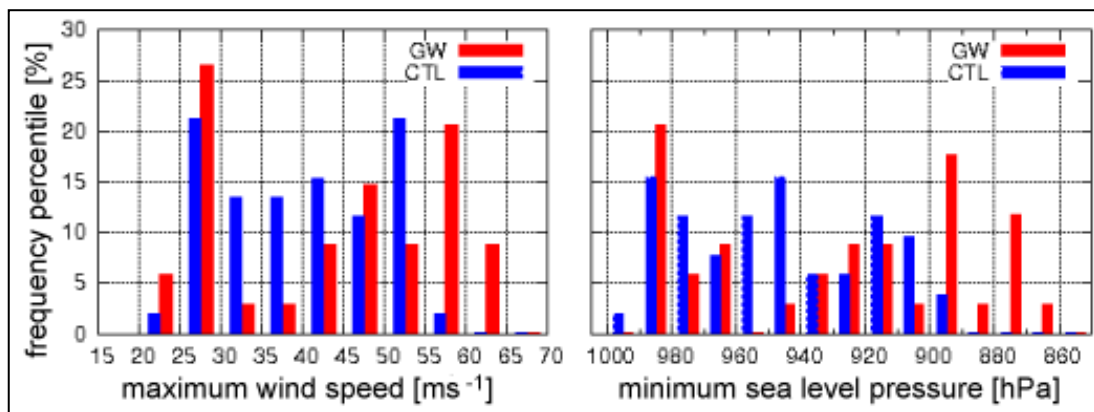
Fig. 5 Comparison between current and future prediction on tropical cyclone

In the future, it is predicted that the frequency percentile of more than 55m/sec in maximum wind speed is approximately 29% compared with approximately 2% in the current situation. In addition, according to the figure on the right, it is found

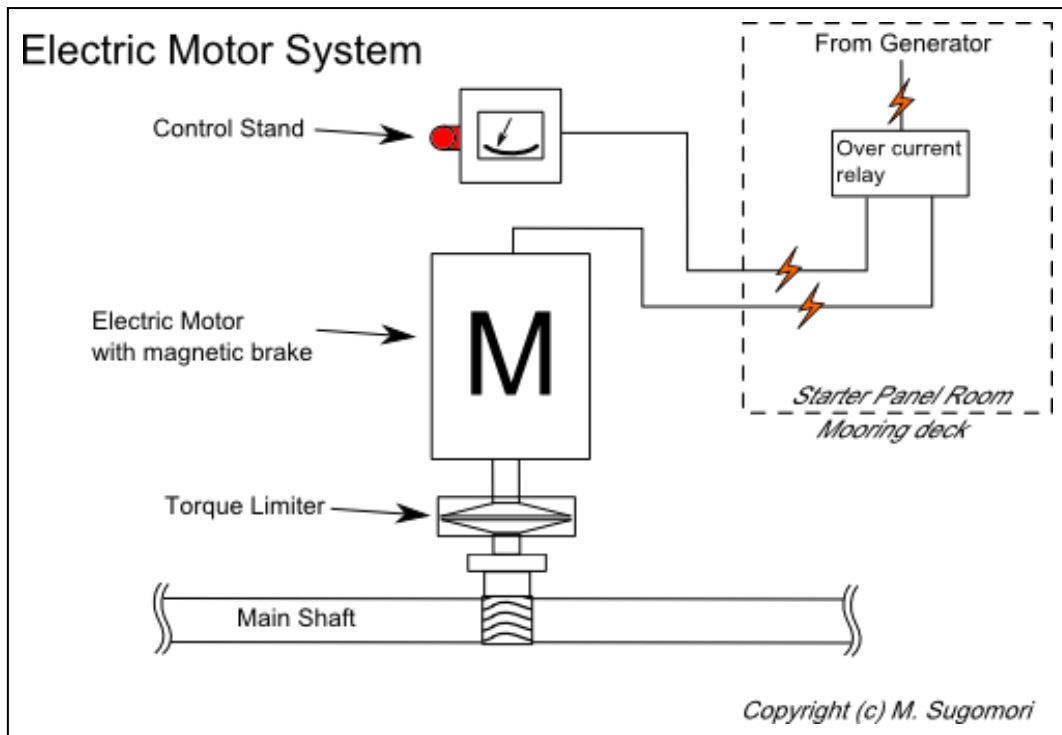
Fig. 7 Electric motor windlass

On the electric motor system, electric motors with electromagnetic brakes are fitted as a driving force generator. Fig. 7 shows this system. Characteristically, a torque limiter is equipped between the motor and main propeller shaft in order to release the overload. For this reason, a torque limiter needs a proper torque setting of mating surface periodically. Otherwise the windlass does not make the proper performance as the manufacturer had intended. As mentioned in Chapter 2, the maintenance of the torque limiter may be a very important factor.

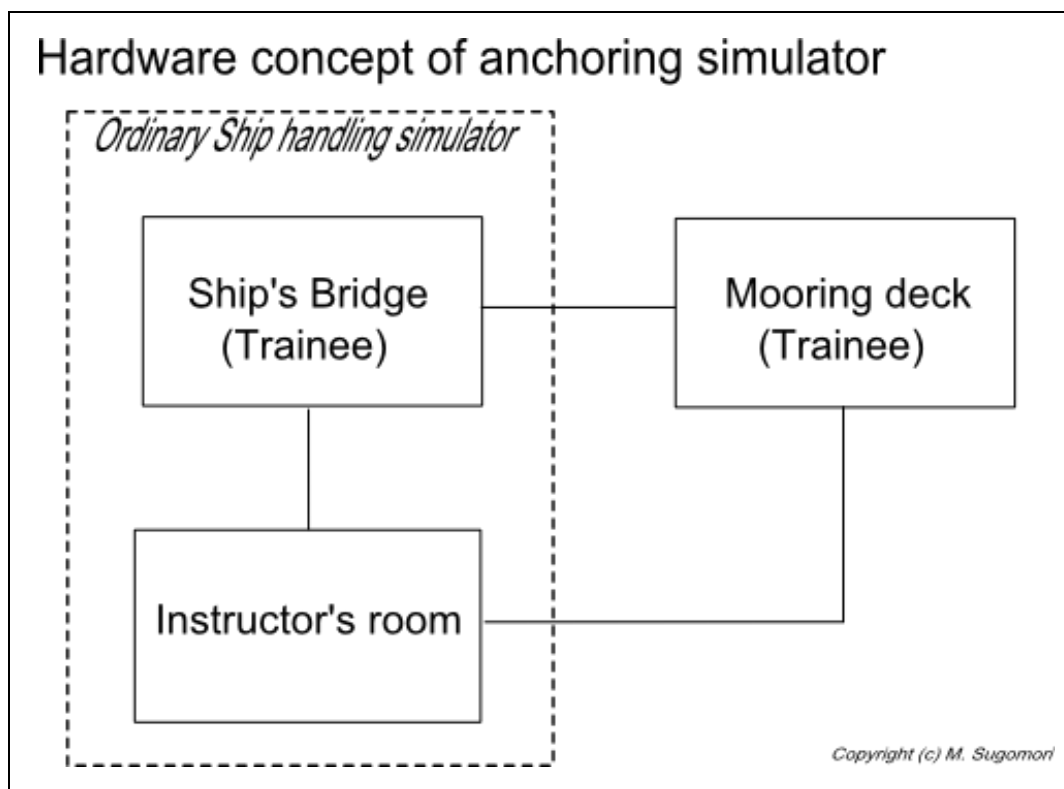
Fig. 13 Hardware concept of anchoring simulator

In fact, an “Anchor handling simulator” has been developed and been used, yet it is used for the personnel of an anchor handling vessel in the offshore industry (Kongsberg). For this reason, a new simulator system which can reproduce all kinds of situations at anchor should be developed for implementing the suggested syllabus. This new system can be built up from an ordinary ship handling simulator. The concept of the system is shown in Fig. 13.
