A method to replace lightning strike tests by ball impacts in the design process of lightweight composite aircraft panels

F. Soulas^{a,b,1}, C. Espinosa^{a,1,*}, F. Lachaud^{a,1}, S. Guinard^b, B. Lepetit^b, I. Revel^b, Y. Duval^b

Composite material aircrafts are protected against lightning on the basis of complex and expansive lightning strike experimental plans aiming at designing optimal protections. The paper aims at reducing the number of lightning strike tests on protected and painted composite panels. An analytical calculation is presented that gives the characteristics of an equivalent mechanical impact configuration based on an assessment of the typical time scale of energy deposit and kinematic behaviour during a lightning strike test. The paper presents our analytical hypotheses and calculations, as well as experimental lightning strikes and mechanical impact settings and results. The method is shown to give an acceptable approximation of both the kinematics and the delamination surface.

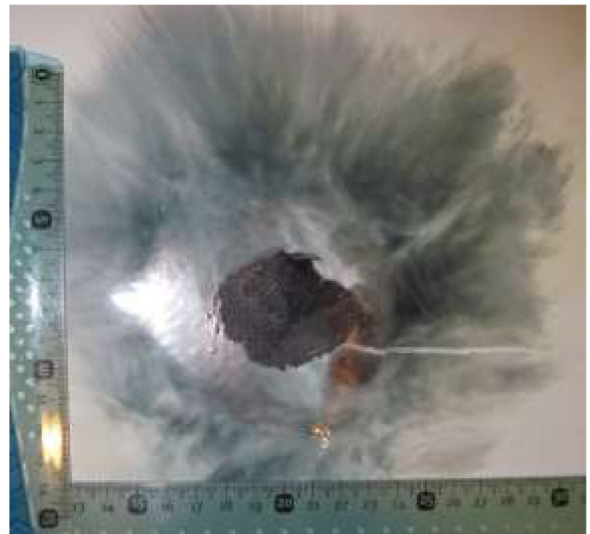
Fig. 4. Typical observable damage after D waveform LS test on a CFRP target.

Firstly, with the help of an interferometric apparatus, the rear face deflection and velocity of the samples have been measured versus time. Secondly, post mortem non destructive and destructive analyses were conducted to measure total delamination area and through thickness distributions. Typical surface damage areas essentially due to thermal effects are shown on Fig. 4: sublimation of the metallic mesh and removal of the paint above the protection as well as burning of the first ply's carbon fibres and epoxy resin.

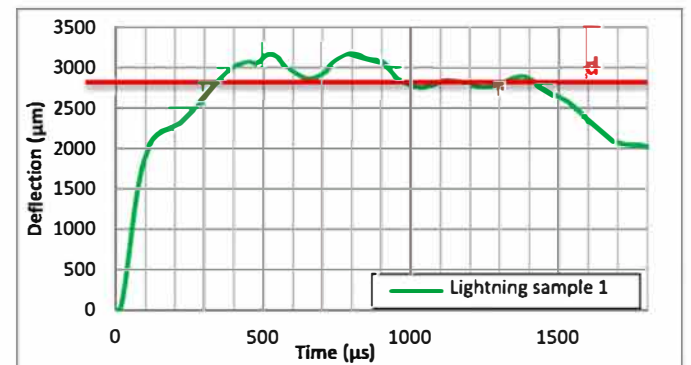
Fig. 9. Displacement vs time curve for lightning sample #1.

The deflection at large times is extracted from Fig. 9 and the corresponding impulse from Eq. 4. In plane Young moduli and Poisson ratios are obtained from standard laminate theory $E_{xx} = E_{yy} = 50.0$ GPa and $\nu_{xy} = 0.305$. The bending stiffness D (36.4 N/m) is chosen as the mean of the bending stiffness $D_{xx} = 51.8$ N/m and $D_{yy} = 21$ N/m of the composite plate for X (0°) and Y (90°) directions. The thickness h is 2 mm here, and the surface mass is $\mu = 3.1$ kg/m^2 .
