# Directionality of Cavities and Porosity Formation in Powder-Bed Laser Additive Manufacturing of Metal Components Investigated Using X-Ray Tomography

Anton du Plessis,<sup>1</sup> Stephan Gerhard le Roux,<sup>1</sup> Gerrie Booysen,<sup>2</sup> and Johan Els<sup>2</sup>

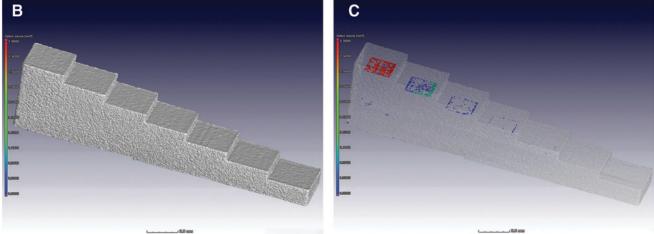
FIG. 1. The step sample with induced layered defects (*flat cavities*) of varying thicknesses perpendicular to the build direction: Shown here are the CAD file (**A**), the X-ray CT surface view (**B**), and a transparent CT defect analysis view (**C**). Color coding of defect volumes shows the largest defect in *red* and the smallest defect in *blue*. CT, computed tomography. Color images available online at www.liebertpub.com/3dp

Three test samples of titanium-6aluminum-4vanadium were manufactured on an EOS M280 using standard good quality build settings, as used in previous studies and as used routinely to build parts with less than 0.1% porosity on average. These settings include 170 W laser power, 1200 mm/s scanning speed, 100  $\mu$ m spot size, and 30  $\mu$ m layer thickness. The samples of ~ 30 mm height and up to 20 mm width were produced with induced defect regions. These induced defects were fabricated by leaving cavities in the CAD file while keeping processing parameters exactly constant. One sample contains horizontal square layered defects in the XY plane, perpendicular to the build direction and with varying layer thicknesses, as shown in Figure 1. A second sample contains straight cylindrical tracks with different diameters, as shown

The designed step sample, which is shown in Figure 1, contains horizontal square defects with varying thicknesses from 180 to 30  $\mu$ m. The X-ray CT results in Figure 1 show the surface of the sample, followed by a transparent view with an

automated defect analysis showing a color-coded defect analysis, that is, red showing the largest pore by volume. In this way, it is clear that the first four defect layers are detected, that is, from 180 to 90  $\mu$ m. It is also clear that the layer thickness varies and is not fully pore space, that is, it is partially solid. This is speculated to be due to remelting from subsequent layers, causing the internal regions to fuse together. Figure 4 shows the same results, but with slice images in the plane of each successive layer, showing good contrast images of the porosity regions. In this case, it is clear that pores are also detected in the expected position of the 5th layer at 60  $\mu$ m design thickness but no defects at the sixth and last layers with 30  $\mu$ m design thickness. It is speculated that fusion occurs through the next layers above the cavity space during the build process, and it is quite surprising that this even occurs up to a cavity layer thickness of 180  $\mu$ m.

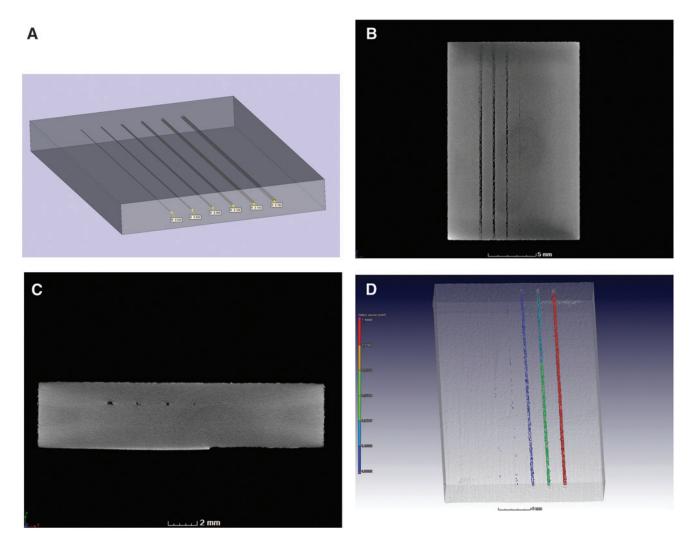
FIG. 2. The rectangular sample with induced line/track defects of varying thicknesses perpendicular to the build direction. Shown here are the CAD file (**A**), the X-ray CT slice images from *top* view (**B**) and *front* view (**C**), and a transparent CT defect analysis view (**D**). Color images available online at www.liebertpub.com/3dp

Figure 2 shows the test sample with defect lines/tracks at varying thicknesses and that such tracks are not fully pore space on their interior, similar to that seen in the previous example. In this case, the track of 90  $\mu$ m diameter is only marginally detectable. The track of 60  $\mu$ m is not seen, but some isolated pores are seen in the expected location of this track. The expected track of 30  $\mu$ m is not seen at all. Again, it is speculated that these results are due to fusion of the layers above the cavity space, with similar results to those of the first test object.

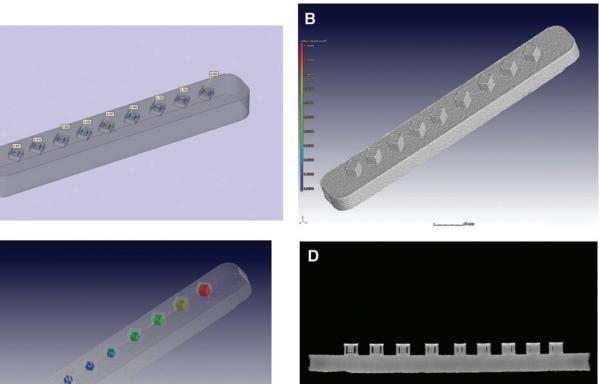
FIG. 3. The cube sample with induced *vertical square* defects of varying thicknesses parallel to the build direction: Shown here are the CAD file (**A**), the X-ray CT surface view (**B**), a transparent CT defect analysis view (**C**), and CT slice images from *side* (**D**) and *top* (**E**) views. Color images available online at www.liebertpub.com/3dp

In Figure 3, the test sample with cube-shaped defects is shown. The build direction is upward in the images, from the horizontal base still attached to the cubes. Therefore, the indicated cube-shaped defects have vertical cavity walls of varying thicknesses, parallel to the build direction. Clearly, all the defects are seen in the CT data, even the smallest designed 7  $\mu$ m cavity wall thickness is seen clearly. The detected cavity walls of the designed 7  $\mu$ m width are in fact 70  $\mu$ m wide in places (as measured by CT), making this type of induced defect much larger than expected.

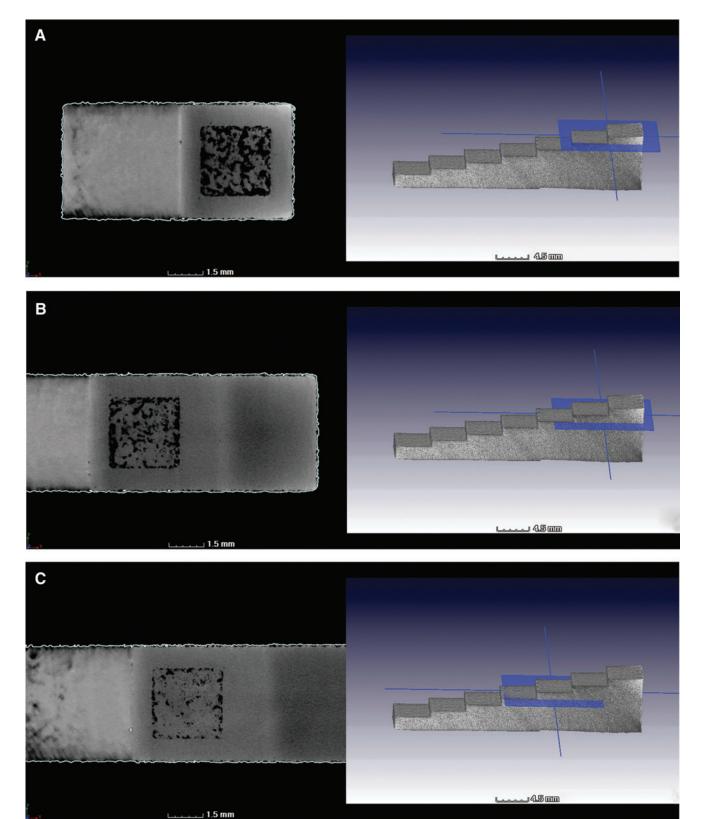
FIG. 4. CT slice images of each defect layer (induced cavity) in the plane of the layer showing good contrast images of the porosity for the steps from *top* to *bottom* in (A–F). *Black* indicates void space, and *gray* areas indicate solid material. *Grayscale* variations are exaggerated as the defect areas are on the same height as the next step edge (the edge between material and air). Color images available online at www.liebertpub.com/3dp

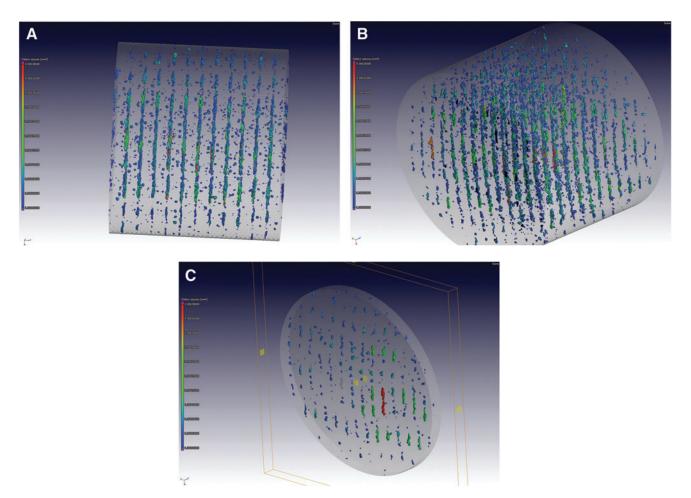
FIG. 5. Structured porosity found under nonideal build conditions on a different system, with porosity trails following the build direction. Shown here are CT defect analysis views from two directions  $(\mathbf{A}, \mathbf{B})$  and one *cropped* view to emphasize the directionality of the porosity trails (**C**). Color images available online at www.liebertpub.com/3dp

In addition to the test specimens reported with induced defects, one example is shown in Figure 5 of unexpected porosity formation at levels of 0.6% average porosity. The sample was built on a different system with nonideal parameters, the details of which will not be reported here as it is still under investigation. It is relevant to report this example since the porosity is well structured in a checkerboard pattern but tends to produce trails in one direction, specifically in the build direction. This observation seems to validate the above discussion with regard to porosity preferentially forming in the build direction. In this case, the demonstration is for unexpected porosity rather than only induced defects as in the above three test samples. It is important to note that the observation of directionality is not limited to one type of defect and would most likely occur with any type of internal cavity or defect and will therefore affect the design of parts with internal cavities.
