A smart multi-functional printed sensor for monitoring curing and damage of composite repair patch

To cite this article before publication: Dimitrios G. Bekas *et al* 2019 *Smart Mater. Struct.* in press <https://doi.org/10.1088/1361-665X/ab2d08>

22 8 **Abstract**

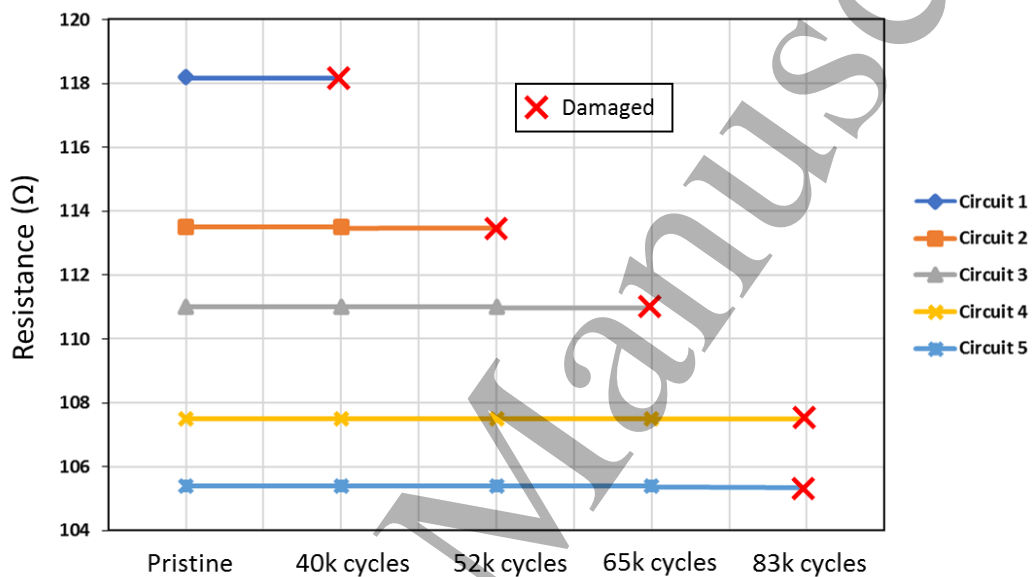
236 The integrity of the bondline was monitored in real-time by tracking the change in the
 237 resistance of the inkjet-printed circuits. Upon damage, the conductive circuits were
 238 interrupted and the connections between the two terminals of the multimeter were lost
 239 (Figure 2b). At that moment, the fatigue testing was stopped, and the integrity of the repair
 240 was investigated using Ir-thermography. Figure 6 depicts the resistance values of the five
 241 printed circuits at different fatigue loading cycles.

243 Figure 6 Electrical resistance values of the five conductive sensors at different fatigue
 244 cycles.

245 For the pristine repaired CFRP plate, all five circuits remained intact and the resistance
 246 values ranged between 105-120Ω. After 40k fatigue cycles, the connections between the
 247 terminals of circuit 1 were lost, indicating the presence of damage in the bondline close
 248 the edge of the repair patch. At the same time, the connection between the remaining four
 249 circuits remained intact and their resistance remained unchanged. Whenever a connection
 250 was lost, the plate was removed from the fatigue machine and the integrity of the patch
 251 repair was investigated via Ir-T, and the fatigue test was continued under the same loading

1
2
3
4 252 conditions. Testing stopped another two times, when the connections of circuits 2 and 3
5
6 253 were lost after 52k and 65k fatigue cycles respectively. This indicates that the damage
7
8 254 propagated in the bondline between the patch and the repaired panel. The same approach
9
10 255 was followed until the connection of all circuits were lost. This occurred after 83k fatigue
11
12 256 cycles. An important advantage of this methodology is that since the detection of damage
13
14 257 is restricted to the bond-line, it is not affected by any degradation of the repair patch or
15
16 258 of the composite panel.

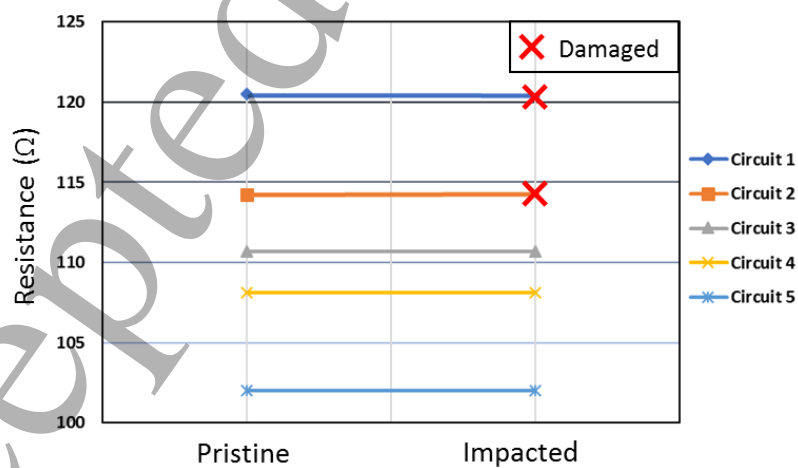
293 The electrical resistance values of the five conductive circuits before and after the impact
 294 testing are summarized in the bar chart in Figure 9.

296 Figure 9 Electrical resistance values of the conductive circuits before and after the impact
 297 testing

As expected, when a circuit was “lost” its resistance could not be measured, indicating the presence of damage in the bondline within the radius of the circuit. As can be observed, the induced damage resulted in the disruption of 2 conductive silver-based circuits while the rest of the circuits remained intact. Electrical measurements indicated that the integrity of the two exterior circuit was damaged. Thus, the extent of the damage within the bondline was approximately 10 mm from the PTFE film.

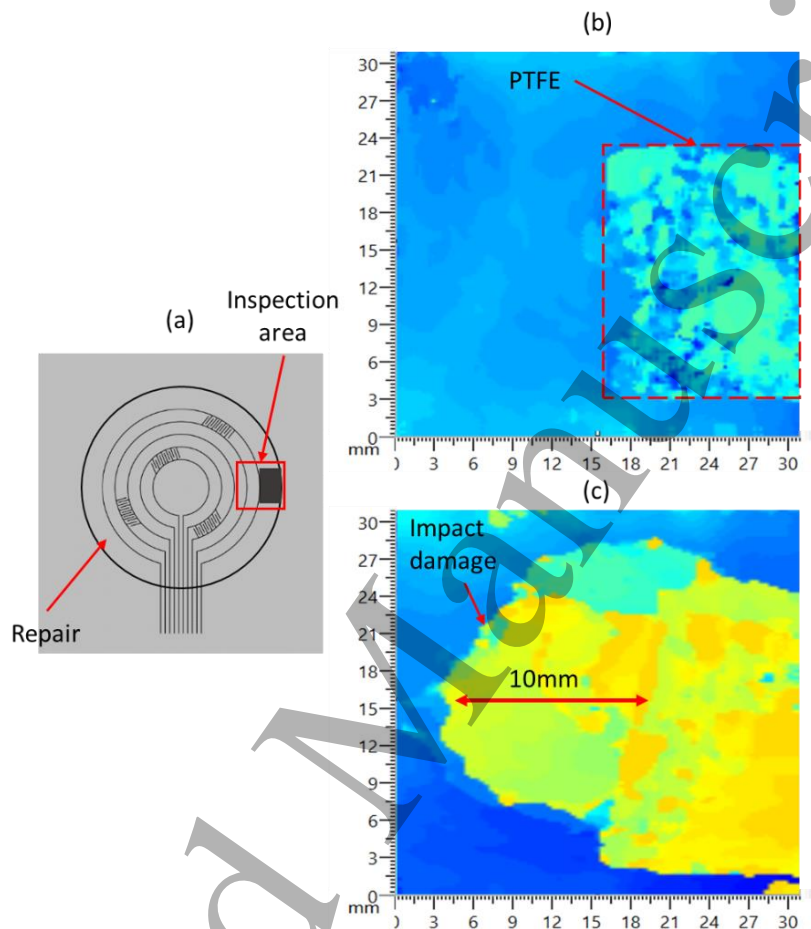
316 To further examine the extent of the damage created by the impact test, the damaged area
 317 was examined using ultrasound inspection. Figure 11(b) and (c) depict the C-scan images
 318 obtained from the pristine and damaged CFRP panels, respectively.

319
 320 Figure 11 (a) Inspection area; C- scan images obtained from the (b) pristine and (c)
 321 damaged CFRP panel

322 The artificially created defect can be seen in Figure 11 (a). After the impact test, the
 323 damaged area increased at about 10 mm towards the center of the repair. It should be
 324 mentioned that the yellow color shows increased severity (Figure 11(b)). The C-scan
 325 images show that the damage propagated at approximately 10 mm from its initial position
 326 towards the center of the repair. This observation is in agreement with the results obtained

1
2
3
4 327 from the resistance measurements which suggested that the two exterior circuits were
5
6 328 disrupted due to the induced damage.
7
8
