The determination and modelling of the brittle structures of the Kumpula Campus Drill hole

Riikka Valtonen
December, 2018
Master's Thesis
Department of Geosciences and Geography
Division of Geology
University of Helsinki

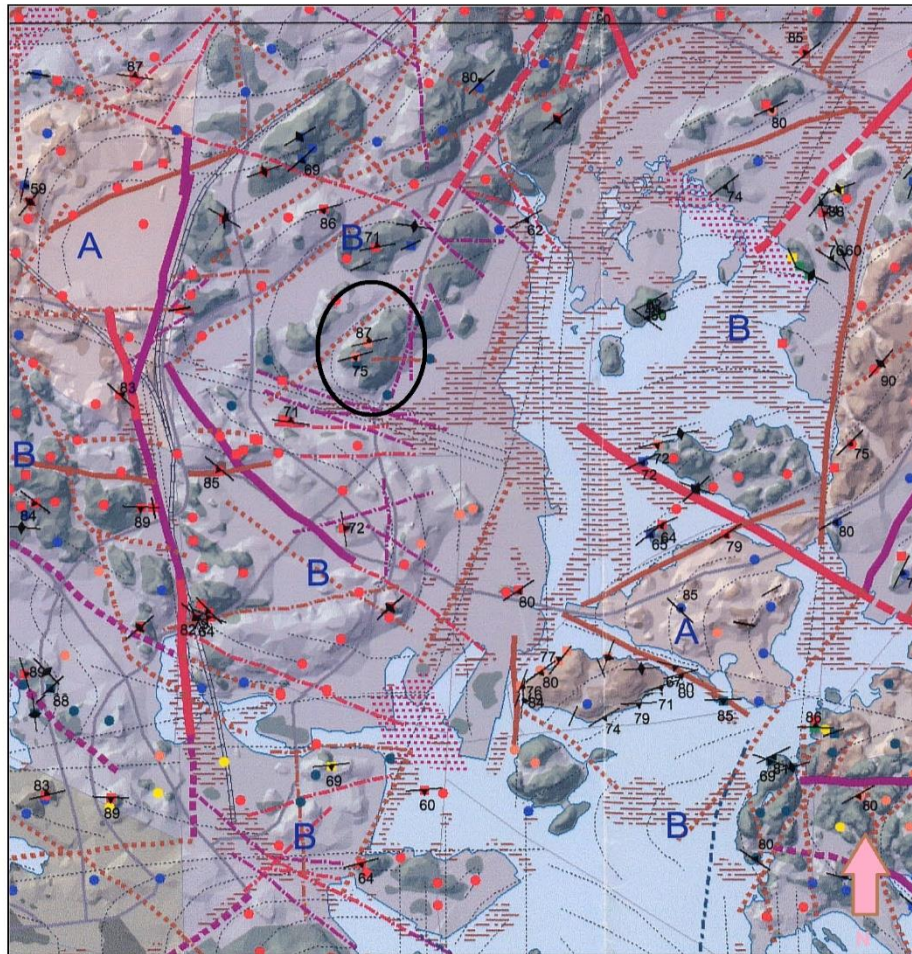
Figure 3. Modified 1:50 000 constructability map of Kumpula area after Pajunen et al. 2002b. The Kumpula hill is marked on black circle to the map. The original legends of the map are in Finnish, so beneath the map has been translated the main points in shorter versions. The map represented the most brittle zones of the bedrock around the Kumpula area.

In previous studies of Pajunen et al. (2001) has been found out that the nearest brittle zones around the Kumpula located at the eastern side, between Kumpula hill and Arabia and the valley of the Vallila (Figure 3). Structures on the west side of the hill has been classified only slightly weathered. The valley of the Vallila situated at the WNW-ESE axis and the eastern brittle zone located almost in N-S axis. The fracture density on the Kumpula hill is around $> 0.5-1$.

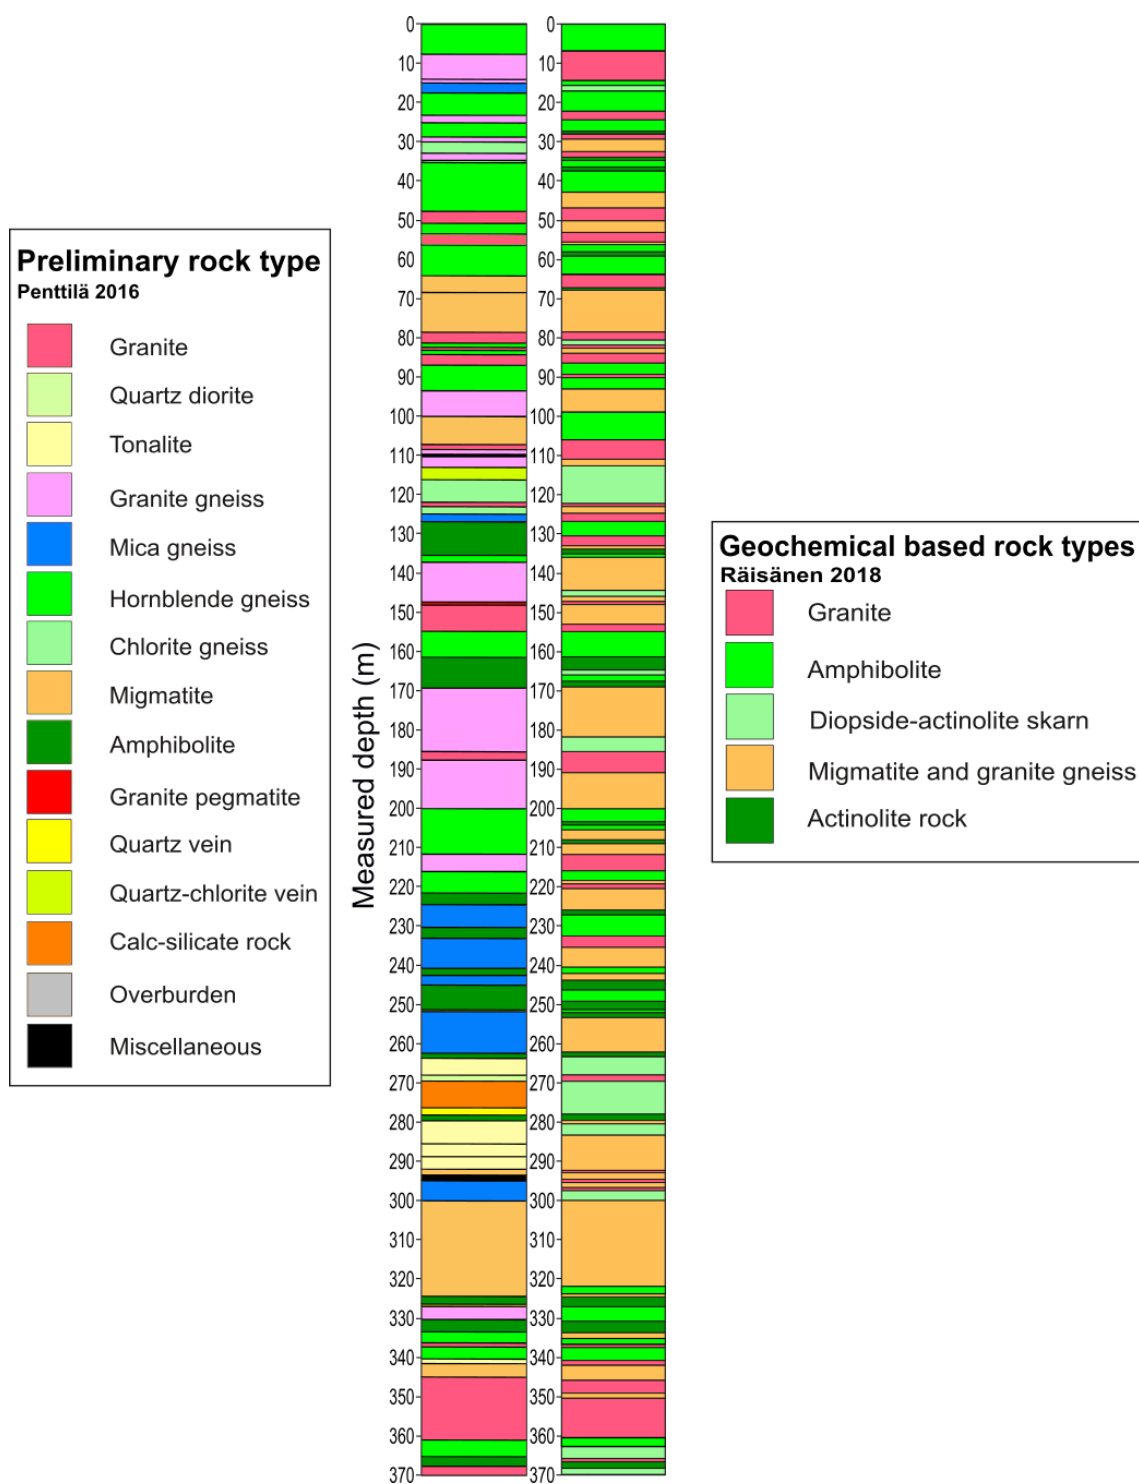
Figure 4. Lithological columns of the Kumpula drill hole. On the left are the rock types after Penttilä (2016) and on the right rock types after Räisänen (2018). The rock types on the left have been determined based on preliminary logging of the drill core and the rock types on the right have been determined based on thin sections, measurements with the portable X-ray fluorescence device, and laboratory X-ray fluorescence device.

The rock types of the drill core have been studied based on drill core and logging and petrography (in prep. Penttilä) and geochemistry (Räisänen 2018). Preliminary logging studies have found at least 13 rock types in the drill core (Figure 4) (Penttilä 2016), whereas with the help of geochemistry, the rock types of the drill core have been divided into the five different classes (Figure 4) (Räisänen 2018).

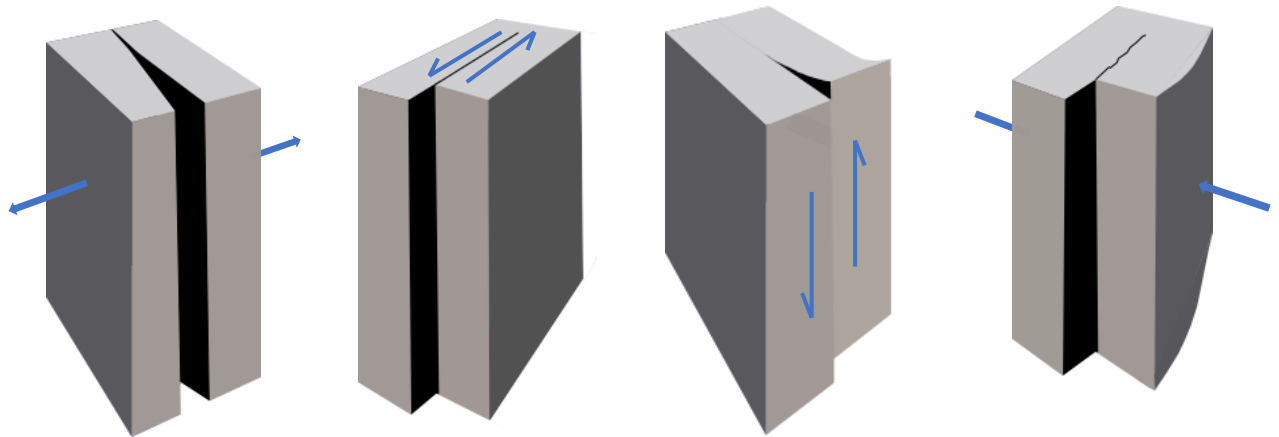
Figure 5. Fracture types based on the relative displacement (after Fossen 2010) a. Mode I is extension fracture with perpendicular to σ_3 , force vectors against to the fracture walls, b. Mode II is shear fracture, oblique to σ_3 , force vectors sliding parallel to the fracture c. Mode III is shear fracture with oblique to σ_3 , force vectors sliding on the edge of the fracture and d. Mode IV is closing fracture, perpendicular to σ_3 , force vectors facing each other.

Based on the relative displacement, fractures can be divided into four classes, which are mode I, II, III and IV (Figure 5) (Fossen 2010). In mode I, the relative movement has happened perpendicular to fracture, whereas in mode II and mode III the relative movement has happened parallel to the fracture (Figure 5) (Twiss and Moores 2001). Mode IV represent fracturing caused by contractional forces and is often called stylolite (Fossen 2010). If fracture has features from both Mode I and Mode II or III, it is called a hybrid fracture (Fossen 2010).

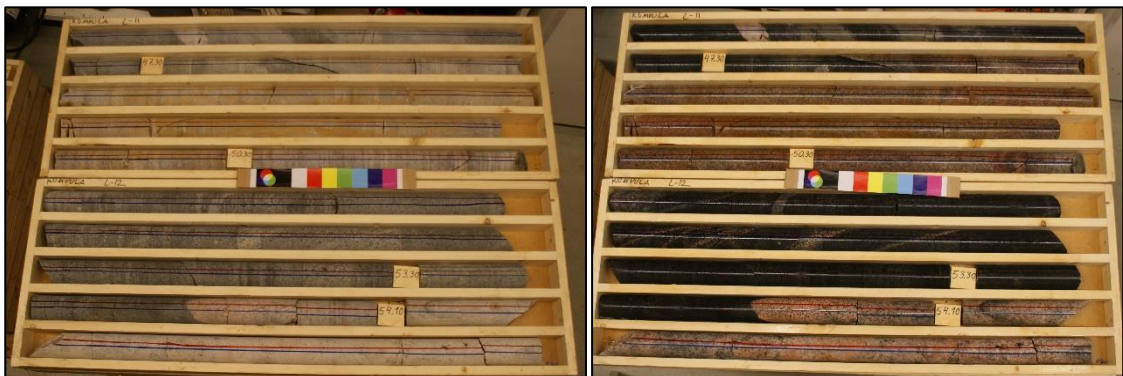
Figure 6. Drill core box number 11 and 12 after drawing accessory lines and before logging, on the left dry core and on the right wet core.

The drill core was salvaged from drill hole during drilling. It was collected to the about 80 wooden boxes, each containing around five meters of drill core. The drill core was not logged before, so the project started with core logging. The core logging started with photographing the core and drawing directional lines (downwards right = blue, downwards left = left) to the core (Figure 6). The core was not oriented during drilling, so the directional lines were drawn by fitting the core pieces together and estimating the continuity by naked eye.

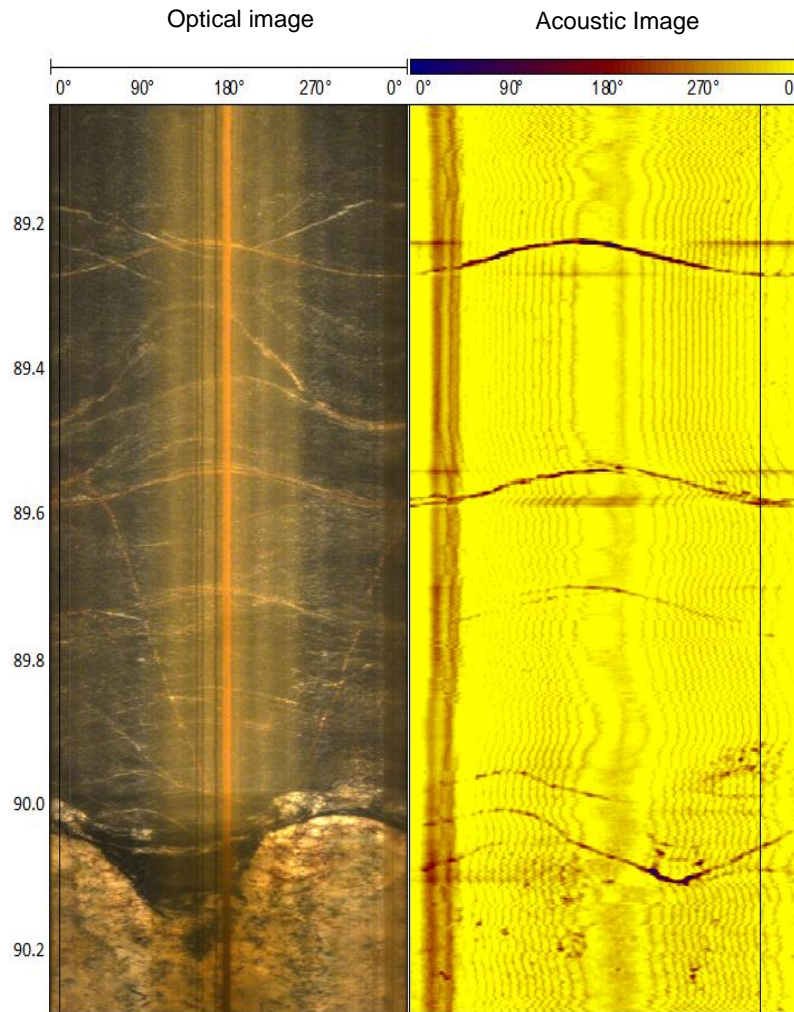
Figure 7. Example images of optical and acoustic logs from the drill hole from the depth of 89.0-90.2 meters.

Data from the drill hole has been raw processed by GRM company. The data was presented in logs: one log contained the optical image, and the other log contained the acoustic image of the drill hole (Figure 7). The optical image begins at the depth of 1.9 m and acoustic image from the depth of 31.0 m and they both continue to the bottom of the drill hole.

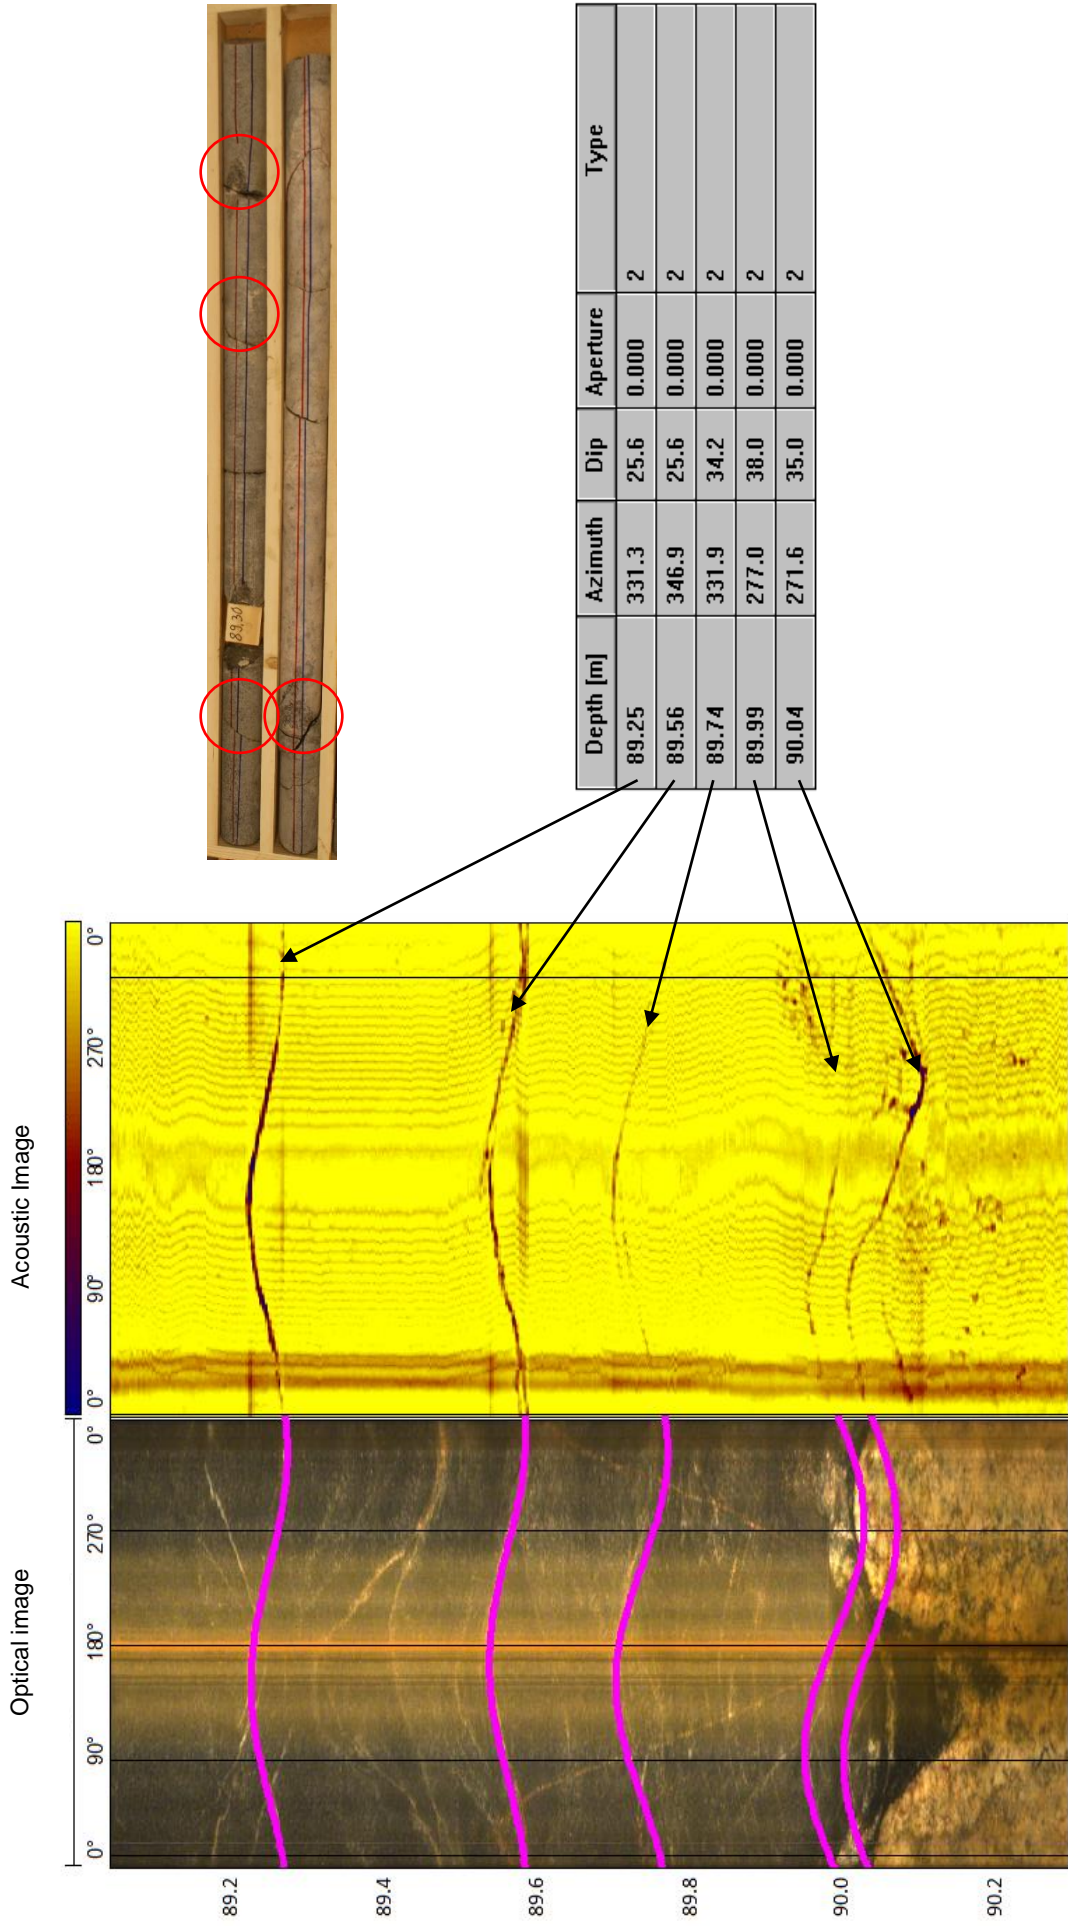
Figure 8. Classification of fractures in Wellcad and image of the drill core, where the tabulated and imaged fractures are indicated with a red circle.

After drawing the fractures, the data was compared to the core logging data. The fractures were classified in Wellcad in different fracture classes, which appear on the log in different colours (Figure 8). Fracture classes based on the logging data are: 1) slickensides, 2) minor fractures (filled and unfilled), 0) crushed zones and fractures. Class

3 was added during Wellcad processing phase after it was noticed that the acoustic image contained fractures, which were not visible in the drill core. Class 2 was later divided in Excel to filled and unfilled fractures based on logging data.

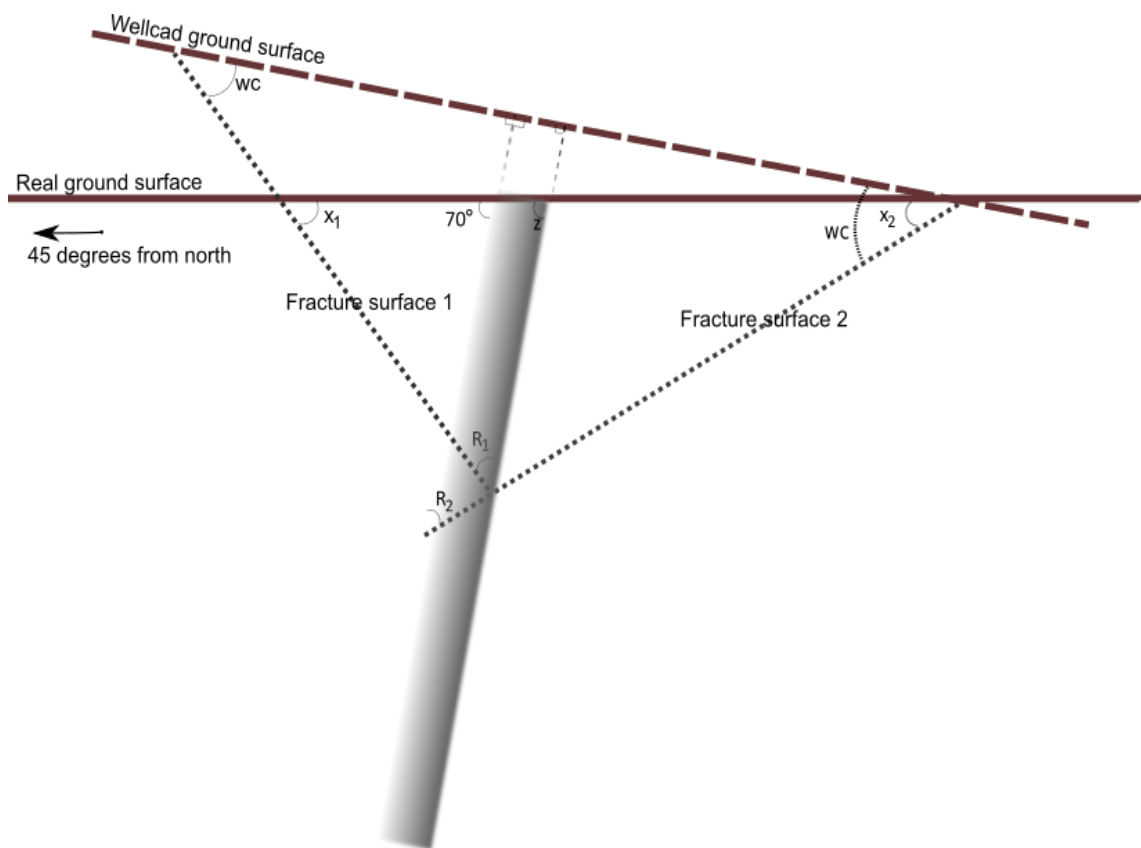
Figure 9. Image of the drill hole in real situation vs. Wellcad basic situation. The drill hole plunge is 70 degrees. When operating in Wellcad, it is assumed that the drillhole is situating 90 degrees from the ground. wc = dip of the fracture calculated in Wellcad-based assumption, R_1 = angle between fracture surface and the drill hole, when the calibrated azimuth is 135–315 degrees, R_2 =angle between fracture surface and the drill hole, when the calibrated azimuth is 0–135 degrees or 315–360 degrees, z = angle between drill hole and the ground, x = the real dip of the fracture.

The dips of the fractures were corrected based on the α -angle (calculated in Wellcad), the real dip direction of the fracture plane (from equation 1), and drilling direction of the drill hole. The calculation of the dip was more complex, because the effect of dip direction must be considered in the equation. Fractures are planes, which approach drill hole from different directions and create different angles between drill hole. Between the drill hole and the ground there are two angles: to the drilling direction this angle is approximately 70 degrees, whereas on the opposite side it is 110 degrees like seen in idealized Figure 9.

The fracture surface, imaginary ground surface and drill hole create a triangle, where it is possible to calculate the angles R_1 and R_2 seen in the Figure 9. between the drill hole and the fracture plane. When that angle is known, it is possible to calculate the real dip from the triangle, which has been created by fracture plane, (real) ground surface and drill hole like in Figure 9. The equations of the dip corrections are given below.

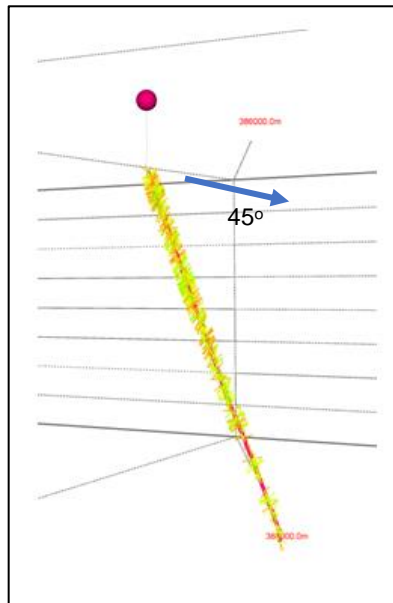
Figure 12. Drill hole with fractures after inputting them to the software. Picture is taken from the south. The drilling direction is marked with the blue arrow.

The drill hole data was input to the Move in a text-file with an AsciiWell data - format. It included the coordinate data, depth, dip and dip direction data of the fractures and the drill hole itself (Figure 12). Also, fracture type was added to the inspection.

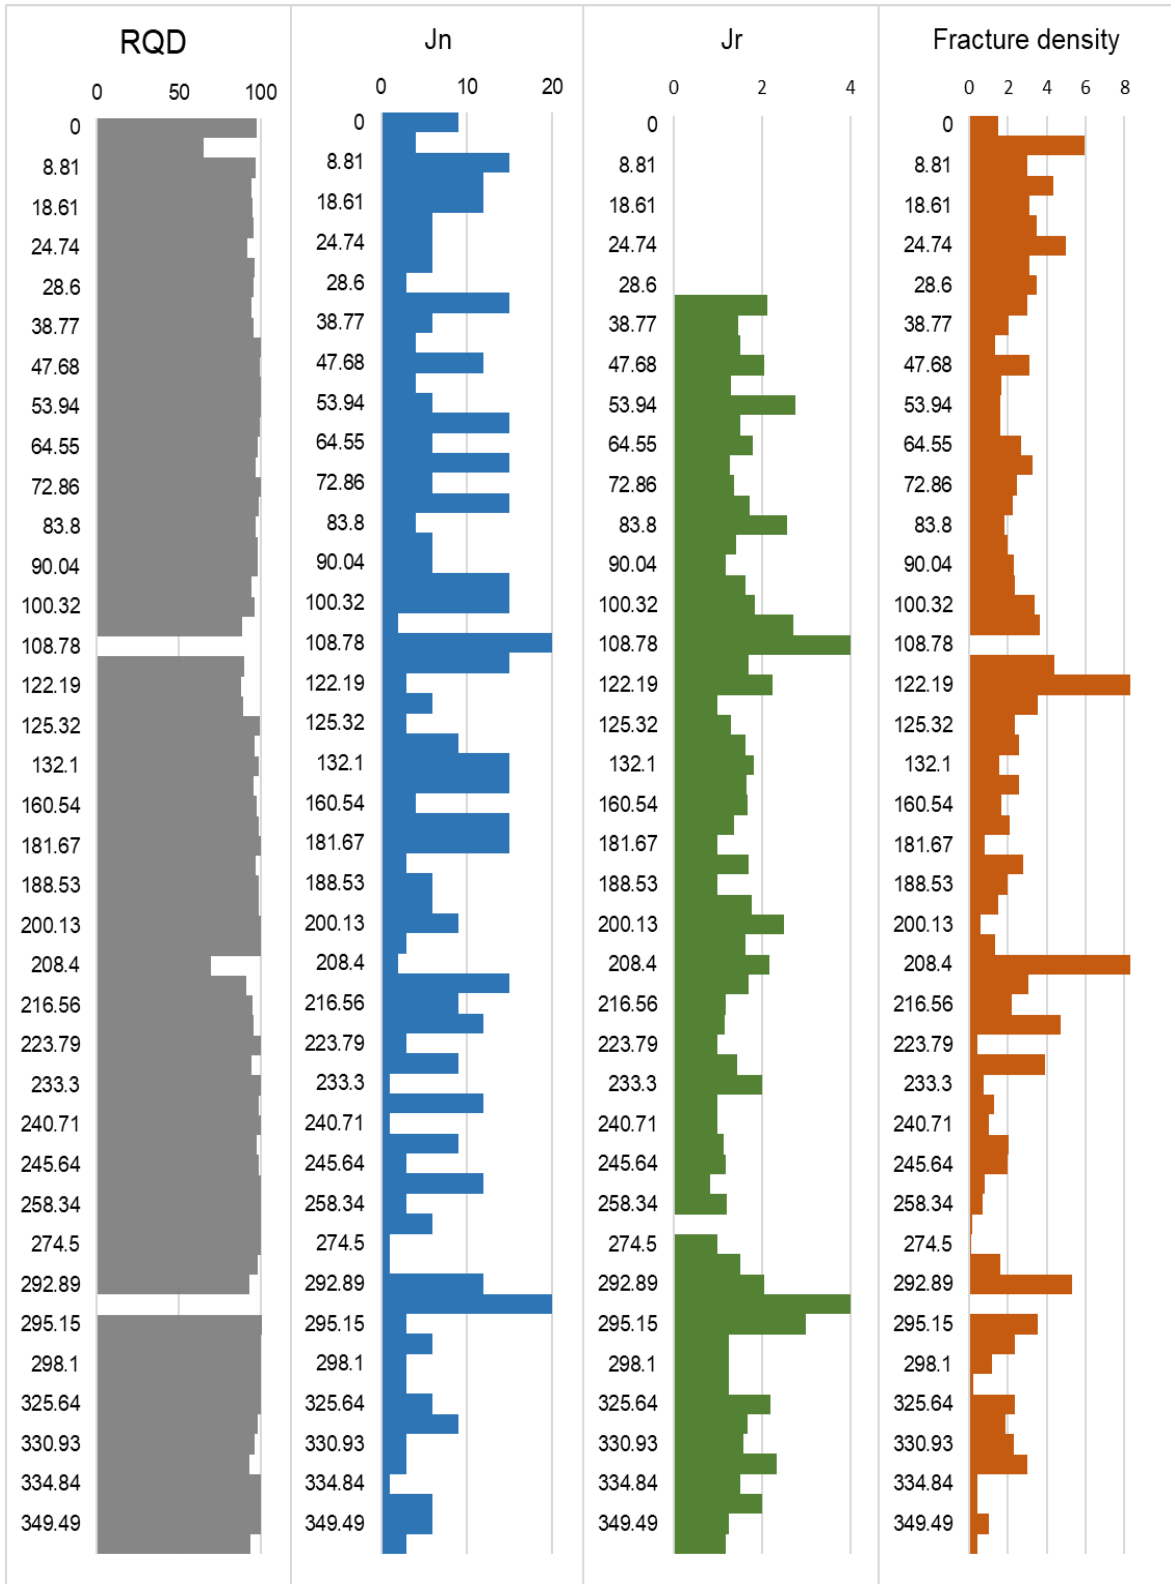
Table 8. RQD, number of joint sets (Jn), joint roughness (Jr) and fracture density values for determined depth intervals of drill hole. The minimum trace length is 0.36 m and maximum is 24.11 m. Mean trace length is 5.14 m. The full data of the analysis is represented in Appendix IV.

Fractures were grouped into sets of 0–30, 30–60, 60–90, 90–120, 120–150, 150–180, 180–210, 210–240, 240–270, 270–300, 300–330, and 330–360. In that way the average J_n value was 7.7. Overall the J_n value differed from 1 to 20. The J_n value was 6 (2 main fractures and random direction) in 17 depth intervals out of 72. J_n value was 9 (3 main fracture directions) in 7 depth intervals and 12 (3 main fracture directions and random direction) in 8 depth intervals. The J_n value was 15 in 14 depth intervals. In crushed zones the J_n value was 20. Fewer than two main fracture and random directions (J_n value under 6) was in 26 depth intervals, of which 15 depth intervals have value 3 (one main fracture direction and random direction).

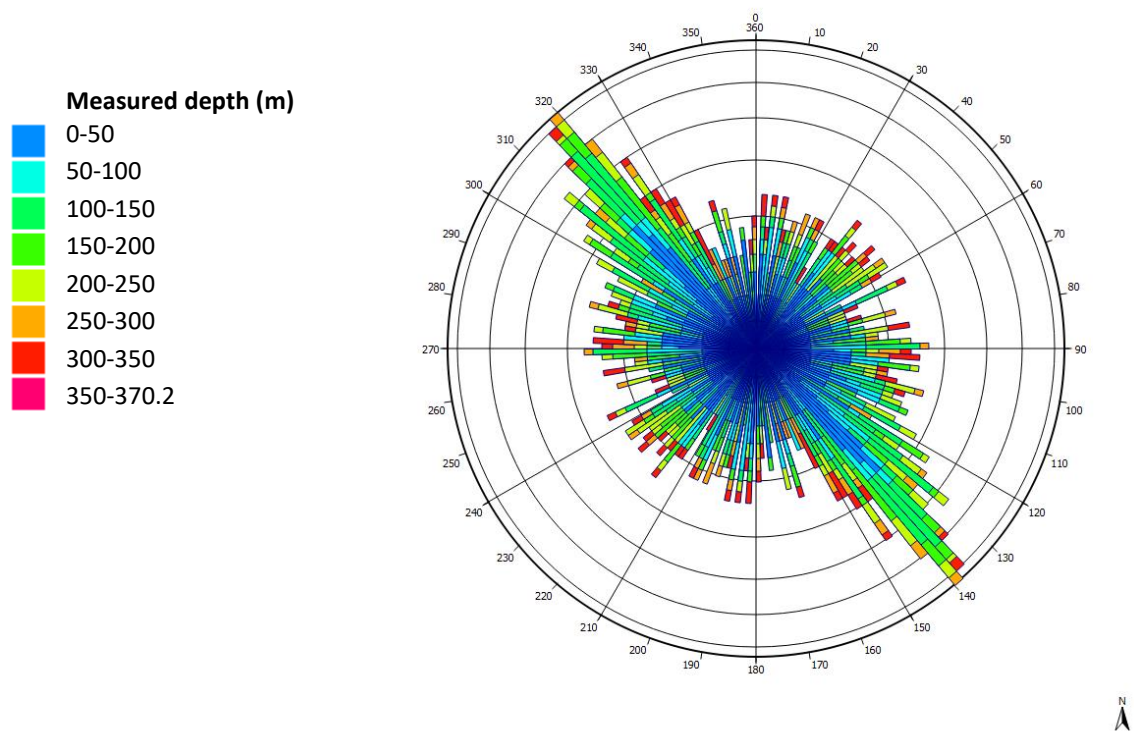
Figure 14. Rose diagram of the strike of the drill core fractures versus different depth intervals.

Drill hole fractures were grouped into depth intervals of 50 meters starting from 0. An exception was made for only the last 20 metres (350–370.2 m). Between these depth intervals the possible strike variation was examined (Figure 14).

To the depth of 200 metres the main strike of the fractures was NW-SE, but in the interval of 200–250 metres besides NW-SE a second main strike direction NNW-SES is also present. The main direction wanders towards north in the last depth intervals so that in the 250-300 metres it was NNW-SES and in the last two it was approximately N-S. In the 250–300 metres there was also the second main strike direction to the E-W, which was associated with the crushed zone in the depth of approximately 294.4–295.14 meters.

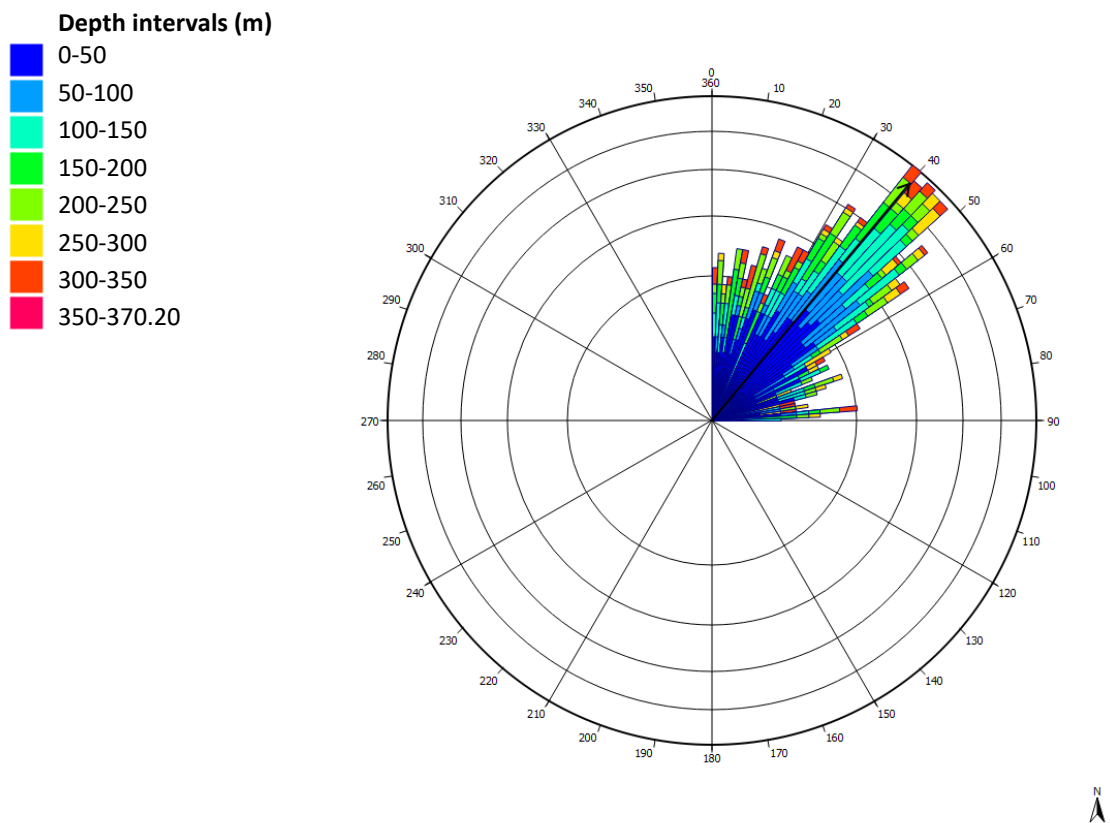
Figure 15. Rose diagram of dips of the all fractures of the drill core versus depth intervals.

Dip angle from 0 to 90 degrees encountered with every depth interval, and every fracture groups. The most common fracture the dip was 40–50 degrees, and this dip appears in every depth interval as well as every fracture group (Figure 15).

Moderate gentle fractures were the biggest dip group in every depth interval. The percentage amount of moderate gentle fractures was over 50 percent in depth intervals of 50–100, 100–150, and 150–200 meters.

The amount moderate steep fractures were on average 20 % in depth intervals of 0–50, 50–100, 100–150, 200–250, and 250–300 meters. The percentage amount of steep fractures was under 20 % in depth intervals of 150–200 and 300–350 meters. In those intervals the percentage amount of gentle fractures was bigger.

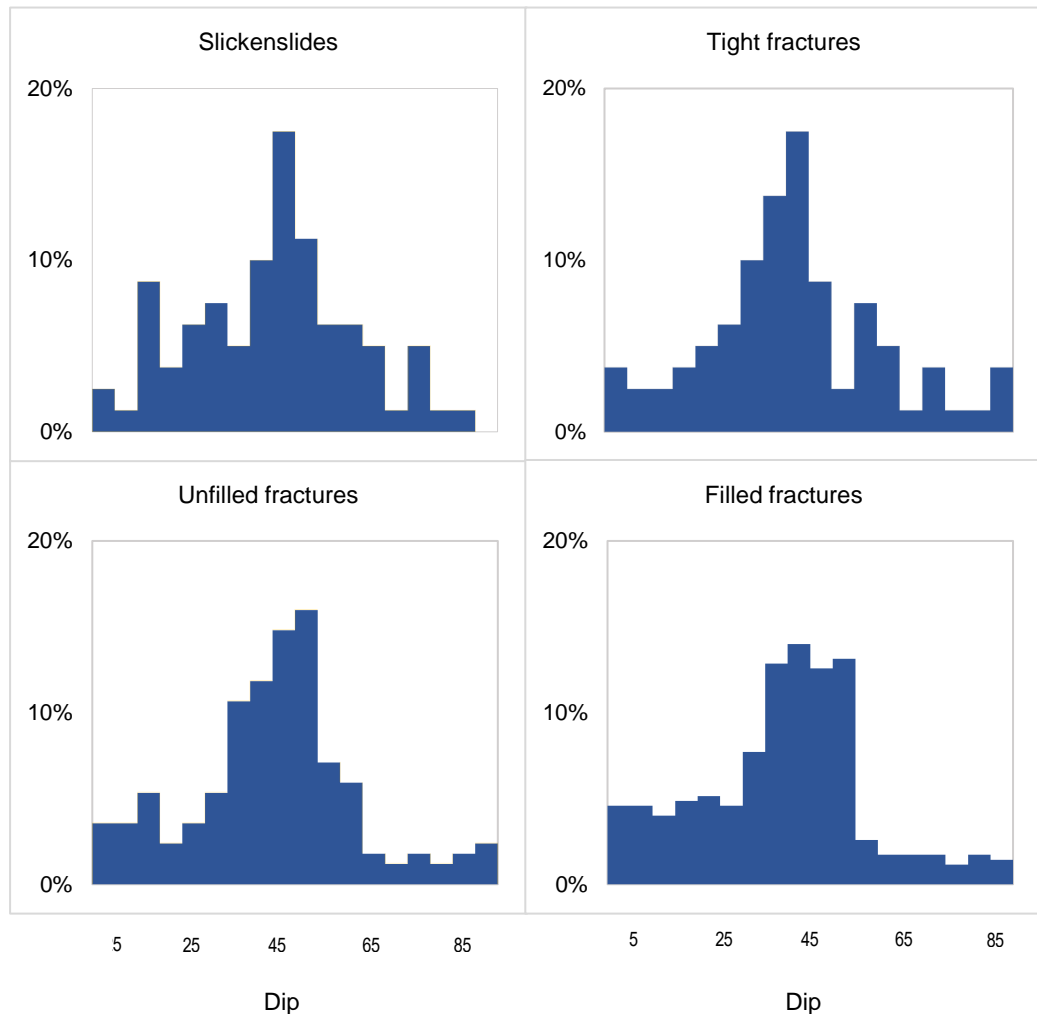
Figure 16. Different fracture groups versus dip.

The dip of 30–50 was the most common in all fracture groups also in every depth interval. (Figure 16). There were some exceptions in unfilled fractures, filled fractures and tight

fractures. The most common dip is 50–70 degrees with minor fractures in the depth interval of 200–250 metres, while in 250–300 metres it was 70–90 degrees and 350–370.20 metres it was 10–30 degrees. The most common dip was 10–30 degrees with filled fractures in depth intervals of 250–300 and 350–370.20 metres.

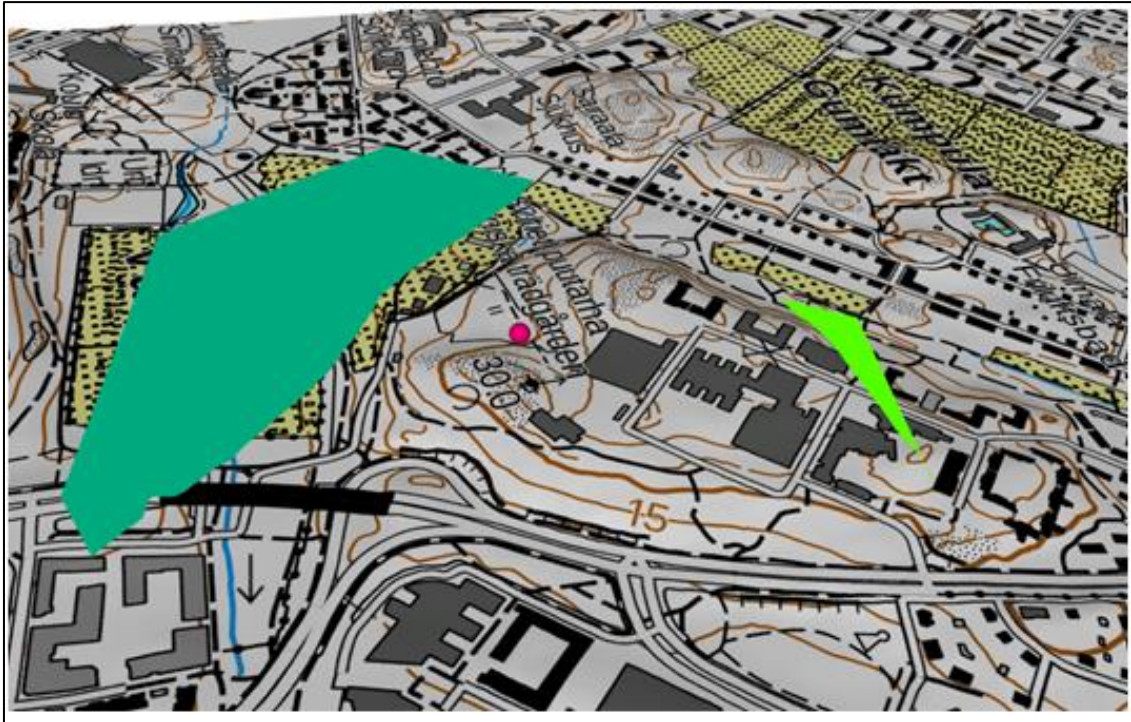
Figure 18. The Kumpula hill from east side. On the left is marked the crushed zone from the depth of 109.0 and on the right is crushed zone from the depth of 296.0. Both are extended from original observation point (from the drill hole) 450 meters in every direction so that they cut with the surface of the ground. The pink point is the place of the drill hole.

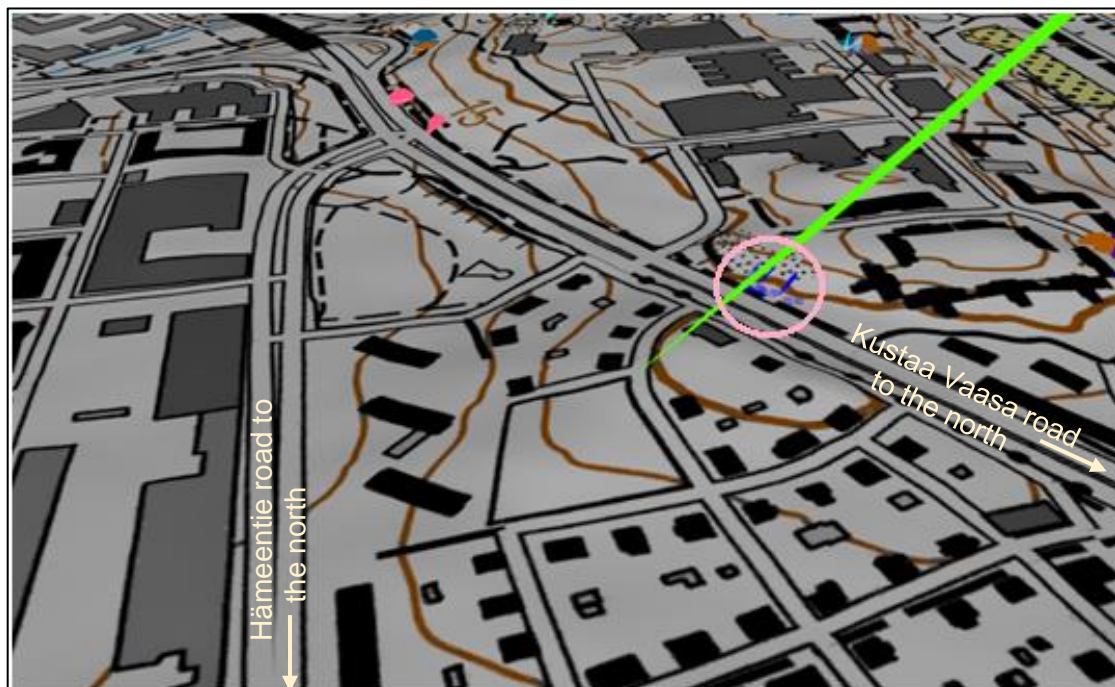
Figure 19. The green surface is the extended crushed zone from the drill hole and the blue planes (circled with pale pink) are fractures on the road cutting (outcrop 8).

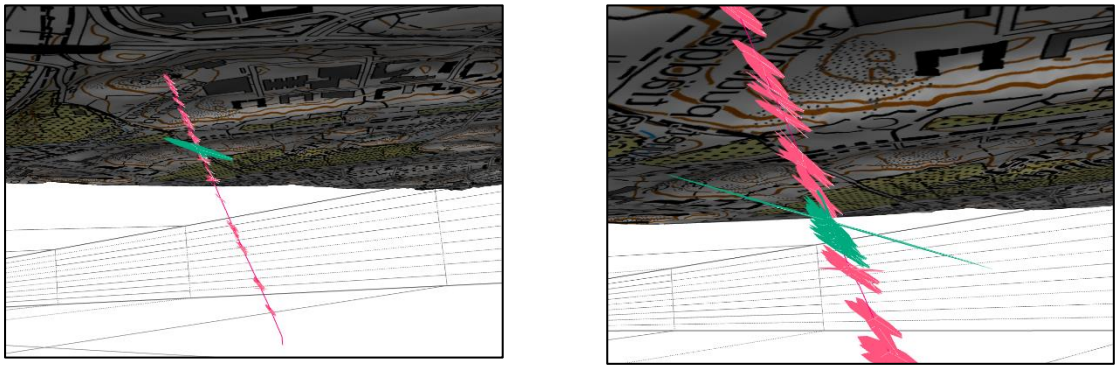
Figure 20. The green surface is the crushed zone and the pink surfaces are filled fractures with same strike (± 15 degrees). Filled fractures with strike of 300-330 degrees are found from top to bottom in the drill hole, but they are also found to be very dense near the crushed zone (fractures marked in green).

Any major faults were not detected on the outcrops. Little faults were discovered based on the veins from the outcrop 3 and 6, but the observed movement was under 15 centimetres, so they were not marked into the model. The crushed zones in the drill hole were only major structures, which were detected according to the available data. The crushed zones were examined visually so that they were extended to the surface at the same dip direction and dip angle as they are in the drill hole (Figure 18). The shallower crushed zone appears to continue at the exact same angle as the valley of Vallila and the other has the same angle as the fractures of the outcrop 8 (Figure 19). Crushed zones continued in same dip direction and dip both 400 metres to every direction from the drill hole. They collide underground in location where the edge of the Kumpula hill is very gentle and covered with soil. The drill hole fractures were examined to see how they were

related to the crushed zones (Figure 20). The strike direction of the crushed zone one is approximately 320 degrees and the second is approximately 90 degrees.

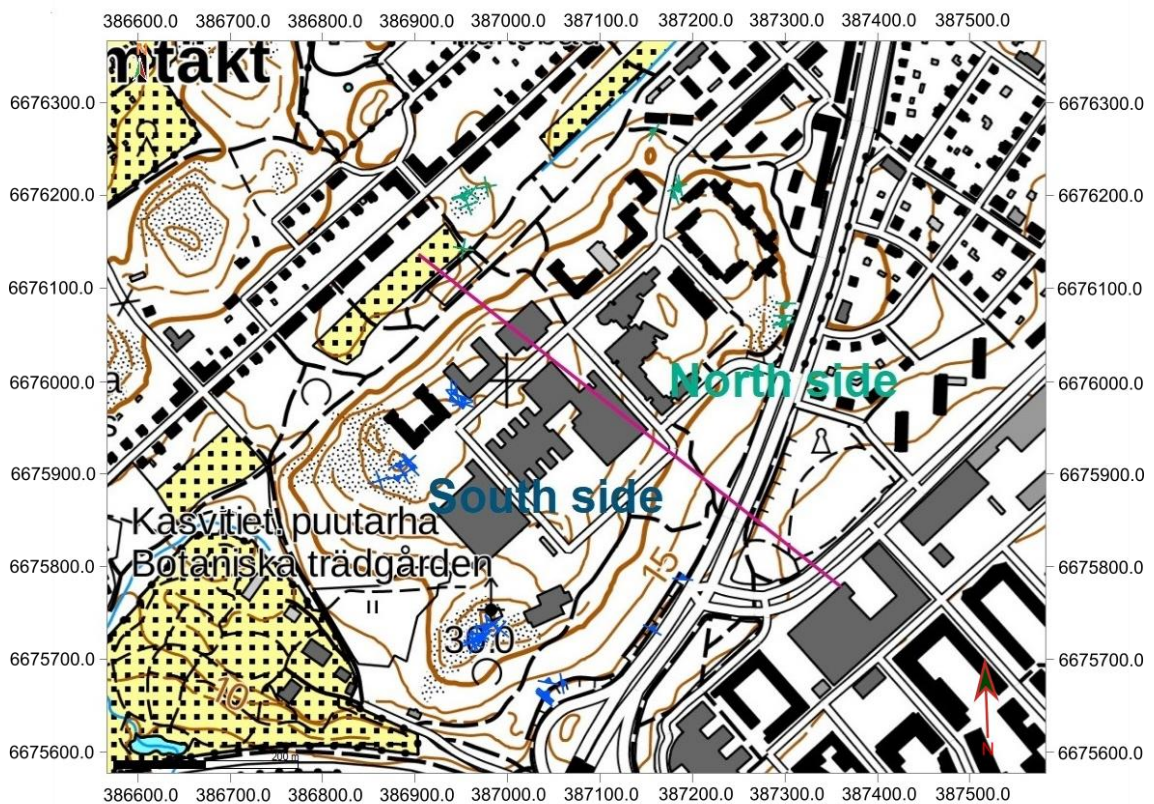
Figure 21. The 2D-map from the Kumpula area divided to the northern and southern sides.

The strike direction on north side and south side of the Kumpula hill was compared with each other (Figure 21). On the south side of the hill, there was more variation between the strike of the fractures, but the the main strike direction was E–W (Figure 22a). There were fewer measurable fractures on the north side of the hill and less distribution between strike direction, so the main strike directions were N–S, and E–W (Figure 22b).

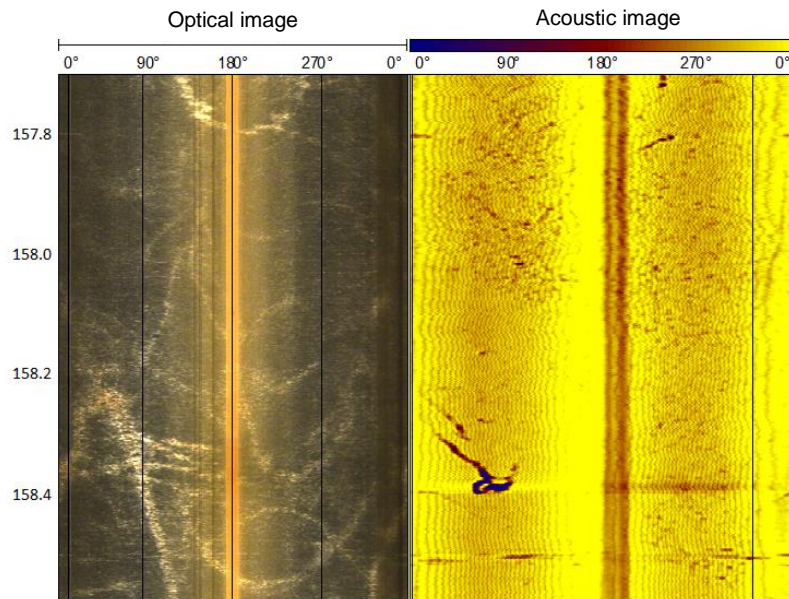
Figure 23. An example unclear acoustic image and dark, fine grained rock type, where it is impossible to detect fractures, which were logged from the drill core. Some marks are seen on the acoustic image, but not enough to be able to draw a curve. According to logging data there should be one slickenside at this depth.

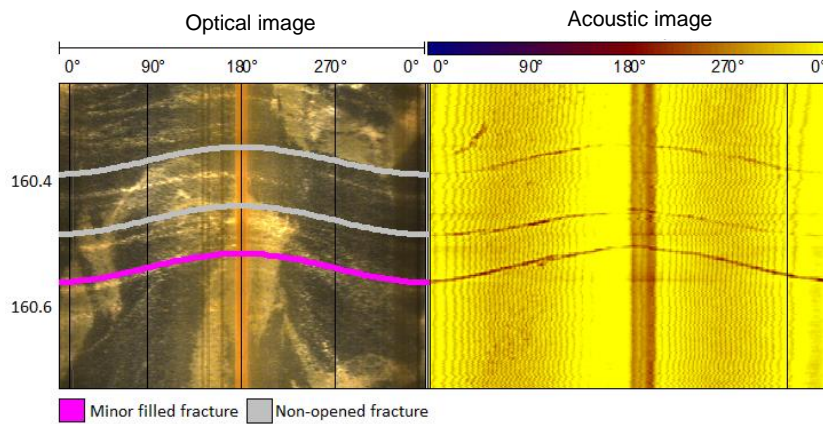
Figure 24. Wellcad-image from the drillhole (depth on the left). Fractures are marked top of the optical image, where the pink colour means a minor filled fracture and grey colour non-opened fracture. On the acoustic image can be seen similar marks.

Tight fractures were a fracture group, which was added to the inspection in the Wellcad phase. They include fractures, which are difficult to detect in the drill core, but are seen clearly in the acoustic and sometimes even optical images (Figure 24). Tight fractures all have the sinusoidal curve on the acoustic image, which means that they are probably natural fractures instead of drilling induced fractures (Tingay et al. 2008). Category could include fractures, which are slickensides, filled or unfilled fractures, but based only on the image it is difficult to accurately classify them. They were added to the inspection because they could affect the weakness of the rock when building on it.
