False Femoral Neck Fracture Detected during Shaft Nailing: A Mach Band Effect

Key Words: Pseudofracture, femur neck, nailing, mach band

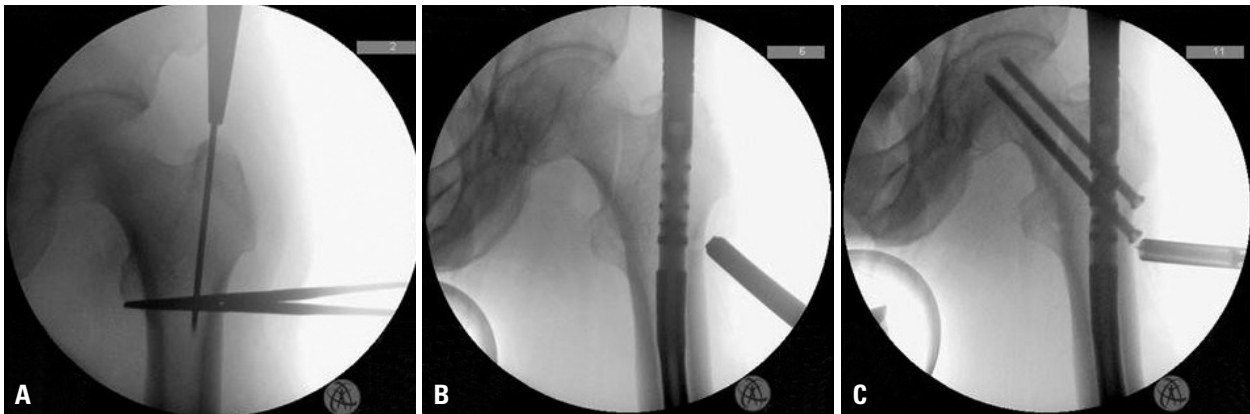
Fig. 1. (A) A 3.2-mm guide pin was inserted at the tip of the greater trochanter; the radiolucent line was not visible at that time. Hemostatic forceps were used to control the external rotation of the proximal fragment.⁴ (B) A radiolucent line mimicking a femoral neck fracture was visible after nail insertion. (C) A reconstruction nail was inserted for fixation of the femoral neck and shaft fracture; the radiolucent line appeared to decrease in size after insertion of two 6.0-mm partially threaded cancellous screws into the femoral neck and head.

greater trochanter. After trochanteric reaming along the 3.2-mm guide pin, a ball-tip guide was introduced into the medullary cavity of the proximal and distal fragments after reduction. A femoral nail (greater trochanter starting nail, 12 mm in diameter, 40 cm in length) was introduced after reaming a hole to 13 mm. The nail was inserted uneventfully without excessive force. At that time, we identified a vertical radiolucent line at the femoral neck, which was thought to be further displacement of a hidden silent fracture or an iatrogenic fracture that developed during nail insertion (Fig. 1). Consequently, we decided to perform reconstructive femoral nailing. We inserted two 6.0-mm partially threaded cancellous screws into the femoral neck and head. Afterwards, we observed that the radiolucent line at the femoral neck had decreased in size. Three distal interlocking screws were then inserted, and a nail cap was applied.

In our case, the pseudofracture was not detected during preparation of the entry point, but instead was found after final settlement of the femoral nail. Unfortunately, it is not uncommon to detect displacement of an undisplaced femoral neck fracture during antegrade shaft nailing. The pseudofracture was vertically oriented in the middle of the femoral neck, thus mimicking a typical femoral neck fracture associated with femoral shaft fracture. After the operation, we realized that it was a pseudofracture, so we attempted to determine the cause of the event. We put the patient on the fracture table and recreated the positions that we used for femoral nailing, but we were unable to make the false femoral neck fracture reappear. We then reversed the saved image that we took during the operation and determined that a radiolucent line was running from the femoral neck to the medial thigh. The boundary of the radiolucent band was a little smoother than that of fracture lines seen in real cases. Intraoperative CT scan or 3D fluoroscopy may also have allowed us to determine that it was a false femoral neck fracture; however, this would have been particularly impractical during femoral nailing with the patient positioned on the fracture table.

after femoral neck screw fixation; however, we realize that rotation of the limb was different. The lesser trochanter was more prominent in the post-fixation image. We suspect a tiny difference in limb rotation caused the decrease in pseudofracture gap on the fluoroscopic image.⁵ In conclusion, we recommend that surgeons check the fracture line again in the reversed fluoroscopic image (tracing the adjacent fat plane and its connectivity with the fracture line) before converting to reconstructive nailing. However, if the presence of a pseudofracture cannot be definitively ascertained, then antegrade femoral nailing must be converted to reconstructive nailing or another method of fixation. Additionally, all supporting fluoroscopic images should be saved for further evaluation and documentation.

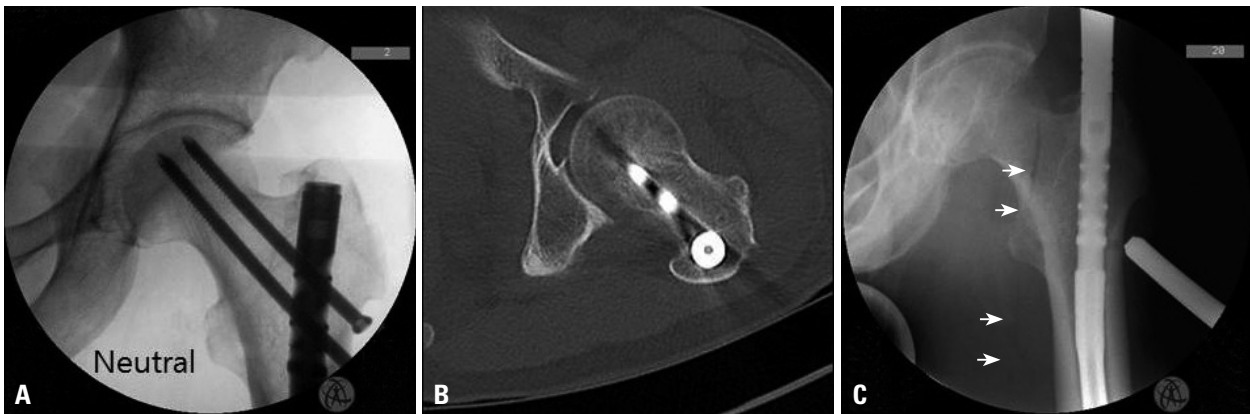
Fig. 2. (A) Postoperative fluoroscopic study failed to reveal the femoral neck fracture in various limb rotations. (B) A CT scan confirmed that the femoral neck was intact. (C) Reversal of the fluoroscopic image taken in the operating room showed a radiolucent line running from the femoral neck to the medial thigh (arrows).

days after surgery, we took a CT scan of the proximal femur in order to analyze the radiolucent line observed during intraoperative fluoroscopy; the femoral neck was confirmed as intact. Reversal of the fluoroscopic image taken in the operating room showed a radiolucent line running from the femoral neck to the medial thigh (Fig. 2).
