## **Stromness - Conservation Area Survey for Orkney Islands Council**

**STROMNESS CONSERVATION AREA**  
Building and Landscape Survey  
July, 2014

The following report presents the results of a collaborative project between the Scottish Centre for Conservation Studies (SCCS), Orkney Islands Council (OIC) and Stromness Townscape Heritage Initiative (STHI), in which a survey of the built fabric of the Stromness Conservation Area was conducted in May 2014.

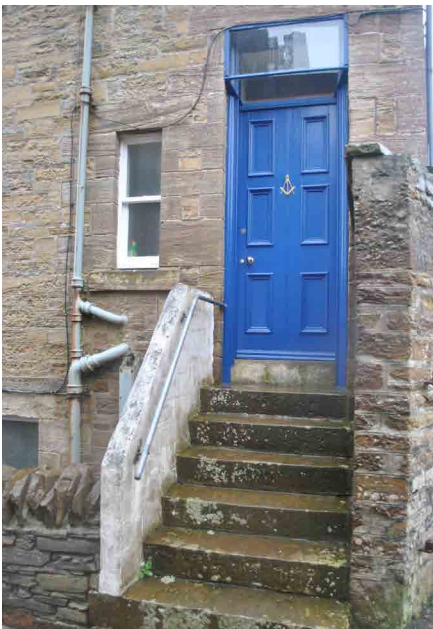
Fig 41. John Street

A relatively common feature in Stromness Conservation Area is that of a glazed panel above the entrance door. While a majority of the panels were of plain glass a few of the glazed panels had etchings or other floral or geometric designs on them.

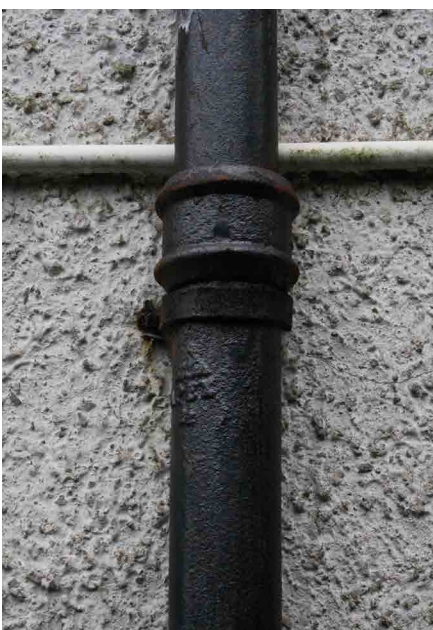
Fig 42. John Street

As is visible from the map, most of the rainwater goods are of a synthetic material with many others in the traditional cast iron. About 6-7% of structures despite having pitched roofs have no rainwater goods.

Many structures have a combination of plastic and cast iron rainwater goods. However for the purpose of documentation the type that featured most was recorded.

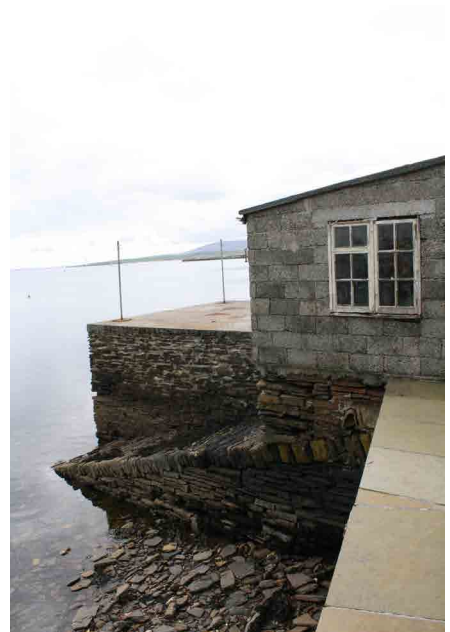
Fig 45. Pier Victoria Street

Many of the piers are in a fair condition with some loss of pointing. However they appear to be structurally stable. While a few of the others are in a good condition, two piers and slipways are in a poor condition and need to be re-examined and repaired.

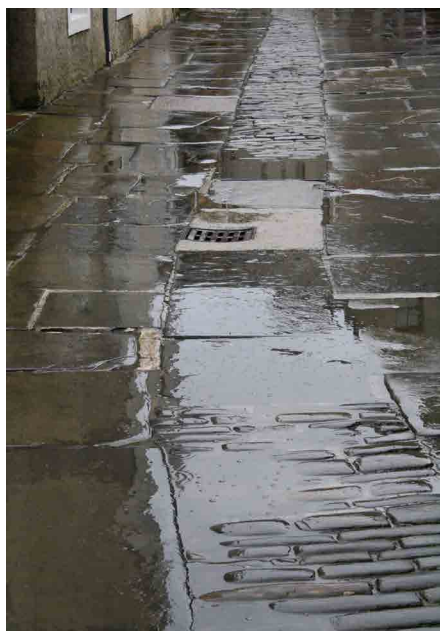
Fig 47. Surfaces

From the surface analysis it can be seen that the materials used for paving differ in places. The majority of the main street of Stromness is covered by locally sourced flagstones, often with a course of setts in the middle of the street, while parts of the northern and southern streets are covered with asphalt. Setts are most common in narrow lanes, while gravel (including green areas) can be observed in small parts of public courtyards, close to the sea. Concrete tiles are also another common pavement type, especially in parts where flagstones meet asphalt or concrete (eg. Port).

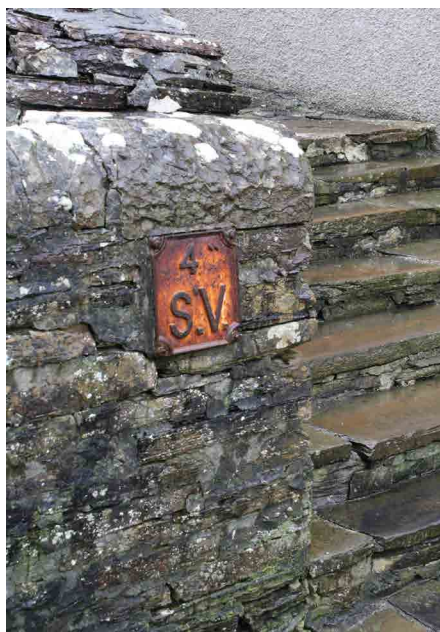
Fig 48. Boundaries

As is visible from the map, there is a variety of boundaries within the Conservation Area. Most of them are attached to buildings, separating properties, and other are used as separate boundaries within the public space. The most common material used for boundaries is exposed stone rubble, generally pointed or filled with concrete elements. Dry stone and concrete walls were found only in a few places in the west part of the Conservation Area. Sandstone kerbs were observed on

both sides of the main street and a concrete kerb was found close to the old primary school. Metal boundaries are most common close to the port, including both barriers for the parking area and the piers, and railings for safe pedestrian access at lanes.

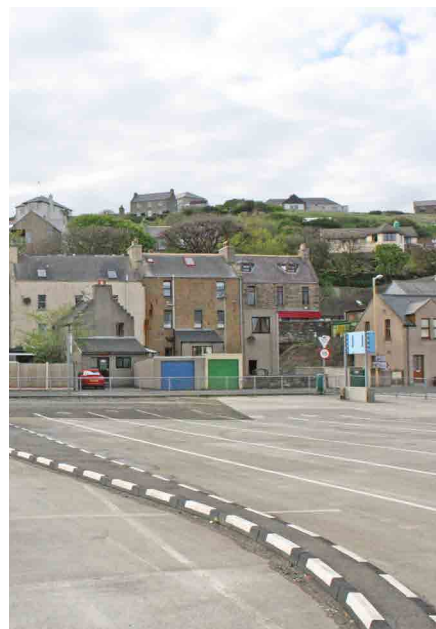
Fig 49. Road Markings

As is visible from the recorded images (see Appendix G), different types of road markings were found around the port and on the North West side of Stromness. These markings which are painted in white and yellow colour, are serving as borders for the parking area close to the port and as road signage for the drivers and the pedestrians.

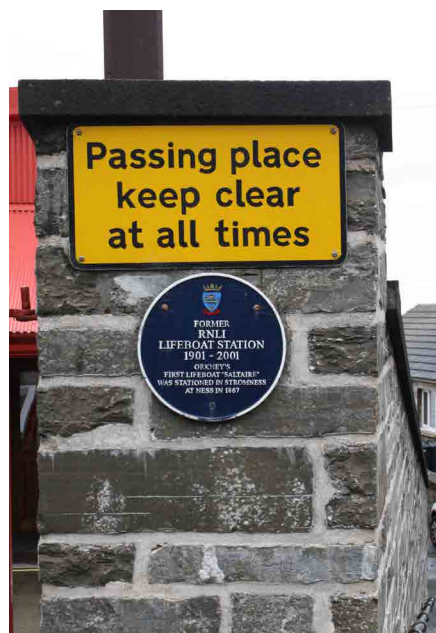
Fig 50. Signage

In this category are included all sign posts and boards that were found on the street, at crossroads or attached to buildings. From the map it can be concluded that most of the signs are located on the main street and quite a few of them are traditional. Road and traffic signage, including information boards, are mostly gathered near the port, where traffic is heavier due to the location of the travel centre and the ferry terminal. Contemporary signage was observed too, in many areas temporary construction notices, but was not recorded.

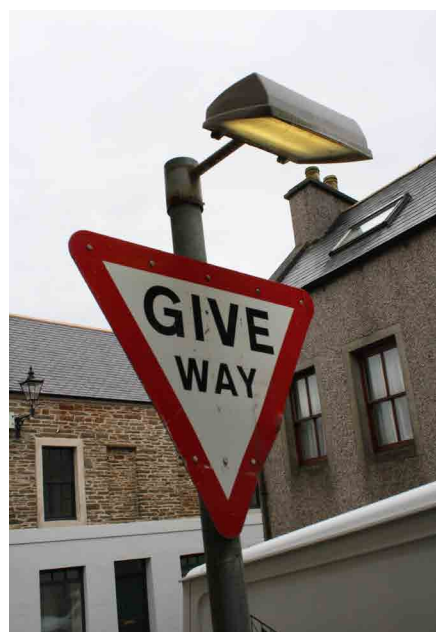
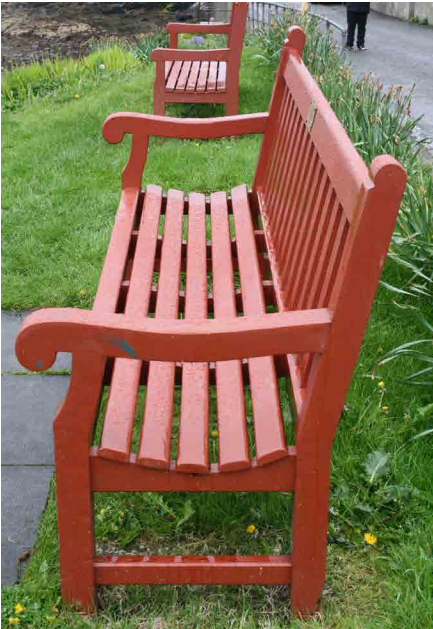
Fig 51. Street Furniture

This map includes a variety of features, such as postboxes, street lights, statues, clocks, telephone booths, electricity boxes, litter bins, benches, bollards and poles. The majority of the features are street lights, most of them modern but there are

some historic examples, close to crossroads and significant buildings (i.e. banks, the library, museum and church). Approaching the town centre, historic features far outweigh modern ones, with a few exceptions at some parts of modern development. There is one clock next to the bus station at the Stromness travel centre and two statues at the main square that leads to the ferry terminal. Bench areas are to be found close to the sea and within small squares around the town centre. At the south side, beside the museum, is located the only historic telephone booth, while two modern telephone booths were placed at the north side of the town in front of the Royal Bank of Scotland. Most of the litter bins are traditional (these are the only ones recorded) with the exception of a few plastic bins in the port and some lanes. A few street light posts with signage were recorded too and shown on the relevant map.
