FACTA UNIVERSITATIS

Series: **Working and Living Environmental Protection** Vol.11, N° 2, 2014, pp. 129 - 143

ACCIDENT PREVENTION IN SEVESO FACILITIES: EXAMPLE OF THE COPPER FLOTATION PLANT IN BOR

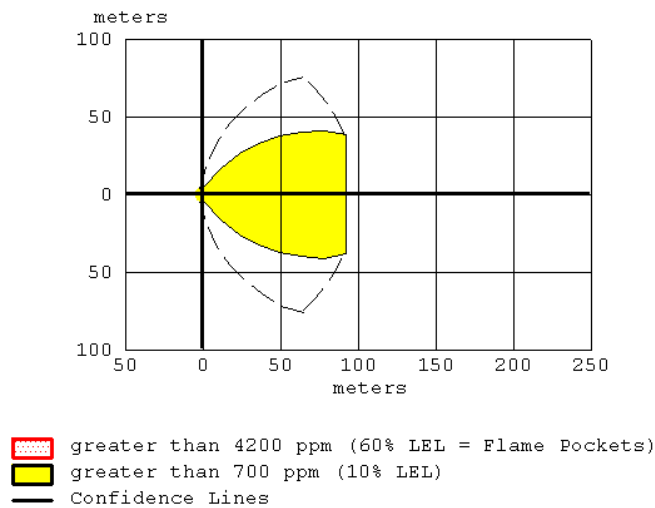
Fig. 5 Zone vulnerable to fire

Figure 5 shows the zone in which a fire can occur if there is an ignition source present together with reagent D-250 vapours. The hazardous concentration level at which a fire can occur if an ignition source is present extends to 90 [m] of the spillage point.

To model the effects of fire, we used ALOHA and CAMEO software suites. We made the calculation for the worst possible scenario – spillage and fire in the reagent repository. The model is based on the amount of 20 [t] of reagent D-250. This reagent was selected because its physicochemical parameters are well known, whereas the majority of KEX reagent parameters required for the calculation were not available. We did the calculation based on the atmospheric temperature of 15 [°C].
