## Disaster due to coal mines explosions

*This paper deals with an account of occurrences and causes behind disaster due to explosions in Indian mines. Principal causes and mechanisms of explosion, and precautions against explosion are also discussed. The review indicates that although frequency of occurrence of explosion induced disasters have reduced over the years in coal mines of India, there is a need of implementation of modern technologies such as environmental tele-monitoring system in fire prone mines in general, and in degree II/III gassy mines in particular, to arrive at the zero-disaster regime. There is a need for an additional categorization of gassiness of seam such as degree IV gassy seam for the seam where rate of gas emissions is more than 20 m<sup>3</sup> per tonne of coal raised. Arrangement for methane drainage or coal seam degasification or coal bed methane recovery should be given top priority on degree III and proposed degree IV mines.*

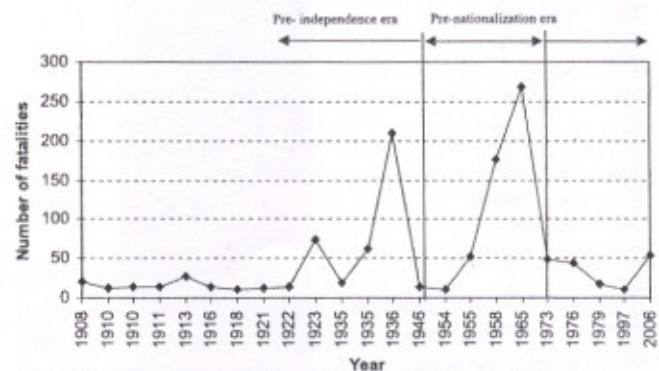
Fig.1 Year-wise fatalities due to explosion caused disaster

Fig.1 depicts that prior to independence disaster due to explosion has steadily increased along with the rise of coal

production. After independence there was huge need of coal mainly for power and steel projects that begun the industrialization of the Indian economy. However during this period of pre-nationalization of Indian coal mines fatalities due to explosion increased remarkably because there was less importance on safety mainly due to two reasons viz., there was no well framed legislation and most of the mines were run by private owners. After nationalization of Indian coal mines fatalities due to explosion led disaster has steadily gone down except the recent one in Bhatdih colliery, BCCL in 2006.
