LJTMU: Vol. 02, No. 01,  
April 2015, (09-14)

## The Discontinuous Carbon Fiber Composite: A Review of the Damage Characteristics

### Abstract

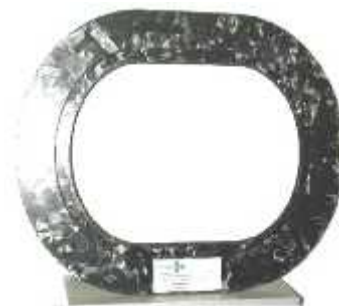
Fig. 1 Window frame of Boeing 787 Dreamliner (Turtle et.al, 2010)

Discontinuous Carbon Fiber Composite (DCFC) is a fully automated preforming solution that uses fibers in the raw and most inexpensive form (DCFC raw material costs are estimated to be only 16% of carbon prepreg, based on €14.00/kg for STS carbon fiber and €2.11/kg for epoxy) and shown to be cost effective between 400 and 10,000 parts per annum, when compared to a commercial semi-prepreg body panel system and steel respectively (Harper, 2006). The commercial application of this material form already exist, for example the window frames of the Boeing 787 Dreamliner as seen in Fig. 1 below.

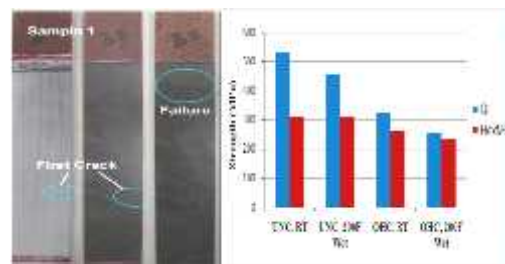
Fig. 2 Failure and insensitive of DCFC (Boursier and Lopez, 2010)

Boursier and Lopez, 2010 investigated the failure initiation and effect of defects on structural discontinuous carbon fiber composite. It was found that DFC is relatively insensitive to the types and sizes of the defects that affect of to the continuous fiber composite (CFC) and also Initial do not correlate failure load or give a good indication of the final failure location. Fig.2 below shows the experimental results that indicate the behavior of DFC material.

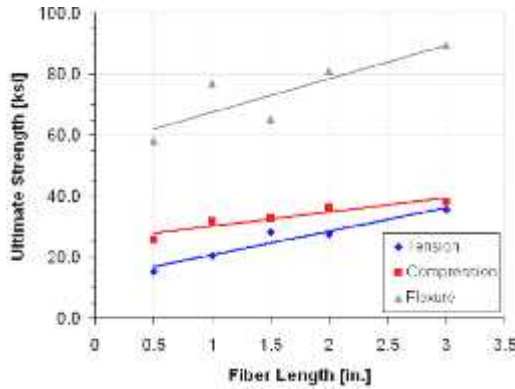
Fig. 3 Ultimate strength of DCFC for different load type (Feraboli et.al, 2009)

tensile strength indicating the different behavior from continuous fiber laminates. Flexural strength of DFC is the highest, followed by compressive, and then tensile strength which continuous quasi-isotropic always have the lowest compressive strength, tensile and flexural strength are usually closer together. These static strengths of DFC highly influenced by the fiber / chip length. Fig.3 below shows the result of different static strength of DFC as a function of fiber length.

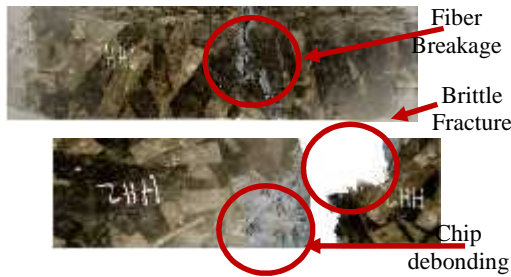
Fig. 4 Damage of DCFC (Feraboli et.al, 2009)

The effect of specimen condition (with and without hole) on elastic tensile behavior and failure responsetor this DFC material also investigated by Feraboli et.al, 2009. For Unnotched specimen, under tensile loading, the specimen fails in a combination of chip disbonding (matrix shearing between the chips) and fiber failure as shown in Fig.4.

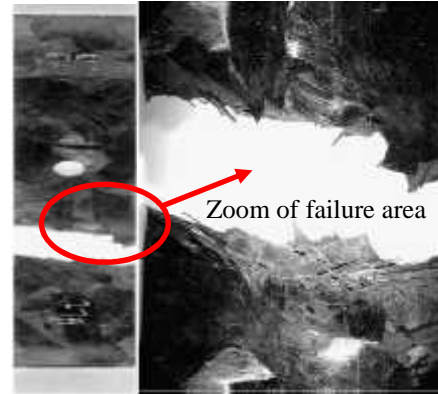
Fig. 5 Failure in gross section (Feraboli et.al, 2009)

shows insensitive behavior due to an open hole condition. The failure of specimen occurred in gross area of the surface for certain test with a small hole specimen (Fig.5). The results also confirm that the strength of this DCFC does not decrease with the presence of the hole (Fig.6).

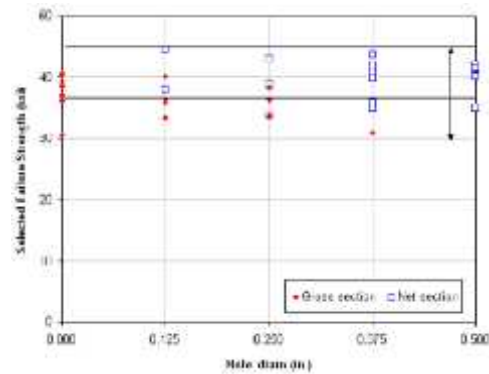
Fig. 6 Variation of notch strength with hole diameter (Feraboli et.al, 2009)

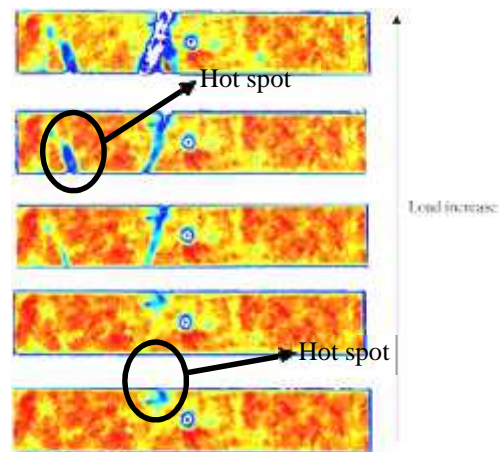
Fig. 7 Ultrasonic imaging up to failure for DCFC specimen with hole (Feraboli et.al, 2009)

As a result of ultrasonic c-scan, the observation shown that the DCFC material exhibit a notch sensitive behavior due to the heterogeneous sub structure of the material. During the tensile test, ultrasonic c-scan indicated that the appearances of hot spots are associated with macro-voids, resin-rich areas, where characterized by low fiber volume content. The hot spot grows away from the hole, and eventually leads to failure in gross section, as illustrated in Fig. 7.

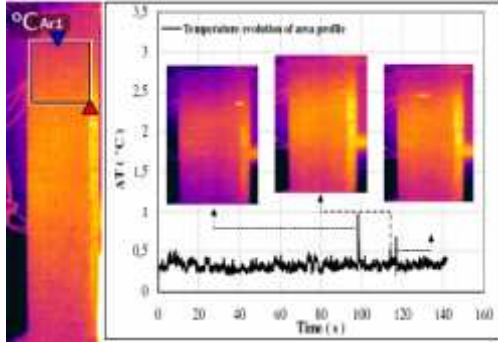
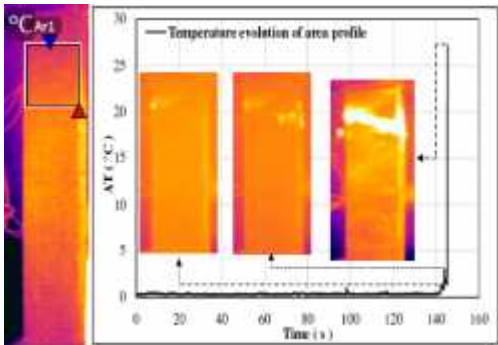
(a). Delta-T spots as first stage of minor increase in temperature evolution

(b). Rupture period as second stage of major increase in temperature evolution

Fig.8 Thermography images of DCFC specimens (Bale et.al, 2013)

the temperature appears, according to two stages. In the first part, the minor increase in the temperature variation is possibly due to the micro defect mechanism which start to appear during the test. This micro defect mechanism also as known as delta-T spot has characteristic features like flashes of light and visible for a few seconds only by means of the IR camera. In the second part, the major increase of temperature reaches at highest point that is corresponding to the rupture that can be seen by the naked eye. During this period when get close to failure, characteristic of breaking sounds can also be heard.

All the delta-T spots with different intensity and location do not grow significantly during the test for specimen without hole. The presence of several delta-T could be possible to indicate the area of final failure, which are exist and concentrate in the region of failure area. Meanwhile, as the initial micro defect that detected by IR camera, these delta-T spots do not indicate as the beginning of damage propagation or initial condition of macro damage. Furthermore, delta-T spot which located at the edges of the specimen could be possibility of other typical micro defect due to the cutting process of the specimen. Previously by Turtle et.al, 2010, this similar investigation using optical microscope concluded that most cracks detected at the edge by optical observation can induce microscopic defects

The thermography images for DCFC specimen recorded by IR camera during the test are shown in Fig. 8.

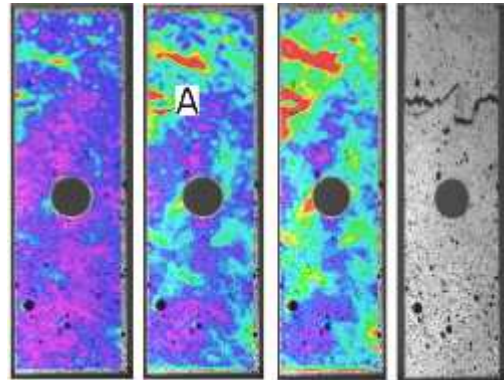
Fig.9 Example of DIC full-field strain plot (Bond et.al, 2010)

A Digital Image Correlation (DIC) is used to monitor full-field strain development of discontinuous carbon fiber composite under static tensile loading within circular notch specimens under tensile loading (Bond et.al, 2010 and Ferabolli, 2009). Both results clearly show that greater strain concentration ('A') occurs far from the notch or it can be noted that DCFC has a complex strain distributions on the surface of the specimen that associated with insensitive behavior due to presence of circular notch, as seen in Fig. 9.
