## New York City High-Rises on Rock: Uncovering the Unknown Leads to Variable Foundation Solutions

## **NEW YORK CITY HIGH-RISES ON ROCK: UNCOVERING THE UNKNOWN LEADS TO VARIABLE FOUNDATION SOLUTIONS**

Construction of high-rise towers in New York City continues to provide exciting challenges for design and construction teams. Sites are becoming increasingly more difficult to build on as “desirable” locations have long since been developed and developers are constructing on sites that were previously over looked. This paper describes two projects that provided unique challenges to the engineers and contractors. The first site is the New York Times Headquarters Tower. This site appeared to be a fairly straightforward foundation design, but became complicated as the subsurface conditions were uncovered. The second case history is the new Bank of America Tower which presented significant design challenges from the outset as it entailed a three basement excavation adjacent to subways and a historic theater façade that required protection. In both cases, close collaboration between the owner, design engineers, construction manager and eventual foundation contractors was required to com

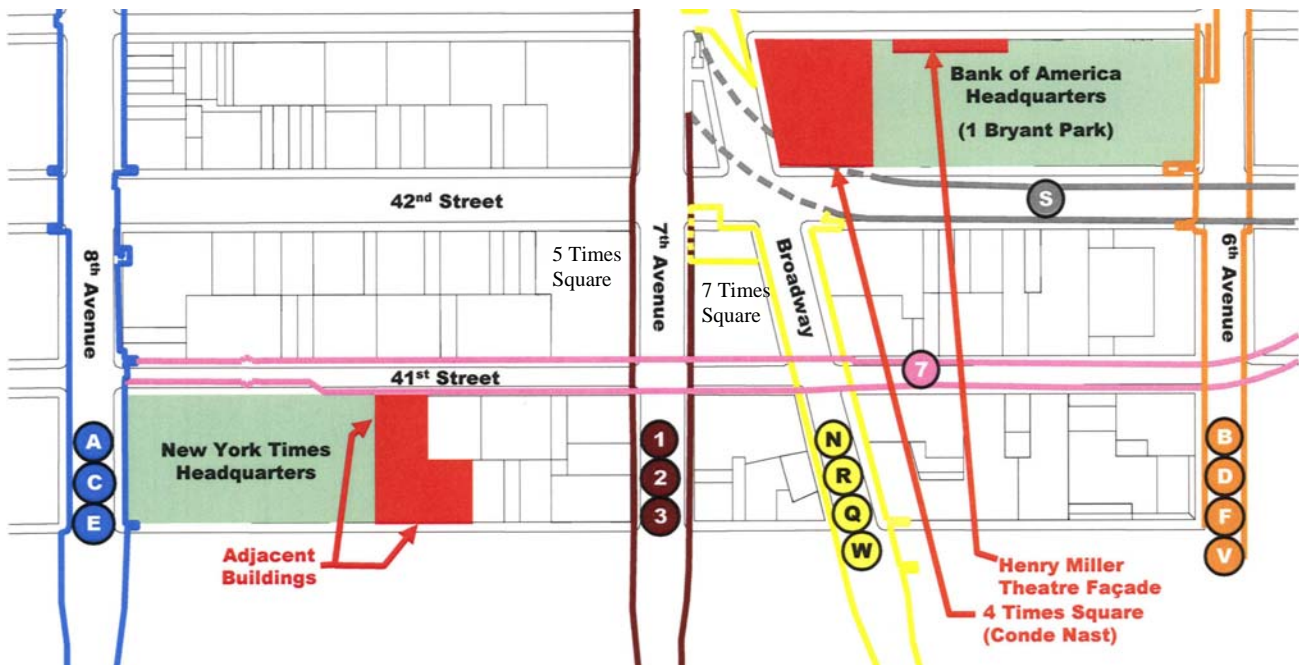
Fig. 1. Location of the two projects.

The New York Times Headquarters Tower (NYT) and Bank of America Tower (BOA) are the latest towers to be constructed in the ever changing Times Square area of New York City. The sites are in close proximity to the 5 Times Square and 7 Times Square sites that were discussed in Canale et al (2004), as shown on Fig. 1.

The New York Times site is on the western half of the block bounded by 8<sup>th</sup> Avenue to the west and 41<sup>st</sup> Street to the north, as shown in Figure 1. The site is bordered by two New York City Transit (NYCT) subway structures to the north and west and existing structures on the east property line. Sidewalk grades around the site generally slope down towards 8<sup>th</sup>

Mueser Rutledge Consulting Engineers (MRCE) was recently involved in several projects in the immediate vicinity of the site (Figure 1). All investigations at those sites encountered competent bedrock at relatively shallow depths, similar conditions were expected at the New York Times site.

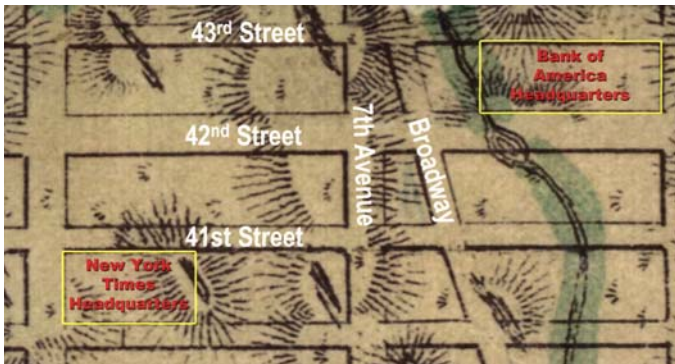
Fig. 2. Topographical Map: Viele, 1874

Prior to early development, the area that is now midtown Manhattan consisted of low hills and meadowlands dissected by occasional streams. A stream existed along the west portion of the BOA site. These features are shown on the 1874 Viele survey in Figure 2. A topographic high point is roughly centered around Times Square. It is likely that the original bedrock surface was near the ground surface in the vicinity of the sites as the 1874 map indicates sporadic rock outcrops. The bedrock surface has been altered by construction of buildings and subways for the past 150 years.

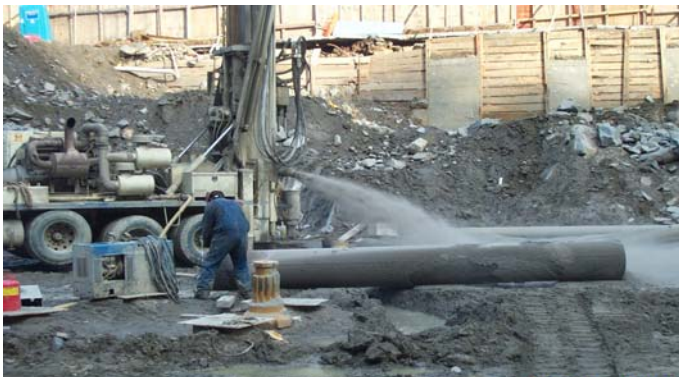
Fig. 6. Caisson Rig at NYT Tower

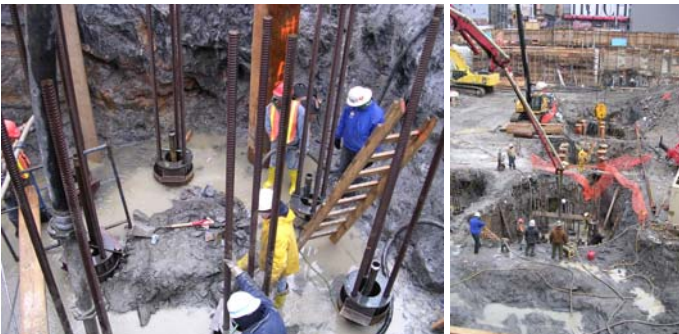
Fig. 7. Grouting of Caissons at NYT Tower

Civetta Cousins Joint Venture (CCJV) was the successful bidder for the project and started construction in September 2004 and the foundations were completed in July 2005. CCJV presented a caisson design for review by the design team that consisted of 42 22-inch diameter caissons with allowable vertical capacities between 850 and 1200 tons. The caissons were reinforced with high strength steel bars and installed using a down-the-hole hammer (pictured in Figure 6) to excavate the rock and seat the casings. Grout with a compressive strength of 6,000 psi was used to fill the caissons, as pictured in Figure 7.

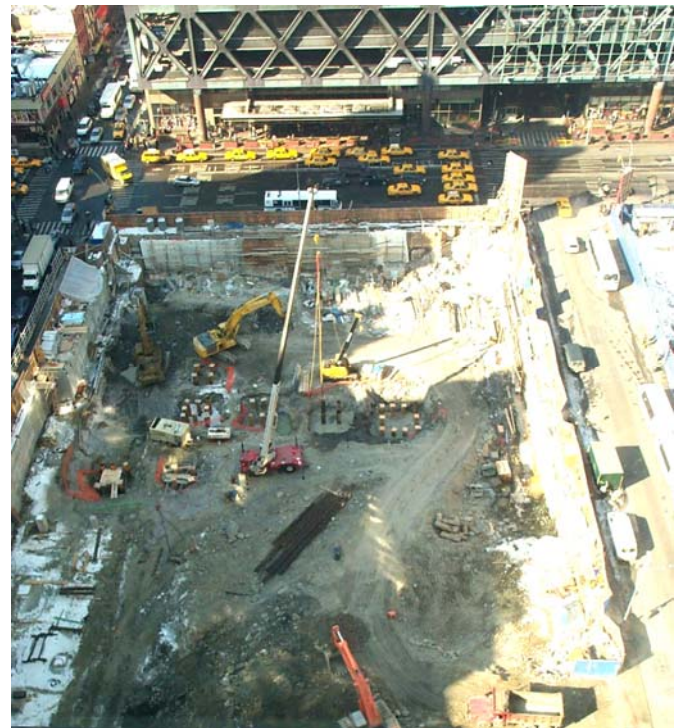
An aerial photograph during the foundation construction (Figure 8) illustrates the locations of the drilled in caissons. As shown, the limits of the caissons were as MRCE recommended in Figure 5 after all of the borings were completed.

Fig. 8. Overhead View of Caisson Caps at NYT Tower

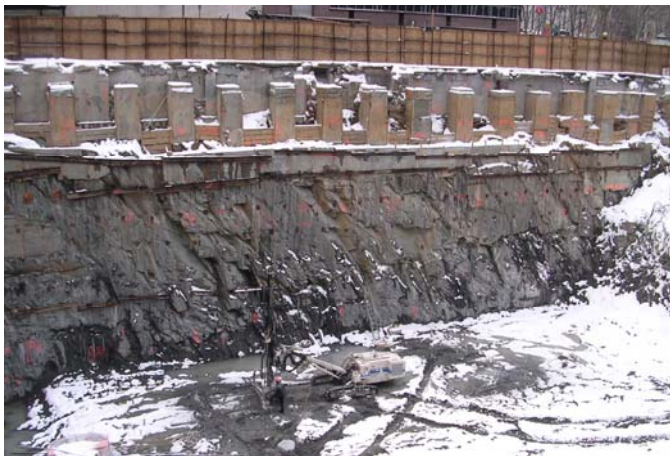
Fig. 17. 6th Avenue Rock Cut

Monitoring of the subway structure utilized seismographs to measure vibrations and strain gauges to measure changes in strain in the subway tunnel. Wang Engineering Services installed fifteen strain gauges along the length of the tunnel in arrays of three, placed on the concrete walls and crown of the tunnel liner. The monitors were connected to remote sensing devices. Results of the strain gauge monitoring program are shown in Figure 16 as changes from stress levels at the time of building construction. The crown experienced a decrease in confining stress ranging from 150 psi to 300 psi when final subgrade was reached. Tunnel walls experienced similar increases in compression. Most of the changes in stress levels were observed after excavation progressed beneath the third anchor level. The finite element benchmarking was successful in replicating most of the observed stress behavior during excavation. A photograph of the completed rock cut is shown in Figure 17.

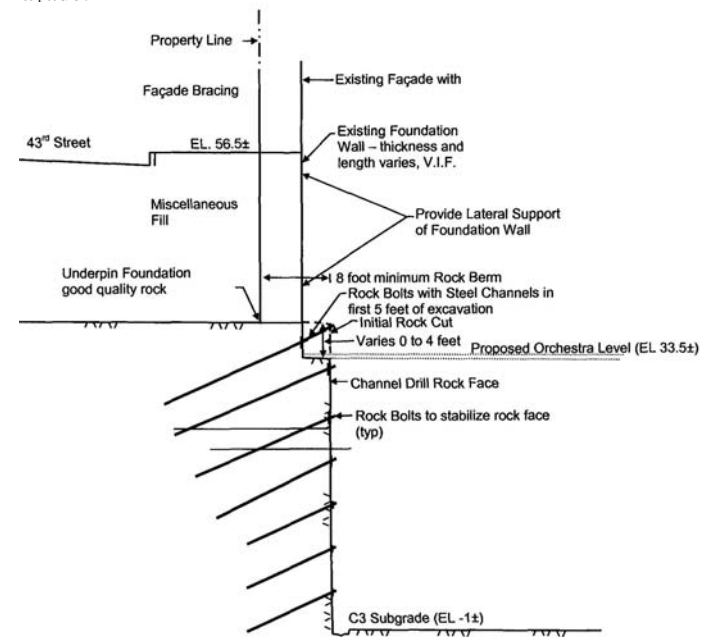
Fig. 18. Conceptual Section Adjacent to Henry Miller Theater

Based on the boring and test pit results, the following recommendations, summarized in Figure 18, were made for the design and installation of temporary support for the theater façade:

1. Laterally brace the above grade portion of the façade from the sidewalk side, supported on micro-piles socketed into rock. The micro-piles were designed to resist the compressive and tensile forces from the support truss.
2. Once the lateral bracing is installed, detach the façade and demolish the balance of the theater. As the excavation progresses, lateral bracing of the below grade foundation wall would be required. This was achieved with tiebacks installed to rock.
3. Once excavation reached the base of the foundation wall, the wall was to be underpinned to good quality rock.
4. Upon completion of underpinning, channel drilling of the rock was required in advance of further excavation to

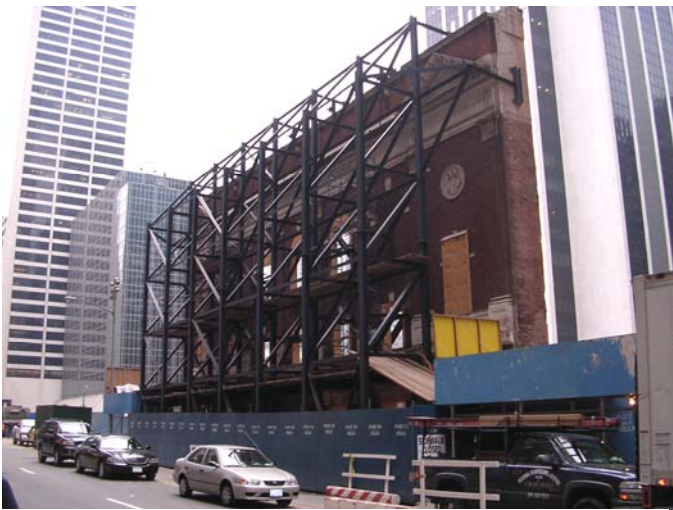
Fig. 19. Above Grade Theatre Façade Stabilization

The above grade theater façade stabilization structure is shown in Figure 19. Figure 20 shows the final cut with the existing walls, underpinning required and subsequent pattern bolting. Multiple levels of underpinning were required at the west and east end of the façade. This work was done with negligible recorded settlement or tilt of the façade and with vibrations generally below the criteria of 0.62 inches per second (ips). Façade preservation was a mini-project within the overall project as bi-weekly meetings were held with the ESDC, the design team and contractor to review the monitoring results, current work and future work. This close coordination allowed the work around the Henry Miller Theater Façade to proceed without any significant delays or damage to the façade.
