Effects of Geology and Geotechnical Properties of Rocks for the Selection of Type of Dams

Baqir Hasan

Water & Power Development Authority, Lahore, Pakistan

Chief Geologist, Dams Review Cell, Water & Power Development Authority, WAPDA, Lahore, Pakistan

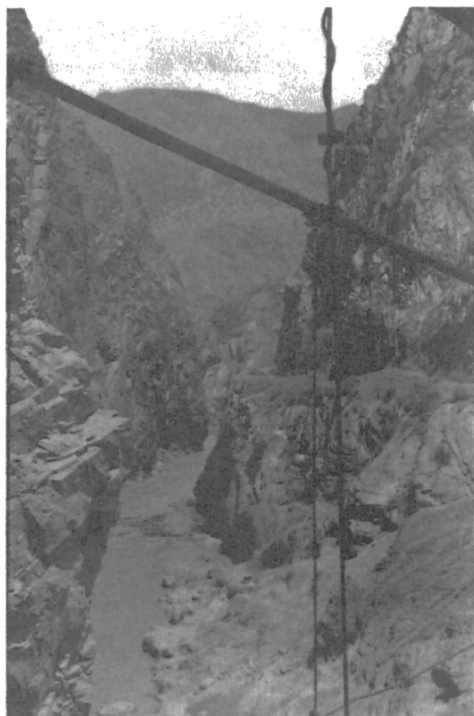
Fig. 2-A General view of the main gorge of Khajuri Kach dam site.

From topographic and morphologic point of view, the proposed Khajuri Kach dam site on river Gomal is one of the finest in Pakistan refer Fig. 2. The project has been investigated upto project planning stage. Considerable amount of surface and sub-surface investigations have already been completed which has given quite good insight of the geotechnical properties of the various rock units.

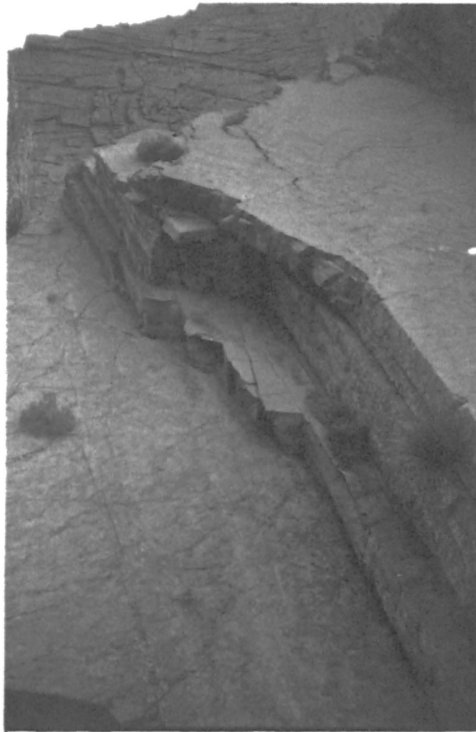
Fig. 5 Thinly bedded limestone at Khajuri Kach dam site.

The canyon forming the dam site is about 152 m deep, with steep bank slopes on the left side $75^{\circ} 1/4 : 1$ and on the right side $65^{\circ} 1/2 : 1$ reducing to $45^{\circ} 1 : 1$ at the top. The gorge near the dam site area has a width of about 30 m at the bottom increasing to about 213 m at the top. The dam site foundations basically consist of thinly bedded Jurassic limestone which is dark grey, hard, and more or less free from caverns and solution channels refer geologic map Fig. 3 and cross section Fig. 4. The microscopic examination indicates that the limestone consists predominantly of calcite (about 95 to 98%). Other minerals consist of quartz, graphite, biotite, pyrite and gypsum etc. Traces of gypsum occur along the joint planes. The limestone rock unit has some intercalations of argillaceous limestone, marly limestone and shale. The limestone is mostly thin bedded with lot of calcite veins refer Fig. 5.

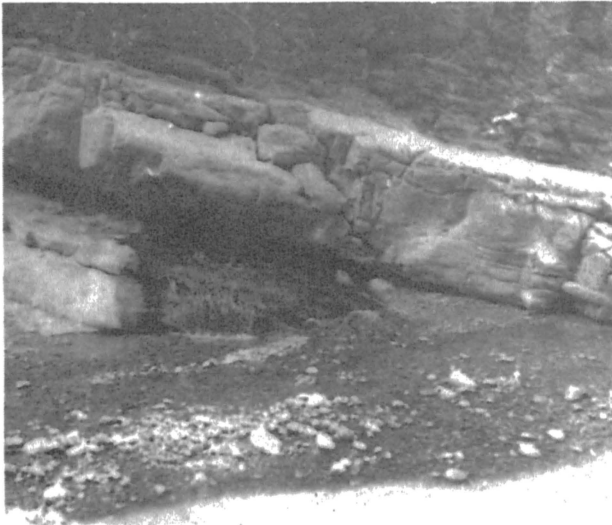
Fig. 9 showing location of spring in the Brewery limestone.

A number of perennial springs also exist in the Brewery limestone of the southern anticline downstream of the dam axis refer Fig. 9. The evaluation of regional geology and the investigations to date, suggest that these springs are being generally fed from regional groundwater which follows the regional geological structures.

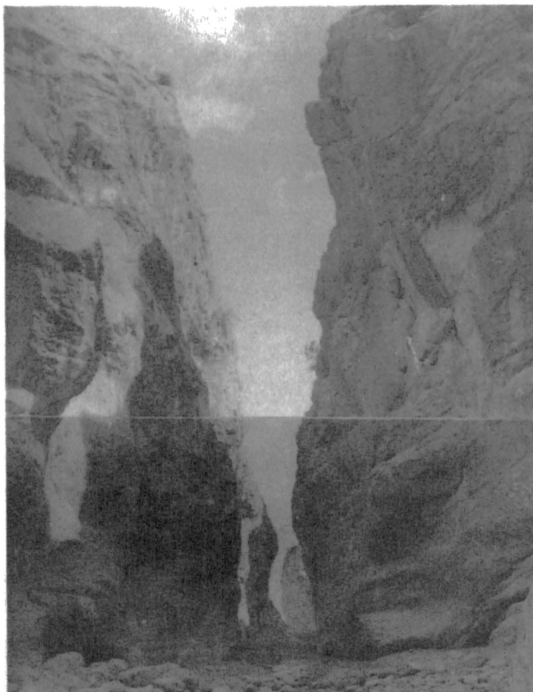
Fig. 10 General view of the gorge of Mangi dam site.

The dam site is located on the northern limb of the downstream anticline on the Khost river. For a masonry dam, the axis would be located about 122 m downstream of the confluence of three tributaries refer Fig. 10. At this axis the width of the gorge at river level is only about 25 m with vertical side walls and many overhangs. For a fill type of dam, the axis would be shifted further upstream on to the dip slopes of the anticline.
