Design and Performance of Arena Dam

Arena Dam is located on the Arena River in north-central Trinidad. Figures 1 through 4 show the location, plan view, and sections of the dam. The dam forms Arena Reservoir, which provides 35,000 acre-feet of storage to augment the dry season flow of the Caroni River. Water from the Arena River is impounded during the wet season (January through June) for release during the dry season (July through December). The Arena River provides about 40 percent of the water needed to fill the reservoir; the remainder is obtained from the adjacent Tumpuna River. A weir located downstream of the confluence of the Arena and Tumpuna Rivers backs water up the Arena River channel to the dam toe. During the wet season, a pump station at the base of the dam pumps water through the outlet works and into the reservoir. During the dry season, water is released through the outlet works and flows down the Arena and Tumpuna Rivers to the Caroni River, from which it is withdrawn for treatment. This system allows year-round production of 75 million U.S. gallons per day of treated drinking water, about half of the island's supply. The dam was designed from 1973 to 1975 and

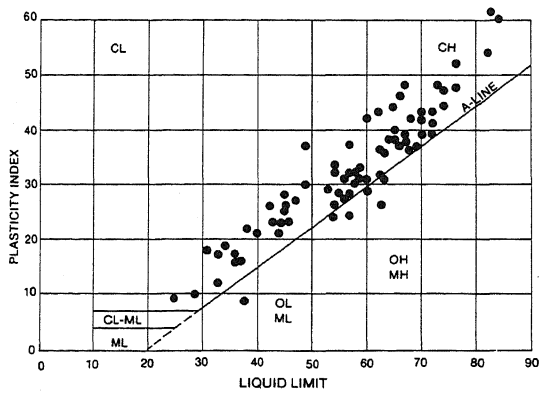
Fig. 5
UPPER CAPARO CLAY PLASTICITY

The Upper Caparo Clay contains frequent very thin sand partings; occasional thin layers of sand (up to 2 feet thick); interlayered sand, silt, and clay beds varying from a few inches to a few feet in thickness; and some varved sand/clay layers. Typical upper Caparo clay properties are given in Table 1. The recompression index was determined by conducting conventional consolidation tests with repeated loading and unloading at the stress levels expected to occur after dam construction. The average slope of the unloading and reloading curves was used as the recompression index. The plasticity characteristics of the clay are shown in Figure 5. The grain size distribution is shown in Figure 6.
