Field Testing of Crushed Ignimbrite for Seismic Retrofit Of Matahina Dam

FIELD TESTING OF CRUSHED IGNIMBRITE FOR SEISMIC RETROFIT OF MATAHINA DAM

Lelio H. Mejia, PhD, PE
URS Corporation
Oakland, California, USA

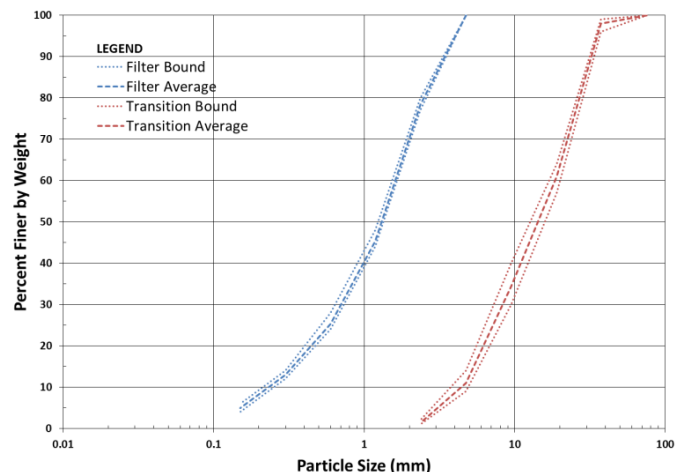
A coarse to medium sand of suitable durability was used for the filter zone. Figure 1 shows the range of gradations obtained for the material from the crushing plant. The fraction of flat and elongated particles in the material was less than 1% indicating equidimensional, yet angular particles. The durability characteristics and minimum and maximum densities of the material are listed in Table 1. Slight particle breakdown occurred in the material during the laboratory compaction test, and the maximum density obtained in that test was slightly larger than that from the relative density test (Table 1).

Fig. 1. Gradations of filter and transition materials in the stockpiles

The transition material was a durable, coarse to medium gravel with less than 15% of flat and elongated particles. The gradation range of the materials produced by the crushing plant is shown on Figure 1. Particle shape tests revealed sub-angular fragments and a fraction of flat and elongated particles less than 6%. Table 1 lists the durability characteristics and the minimum and maximum densities of the material. The maximum density obtained in the laboratory compaction test was significantly larger than that obtained in the relative density test due to particle breakdown, which was characterized by an increase from about 5% to 15% in the amount of material passing the No. 8 sieve.

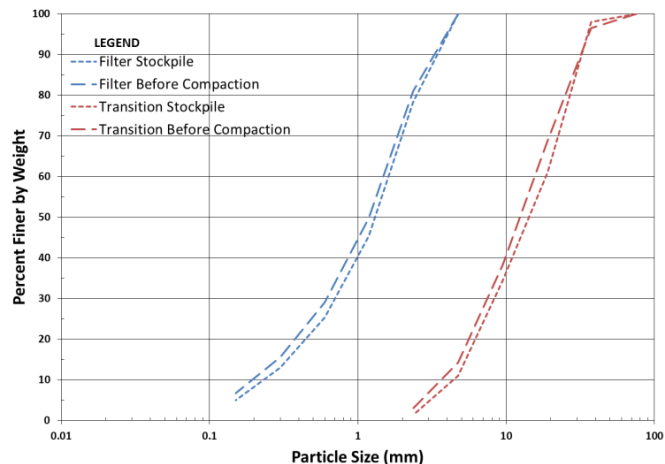
Figure 4 compares the average gradation of the materials in the stockpile with that of the materials in the fill before compaction. This comparison shows that handling and placement of the filter material in the fill (without compaction) increased the percent finer than the 0.15-mm size (No. 100 sieve) from 5% to 7%, due to particle breakdown. Similarly, handling and placement of the transition material increased the percent finer than the 2.36-mm size (No. 8 sieve) by about 2%, as well.

Fig. 4. Average gradations in the stockpile and in the fill before compaction

Little particle breakdown occurred during field compaction of the filter and transition materials, once they had been placed and spread in the fills. The average gradations of the materials measured after compaction were very close to those measured before compaction. Throughout the particle size range, the percent finer after compaction of the filter material, regardless of the number of passes or vibratory roller, was within 1% or less of that before compaction. Likewise, the gradation of the transition material after compaction was within 2% of that prior to compaction.
