International Conference on Case Histories in  
Geotechnical Engineering

(1984) - First International Conference on Case  
Histories in Geotechnical Engineering

## Discussions and Replies

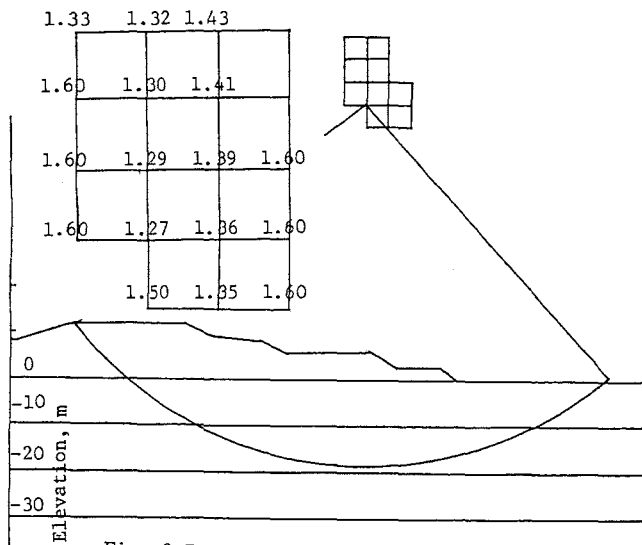
Fig. 3 Factor of safety with slip circle.

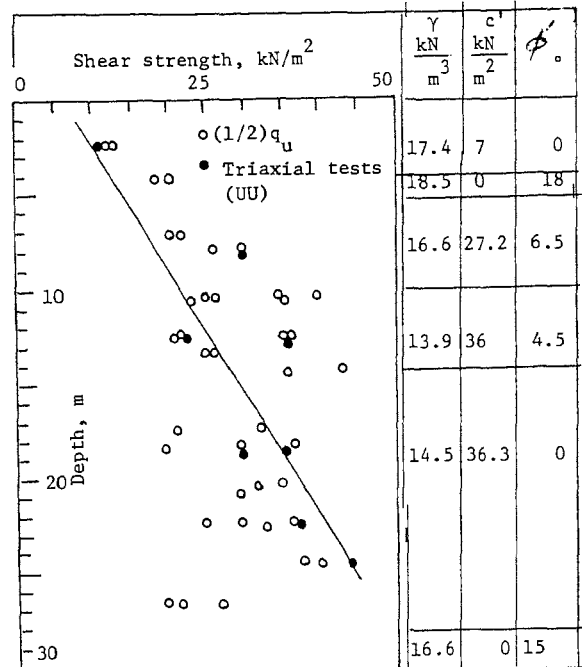
Note: Design parameters, unit weight  $\gamma$ , cohesion  $c'$ , angle of internal friction  $\phi'$ .

Fig. 1 Soil parameters for design.

No evidence of failure had been found before the rupture took place. Therefore, no detailed investigation was performed at that stage. The soil investigation was conducted following the method commonly used in Japan. Unconfined compression tests and unconsolidated undrained triaxial compression tests were made with undisturbed samples. Thus, unconfined compressive strength  $q_u$ , effective cohesion intercept  $c'$  and effective angle of internal friction  $\phi'$  were obtained. The design shear resistances were calculated as plotted in Fig. 1. Usually shear resistance increments are neglected assuming rapid construction work.

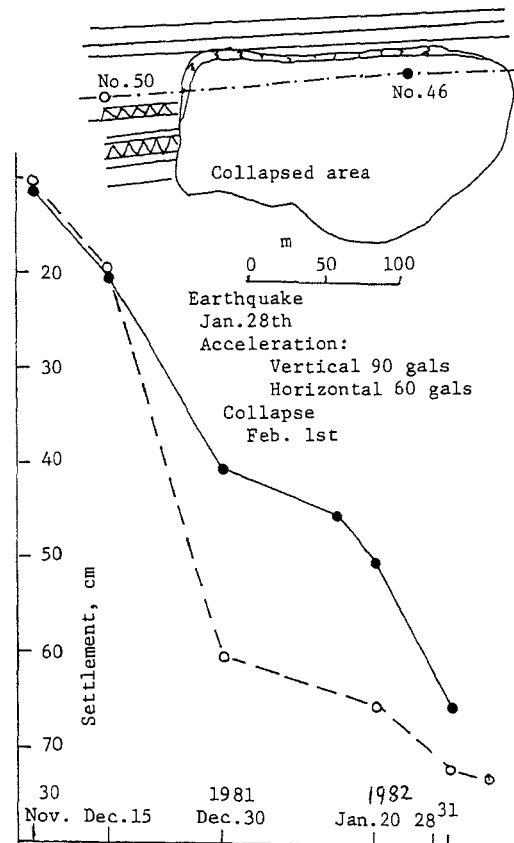
Fig. 2 Time-settlement curves.

The earthquake might cause increase of pore water pressure and result in increasing shear stress and reducing shear resistance, but it is not very clear. Time settlement curve could have not been used for predicting rupture. Figure 2. shows time settlement curves at the Stations 46(collapsed) and 50 (safe). No evident increase of settlement was observed before the slide. No cracks were observed on the surface of the embankment.

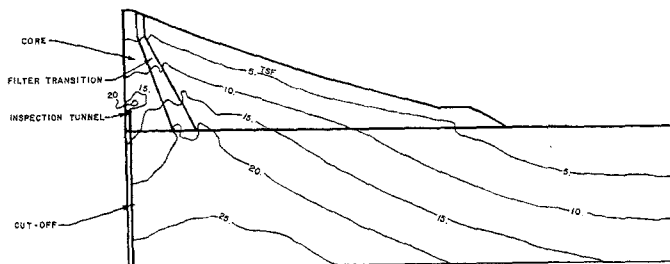
Fig.9:Major principal stresses in the embankment and its foundation

The development of an arching phenomenon in the dam's embankment was also confirmed by finite elements analysis (fig.9) carried out by Lefebvre and St-Arnaud (1975).

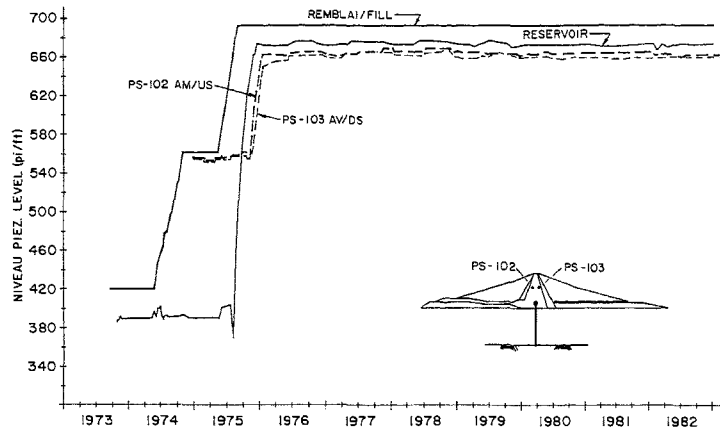
Fig.10:Pore pressure at the upstream and downstream zone of the core (elevation 550')

The author would like to thank particularly Mr. J. Sherard for the valuable supplementary explanations. To emphasize his conclusions fig. 10 is presented, illustrating the pore pressures recorded at elevation 550 for the last 10 years. As can be seen since the reservoir's impounding the pore pressures have remained practically constant (small variations due to reservoir level variations) with only a few feet head loss between the two piezometers. The adequate filter material by preventing the migration of the core's fine particles, allowed the buildup of a thin impervious zone at the core-filter interface, which remained stable for such a long time period in spite of being submitted to a very high hydraulic gradient.
