Braced Sheet Pile Shoring Wall in Sensitive Clay

Yadav Pathak
EBA, A Tetra Tech Company, Canada

BRACED SHEET PILE SHORING WALL IN SENSITIVE CLAY

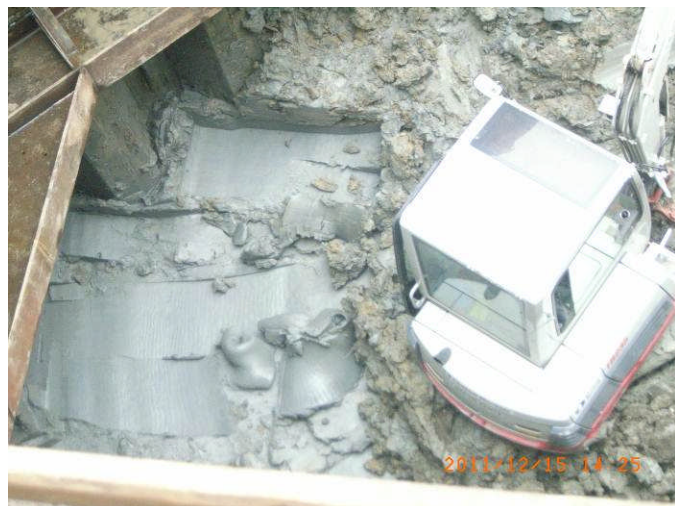
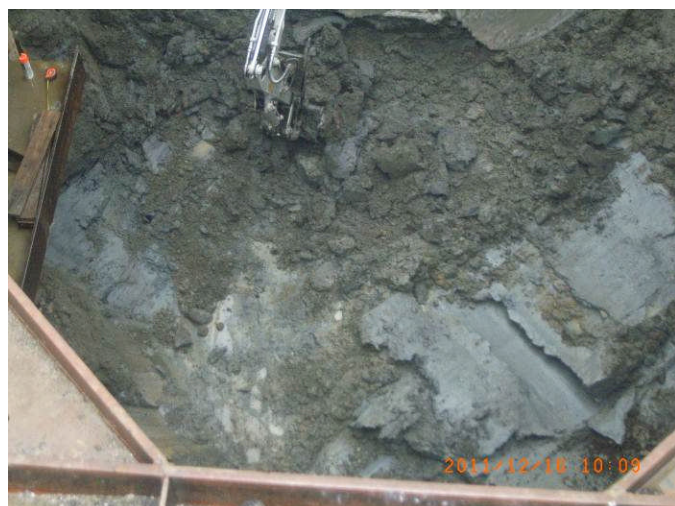
Fig. 7. Excavation Photographs below third row of bracing (a) South headwall (b) North headwall

Figure 7 shows the excavation at the south and north headwall location below the third row of bracing. The excavation was successfully completed to the final elevation and the reinforced concrete slab was poured on December 19, 2011.

The soils encountered in the excavation were significantly different in the north and south halves of the shoring box (see Fig. 7).

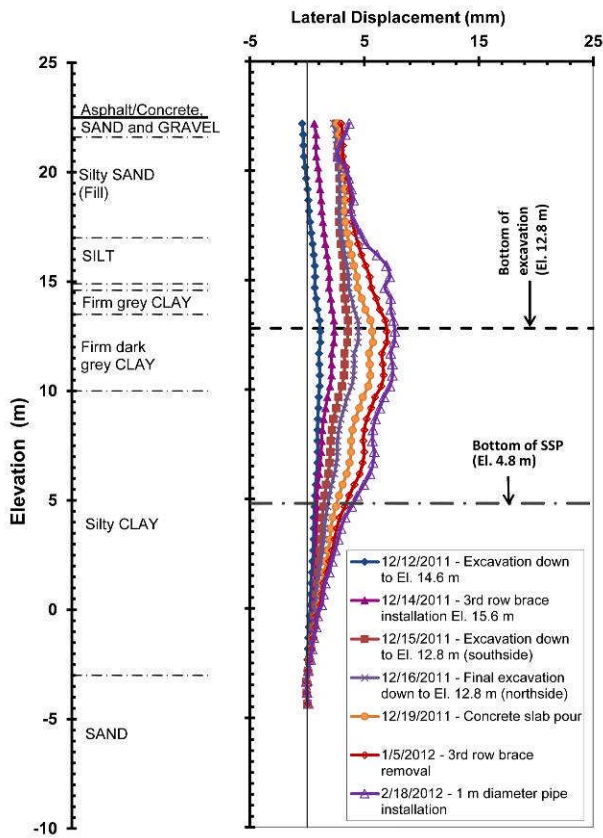
Fig. 9. Lateral soil movement observed at the north headwall (SI-2)

Figures 8 and 9 show lateral soil displacement towards the excavation measured at inclinometer SI-1 and SI-2 locations along with soil conditions observed during excavation. Because of the construction schedule, baseline readings of the inclinometer measurement could not be established prior to the start of the excavation and therefore, lateral soil displacement due to excavation down to El. 17 m (December 5, 2011) are not included in Figs. 8 and 9. However, the measured lateral displacements in the inclinometers were likely less than about 2 mm during the period December 3 to 10, 2011.

As the excavation progressed in the soft clay, soil moved incrementally towards the excavation. Figures 8 and 9 both show similar patterns of movements. Lateral movements extend below the bottom of the excavation. The maximum lateral movements occur at about 0.5 m below the final excavated grade, and are equal to about 20 mm (i.e., 0.21% of H) at SI-1 and 8 mm (0.08% of H) at SI-2. The differing values of lateral soil movement reflect the differing soil conditions encountered in the excavation. The observed lateral displacements are about half those predicted using the Clough *et al.* (1989) method and about 40% of the SPW911 calculation. The small lateral displacements are likely due to the 3-dimensional nature of the shoring box and good workmanship during construction of shoring wall.

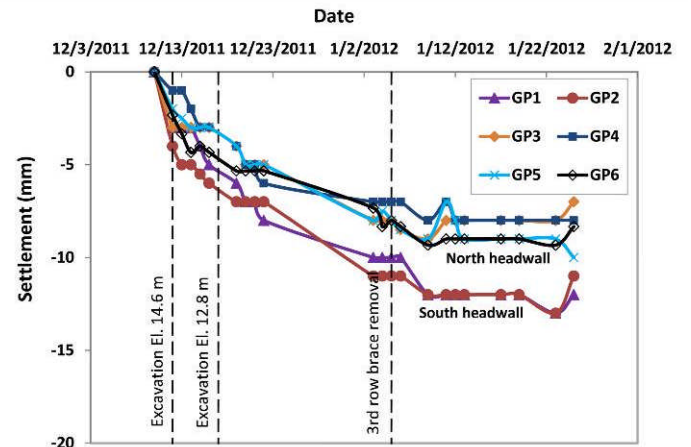
Fig. 11. Ground settlement observed at GP1 to GP6

Figure 11 shows the ground settlement during excavation and construction. Observed maximum ground settlements were about 12 mm (0.12% of H) and 8 mm (0.08% of H) in the south and north headwall locations, respectively. As expected, settlements decreased away from the shoring box. Minor settlement of less than 10 mm likely occurred below Highway 1, but measurement was not possible due to the heavy traffic.

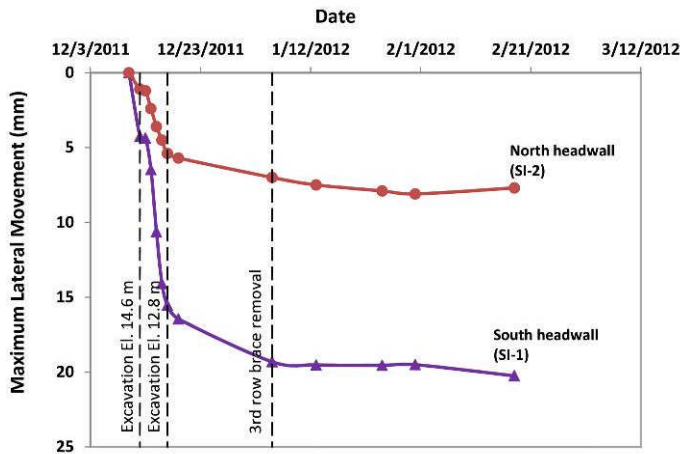
Fig. 10. Maximum lateral soil movement at the south and north headwalls (SI-1 & SI-2)

Figure 10 shows the maximum lateral soil movement and demonstrates that significant creep movements developed in the clay after excavation to the final grade until the concrete slab gained strength, and the creep movements reduced thereafter.

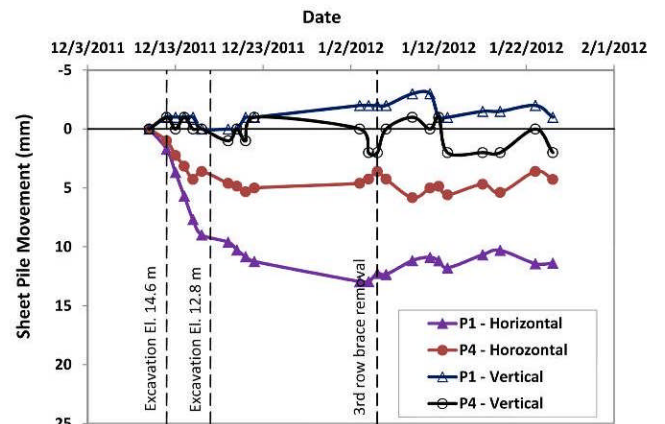
Fig. 12. Sheet Pile top movement observed at Prisms P1 & P4

Figure 12 shows the vertical and horizontal movements of the top of the sheet pile at P1 and P4 locations. Prism P1 moved about 12 mm away from the excavation in a southwest direction. Prism P4 also moved about 5 mm away from the excavation in a northeast direction. The lesser movement of P4 compared to P1 was compatible with the lower inclinometer displacement and ground settlement in the north headwall than in the south headwall. Settlement was generally negligible and within the survey measurement accuracy. Prism observation indicates the sheet pile top moved out of the excavation. Note that inclinometer monitoring shows the toe of sheet pile moved towards the excavation. The bracing has pushed the sheet pile out of the excavation at the top.

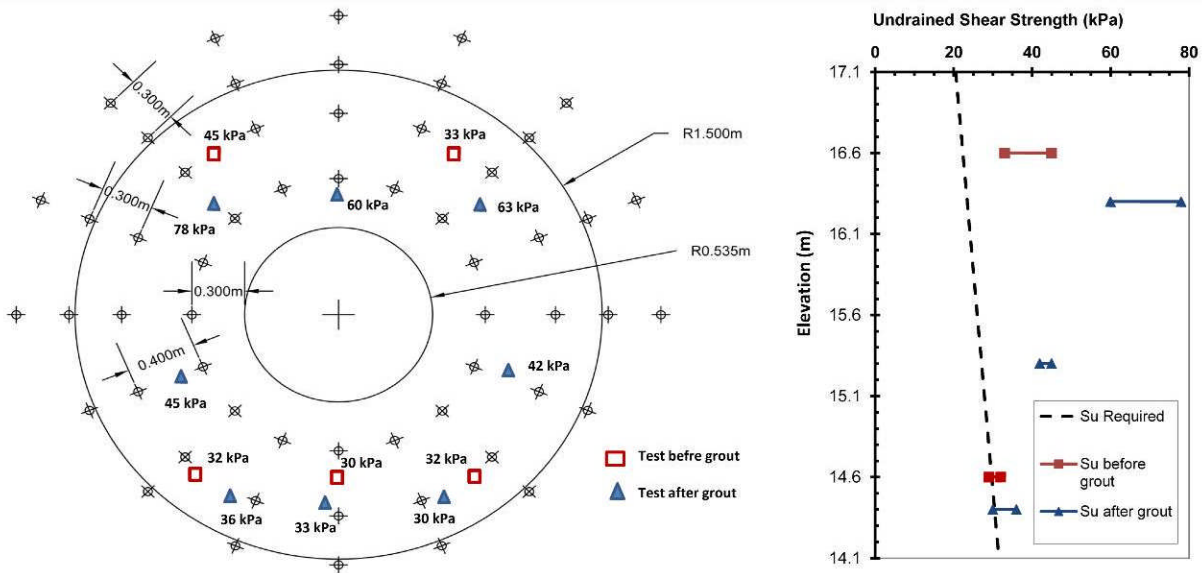
Fig. 13. (a) Location of grout injection hole pattern in bulkhead face including location of undrained shear strength testing, (b) Undrained shear strength of clay before and after grout injection in the south bulkhead face

In the south headwall bulkhead, the undrained shear strength of clay behind the bulkhead was measured before and after grout injection (Fig. 13). Shear strength testing before grout injection, using a hand vane shear indicated undrained shear strengths of about 30 to 32 kPa in the lower half of the bulkhead and about 33 to 45 kPa in the upper half. The clay was wet.

Undrained shear strength tests were performed using the hand vane shear test in the grouted soil during the soil removal from the 3 m diameter pipe on March 31, 2012. The measured strengths were greater than before grouting (see Fig. 13). Soil was moist and firm. Visual observation showed layers of grout in the soil. The spreading of the grout was non-homogeneous, which is similar to that described by Hellmeier *et al.* (2011) in their laboratory tests on cohesive soil. It is likely that grout followed weak layers in the clay.
