# Design of Road Cut Adjacent to Existing Structure

**SYNOPSIS** Interchange improvements within an urban environment required the deepening of a hillside cut. Design restraints required as deep a cut as possible without disturbing a water tower located at the crest of the slope or interfering with a shopping center at the toe. The water tower, constructed in 1933 with a steel tank encased in a concrete and brick structure, was founded on shallow spread footings. Foundation soils were silts and silty sands with seams of silty clay. The design investigation involved hydrogeologic studies, SPT borings, undisturbed sampling, laboratory testing, and stability analyses. Laboratory studies involved routine and unusual testing procedures to evaluate deformation potential upon drying. Results of the investigation allowed the deepening of the cut some 20 feet using conventional construction techniques. This paper details the geotechnical investigation, laboratory testing, analysis procedure, construction monitoring, and project results.

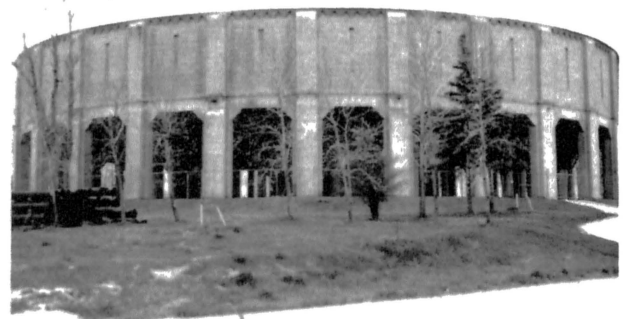
The reservoir, known locally as the Taylor Park Water Reservoir, was constructed in 1933, and is shown in Figure 1. The water tower stands some 60 feet above ground level, and is located at the highest point in Sheboygan County. Thus, it provides pressure control for the entire city water system. The 185 foot diameter reservoir consists of a 4 million gallon steel tank within a reinforced concrete and brick structure. Foundation for the structure consisted of 80 individual spread footings at depths ranging from 4 to 8 feet below ground surface for perimeter and interior footings respectively.

Fig. 1. Taylor Park Water Reservoir

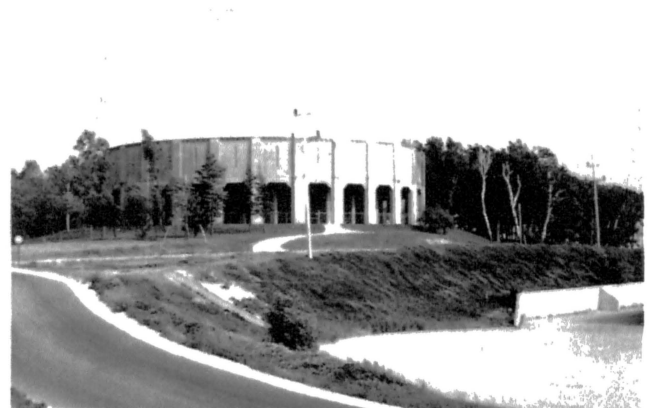
A shopping center, located across Taylor Boulevard directly west of the water tower provided an additional design restraint. A considerable cut had been made adjacent to Taylor Boulevard to permit construction of this complex. A reinforced concrete retaining wall had also been constructed to allow an auto service store within the complex to be located closer to Taylor Boulevard. The existing cut and retaining wall are shown in Figure 2.

Fig. 2. Existing Taylor Boulevard Cut

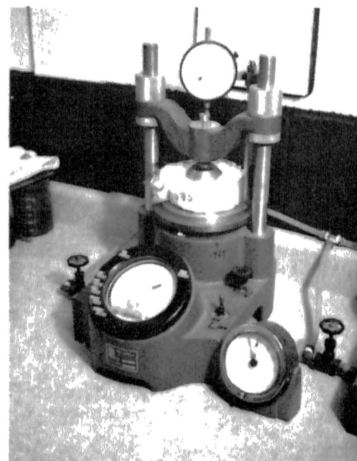
To assess the settlement potential of the foundation soils under actual field loadings, samples were placed in conventional consolidation testing equipment. One-dimensional shrinkage was measured by placing a constant load, equal to the estimated overburden stress, and drying the specimen. Drying was accomplished by surrounding the consolidation ring with calcium chloride pellets. Figure 6 shows the test equipment. Conventional consolidation tests were also run on companion samples to determine the amount of settlement that would occur at this same location.

Fig. 6. Consolidation Under Load

These test results again showed very minimal shrinkage amounts, with percent of vertical shrinkage ranging from 0.56% to 2.81%. The largest measured percent of shrinkage again was noted in the silty clay soils. These results were also felt to be conservative, as the soils were dried to moisture contents similar to those achieved by oven drying, and equipment deformations and "seating load" settlements were also added into the total percent shrinkage calculations. When settlements measured with the conventional test are subtracted from the drying test measurements, almost negligible amounts of shrinkage are obtained.

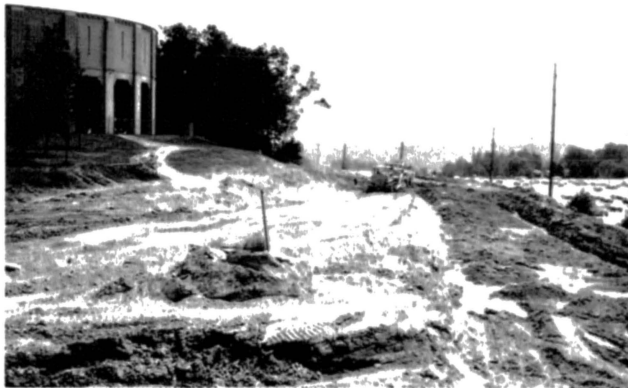
Project construction began in the spring of 1979, and was completed in the fall of the same year. During construction, problems developed with the excavation procedures. Ground water in the cut area was much higher than expected from the field investigation and analysis. Earth moving equipment continually became mired down in the wet silts and silty sands, as is demonstrated in Figure 9. Much of the cut was finally excavated with a dragline and bucket operation. After reaching final grade and installing the edgeline underdrain the roadway subgrade dried to the point that the roadway construction could proceed. Areas of the cut slope, however, continued to seep water causing surface sloughing. Additional pipe underdrain was placed laterally into these areas and allowed to drain into the edgeline underdrain. This stabilized the slope to the point where topsoil could be placed.

Fig. 9. Construction Excavation Problems

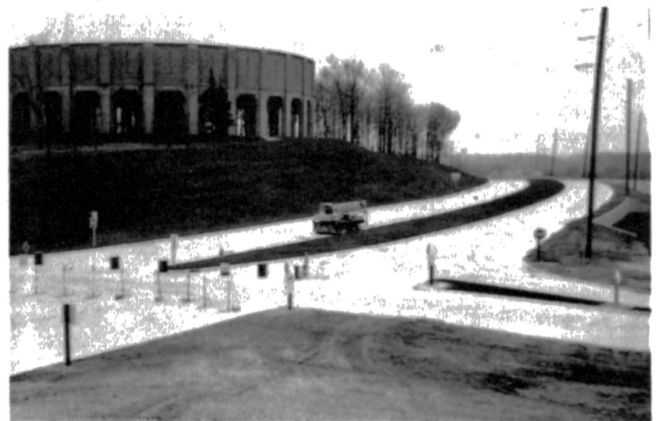
Horizontal ground movements, structure settlements, and ground water levels were measured during construction and for a two year period after project completion. Results of these measurements showed that no measureable structure settlement or horizontal ground movement had occurred. This was also substantiated with studies made by the city's consultant. A cursory inspection of the reservoir structure also indicated that the structural cracking observed in the preconstruction survey had not worsened. Water level readings made over this same period showed that the water table in the area of the water tower had dropped approximately 5 feet, with no adverse effects on the structure from desiccation. The pipe underdrains placed along the curbline and into the cut slope stabilized the subgrade and slope so that both the pavement and backslope have performed satisfactorily. While instrumentation monitoring was terminated at the end of 1981, some 2 years after project completion, the instrumentation has remained in place for additional readings if needed. The cut has been continued to be observed, however, with no visual signs of problems, as shown in Figure 10.

Fig. 10. Completed Excavation
