2001 - Fourth International Conference on
Recent Advances in Geotechnical Earthquake
Engineering and Soil Dynamics

Seismic Safety Analysis of Earth Dam – Case History Studies

SEISMIC SAFETY ANALYSIS OF EARTH DAM - CASE HISTORY STUDIES

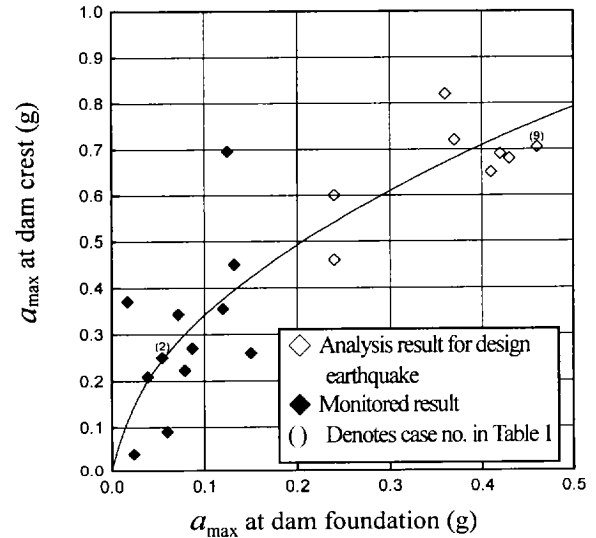
Fig. 11 Relationship between a_{max} at dam crest and a_{max} at dam foundation

Comparing the results of analysis and actual observed performances for the two dams studied, it appears that the Seed-Lee-Idriss approach employed can capture the main features of dam performance. Dynamic responses during earthquakes and the overall post-earthquake deformation of the dambody can be predicted reasonably well. For more comprehensive comparisons of actual performances with the results of analysis, the records of case histories collected from Taiwan and abroad as shown in Table 2 were used. In these case histories, the information of PGA value at the dam site, the recorded maximum acceleration at the dam crest and the maximum post-earthquake settlement at the dam crest were collected. Several cases of seismic safety analysis under design earthquake condition were also included. By plotting the maximum acceleration and final settlement at the dam crest versus the maximum acceleration at the dam site for actual case histories and the cases analyzed for the designed earthquake condition, the results are shown in Figs. 11 and 12.

In the figures, some scattering in results may be observed. Considering the difference in valley shape, dam height, dam design, material used, and characteristics of the earthquake, etc., in these case histories, such a scattering is natural. However, the actual records and the results of analysis are in a very similar trend. Therefore, with appropriate testing and assessment of material properties, the semi-analytical and testing approach suggested by Seed-Lee-Idriss can predict the earthquake performance of earth dam reasonably well.

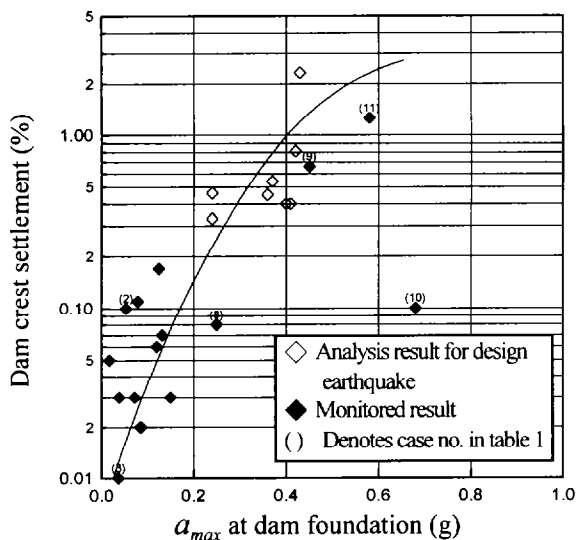
Fig. 12 Relationship between settlement at dam crest and a_{max} at dam foundation
