Cornell University School of Civil Engineering Tests on light beams of cold-formed steel

SCHOOL OF CIVIL ENGINEERING, CORNELL UNIVERSITY
TESTS ON LIGHT BEAMS OF COLD FORMED STEEL
FOR THE AMERICAN IRON AND STEEL INSTITUTE

ELEVENTH PROGRESS REPORT, JUNE 27, 1940

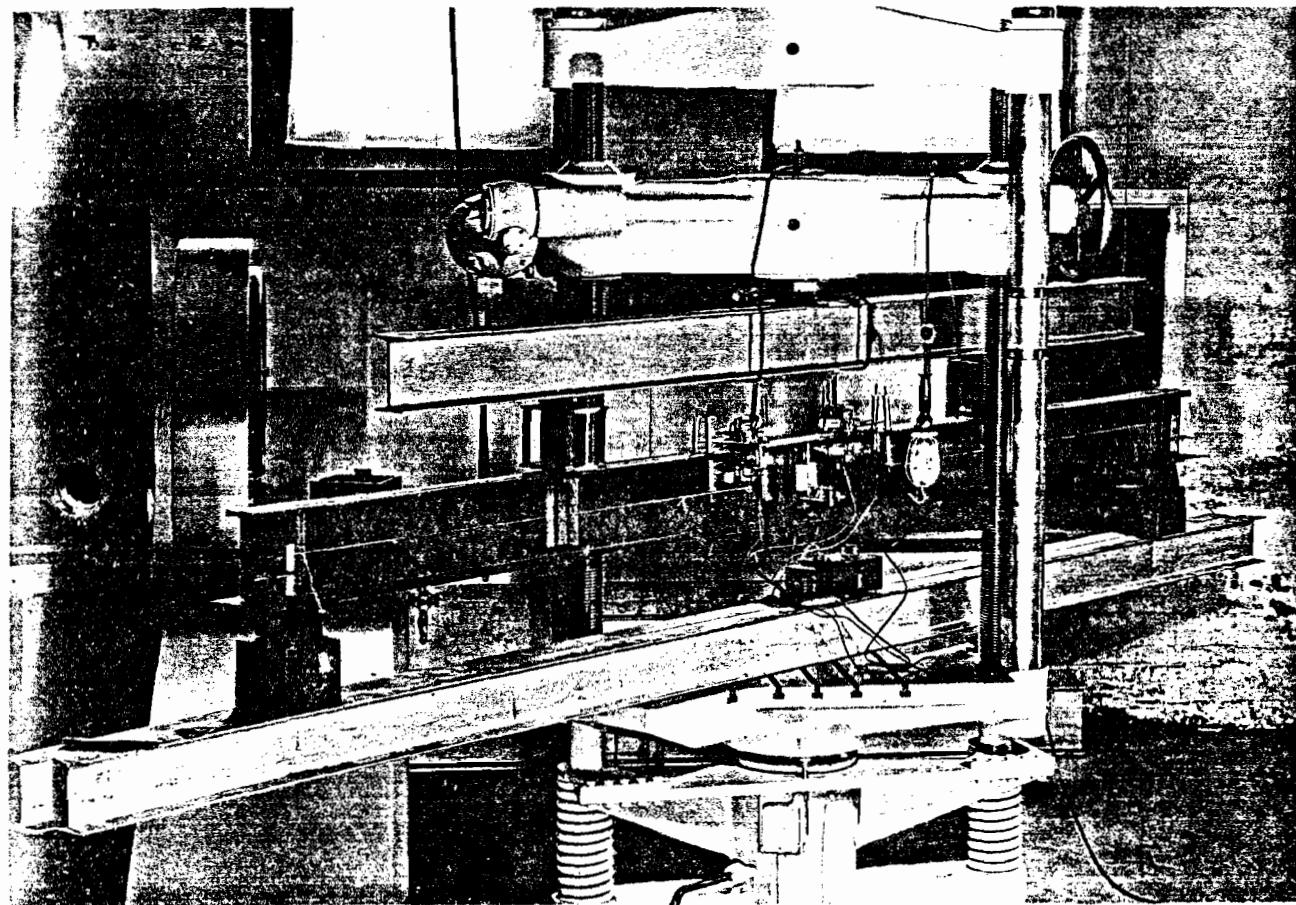
The failure tests have been carried out in the same way as described in the 10th Report, section II. Two photos are included in this report, the first of which shows the general set-up of the beams in the testing machine and the second of which gives a close-up view of the mounting of the strain gages and the means of taking deflection measurements. The first photo shows the beam supported by two rockers resting on an I beam extension of the table of the machine. The quarter point load is transmitted to the beam by means of an auxiliary aluminum I section fastened to the head of the machine and loaded through a roller. From this aluminum beam the load is transmitted further by the aid of two short I sections placed at the quarter points of the specimen. Between one of the I sections and the aluminum beam a roller is inserted, whereas the load is transmitted to the other I section through a half round. In order to take deflection readings, a wire is fastened to the supports of the specimen by means of C clamps. Tension in the wire is maintained by means of a rubber band. The second photo shows the mounting of eight strain gages on the top flange, six of which can be seen on the picture. The gages on the left side are mounted longitudinally, those on the right side transversely. A doorbell buzzer is attached to each gage to eliminate frictional lag. At the bottom of the picture the transformer unit used to control the intensity of vibration is shown. A 1/100 in. steel scale is seen fastened
