Multifrequency Eddy Current Inspection of Corrosion in Clad Aluminum Riveted Lap Joints and Its Effect on Fatigue Life

MULTIFREQUENCY EDDY CURRENT INSPECTION OF CORROSION IN CLAD ALUMINUM RIVETED LAP JOINTS AND ITS EFFECT ON FATIGUE LIFE

ABSTRACT. Aging aircraft are prone to corrosion damage and fatigue cracks in riveted lap joints of fuselage skin panels. This can cause catastrophic failure if not detected and repaired. Hence detection of corrosion damage and monitoring its effect on structural integrity are essential. This paper presents multifrequency eddy current (EC) inspection of corrosion damage and machined material loss defect in clad Al 2024-T3 riveted lap joints and its effect on fatigue life. Results of eddy current inspection, corrosion product removal and fatigue testing are presented.

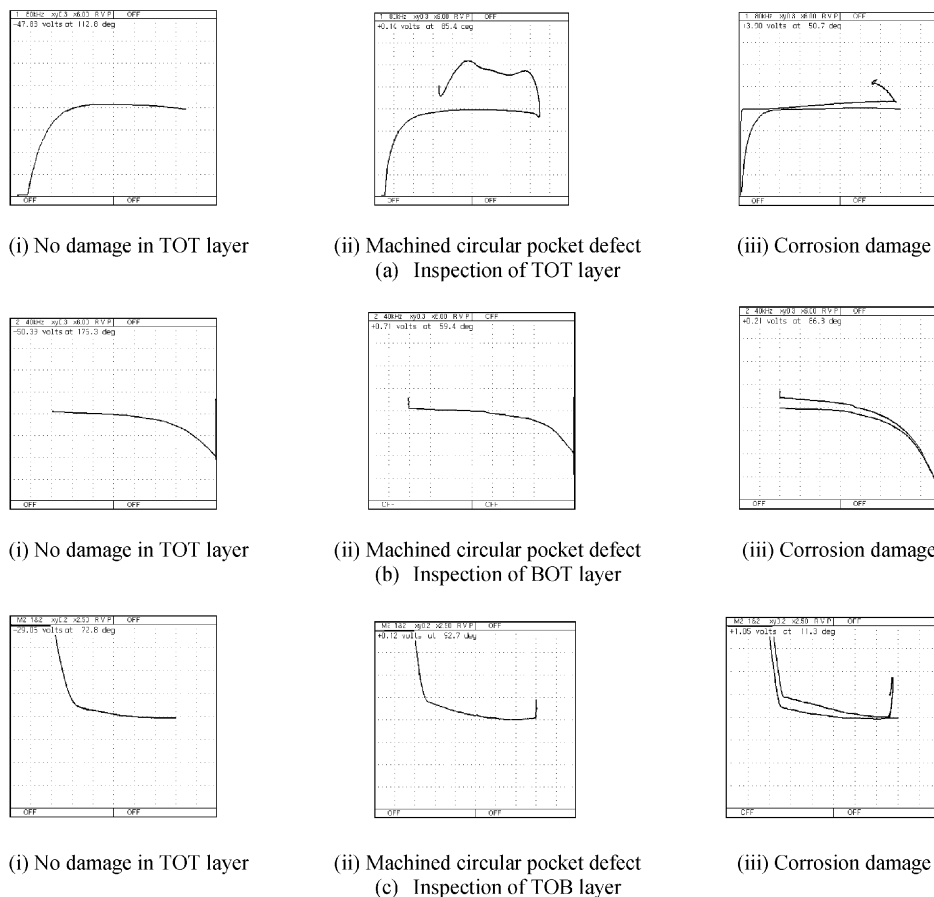
FIGURE 3. Impedance plane plot of eddy current inspection of non-riveted reference specimen with no damage, non-riveted lap joint calibration specimen with machined defect of 12.7 mm diameter and 0.48 mm depth, and riveted lap joint specimen with corrosion damage due to accelerated corrosion testing in (a) TOT layer (b) BOT layer and (c) TOB layer.

Pitting and crevice type of corrosion were observed in the specimens, which are also observed in real-life aircraft lap joints [11]. The corrosion products from BOT and TOB layer accumulated between the faying surfaces of lap joint, resulting in ‘pillowing’. Figure 3 shows the EC scan impedance plane plot for no damage, machined pockets in calibration specimens and corrosion damage in TOT, BOT and TOB layers of the riveted lap joint specimens. Hence by observing the impedance plane plot, defects in different layers of lap joint can be detected. From the results of EC inspection of the calibration specimens it was observed that for a given layer in lap joint the amplitude of impedance plane signal depends on both the diameter and depth of the pocket and hence the defect cannot be quantified. Figure 4 shows the amplitude of impedance plane signal for different zones of the double column riveted lap joint specimens for exposure periods in corrosion chamber. In general, an increasing trend in the amplitude of impedance plane signal with increase in exposure period in corrosion chamber for the different zones in TOT, BOT and TOB layers of double column riveted lap joint specimen can be observed. But the amplitude value for inspection of BOT layer of specimens of exposure periods 4, 8 and 12 weeks showed some overlap and did not follow the trend. Triple column and single column riveted lap joint specimens did not show an increasing trend in the amplitude values with respect to exposure period. The possible reasons for this irregularity could be: (i) The location and extent of damage in the specimens varied due to variation in location in corrosion chamber. (ii) Longer exposure periods resulted in damaged rivet heads causing movement of the upper layer of the lap joint during EC scanning. (iii) The presence of larger interlayer gaps than what was considered during the calibration process of dual frequency mixing.
