Effect of Zinc Galvanization on the Microstructure and Fracture Behavior of Low and Medium Carbon Structural Steels

I. C. Okafor et al., "Effect of Zinc Galvanization on the Microstructure and Fracture Behavior of Low and Medium Carbon Structural Steels," *Engineering*, vol. 5, no. 8, pp. 656-666, Scientific Research Publishing Inc. (SCIRP), Aug 2013.

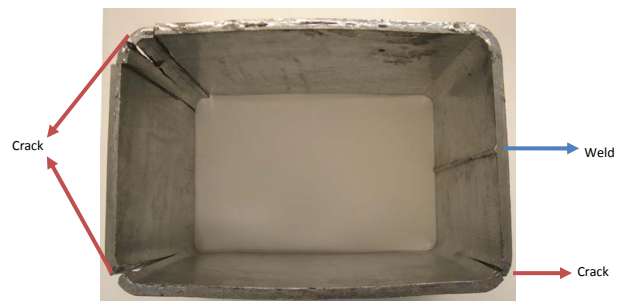
Figure 1. Cracks seen in the galvanized ultra high strength hollow structural steel (HSS) tubing.

Our interest in this work derived from two cases; in one a customer reported severe cracking in A572 Grade 65 material used for wind tower applications; and in the other, an ultra high strength steel (HSS) hollow tubing (**Figure 1**) used for structural applications cracked, after the material had been zinc galvanized. Material from the same heat of both materials had been sold to a second customer, but no such problems were detected after identical treatment. In consequence a second steel chemistry was designed to counter this phenomenon. This paper reviews only one material (A572 Grade 65 steel) for the

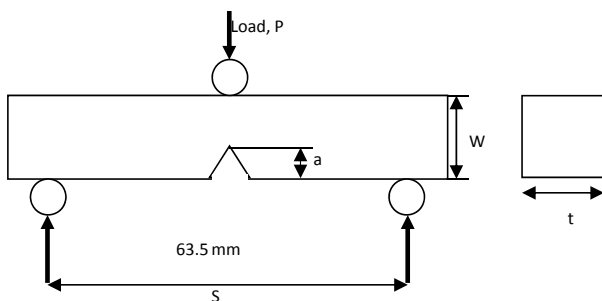
Figure 2. Typical loading configuration and the dimensions of the test specimen.

All specimens for 3-point bend tests were taken as described above and cut in the geometry and specimen dimensions shown in **Figure 2**. These specimens have the nominal dimensions of 75 mm in length with a two-point bottom load span of 63.5 mm. The top load was at the opposite (top side) of the notch. The width of all the specimens was about 12 mm and thickness varied with the respective material. A 60° notch of about 5.2 mm was also introduced to one free edge of the sample along the width. The notch depth to sample width (a/W) was approximately 0.4.

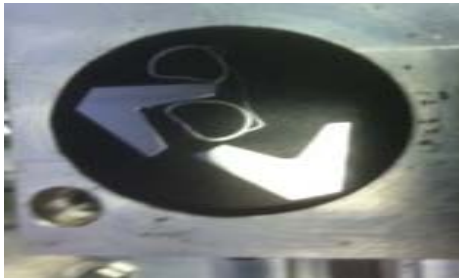
Figure 4. Two “V” shaped samples (one with clip is parent and shiny one is galvanized with coating completely ground off).

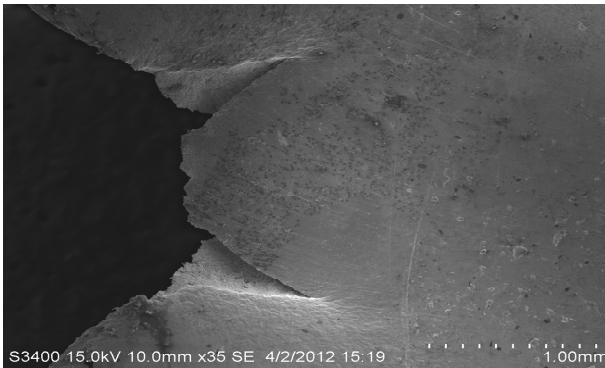
Figure 5. Shows cracked zones of the “V” notch studied for LME cracking.

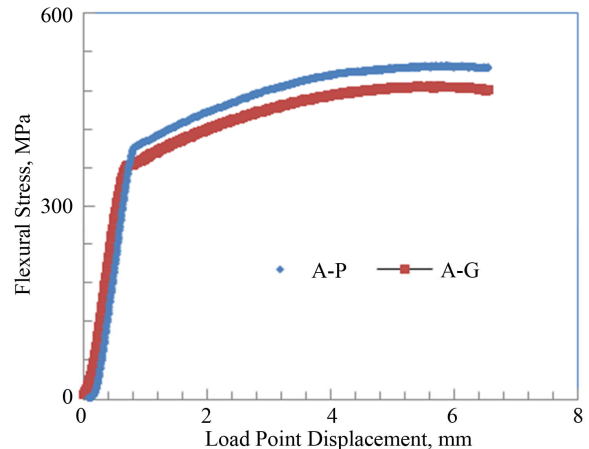
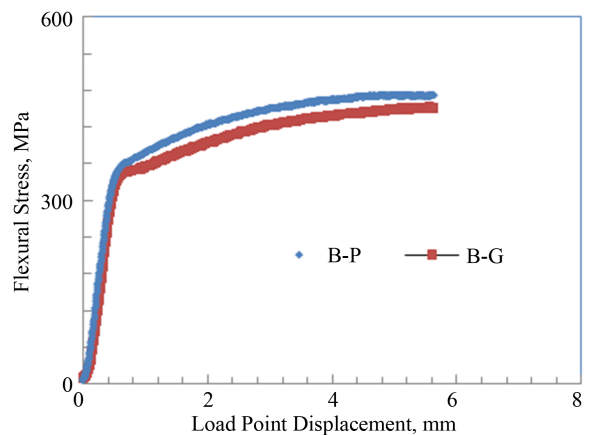
Figures 6. Average flexural stress versus load point displacement curves of parent and galvanized low carbon steels: (a) Plate thickness = 9.8 mm; (b) Plate thickness = 6.4 mm.

Flexural tests were conducted for both the parent and galvanized low carbon steels on the notched specimens. The plots for flexural stress vs. load point displacement (LPD) for both low carbon steels A and B are shown in **Figures 6(a)** and **(b)**. The graphs reveal the flexural stress of the notched parent and galvanized low carbon steels A and B. For both parent and galvanized specimens of steels A and B, the graph follows a linear elastic behavior followed by a long non-linear or plastic behavior to failure. The maximum flexural stress of the parent and galvanized low carbon steel A were about 520 and 490 MPa, respectively. For the low carbon steel B, the maximum flexural stress was about 475 for parent and 455 MPa for galvanized, respectively. There was a decrease of 6% in the flexure stress for galvanized steel specimen A when compared to the parent. The flexural stress for the galvanized steel sample B had a decrease of about 4% when compared to the parent sample.

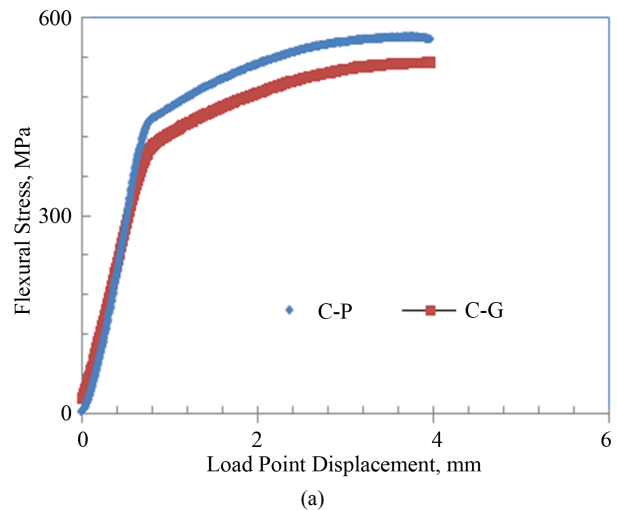
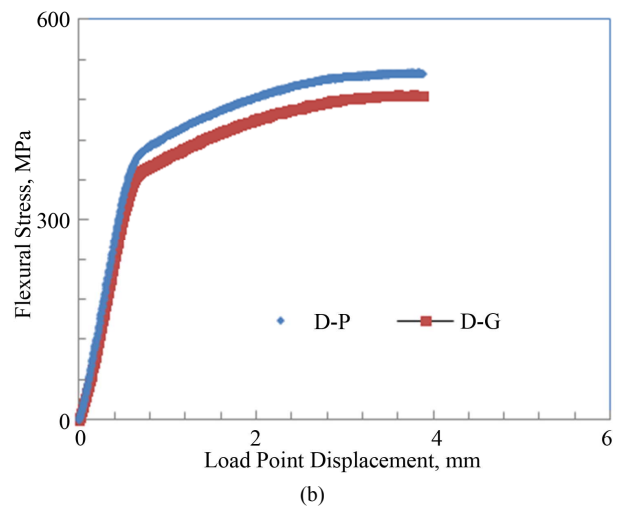
Figure 7. Average flexural stress versus load point displacement curves of parent and galvanized medium carbon steels: (a) Plate thickness = 13 mm; (b) Plate thickness = 9.8 mm.

The average flexural stress vs. load point displacement curves of the notched parent and galvanized medium carbon steels C and D are shown in **Figures 7(a)** and **(b)**. The curves of both steels C and D show both elastic regions followed by plastic or non linear portions representative of ductile fracture. For steel C, the maximum flexural stress for the parent and galvanized specimens were about 575 and 535 MPa, respectively. For steel D, the maximum flexural stress for both parent and galvanized specimens were about 520 and 490 MPa, respectively. The flexural stress for the galvanized specimens had a decrease of about 7% and 6% when compared to their parent counterparts, respectively.

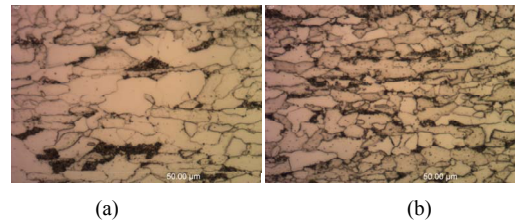
Figure 8. Optical micrographs of parent low carbon steels (a) A and (b) B taken in longitudinal direction at 100 \times magnification.

The microstructural analysis of the parent and galvanized low carbon steels were done using an optical microscope. The micrographs of the parent low carbon steels A and B taken in the longitudinal direction at 100X magnification are shown in **Figure 8**. It was found that the low carbon steels A and B showed similar phases in the microstructure. The predominant phase was ferrite, with smaller amounts of pearlite. Steel A seemed to have larger ferrite grains than steel B. The volume fraction of bainitic pearlite increased vice versa (more in B than A).

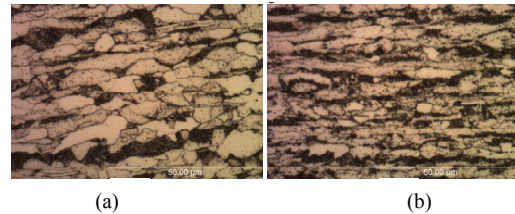
Figure 9. Optical micrographs of parent medium carbon steels (a) C and (b) D taken in longitudinal direction at 100 \times magnification.

Figure 9 shows the optical micrographs of the parent medium carbon steels C and D taken in longitudinal directions at 100X magnification. These micrographs are

typical ferrite and pearlitic structures. Steel C shown in **Figure 9(a)** reveals a larger ferrite phase than steel D, which is shown in **Figure 9(b)**. Steel D has a finer grain structure.

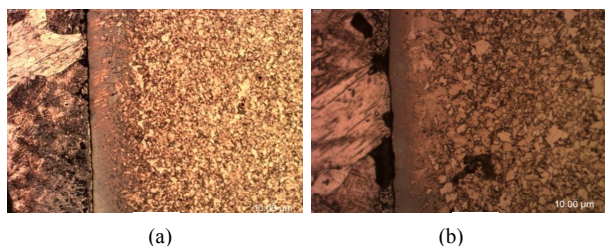
Figure 10. Optical micrographs of the galvanized low carbon steels (a) A and (b) B taken near the notch location at 20× magnification.

The micrographs of galvanized low carbon steels A and B taken at the notched location are shown in **Figure 10**. These micrographs show that both steels had dull grey appearance in the middle where the fusion of zinc into the steel occurred. Yeomans [23] explained the dull gray appearance as the result of zeta crystals having grown to the outside of the zinc coating and consuming the pure zinc layer. The coating is non-uniform, poorly adherent and also brittle in nature, as previously reported by Kinstler [13].

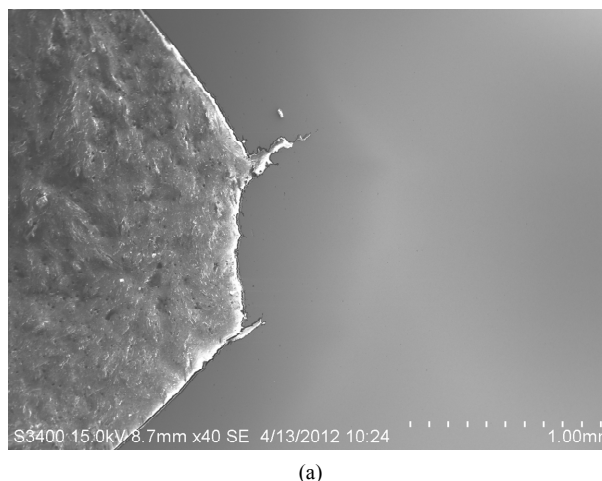
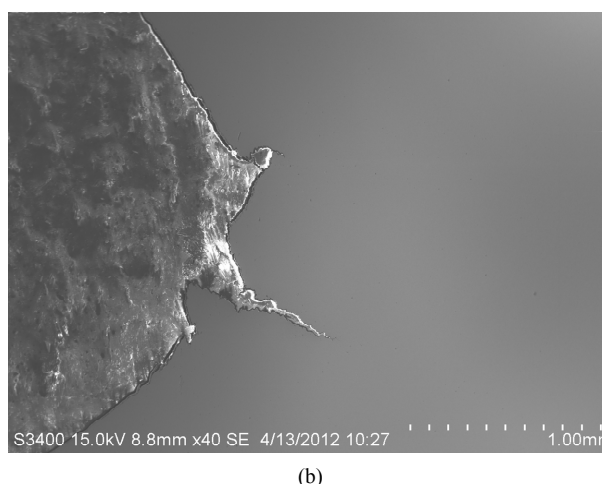
Figure 11. SEM micrographs of low carbon (a) parent and (b) galvanized steels showing the cracked region as a result of 3-point bend mechanical test.

SEM micrographs of the crack regions from the 3-point bend testing for both parent and galvanized low carbon steels are shown in **Figure 11**. The fracture behavior of the parent sample is shown in **Figure 11(a)**. It shows little crack tip propagation. **Figure 11(b)**, however, obtained for the zinc coated piece, shows a longer crack tip travel on the lower right hand corner and a broader crack opening for the top right hand side. This might be due to the zinc galvanization.

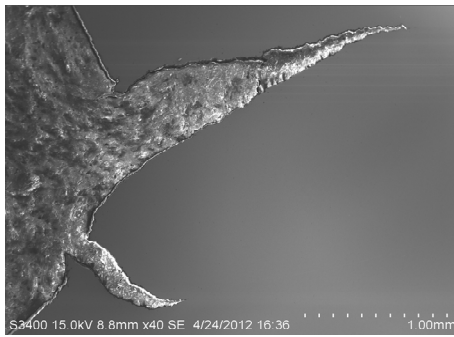
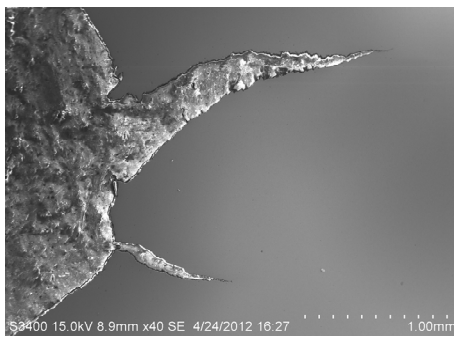
Figure 12. SEM micrographs of medium carbon (a) parent and (b) galvanized steels showing the cracked region as a result of 3-point bend mechanical test.

Figure 12 shows micrographs of similar crack region for parent and galvanized medium carbon steel. The galvanized steel micrograph from **Figure 12(b)** shows more of a contracted crack, or compressed crack, behavior than the parent sample from **Figure 12(a)**. The crack from the parent sample, however, is more relaxed and open. This might be due to the aging response on the surface of the material, where the material behavior is brittle in nature at the surface as the bulk of the steel is not embrittled.

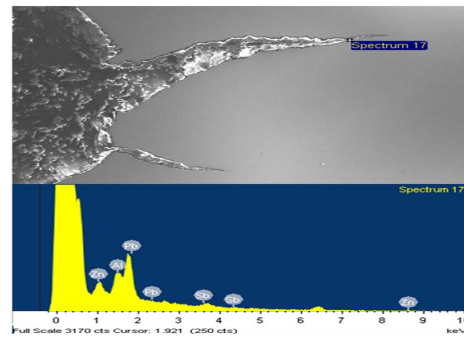
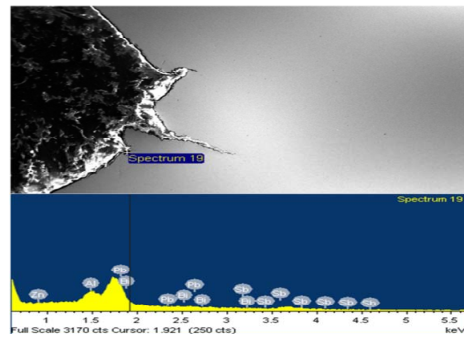
Figure 14. (a) and (b) show the X-ray spectra at locations with more Pb peaks at various points along the crack tip.

and cracked regions to analyze for any presence of zinc and or zinc bath additives. Over 80% of peaks obtained showed clear evidence of presence of zinc as the main constituent element. Other elements such as lead (Pb), antimony (Sb), aluminum (Al), and tin (Sn) were also present. A few typical spectra obtained are shown in **Figures 13-16**.

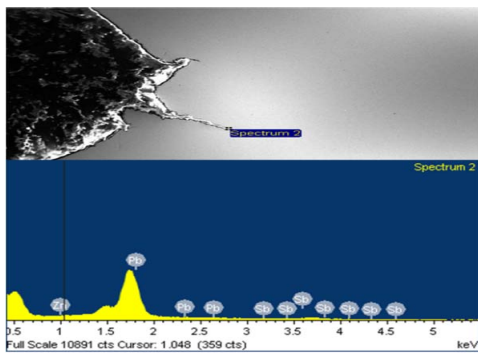
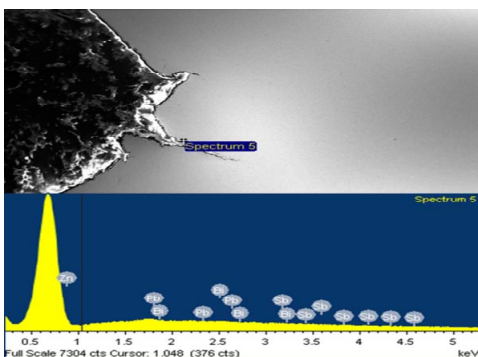
Figure 13. (a) and (b) show the X-ray spectra at locations with Zn, Pb, and Sb peaks around the crack tips.

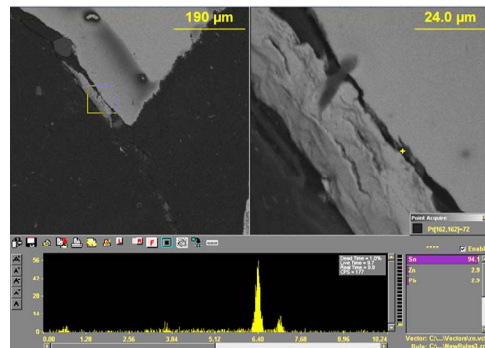
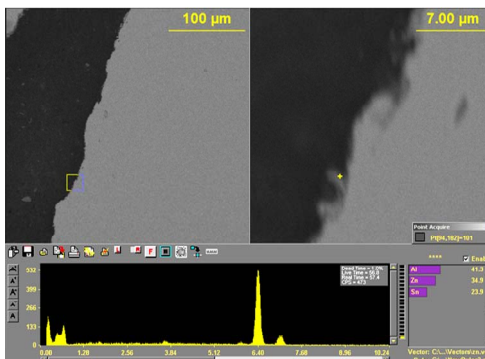
Figure 15. (a) and (b) Show the X-ray spectrums with (a) Sn (94.1), Zn (2.9%) and Pb (2.9%) and (b) Al (41.3%), Zn (34.9%) and Sn (23.9%).

The samples were therefore studied for Bi, Sn, Pb, Sb and Zn. More results are shown in **Figures 15** and **16**. Notice that several peaks for Sb, Sn, Pb and Zn were
