A Hybrid Process Integrating Reverse Engineering, Pre-Repair Processing, Additive Manufacturing, and Material Testing for Component Remanufacturing

Xinchang Zhang

X. Zhang et al., "A Hybrid Process Integrating Reverse Engineering, Pre-Repair Processing, Additive Manufacturing, and Material Testing for Component Remanufacturing," *Materials*, vol. 12, no. 12, MDPI AG, Jun 2019.

Article

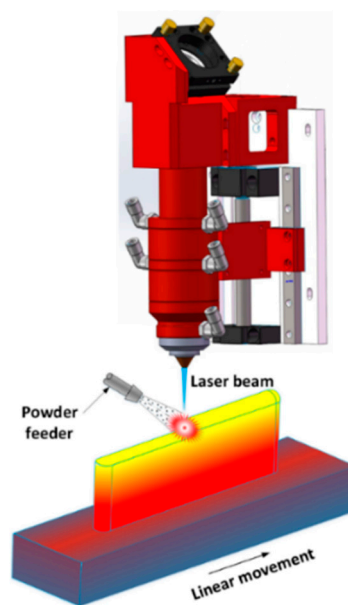
Figure 1. Schematic diagram of the laser-aided direct energy deposition process.

Laser-aided Direct Energy Deposition (DED) (Figure 1) is suitable for part repair. For example, varied shapes of grooves and slots were machined on AISI H13 tool steel substrates and then refilled by depositing H13 tool steel powder [7]. The process can fabricate high-quality repaired parts, but some defects may exist if the defect's boundary is too steep. Investigators prepared different groove-shaped defects on Stainless Steel and Ti-6Al-4V substrates and attempted to restore these missing volumes by modifying AM processing parameters [8]. The result shows that high quality repaired samples can be obtained with a reasonable combination of processing parameters. Defects on Ti-6Al-4V substrates were also generated and subsequently repaired by filling Ti-6Al-4V powder [9]. The mechanical qualification reveals good bonding strength and higher tensile strength within the deposits than the substrate. In summary, the DED process for repair has the following benefits: (1) less thermal input, which is required for repairing dimensional sensitive parts such as engine blades [10]; (2) good metallurgical bond between deposits and base metals [11]; (3) flexible integration with CNC (computer numerical control) machine or robot to develop a hybrid process to automate the repair [12].

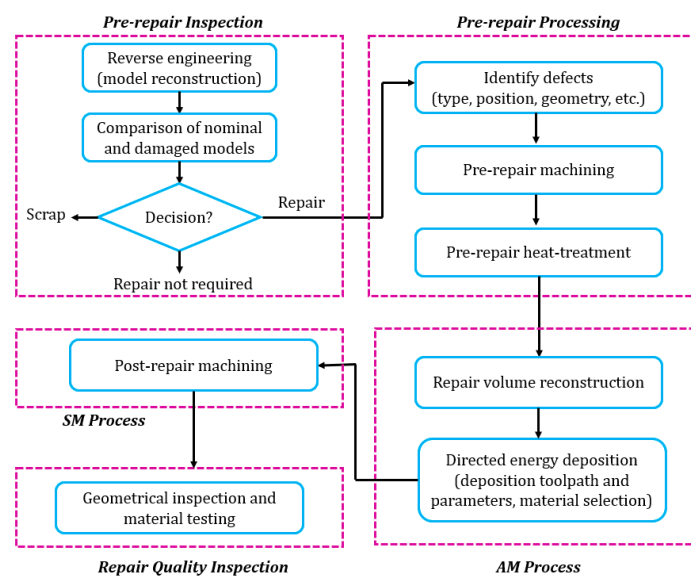
Figure 2. Diagram of the integrated hybrid process.

An integrated hybrid process for component remanufacturing in this study obeys the following procedure as shown in Figure 2: (1) pre-repair inspection; (2) pre-repair processing; (3) AM; (4) subtractive manufacturing (SM); (5) repair quality inspection. In the beginning, a complete inspection was performed on worn parts to assess the feasibility of repair. Considering the excessive variety of locations and geometries of defects, the inspection is highly a case to case basis. After that, pre-repair processing was conducted to guarantee the worn parts were repairable. Previous work in component repair is concentrated on post-machining. However, pre-repair processing is also crucial in the repair chain. Pre-repair processing discussed in this paper includes pre-repair machining and pre-repair heat-treatment. Pre-repair machining is required because many defects such as cracking are not directly accessible to AM systems. Such defects cannot be repaired without machining off materials surrounding the inaccessible defects. The inclination angle of boundaries of defects should also be considered in the machining process since it is reported that too steep walls cannot form sound bonding between filler material and substrates [19]. The AM process builds materials in the damaged area to restore the missing geometry in a layer-upon-layer fashion [20]. The key is to reconstruct

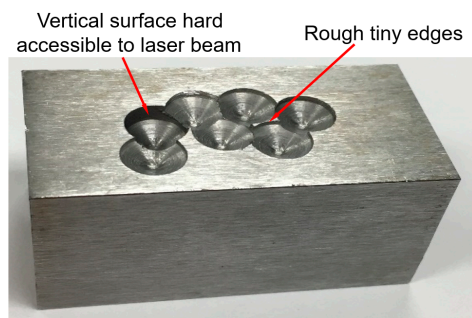
Figure 4. An H13 tool steel substrate with ball-indented defects.

An H13 tool steel block with dimensions of $50 \times 25.4 \times 25.4 \text{ mm}^3$, shown in Figure 4, was utilized as an example for illustrating machining strategy for surface impact defects. Ball-indented defects were randomly prepared on the surface of the substrate using an 8 mm drill bit. The holes on the block have varied depths and overlap ratios.

One can see in Figure 4 that the damaged substrate cannot be repaired directly due to at least two reasons. One is that vertical surfaces on the side of the holes are not accessible to the laser beam and powder feed nozzle for the 3-axis AM system. Therefore, materials surrounding vertical surfaces need to be machined to reveal a tilted surface to guarantee accessibility. Another reason is that the rough tiny edges in the damaged area complicate the toolpath planning for material deposition and may distort during deposition due to heat input. Such deformation could ruin the accuracy of the as-deposited geometry.

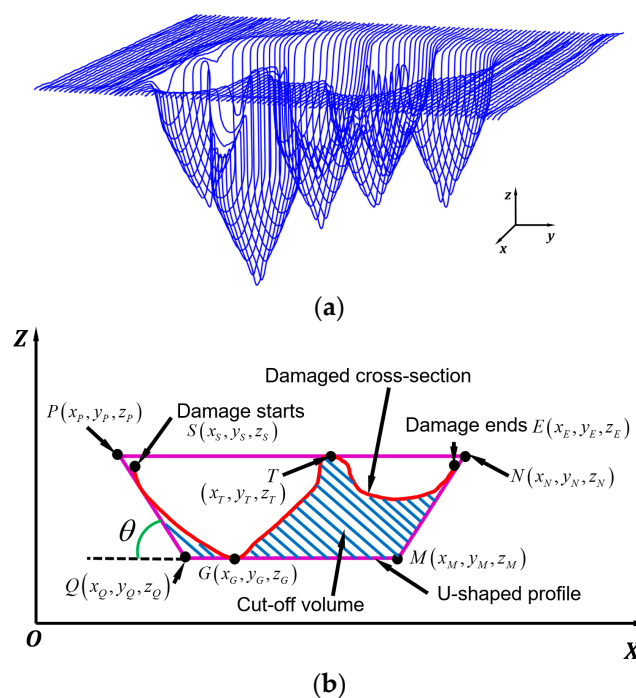
Figure 6. (a) Cross-sections of the block; (b) U-shaped boundary (UB) definition.

The STL model of the damaged part was sliced into several layers along the y-axis with a layer thickness of 0.5 mm as shown in Figure 6a. The slicing outputs a series of layers that combined

damaged and undamaged cross-sections. Damaged cross-sections contain points in damaged and undamaged regions. Damaged points can be extracted by calculating the distance from the points to the nominal surface. Points with distance beyond a tolerance were defined as damaged points. Figure 6b presents a damaged cross-section where damage starts at point *S* and ends at *E*.

As shown in Figure 6b, two approaching lines *PQ* and *MN* with an inclination angle θ were utilized to approach the damaged cross-section. The damage starting point *S* and ending point *E* were known in the damage searching step. It is necessary to find points *P*, *Q*, *M*, and *N* to define the two approaching lines. Such points can be defined as follows: Z_P and Z_N were defined by finding the maximum *z*-coordinate on the damaged cross-section, which is Z_T . Z_Q and Z_M were defined by exploring the minimum *z*-coordinate on the damaged cross-section, which is Z_G . Since the damaged model was sliced along the *y*-axis, $Y_P = Y_Q = Y_M = Y_N = Y_S = Y_E$. X_P and X_N were randomly defined as long as X_P is less than the minimum *x*-coordinate of the damaged points and X_N is larger than the maximum *x*-coordinate of the damaged points. Once X_P , X_N , and the sidewall inclination angle θ are defined, the coordinates X_Q and X_M can be calculated according to Equation (1).

Once the two approaching lines were defined, the relationship between the approaching lines and the cross-section was checked. If there is no intersection, a step was applied to X_P and X_N to make the lines approach the cross-section, and another checking iteration was conducted. Two lines that firstly have intersections with the damaged cross-section can be obtained and lines before this iteration were gathered, which is shown in Figure 6b.

One can see in Figure 6b that for UB, the bottom-line QM is parallel to the x-axis, and this may result in extra material cut-off in the polygon $GMETG$. This material over-cut becomes worse when one deep defect is presented while majority defects are shallow. To further minimize cut-off volume, the CHB was obtained as shown in Figure 8a. The convex-hull of any polygon can be easily obtained based on the existing algorithm [22]. However, one should notice that the convex hull cannot be directly utilized as the boundary for machining owing to the possibility of the steep area as shown in Figure 8a. The line segments in such regions have big tangents that cannot guarantee accessibility. Therefore, such lines need to be tilted. The algorithm for tilting lines is schematically depicted in Figure 8b and discussed below.

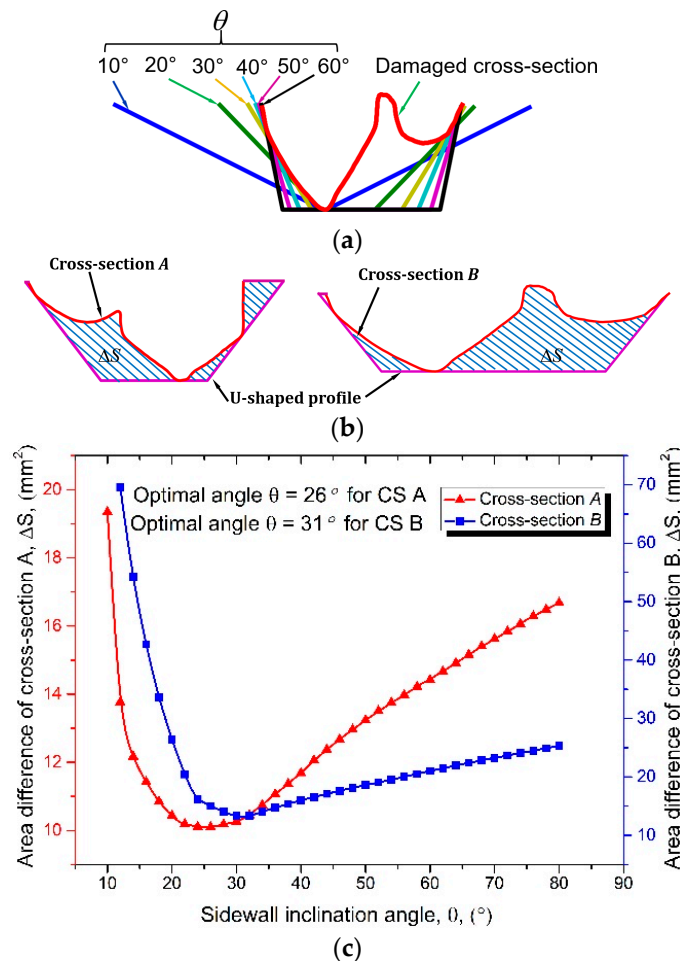
Figure 7. Sidewall inclination angle optimization for UB. (a) UB with varied approaching lines; (b) UB for cross-sections A and B; (c) relationship between area difference ΔS and inclination angle θ .

The inclination angle θ of the two approaching lines can be operator-determined and adjusted flexibly according to the specifications of the AM system. It should be noted that the inclination angle has a significant effect on the cut-off volume. A small θ gives good accessibility but may result in a much greater cut-off volume. An optimized θ needs to be determined which not only reveals good accessibility but also holds a minimized cut-off volume. For this purpose, a series of approaching lines with varied inclination angles were adopted to intersect a cross-section shown in Figure 7a. Inclination angle θ controls the accessibility and it should not approach 90° . The authors conducted a series of experiments that aimed to refill slots with different sidewall inclination angles and it was revealed that 75° can still yield a sound bi-material bonding and good material properties [20]. Therefore, the range of angle θ was limited to 10° - 75° . The area difference between UB and the cross-section, ΔS as shown in Figure 7b, indicates the cut-off area. A series of approaching lines were processed on cross-sections A and B as shown in Figure 7b and the relationship between ΔS and θ is plotted in Figure 7c.

It was observed from Figure 7c that for both cross-sections, the area ΔS decreases and then increases with the increase of angle θ . It was found that the optimal angle θ (angle that results in the minimum ΔS) for cross-section A is 26° and is 31° for cross-section B. The curves indicate that neither a minimum nor a maximum tilt angle can result in the minimum cut-off volume. Therefore, the optimal angle θ is highly dependent on the profile of the cross-section and should be determined for each one.

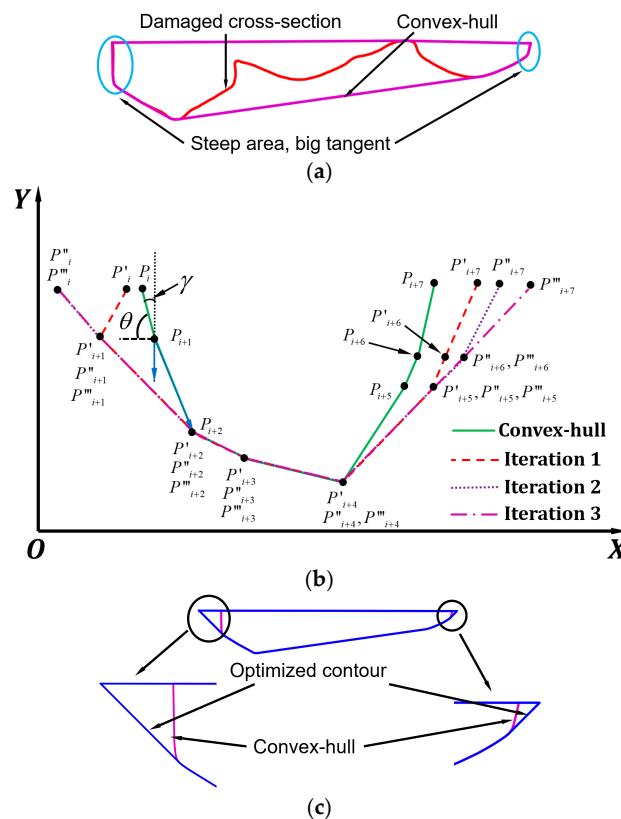
Figure 8. Sidewall inclination angle optimization for the convex-hull boundary (CHB). (a) CHB processed on a damaged cross-section; (b) schematic diagram showing optimization algorithm; (c) optimized contour.

The algorithm was applied to a cross-section as shown in Figure 8a and the optimized contour is depicted in Figure 8c. As illustrated in Figure 8c, the steep area in the original convex-hull was successfully tilted.

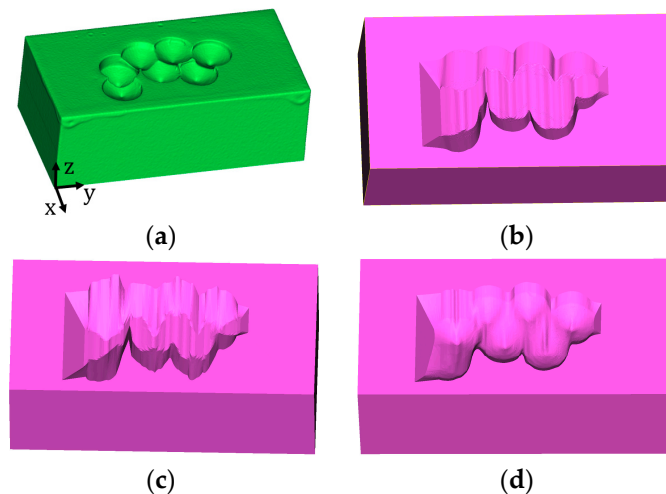
Figure 9. Damaged and machined models. (a) Damaged model; model machined using the UB method without optimization (b) and with optimization (c); (d) model machined using the CHB method.

UB and CHB were processed on the model shown in Figure 9a. For UB, sidewall with a fixed angle $\theta = 45^\circ$ and optimized angles were both conducted, and the target models are shown in Figure 9b,c, respectively. The model processed using CHB method is presented in Figure 9d.

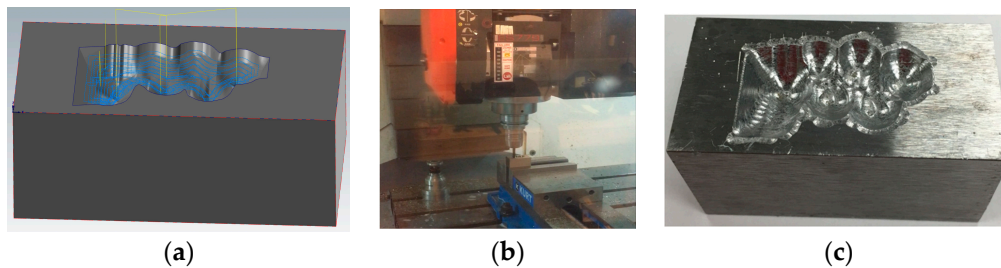
Figure 10. (a) Machining toolpath; (b) machining setup; (c) part after machining.

Once the target geometry was obtained, it was loaded to a CAM (computer aided manufacturing) software (MasterCAM 2018) to generate the machining toolpath as shown in Figure 10a. The milling parameters are listed in Table 2. The damaged part was machined on a Fryer MC-30 with the setup shown in Figure 10b. The machined part is shown in Figure 10c.

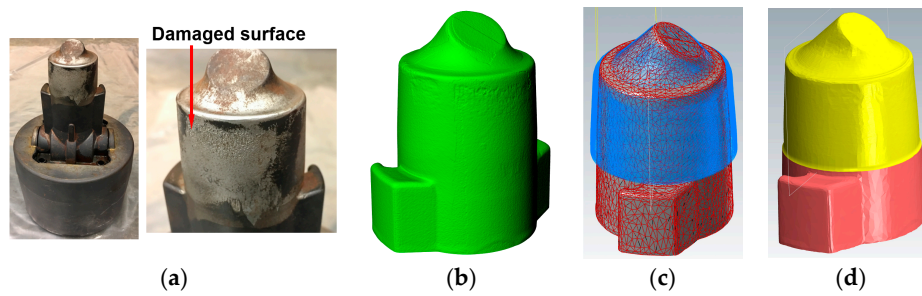
Figure 11. (a) A die with surface superficial defects; (b) STL model of the die; (c) machining toolpath; (d) model of the die after machining.

As an example, a casting die shown in Figure 11a has damaged regions on the working convex area that are dominated by tiny rough surfaces. In order to machine off a thin layer of material from the part, the model of the die was generated as shown in Figure 11b. Creating the model of the whole part is not necessary because only the surface with defects needs to be targeted. Generating the whole model not only dramatically slows down the 3D scanning process, especially for a large complex structure, but also makes the toolpath generating process more complicated due to the large size of the imported 3D scanned model.

The volume of materials to be machined depends on the depth of surface defects. The defects of surface erosion, wear and corrosion are usually superficial and can be effectively removed through one pass machining. The cut depth for machining can be determined based on the condition of the damage. For the casting die, materials with 0.5 mm layer thickness were machined. The toolpath was generated as shown in Figure 11c and the simulated machined part is shown in Figure 11d.

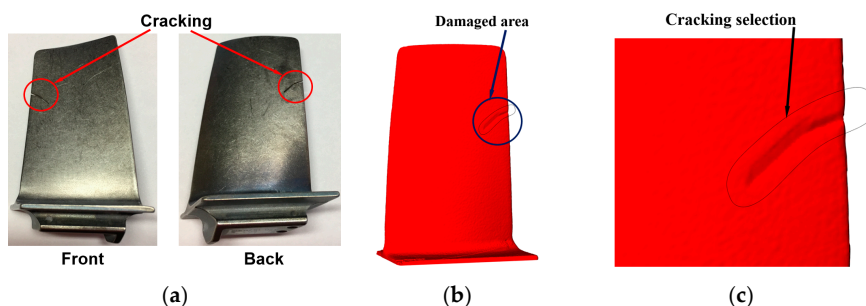
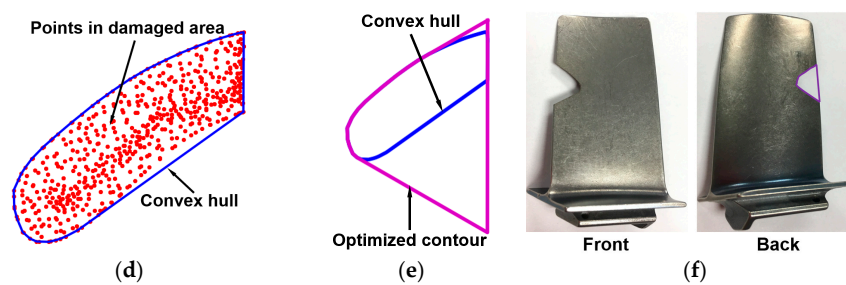
Figure 12. (a) Damaged blade; (b) 3D model of the blade; (c) point cloud in damaged area; (d) convex hull of the point cloud; (e) optimized contour for machining; (f) blade after machining.

To perform machining, the blade shown in Figure 12a was digitally scanned to acquire the 3D model as shown in Figure 12b. After that, the defective area was selected as shown in Figure 12c. By selecting the damaged area, the points located at the worn domain can be easily extracted which is shown in Figure 12d, and subsequently, the convex-hull of the point set was obtained. It should be pointed out that the convex hull cannot be directly used for machining because the bottom portion of the convex hull blocks the accessibility. In order to create a V-shaped geometry, the line segments of the convex hull were tilted according to the algorithm illustrated in Section UB Definition. The maximum sidewall inclination angle is limited to 60° . The finally optimized contour is shown in Figure 12e. EDM wire follows the optimized contour for machining and the machined blade is shown in Figure 12f.

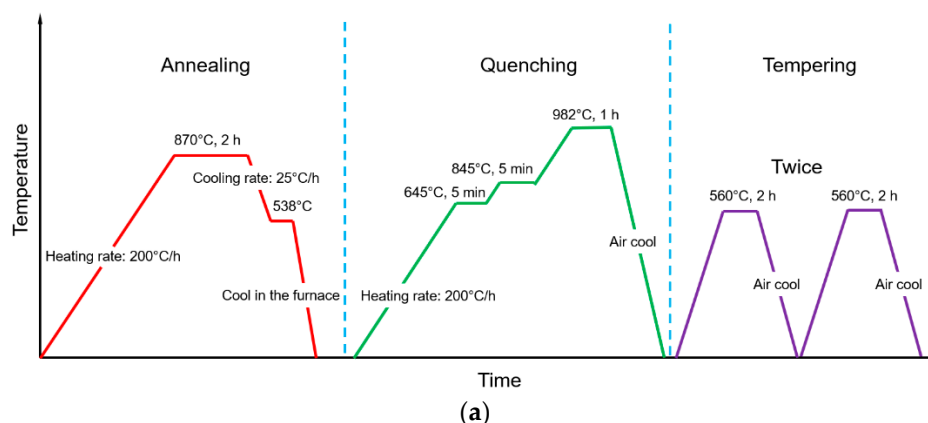
Figure 13. (a) Schematic diagram of the re-hardening process for H13 tool steel; (b) tensile testing data; (c) hardness measurements.

Figure 13b shows the tensile testing data of the worn H13 tool steel (BH), H13 tool steel after re-hardening (AH) and nominal H13 tool steel (N). It can be observed that the Ultimate Tensile Strength (UTS) of BH is 1427.9 MPa. By re-hardening, the UTS can be increased to 1846.7 MPa and the ductility also increased. The tensile properties of re-hardened H13 tool steel are comparable with that of the nominal one. Therefore, it can be concluded that re-hardening restored the tensile property of worn H13 tool steel.

Figure 13c shows the hardness measurements of BH, AH, and N. In terms of hardness, the BH has a hardness of around 420–440 HV while the AH is about 540–550 HV which is similar to the nominal hardness. The re-hardening process successfully restored hardness of worn H13 tool steel.

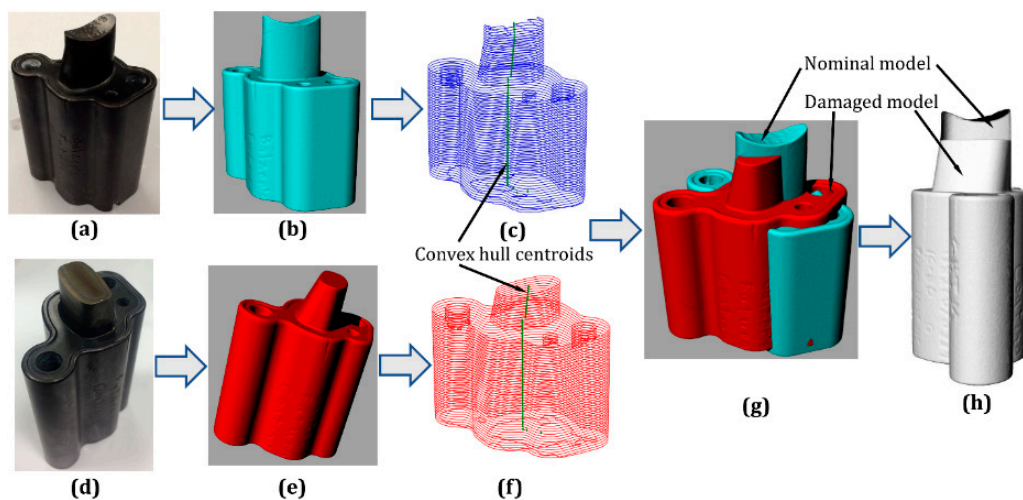
Figure 14. Model alignment. (a) Nominal part; (b) nominal model; (c) cross-sections of the nominal model; (d) damaged part; (e) damaged model; (f) cross-sections of the damaged model; (g) models before alignment; (h) models after alignment.

As shown in Figure 14, an H13 tool steel die was scanned to recreate the nominal model. After that, defects were created on the part using wire electrical discharge machining (EDM). The damaged component was then captured to recreate the damaged model. Afterward, the damaged model was accurately aligned with the nominal model by using the algorithm discussed in [35] with the following steps.

- Step 1: Select an initial slicing vertex P_0 and normal direction n_0 . The vertex P_0 is the point where the slicing process initiates and the normal direction n_0 is the slicing direction.
- Step 2: Once the initial slicing vertex and direction were selected, a planar reference going through the slicing vertex was utilized to slice the model, generating the cross-section of the layer. After slicing the initial layer, the slicing plane moved according to a defined layer thickness to slice the next layer. The slicing process continues throughout the model. The sliced layers of nominal and damaged models are shown in Figure 14c,f, respectively.
- Step 3: The convex-hull centroids of the nominal and damaged models were calculated and obtained as shown in Figure 14c,f.

The least squares method was used to acquire x , y , z and α , β , γ . The objective of the least squares method was to minimize the distance of the transformed points P_d^t to the points of the nominal model P_n , which is illustrated in Equation (5). The models prior to and after alignment are depicted in Figure 14g,h, respectively.

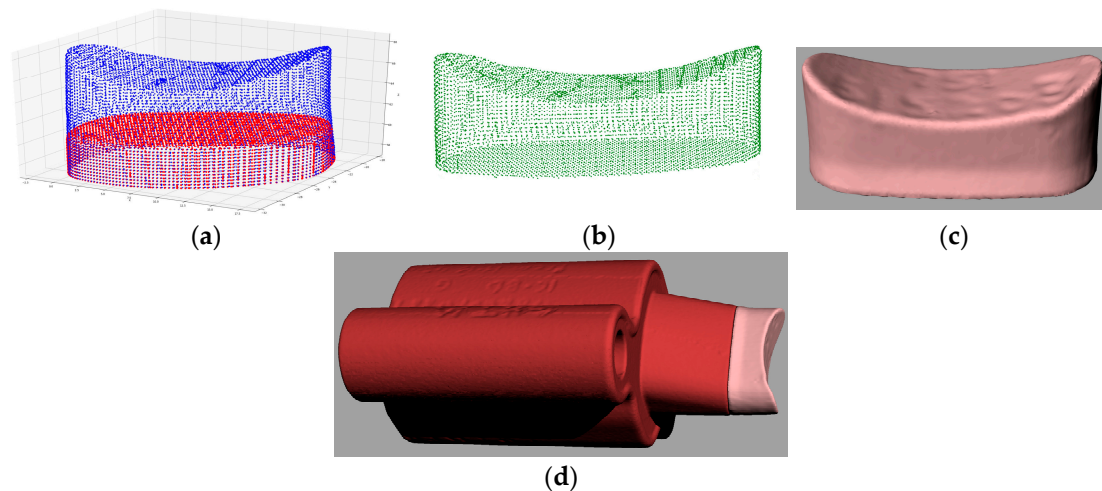
Figure 15. Repair volume reconstruction. (a) Intersections of rays with nominal and damaged models; (b) extracted points; (c) model of the extracted points; (d) damaged geometry on the damaged model.

Once the damaged model was aligned with the nominal model, the ray casting method was adopted to regain the repair volume [36]. Casting rays with a specific interval were injected to intersect both the nominal and damaged models, which is depicted in Figure 15a. Intersections of these casting rays with both models can be obtained. By comprising the coordinates of each intersection on the nominal model with the intersection on the damaged model, the point cloud that only belongs to the nominal model and is missing from the damaged model was extracted as shown in Figure 15b.

The point cloud was then processed to generate the STL model in Figure 15c. The virtually repaired die is shown in Figure 15d.

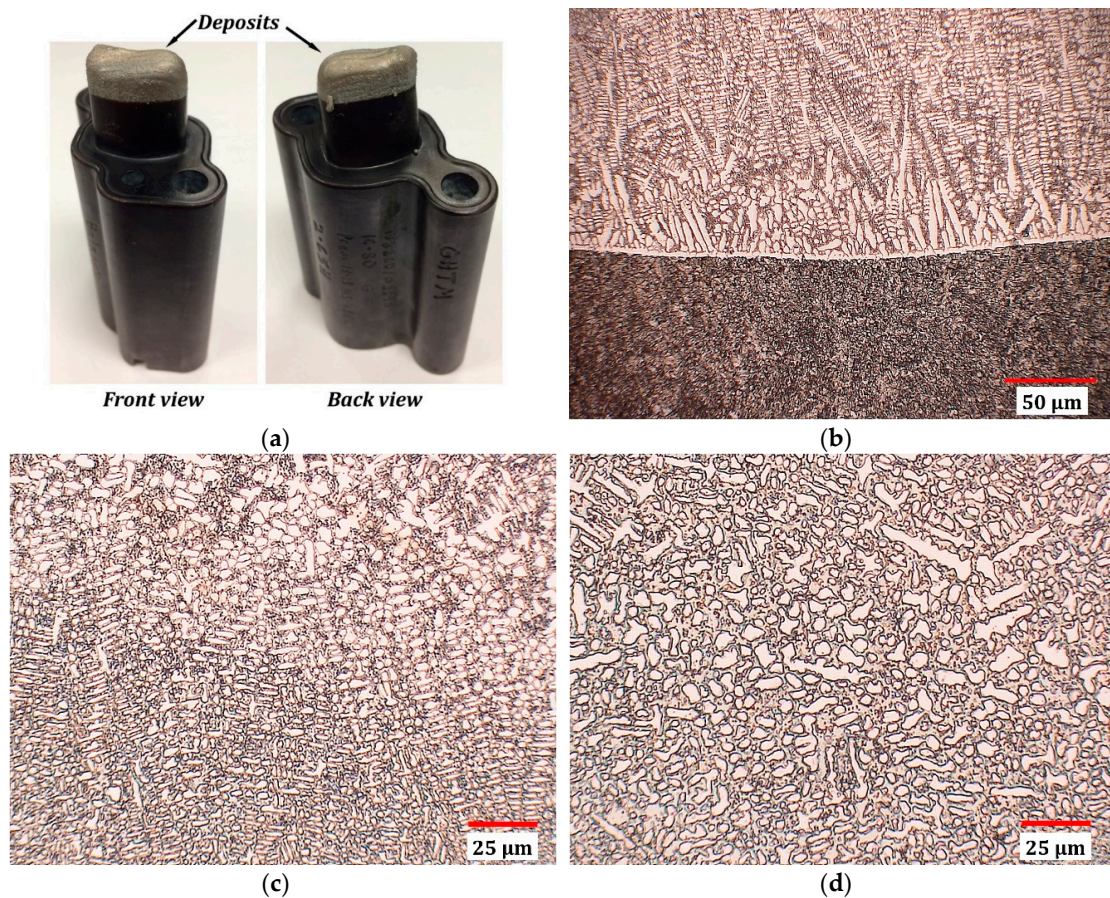
Figure 16. (a) Damaged part after repair; optical micrographs of materials at the interface (b), in the middle layers of deposits (c) and on the top layers of deposits (d).

Figure 16a reveals the part after the DED process. It shows the material was successfully restored at the damaged region. In order to evaluate the repair quality, the repair region was sectioned and tested through microstructure characterization and tensile testing.

Figure 16b–d shows the microstructure of materials at the interfacial area (Figure 16b), in the middle layers of deposits (Figure 16c) and on the top layer of deposits (Figure 16d). The microstructure of as-deposited material at the bonding area exhibits a columnar structure which is typical for additively manufactured materials since the cooling rate is high, causing the grains to grow in the heat flux direction. As materials were built layer upon layer, the solidification rate decreased and the deposits changed to dendrite structure with interdendritic eutectics. In the top layers, since the cooling rate is relatively low, the area is composed of mostly equiaxed structure and the quantity of dendrite is small.

It disclosed in Figure 16b that the bi-material interface is distinct. Examination of the area demonstrated the interface is free of defects, confirming the solid bonding between both materials. Besides, no defects were detected at the as-deposited materials, affirming the feasibility of fabricating Wallex 40 using the DED process.

The repaired part in Figure 16a was sectioned using EDM to obtain tensile specimens according to dimensions shown in Figure 17a. Two types of specimens were prepared: (1) Wallex 40 + H13 tool steel specimens with the interface approximately in the middle of the tensile gauge length (Figure 17b); (2) Samples made of as-deposited Wallex 40 (Figure 17c). Samples were tested using an Instron universal tester (Model 5969) with a crosshead rate of 0.015 mm/min.

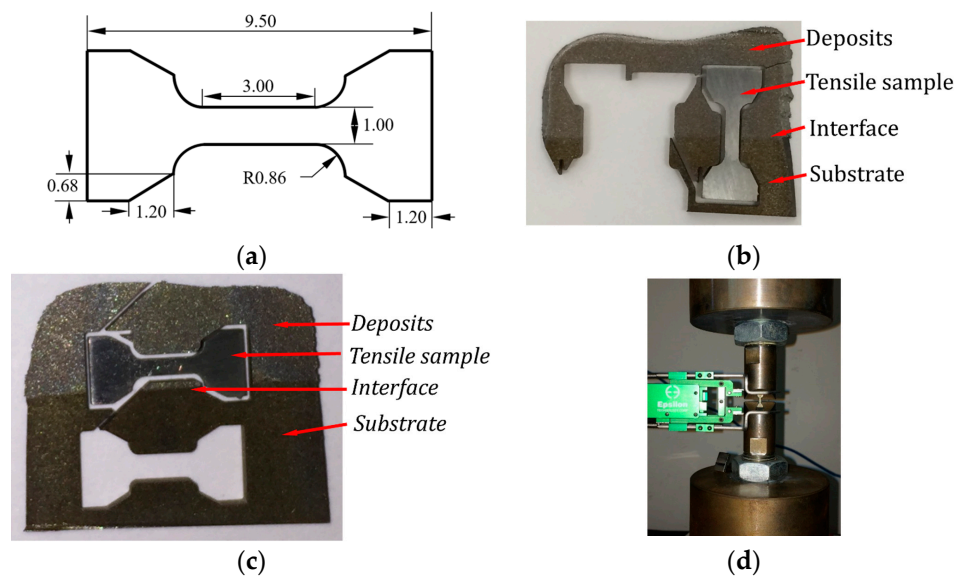
Figure 17. (a) Dimensions of tensile specimen (all dimensions in mm, 1 mm in thickness); (b) obtained Wallex 40 + H13 tool steel specimen over the sectioned part; (c) obtained Wallex 40 specimen over the sectioned part; (d) tensile testing setup.

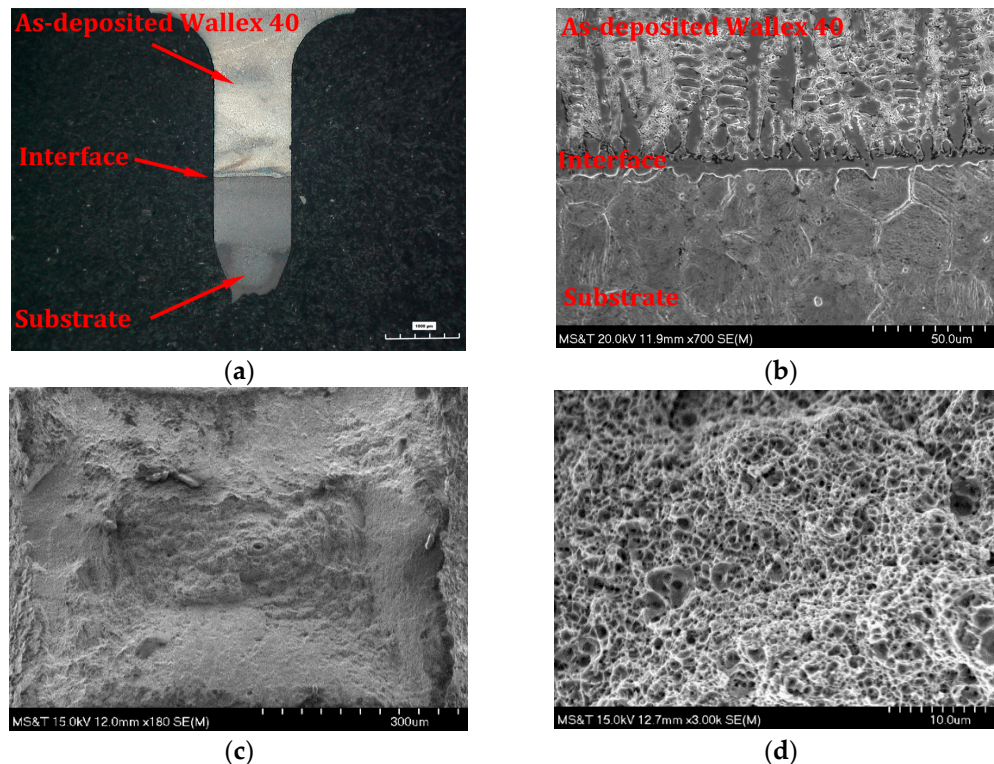
Figure 19. Tensile fracture morphology of Wallex 40 + H13 tool steel sample. (a) Overview of the fracture surface in longitudinal section; (b) magnified view of the bonding area; (c) overview of the fracture surface in cross-section; (d) magnified view of the fracture surface in cross-section.

The optical micrograph shown in Figure 19a revealed that the Wallex 40 + H13 tool steel tensile sample fractured at the H13 tool steel region. A necking region was found near the fracture area. The SEM image in Figure 19b shows that the interface is intact and fracture-free, which confirmed the strong adhesion strength. Since the Wallex 40 + H13 tool steel samples fractured at H13 tool steel section, the UTS of as-deposited Wallex 40 is higher than the substrate. This result indicated that the mechanical properties of repaired components were enhanced.

SEM micrographs of the cross-section of the tensile fractured surface are depicted in Figure 19c,d. The overview of the fracture surface revealed unsmooth fracture regions. A large number of voids and dimples were observed in the magnified view revealing the ductile fracture mechanism.
