# Data Recovery Excavations of the Carriage House, Greenhouse, and Greenhouse/Carriage House Well at Gore Place, Waltham, Massachusetts

**Cultural Resources Management Study No. 45**

**March 2011**

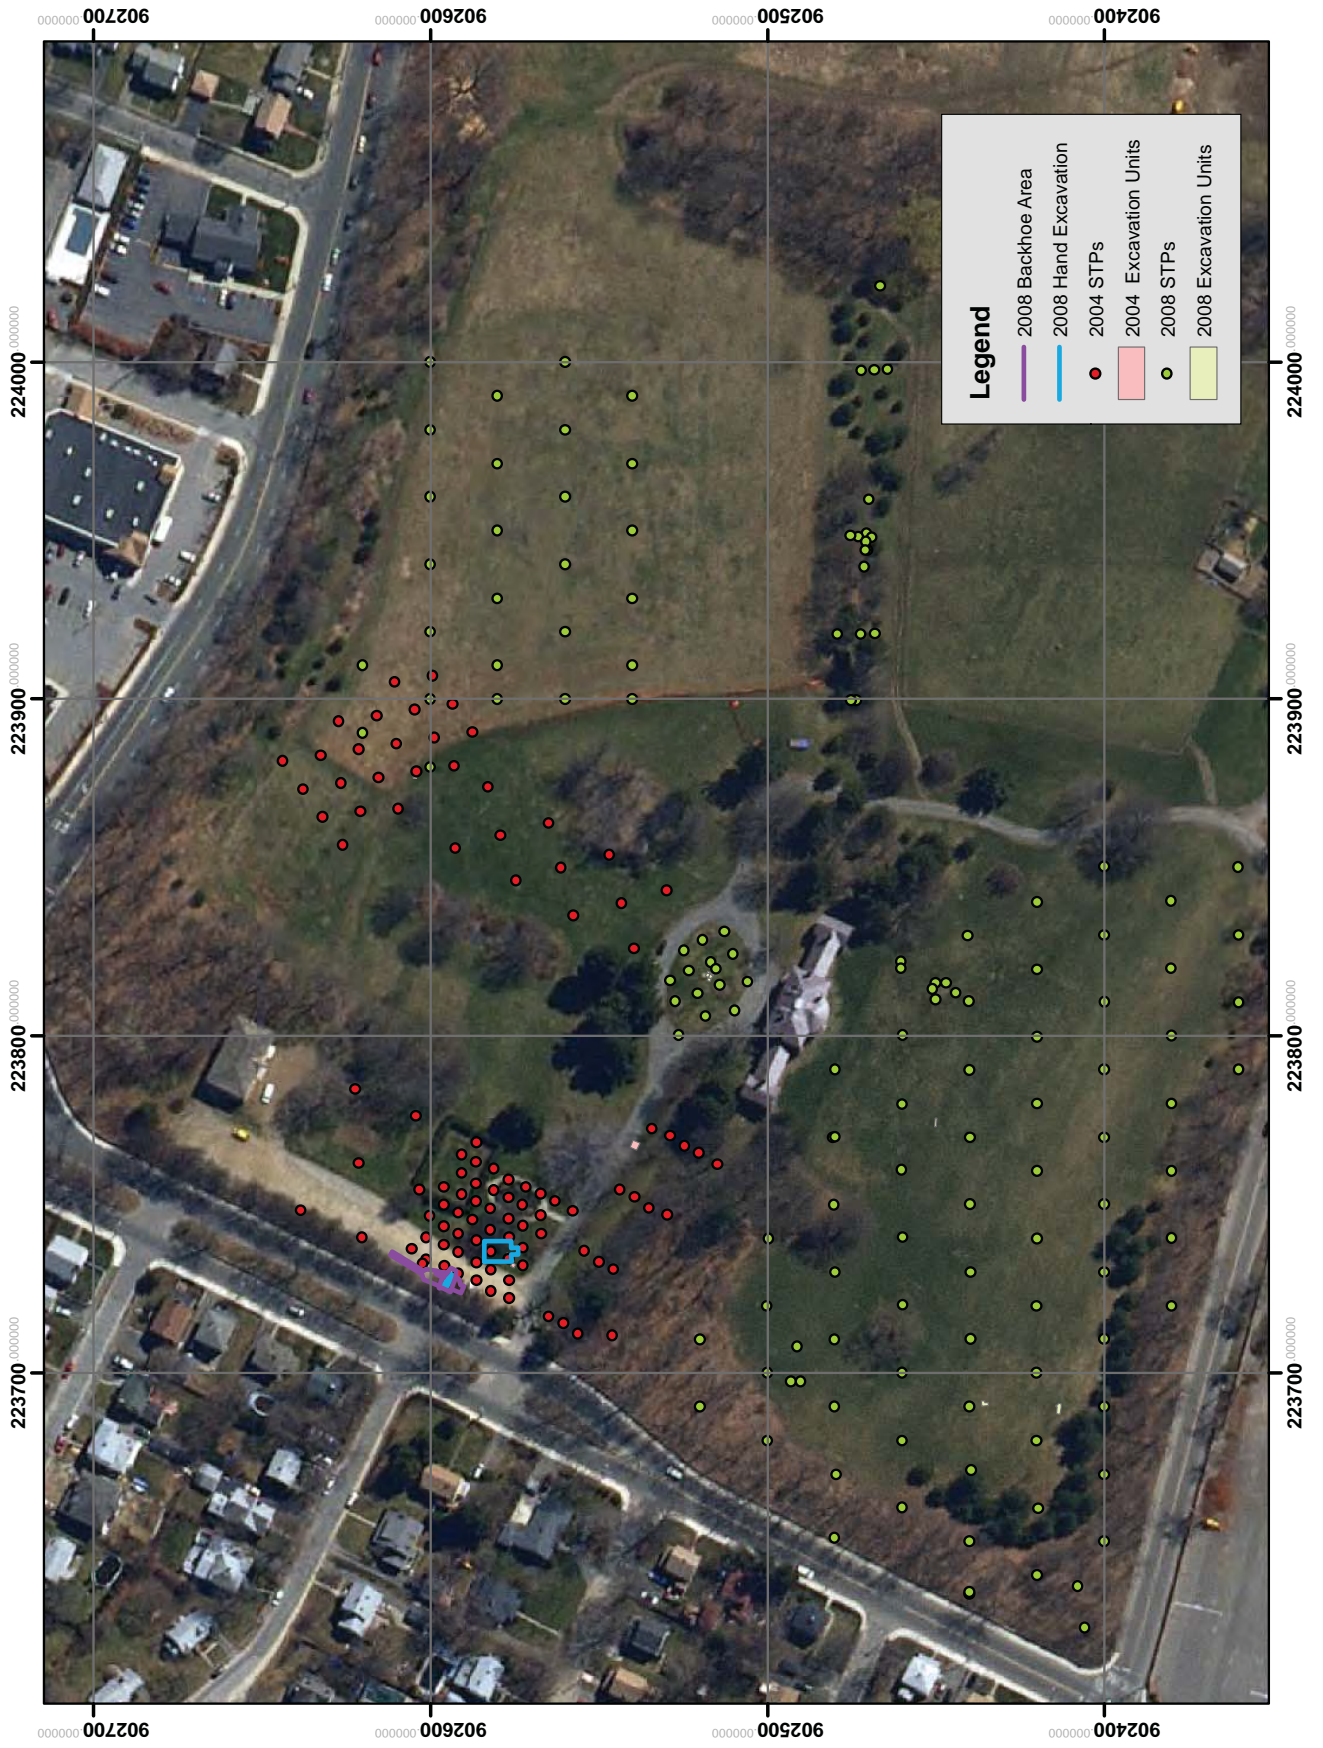
Frontispiece (next page). Locations of all excavation areas at Gore Place to date. Note that in order to be visible, the STPs are shown larger than actual size and that 1 by 1 m excavation units are just visible at this scale. This figure is also contained in the electronic documentation, and units can be seen more clearly by zooming in.

Frontispiece. Locations of all excavation areas at Gore Place to date. Note that in order to be visible, the STPs are shown larger than actual size and that 1 by 1 m excavation units are just visible at this scale. This figure is also contained in the electronic documentation, and units can be seen more clearly by zooming in.	x
Figure 1.1. Gore Place property on USGS Boston South Quadrangle.	2
Figure 1.2. Locations of the original site of the Carriage House, the greenhouse, and the well near the entrance to the property, with excavation areas overlain.	3
Figure 1.3. GPR transects.	7
Figure 1.4. Gore Place during the 1920s while the property was used as a golf course. The house is that built by the Gores in 1805-1806. View looking north.	8
Figure 2.1. Carriage house as it appeared ca. 1937.	12
Figure 2.2. First floor plan of carriage house (HABS 1936).	12
Figure 2.3. Detail of plan of Theodore Lyman Estate ca. 1834-38.	14

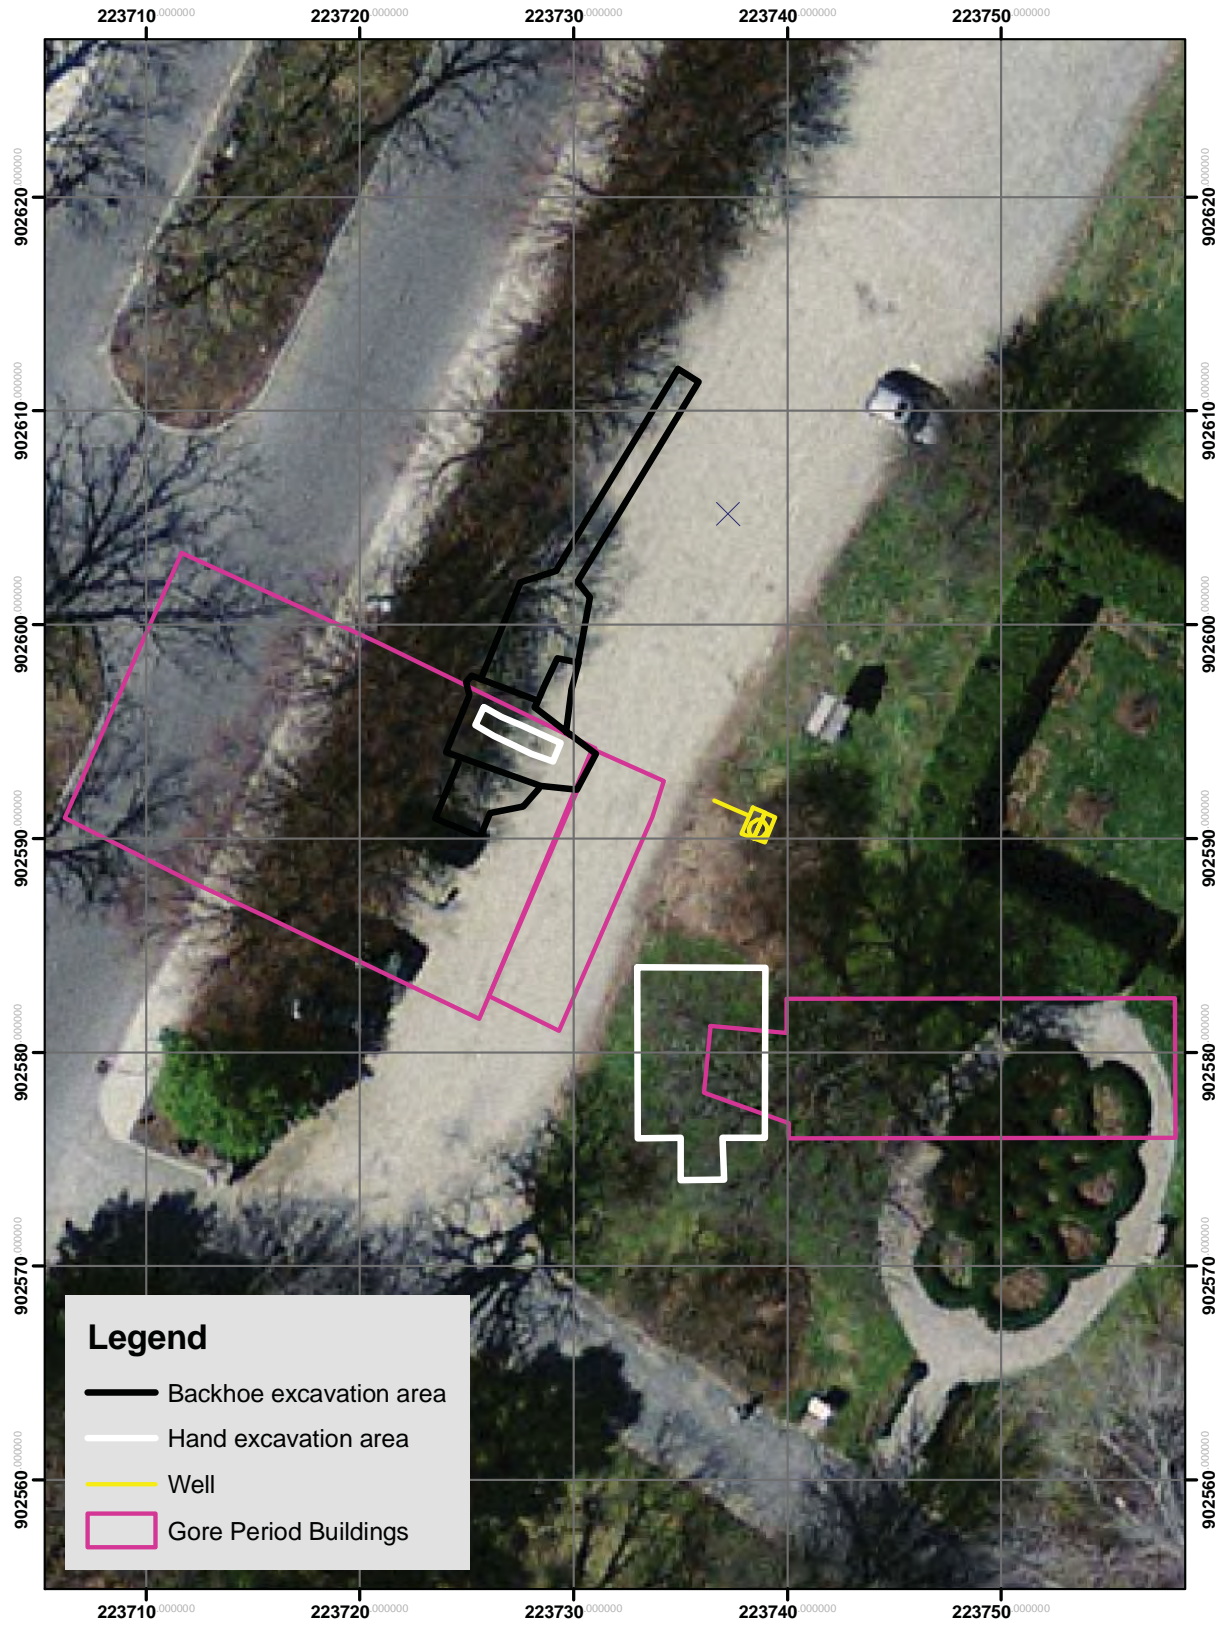
Figure 1.2. Locations of the original site of the Carriage House (to the west), the greenhouse (to the east), and the well near the entrance to the property, with excavation areas overlain.

This report covers the archaeological data recovery of the original locations of the Gore-period carriage house and greenhouse located near the entrance drive (Figure 1.2), both important elements of Gore’s agricultural and horticultural work on his farm. It also covers the excavation around

(Gore Street), on the north by the formal vegetable garden, on the east by a cart way, well, and the greenhouse, and on the south by the carriage house court yard adjacent to the formal entrance drive (see Figure 1.2). Across the drive, at least for a period of time, was an additional garden. The cel-

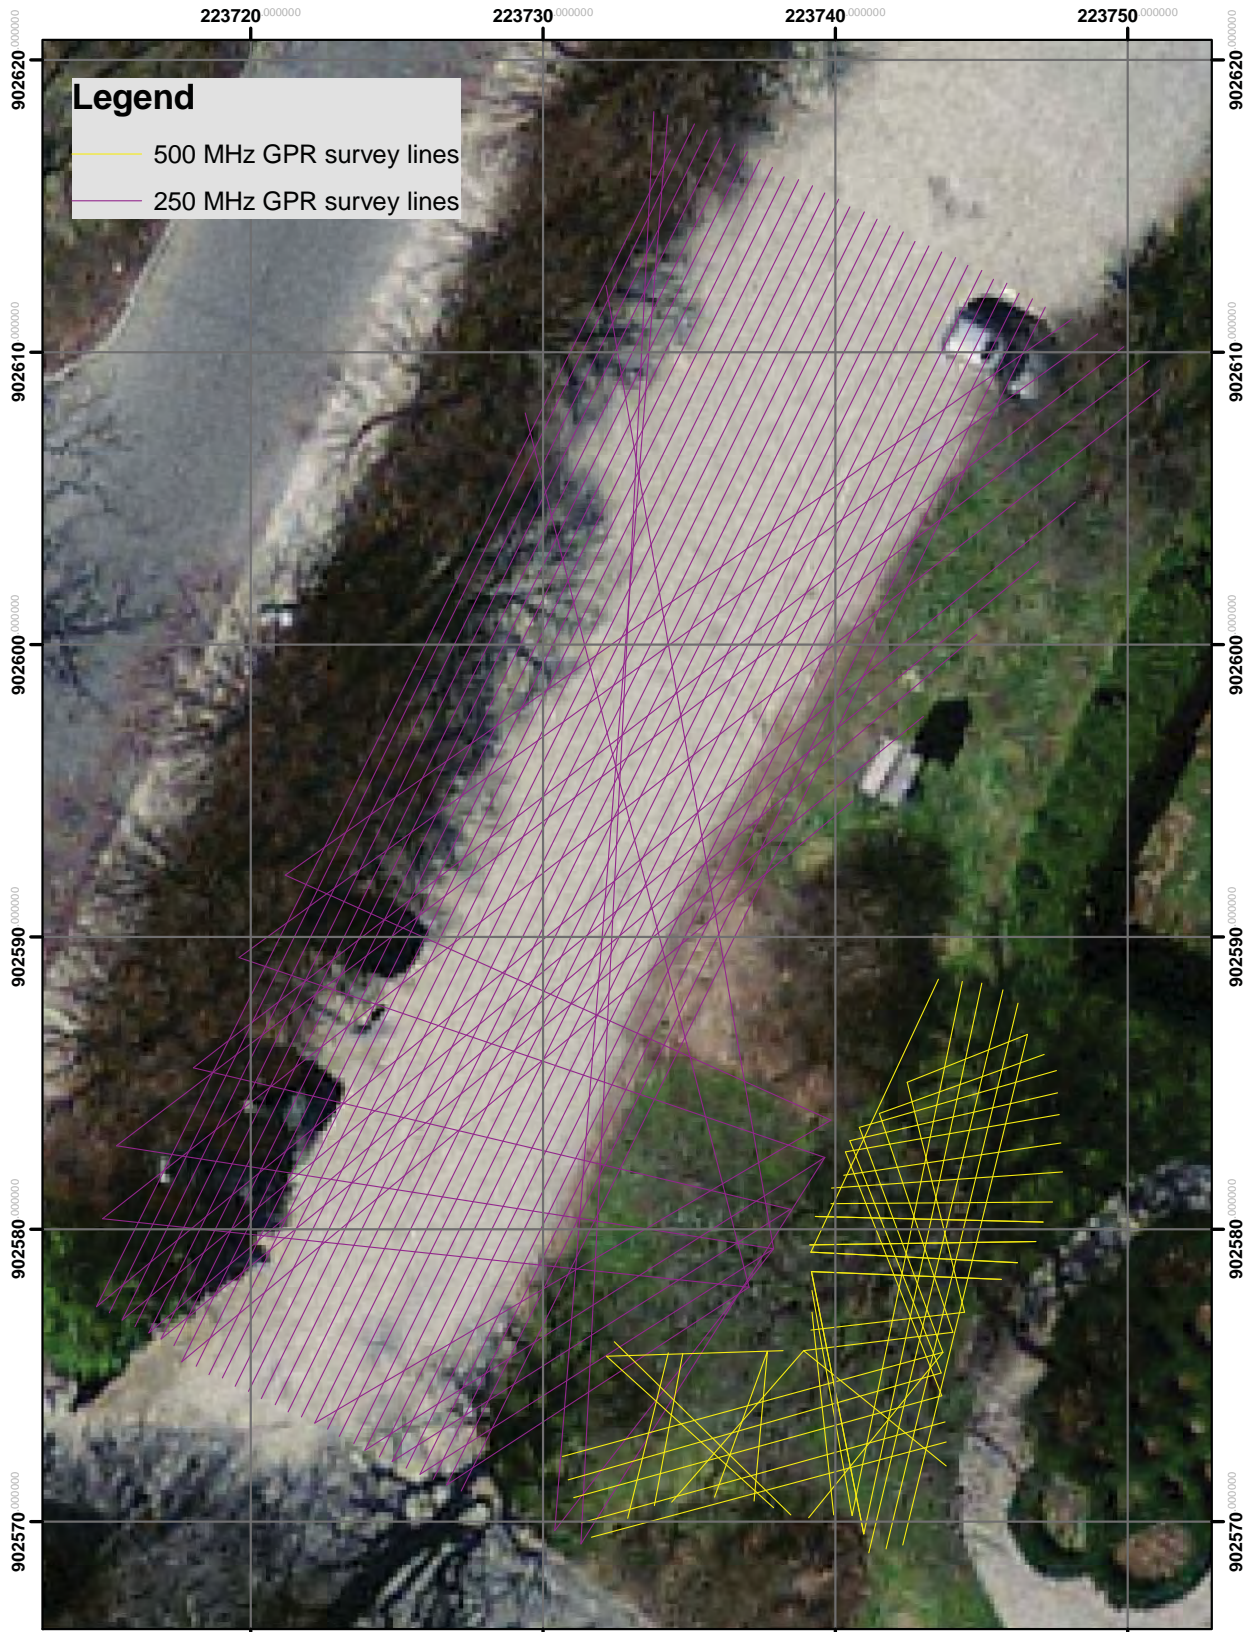
Figure 1.3. GPR transects.

The original goal of the GPR archaeogeophysics at Gore Place was to locate the carriage house foundation. The target location was under a gravel driveway. While radar propagates well through gravel, gravel at the surface can scatter shorter wavelengths, reducing the strength of the signal that penetrates the subsurface. The gravel surface can also scatter the returning radar reflection. Therefore, over the parking lot we opted for an antenna with a longer wavelength, to get more energy through the gravel than we would otherwise use for locating the target carriage house foundation. Normally we would use a 500 MHz antenna for a structure with walls less than 1 m thick and 50 cm below the ground surface. In this case, with the gravel road surface, we opted for a 250 MHz antenna with 50 cm transect spacing.

All things being equal, we like to survey with transects following the orientation and coordinate system of the Massachusetts State Plane system. More importantly, results are best when the target is encountered perpendicular to the transect lines (Neubauer et al. 2007; Pomfret 2006). Because the general orientation of the target carriage house foundation was known, but not its exact location, we opted to use "off-grid" transect orientation. We placed alternating color PVC flags 50 cm apart in parallel lines at each end of the driveway. Each flag was recorded with the total station. The flags' state plane coordinates served as the start and end points of the GPR transect lines (Figure 1.3). Several flags were placed on the edges to fill out the grid with crossing transect lines. In most of the GPR analysis, we use the complete set of GPR transects for the slices (e.g., Figure 2.13). However, crossing transects, can reduce the apparent strength of an anomaly (Goodman 2011). Therefore, we also examined the three groups of parallel

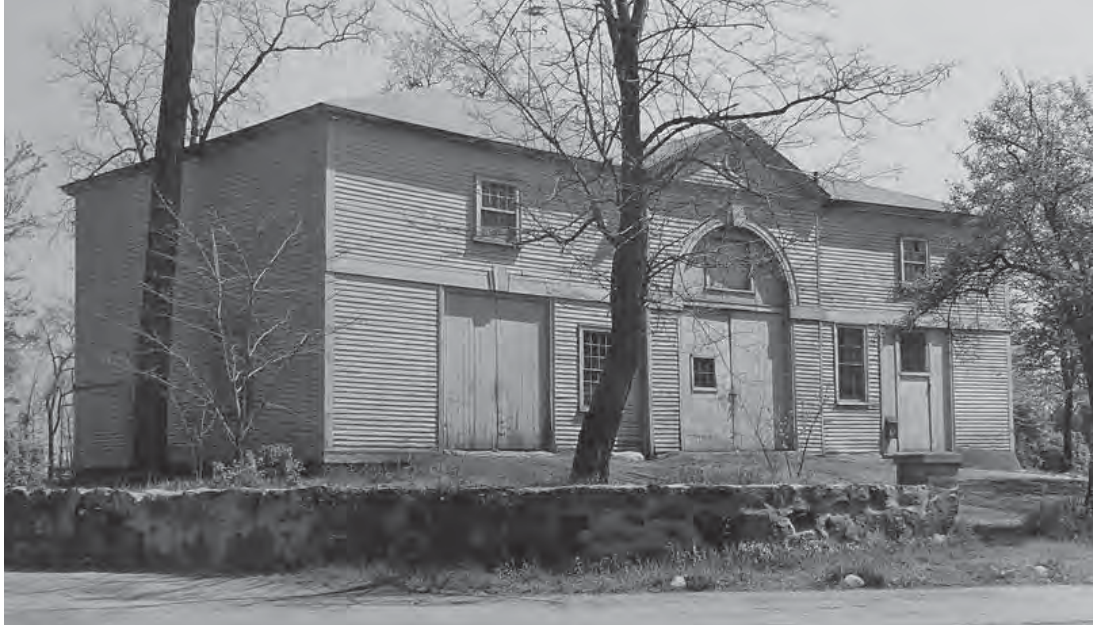
Figure 2.1. Carriage house as it appeared ca. 1937.

The carriage house, also known as the coach house or coach barn, is a large, two-story structure that was originally located on the north side of Gore's entrance drive adjacent to Gore Street (former Cross Road; Figure 2.1). It was built around 1793 of timber frame construction finished with clapboards and relatively high style Federal period detailing. It is one of a small number of such barns to survive intact from the late 18th century in New England and played an important role in the management of the estate. Its construction date is based on its similarity to the carriage barn at the nearby Theodore Lyman estate (The Vale) known to have been built at that time and designed by the accomplished architect, Samuel McIntyre of Salem, Massachusetts. The Gore carriage house measures approximately 70 × 40 ft, and according to Historic American Buildings Survey (HABS) records was set on a full, dry-laid fieldstone (rubble) foundation. The first floor consists of three bays, each with its own access door (Figure 2.2). At present, the western bay or coach room features plastered walls and ceiling with horizontal plank wainscoting. The central bay is formed by wood plank and stud partitions, while the east bay contains a harness or tack room and seven horse stalls. The stalls are constructed of match-board paneling with curved arches and numbered keystones that may have been installed in the mid 19th century. The second floor follows an open plan and is accessed via a wide staircase at the central rear of the building. The cellar was present under the entire structure and was accessed via a ramp and exterior opening in the east foundation wall. The ramp was protected from the weather by a shed addition that is clearly depicted on the Greene estate plan, and the ghosted image of its roofline was documented by the HABS drawings.

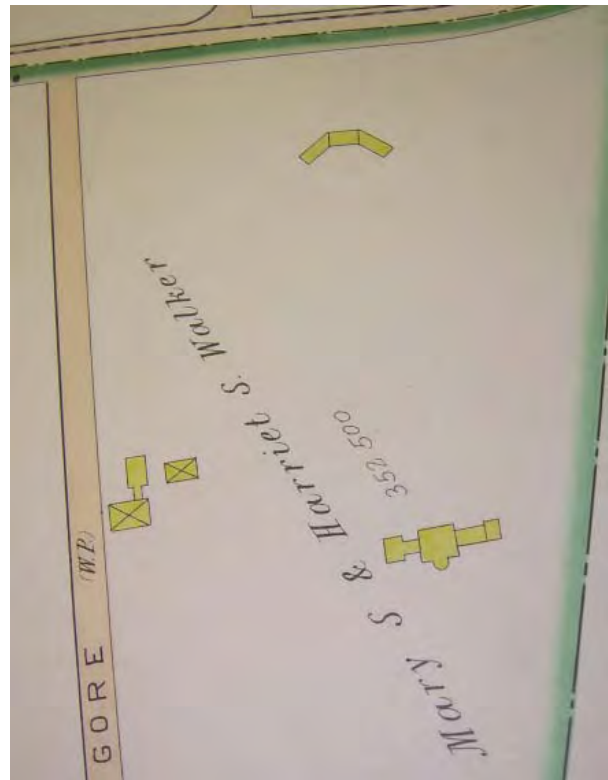
Figure 2.5. Detail of 1900 map from *Atlas of Middlesex County* (Anon. 1900).

With the death of the Gores and the sale of the estate to successive owners, no further details of the use of the structure are known. It is likely that manure production here ceased, if not by the time of the Lymans, then by that of the Greenes, potentially making the cellar available for the collection of horse manure and for general storage. The only documented changes to the building in later years were the removal of the shed over the cellar entrance prior to 1900 and construction of an ell or shed off the rear of the building (Figure 2.5). The

same 1900 atlas shows a second barn off the north east corner of the carriage house. The addition and second barn do not appear on later maps, suggesting they were demolished before HABS documented the property in 1935.

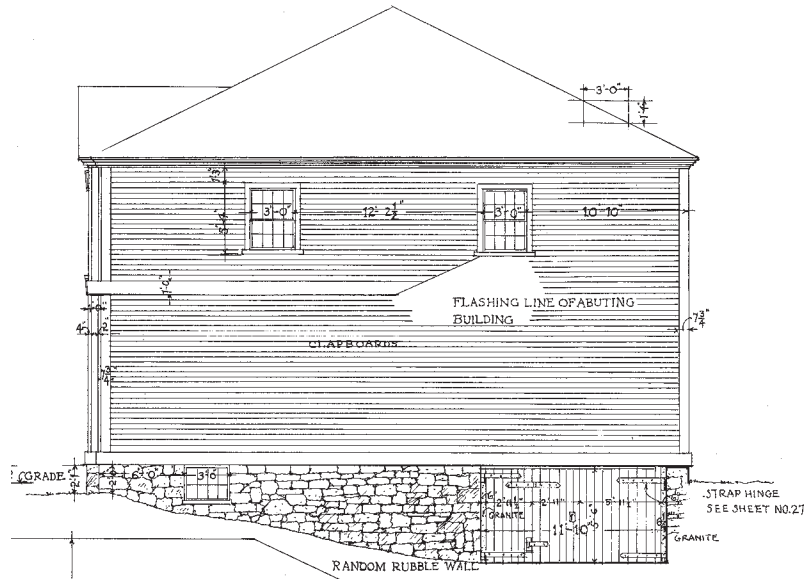
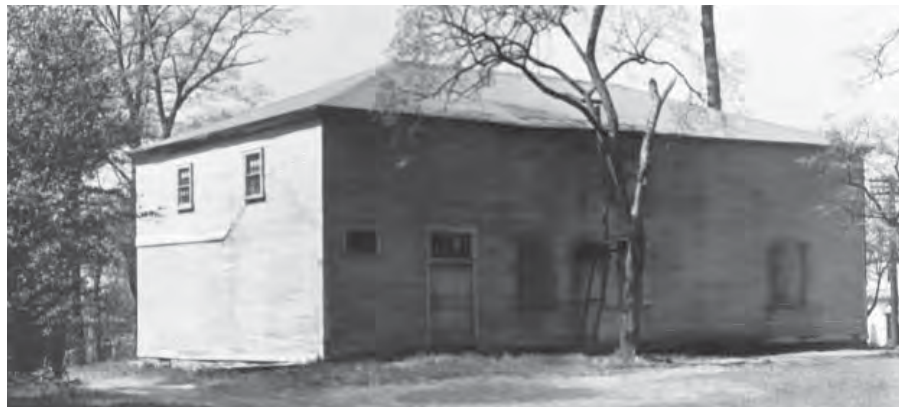
Figure 2.6. A) Detail of the east side of the carriage house; B) photograph showing the ghost image of the roofline (HABS 1936).

When the estate came under the ownership of the Gore Place Society in 1935, repairs were made to the roof of the building as a result of a second floor fire, but the cause of the fire is unknown. In the same year, the carriage house was documented along with the mansion house by HABS. This work provided detailed drawings as well as photographs of the exterior and some interior spaces. Particularly noteworthy was the depiction of the east carriage house foundation wall, ramp, and wooden cellar door (Figures 2.6 and 2.7). Dimen-

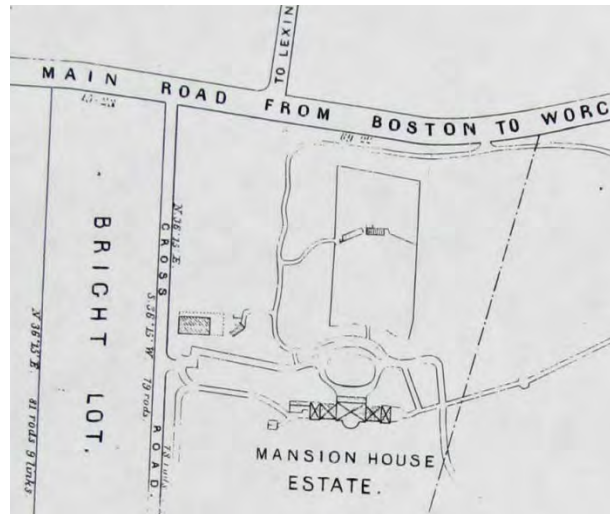
Figure 2.8. Plan drawn in 1841 and used in J. S. Copley Greene's 1853 estate sale. Original on file at Gore Place.

The drawings, along with the Greene estate plan, provide the most information available for the cellar entrance cover structure (Figure 2.8). While the accuracy of the Greene plan is questionable in some respects, the addition was definitely present and is shown to extend out close to a third of the overall length of the building (east-west) or approximately 26 ft. The addition is also shown

the full depth of the structure (north-south) and extends north and westward to wrap around the entire rear or north wall. Thus, the north-south depth of the addition was probably close to 50 ft. The HABS drawings and photographs show a ghosted gable roofline for this addition that rises to the sill of the northern second floor window (see Figures 2.6 and 2.7). The indicated roof has a pitch similar to that of the carriage house itself and probably followed a hip roof form. If one extends the indicated roofline southward, however, the roof would be too low by the time it reached the front of the building. This observation suggests that the upper portion of the ramp may not have been covered, or the slope of the roof changed toward the front of the building. It was hoped that archaeological investigations would provide some evidence of the addition's support structure, and thus details of its construction, but this area could not be investigated due to the need to maintain access to the parking lot.

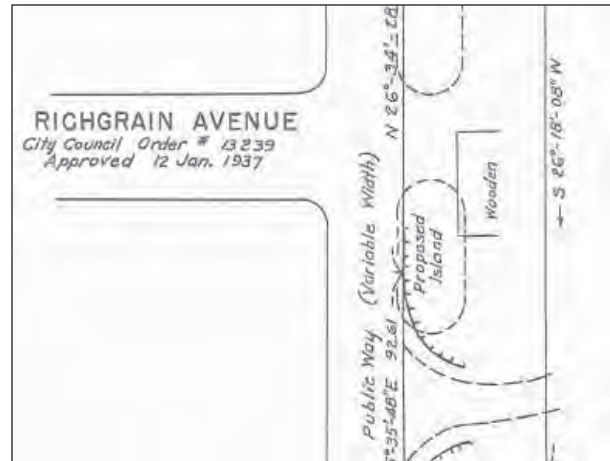
Figure 2.10. Detail of plan of proposed widening of Gore Street ca. 1967.

The most useful plans for determining the carriage house's original location were those completed by the HABS and a plan depicting the proposed widening of Gore Street from ca. 1967 (Figure 2.10). Both of these showed the north wall of the structure to be a little south of the center of

Richgrain Avenue. The street plan showed how the west end of the building extended well into the newly proposed road.

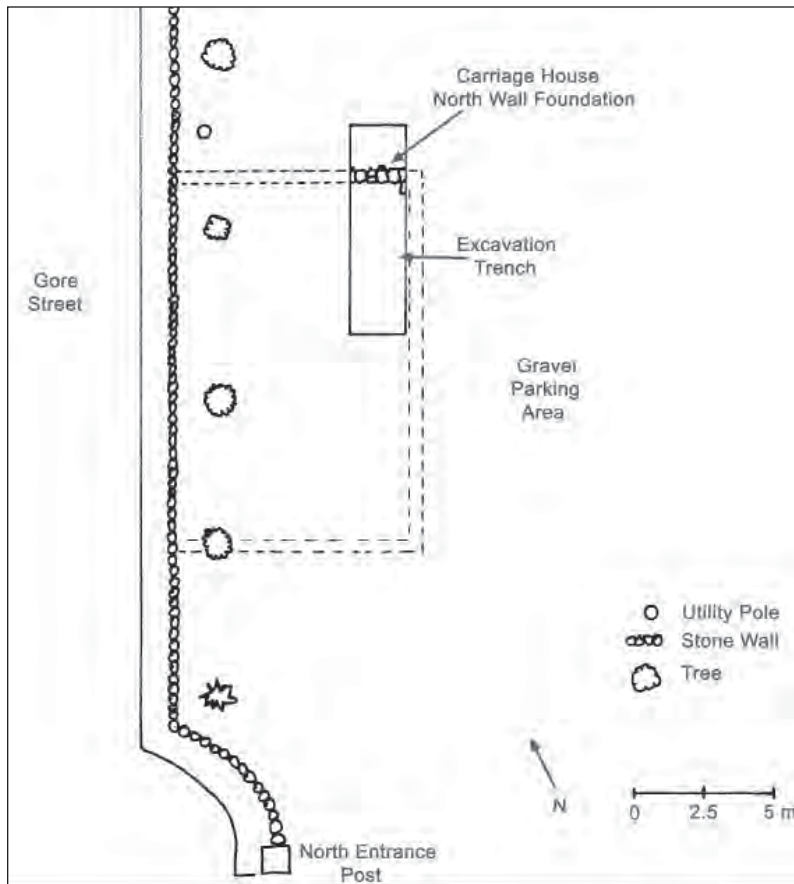
Figure 2.11. Plan of carriage house north wall location as discovered in 2004.

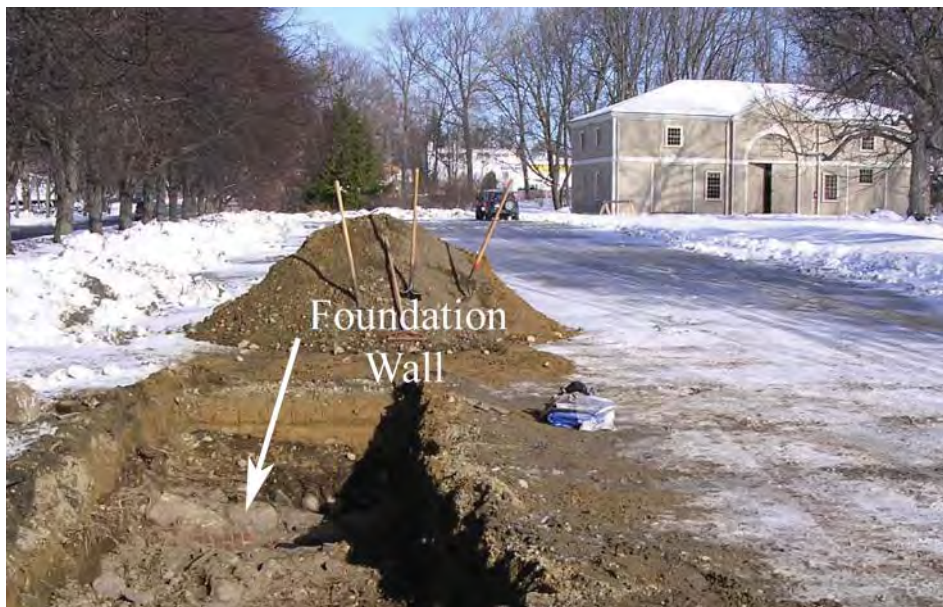
Figure 2.12. Excavation trench and north wall location in 2004 (facing north).

the north side of the foundation wall at an elevation between 70 cm (27.5 in) and 100 cm (39 in) below the parking lot surface (Figure 2.12). After the wall's location was recorded the excavation trench was backfilled.

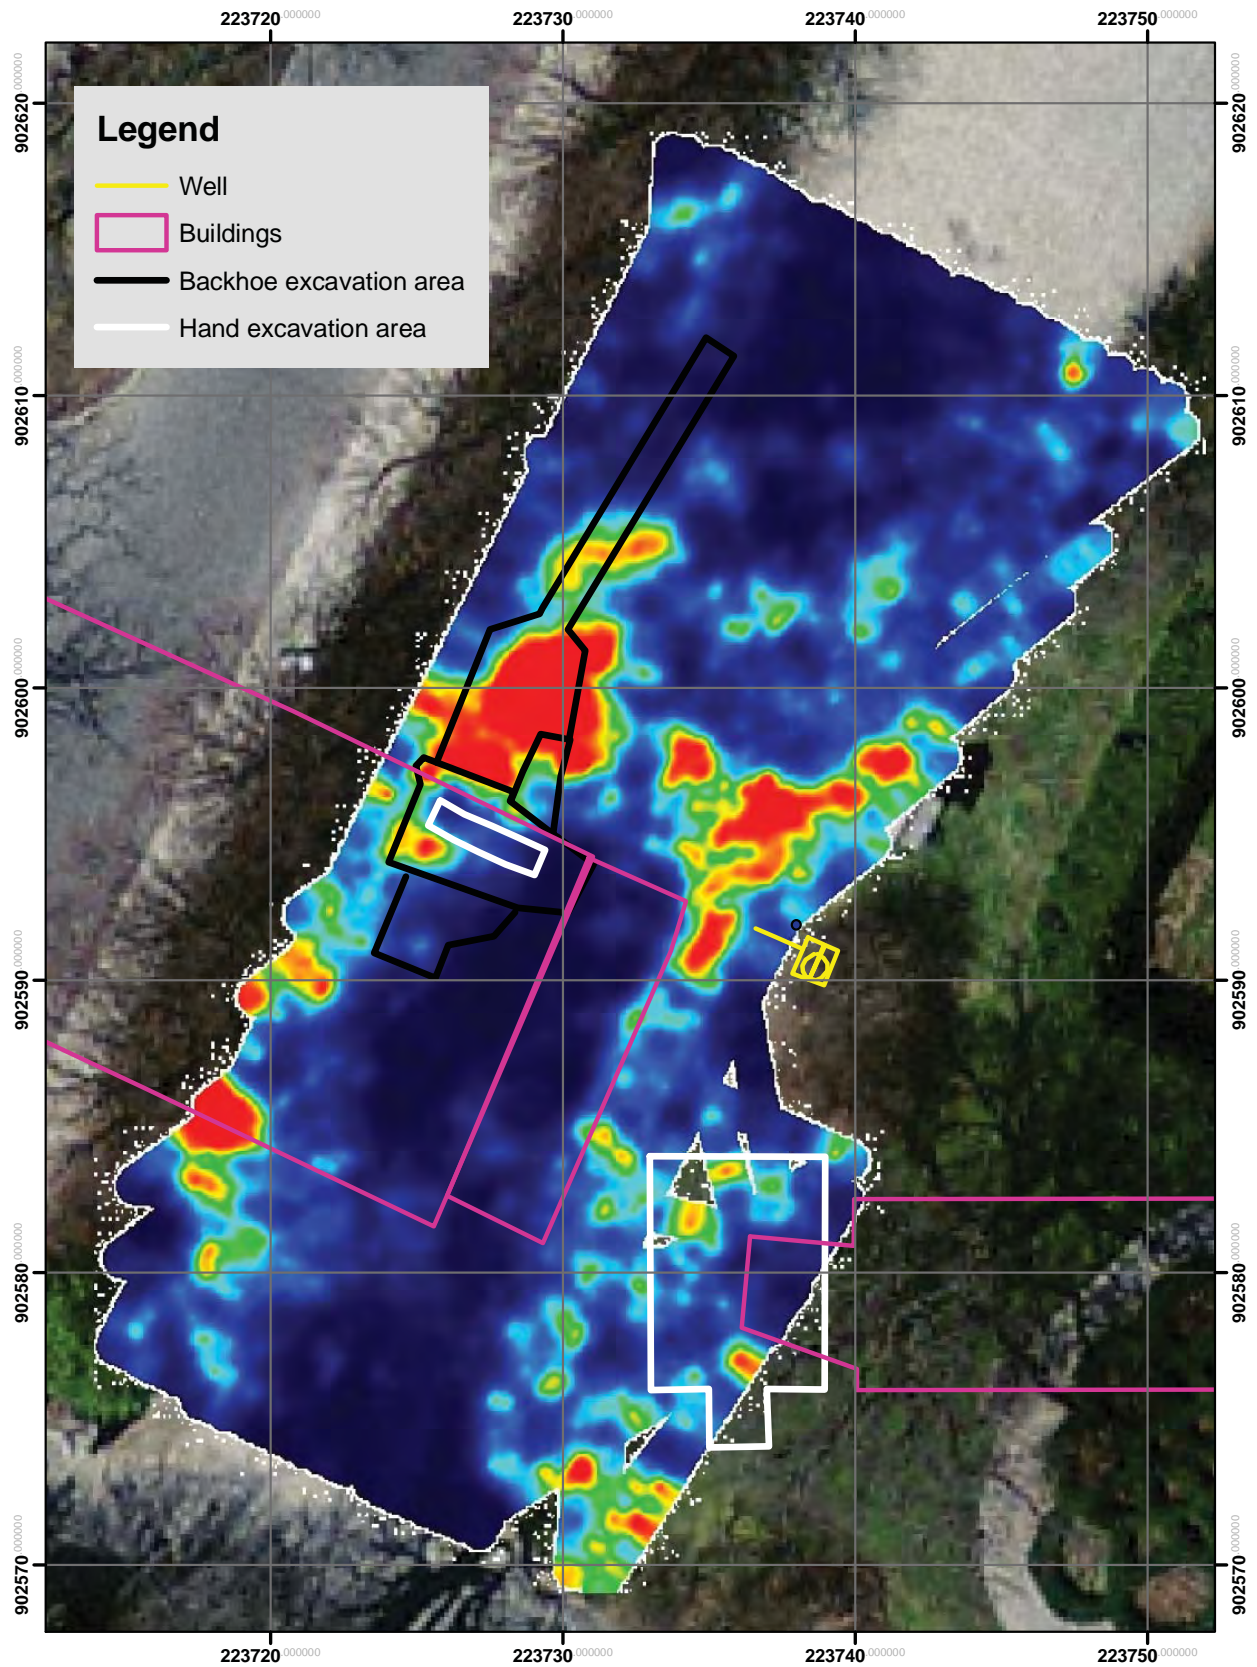
Figure 2.14. GPR slice at 50 cm below the surface showing the absence of reflectors that delimit the area of the carriage house cellar and ramp.

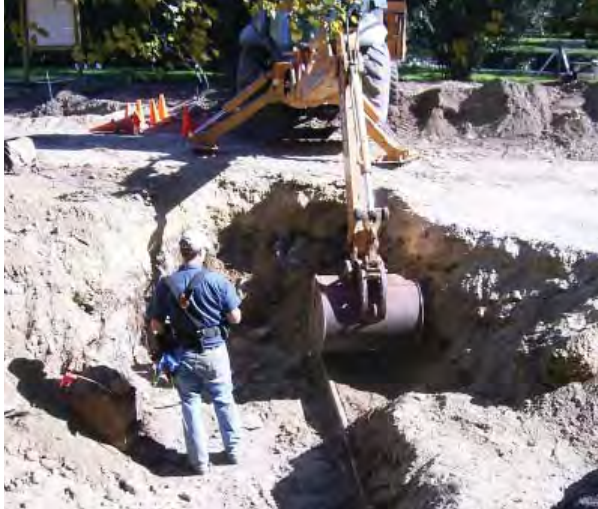
Figure 2.15. Backhoe removing fill from carriage house cellar, facing east.

The backhoe was repositioned to the east side of the excavation area to carefully remove remaining cellar fill and to expand the area eastward in hopes of encountering the east foundation wall (Figure 2.15). As soil fill was mechanically removed from west to east just inside the north foundation wall, a split granite post containing an iron pintle was revealed adjacent to the wall. It was immediately recognized that this was a support for the cellar door. Excavation in the area had to be ceased at that point in order to maintain a safe passage for cars to enter the rear portion of the parking lot. Thus, none of the ramp or ramp walls were exposed.

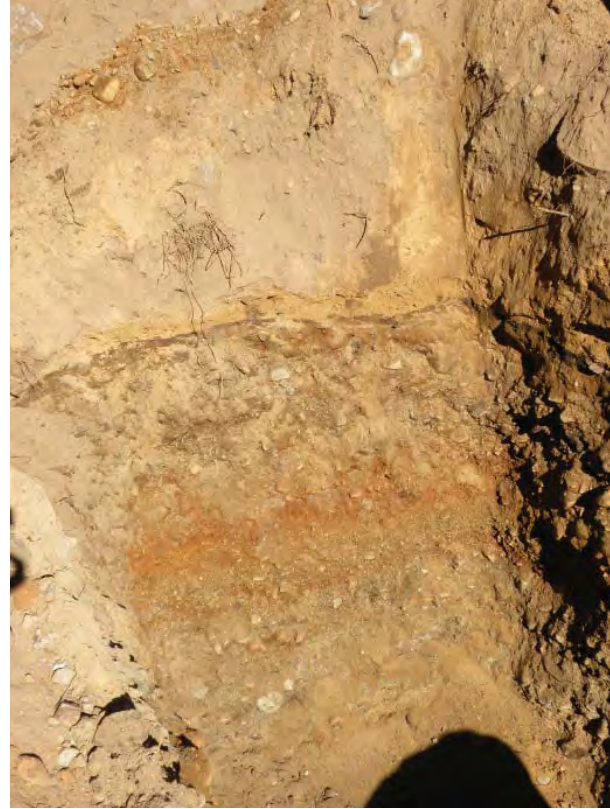
Figure 2.16. East wall profile of Test Trench 1.

and rounded gravel and stones were found instead. Interpreting this to represent possible feature fill, this trench (Test Trench 1) was expanded to 1.2 m in width and 2.5 m long, and was mechanically excavated to a depth of 2 m. This revealed four episodes of sand and gravel fill (Figure 2.16). Given this unexpected finding, the backhoe was repositioned immediately westward to open up a larger area to search for a possible feature border and for a buried ground surface if one still remained intact. Removal of the parking lot fill to a depth of 30 cm bs showed sandy gravel to be present across the entire area. A single trench (Test Trench 2) was extended northward to search for a border of the sand and gravel fill. Excavation proceeded to a depth of 40 cm and the trench was extended 17.5 m north of the rear carriage house foundation wall. Parking lot gravel, yellow sand bedding and sandy gravel fill was present for the entire length of the trench to a depth of 40 cm bs. Archaeological testing in this portion of the parking lot in 2004 showed parking lot gravel and sand bedding to range in depth between 35 and 50 cm.

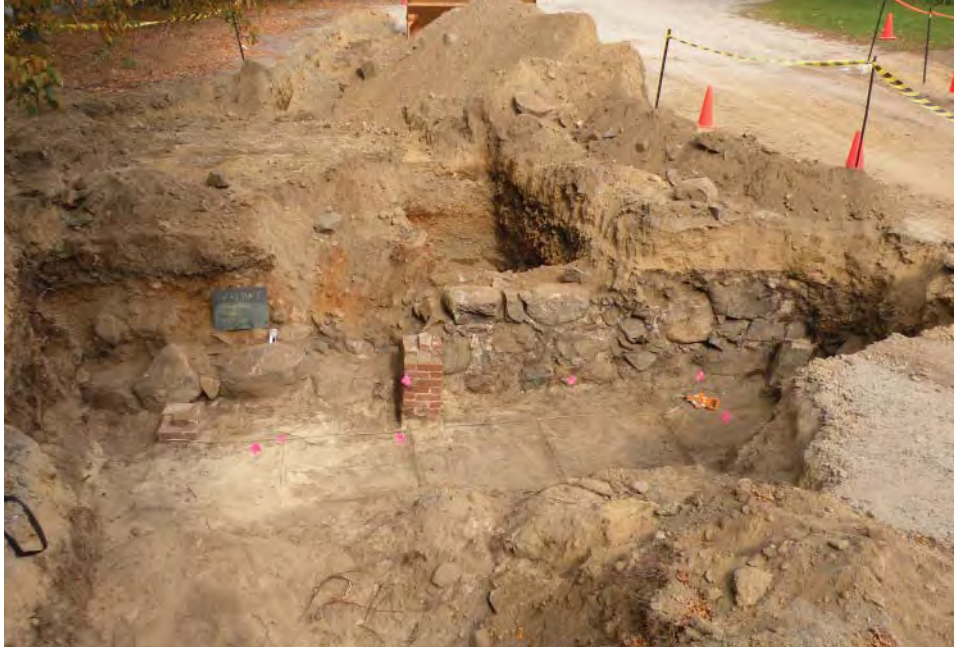
Figure 2.17. Northeast portion of carriage house cellar with fill removed, facing north.

With the completion of mechanical investigations, remaining fill in the cellar was removed by hand to reveal a hard-packed surface of grayish brown loamy sand with gravel (Figure 2.17). As the surface was cleaned of overlying fill, a ball clay tobacco pipe bowl was found at the junction of the floor and the rear foundation wall (Figure 2.18). The bowl displays a “TD” maker’s mark that was produced for much of the 19th century. The bowl shows little evidence of use and may have been deposited with household refuse used in manure production. It also may have been deposited after the Gore period by estate workers. Approximately 12 m<sup>2</sup> of floor surface was exposed by the excavation, bounded on the north by the rubble stone foundation wall, on the east by the cellar entrance, on the south by the galvanized steel water pipe and fill, and on the west by fill.

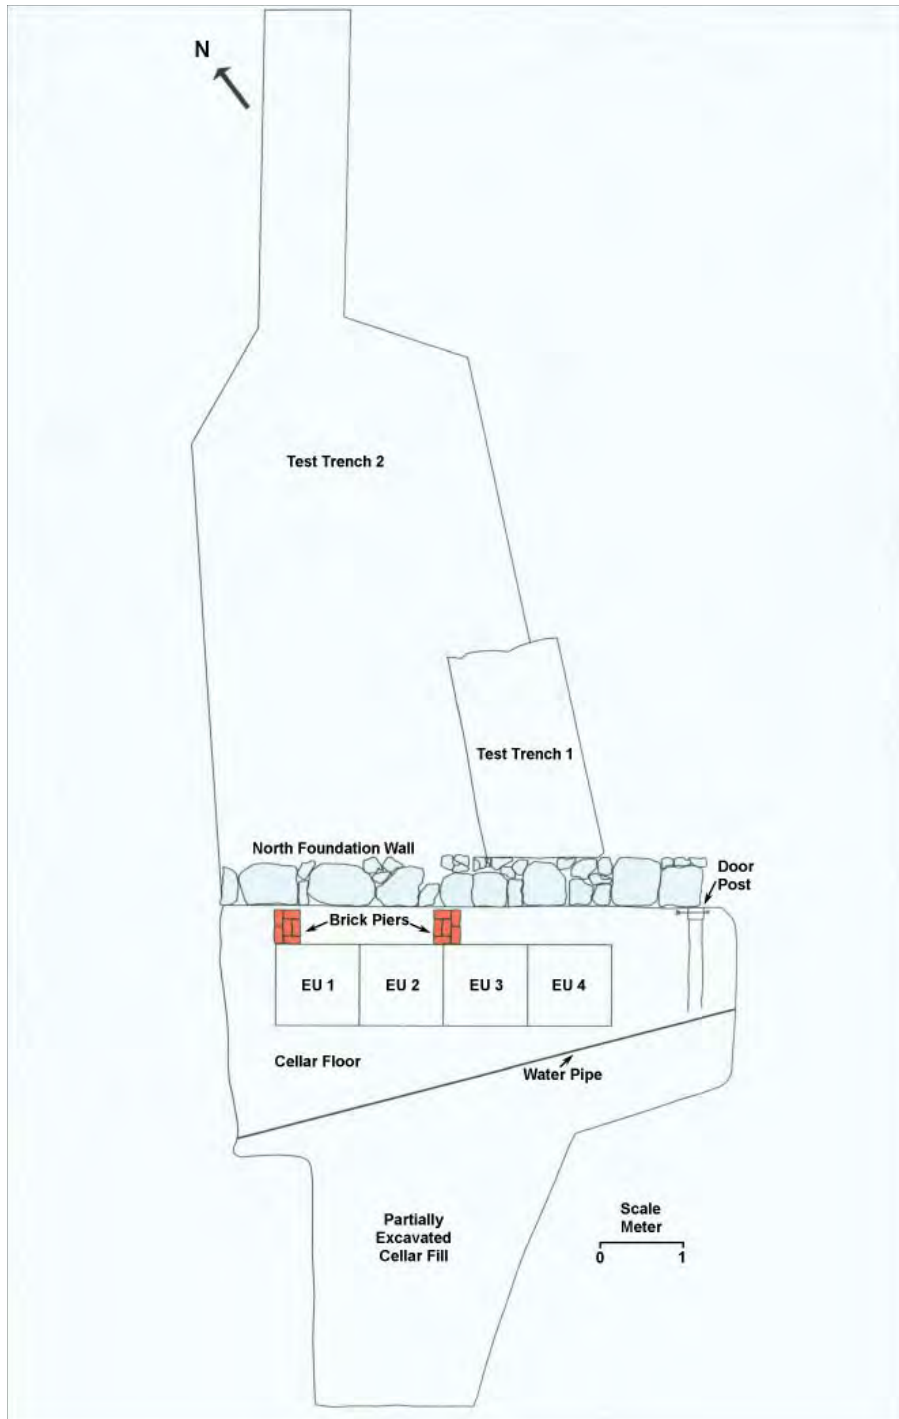
Figure 2.19. Plan of carriage house excavation unit locations.

A series of four contiguous 1 × 1 m excavation units were marked on the cellar floor parallel to the north wall to investigate floor deposits (Figure 2.19). EU 1 to the west, was aligned with the west edge of the western brick pier. The remaining three units extended eastward toward the cellar entrance. Soil profiles in all three units were identical, consisting of two fill layers over a series of seven more layers of C-horizon glacial

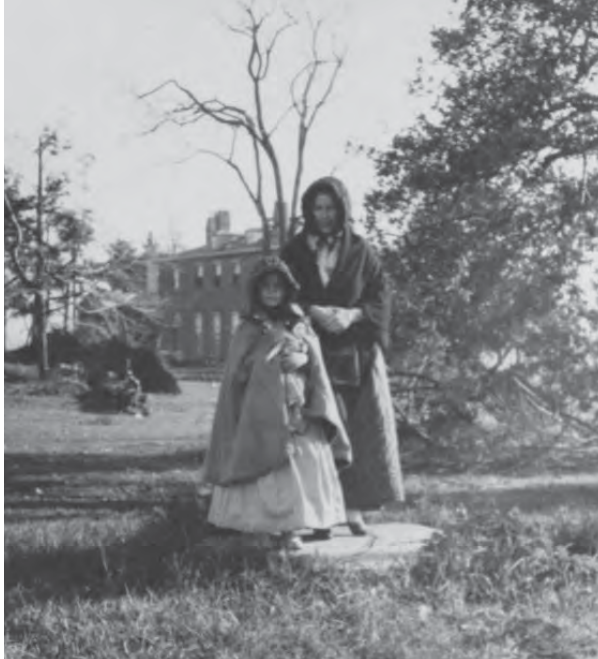
Figure 2.22. Photo of ca. 1927 depicting the two stones that cover the well.

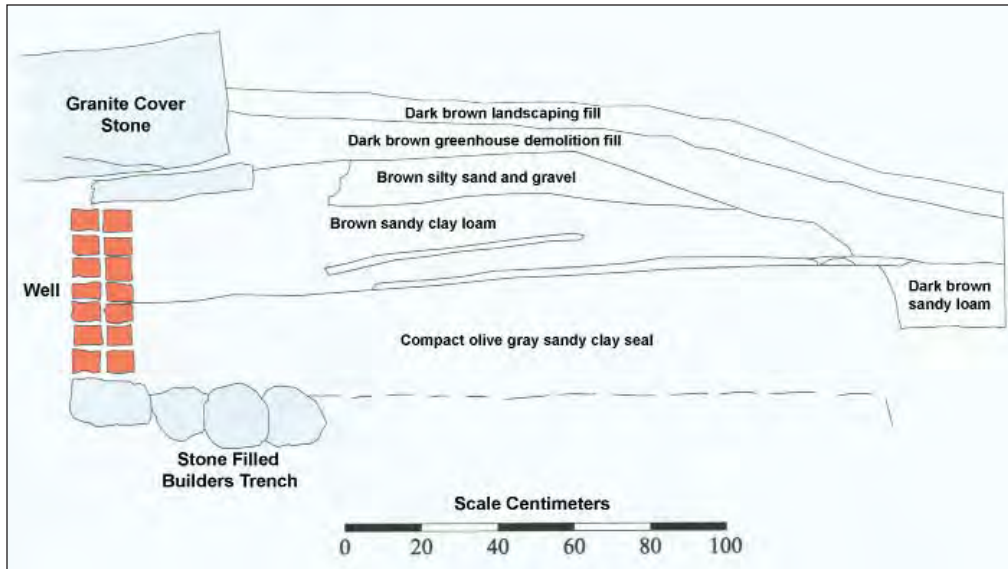
Figure 2.24. South wall profile of well excavation area.

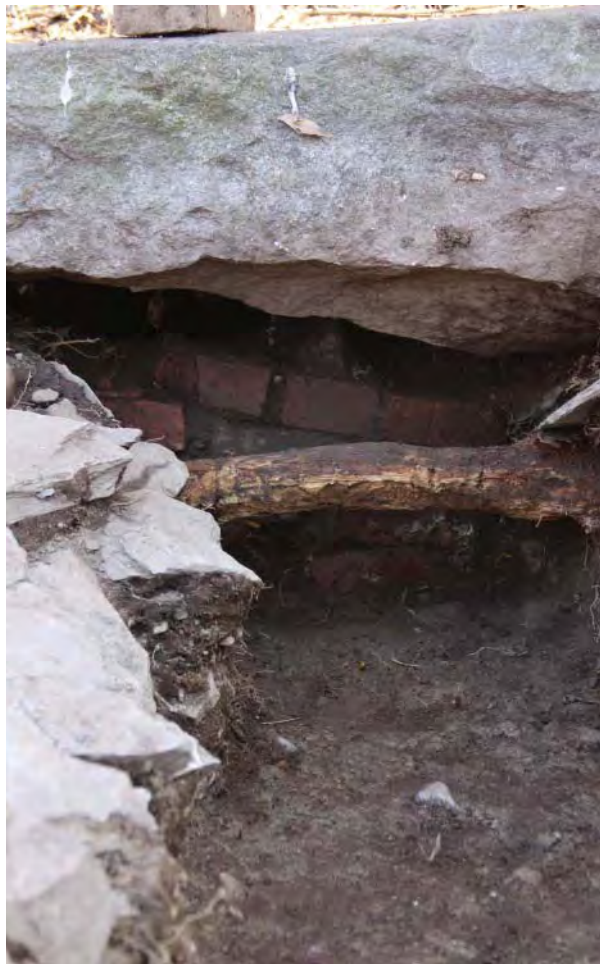
Figure 2.25. Brick wall of well (facing east).

for the well, identical to construction methods used for the drive circle well. The brick wall of the well, which was constructed of two courses of whole and partial bricks, transitioned to stone at the surface of the cobbles. The only artifact in the clay seal was a single fragment of creamware ceramic (ca. 1762-1820). The clay seal extended out from the well a distance of 1.85 m, again very similar to the drive circle well (Figure 2.26).

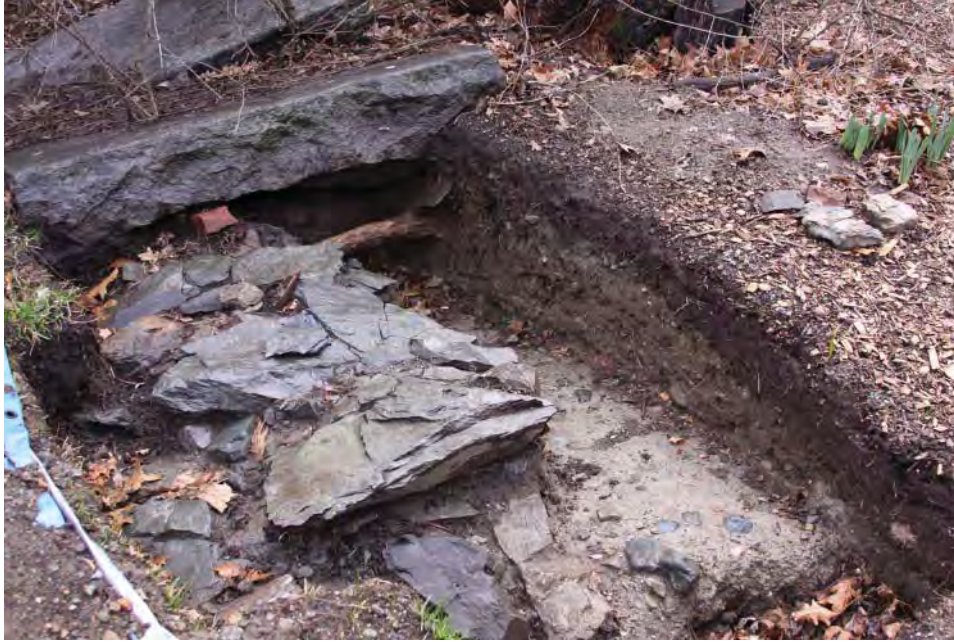
Figure 2.26. Well excavation area showing extent of clay seal.

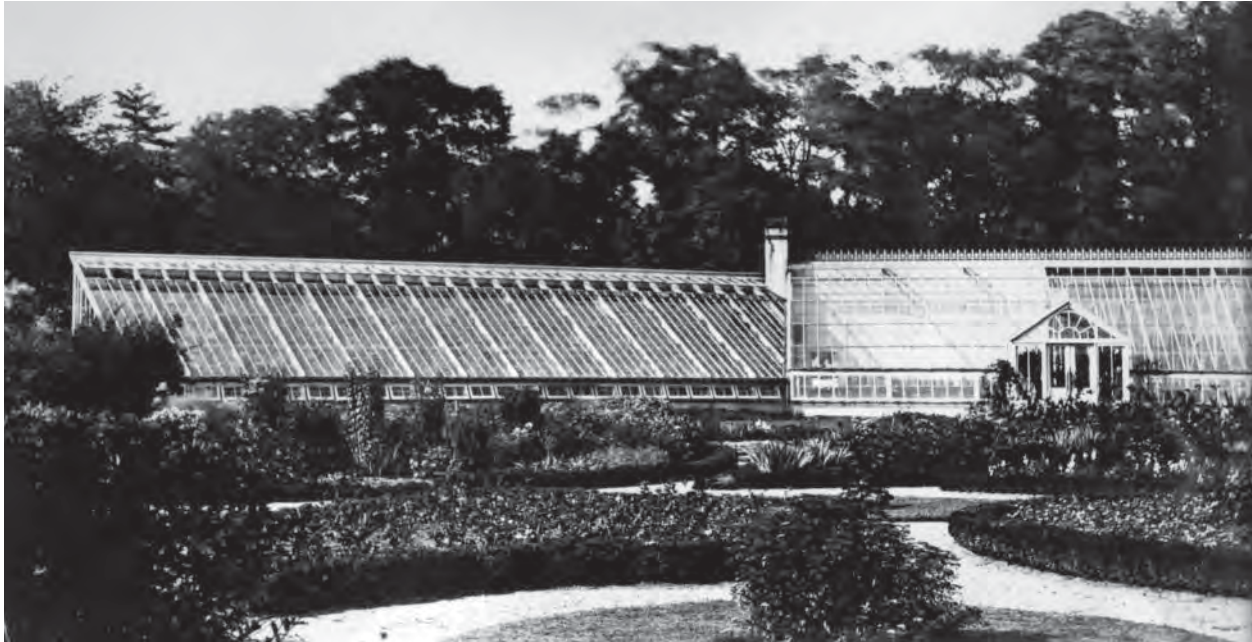
Figure 3.3. The greenhouses along the fruit wall, seen in an early 20th-century photograph. Original on file at Gore Place.

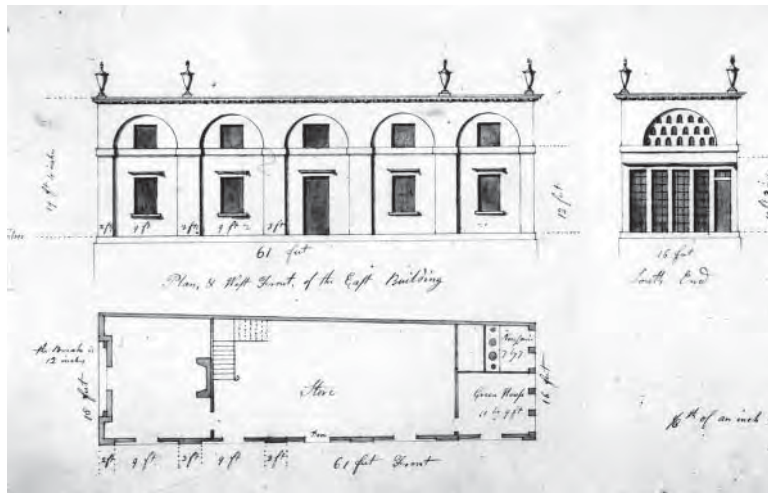
Figure 3.4. Samuel McIntire's drawing of the late 18th-century Derby greenhouse in Salem, Massachusetts (Woods 1988: 85).
