# Data Recovery Excavations of the Carriage House, Greenhouse, and Greenhouse/Carriage House Well at Gore Place, Waltham, Massachusetts

**Cultural Resources Management Study No. 45**

**March 2011**

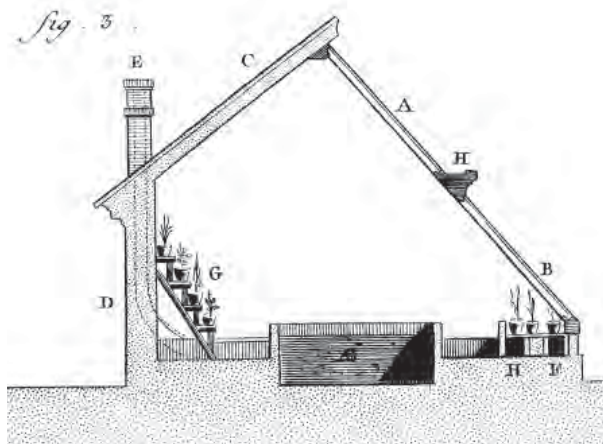
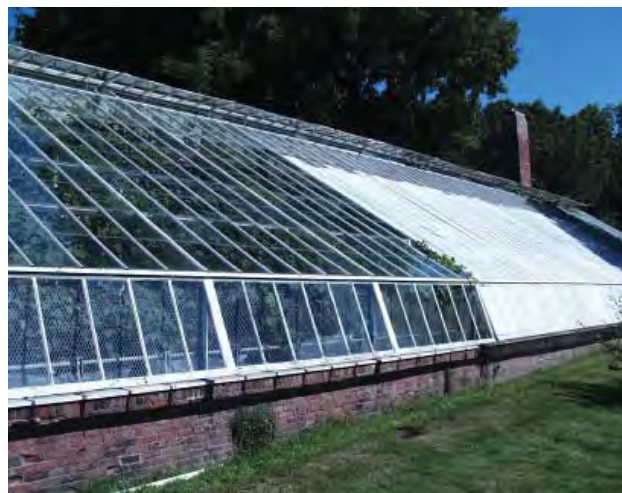
Figure 3.5. A) Profile of a greenhouse with a substantial back wall and short front knee wall from Diderot's *Encyclopedie*; B) Detail of greenhouse at the Vale using this construction method.

The second type, introduced near the end of the 18th century (Pogue 2009) was designed to take more advantage of the sun's energy and had a substantial back wall and a sloped roof and front constructed mostly of glass, resting on a shorter and less substantial knee-wall in front, sometimes called a lean-to style greenhouse (Figure 3.5). Examples of this type were built at the Lyman Estate in Waltham, Massachusetts, and Oatlands Plantation in Virginia. M'Mahon suggests that the piers between the sashes be made of wood to let in more light and that a half to a third of the roof be glazed, the rest roofed in slate (1806: 80).

On the interior, plants could either be planted in built-in beds (as they are in the late 18th-century Lyman greenhouse) or placed in pots on tiered shelves (Loudon 1825: 12) as illustrated in Figure 3.5. A third option was to have a sunken section of the floor, known as a "bark pit" (Figure 3.6). The pit was filled with pieces of bark and plant pots were set into the bark medium so that the decaying bark could provide a moist heat (M'Mahon 1857: 104-109). Jacob Farwell's *Farm Journal* notes that on occasion he hauled loads of oak and cherry tree bark (April 5, 1823); he does not specify whether this is for a bark bed, other aspects of soil preparation, or another purpose, such as tanning hides (possible since Farwell also mention leaching pits, likely also for tanning). On two occasions, he specifically states that he was getting the bark "for Mr. Gore" (March 4, 1823; June 22, 1824).

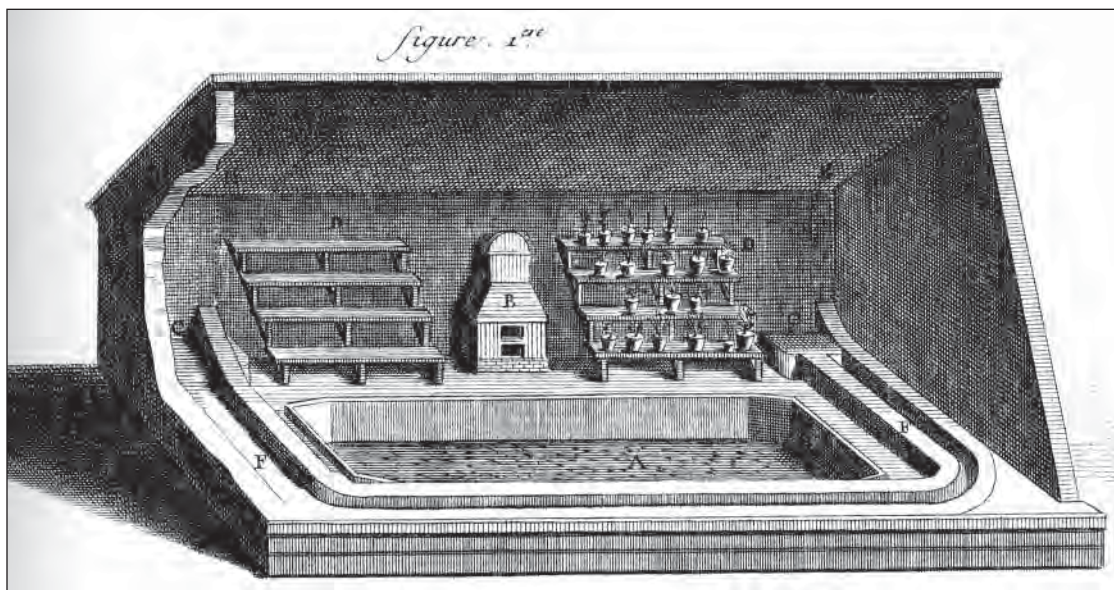
Figure 3.6. An example of sub-floor flues circling the greenhouse interior, from Diderot's *Encyclopedia*.

The size and layout of flues was also a subject of frequent discussion; much of Loudon's 1805 publication is devoted to improved schemes for flues. Flues could run under the greenhouse floor or through the walls, sometimes snaking back and forth in the tall back wall several times (Figure 3.6). Hibbert and Buist advise that if using coal, the flues should be 6 inches wide and 8 inches deep, plastered only on the bottom; if using wood, the flues should be larger by half (1834: 346).

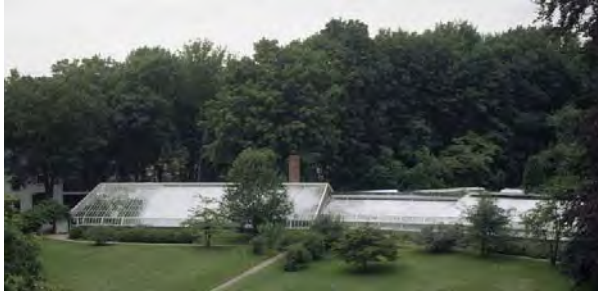
Figure 3.7. Overview of the Lyman greenhouses at the Vale, Waltham, Massachusetts.

additional heat. This greenhouse was later transformed into a grapery, at which point beds were added for the grape vines. The original configuration of the interior is not known. In 1820, Lyman built another lean-to greenhouse along the peach wall, now known as the Camellia house, but apparently originally built to grow peach trees (Historic New England). In 1840, the space between these two greenhouses was filled with a third greenhouse, intended to grow flowers to be cut for use in the house, creating a connected complex (Figure 3.7).

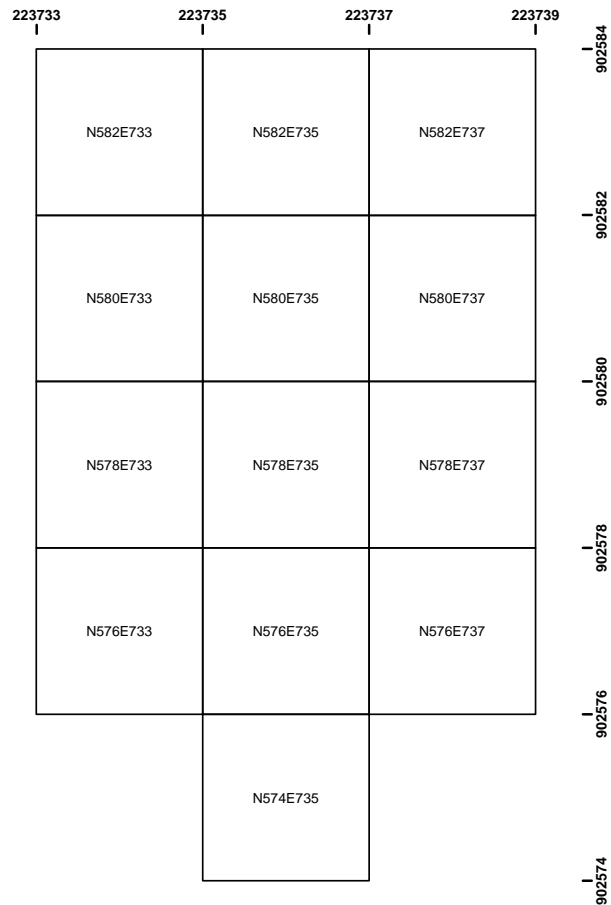
Figure 4.1. Units excavated around the greenhouse extension in 2008. Axes labeled with UTM coordinates.

The 2008 excavations consisted of thirteen  $2 \times 2$  m units (a total of 52 sq m), covering a  $6 \times 8$  meter area with one additional unit to the south (Figure 4.1). Units were labeled with the coordinates of their southwest corners. With the exception of unit N576 E733 and parts of N574 E735, all of the units were excavated to subsoil or until architectural features were encountered. Intact architectural features such as the greenhouse floor and the stone drain were left in place; we did excavate all or part of the two French drains in the area, however.

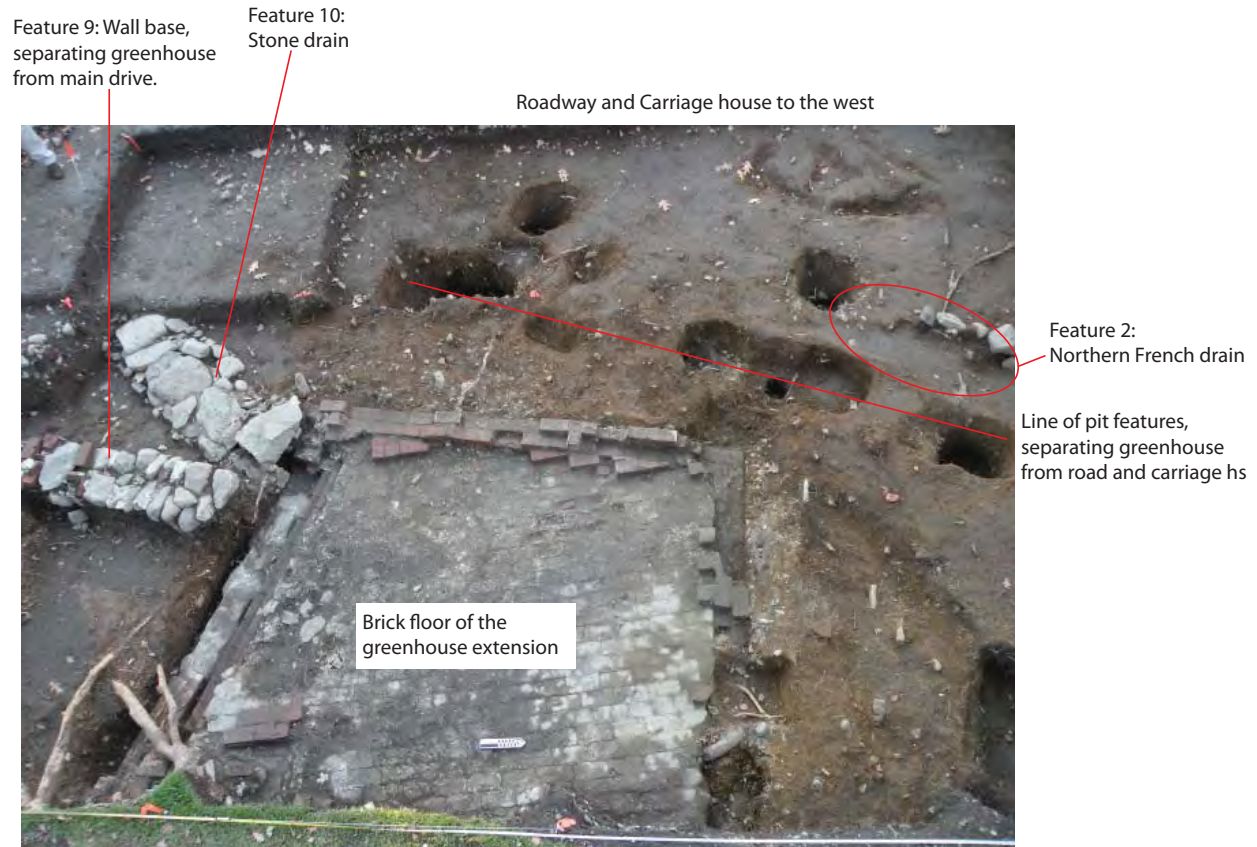
Figure 4.2. The greenhouse area at the end of the 2008 excavation, facing west.

The excavation uncovered a roughly  $3 \times 3$  meter trapezoidal brick floor, interpreted as the greenhouse extension depicted on the 1834 Lyman map (Figure 4.2). This floor was surrounded by a prepared ground surface and a number of features that seem to have been contemporary with the operation of the greenhouse, including a roadbed that passed between the greenhouse and the carriage house. A row of large post holes separated

The northern French drain ran roughly north-south through unit N582 E735 into units N580 E733 and E735 (see Figures 4.2 and 4.11). It was located between the edge of the roadway and the line of postholes that delimited the greenhouse area, placing it outside the greenhouse area. It is not clear what it was intended to drain, but it may have carried away water that ran off the roadway, since the edge of the roadway sloped down to the east. The west side and south end of the feature had been disturbed and cut away by later activity associated with the destruction of the greenhouse (see below). The drain cut through layers that had built up over the old ground surface, burying Feature 3, the clay pathway. Therefore, the drain is later than Feature 3, and later than the construction of the greenhouse. The drain was a sloping trench, up to 50 cm deep and 90 cm wide in the north, with a relatively flat bottom that had been lined in places with the same kind of marine clay used on the road bed (described above) and around the Drive Circle well. Its width at the south end cannot be determined because the feature was cut through by later activity at the site. The feature was filled with some large cobbles at the bottom, whole planting pots, large bones, sheets of window glass, and large metal tools including three shovel

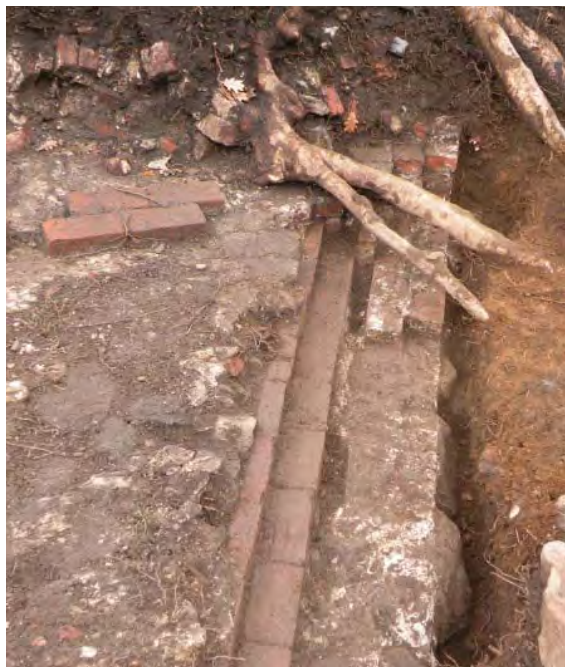
Figure 4.3 Brick channel at the south edge of the greenhouse extension floor, facing east. The fieldstone base of the south wall and the narrow builder's trench are visible at the right.

of the floor (Figure 4.4). The lowest course rested on a bed of mortared stone rubble which extended just slightly beyond the bricks. The mortar on the exterior of the bricks was very rough, suggesting that these courses were below the ground level while the building was in use and were not visible. The southern wall, on the other hand, was built of bricks set in mortar on a fieldstone foundation (see Figure 4.3).

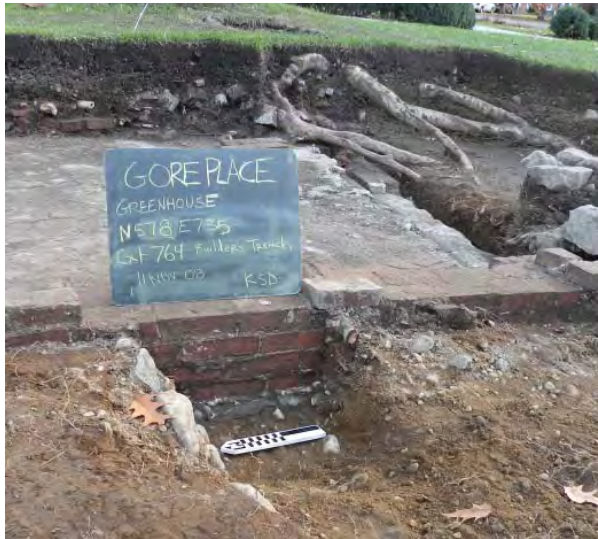
Figure 4.4. West edge of the greenhouse, exterior. Note unfinished mortar joints, as these would have been below grade and not visible.

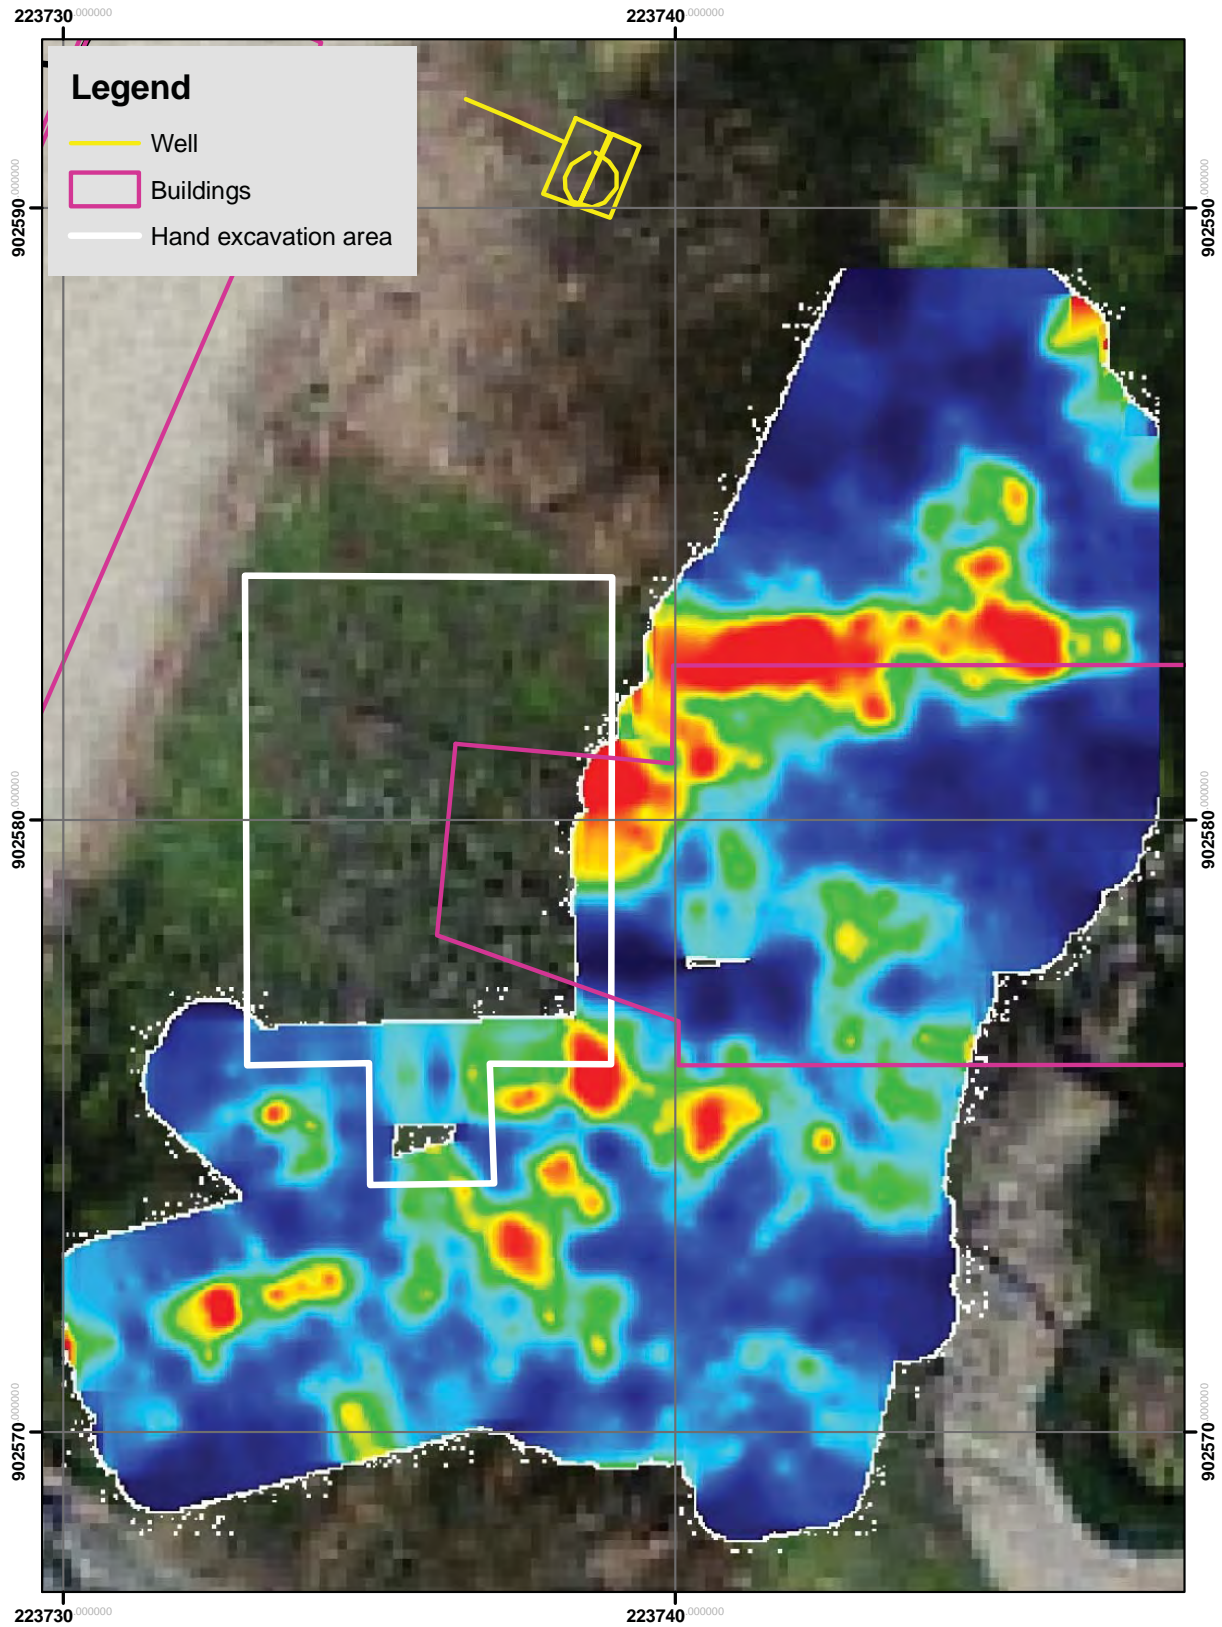
Figure 4.5. GPR slice at 55 cm below the ground surface showing the rear wall of the main body of the greenhouse (strong reflector [red] feature running east-west).

almost directly east-west, north of the brick floor (Figure 4.5). We interpret this as the remains of the rear wall of the main body of the greenhouse, which would have been more substantial than the south wall. Some more of the brick floor, which covered the whole area of the west extension, can also be seen as a hard reflector (red) in the unexcavated portion of the extension.

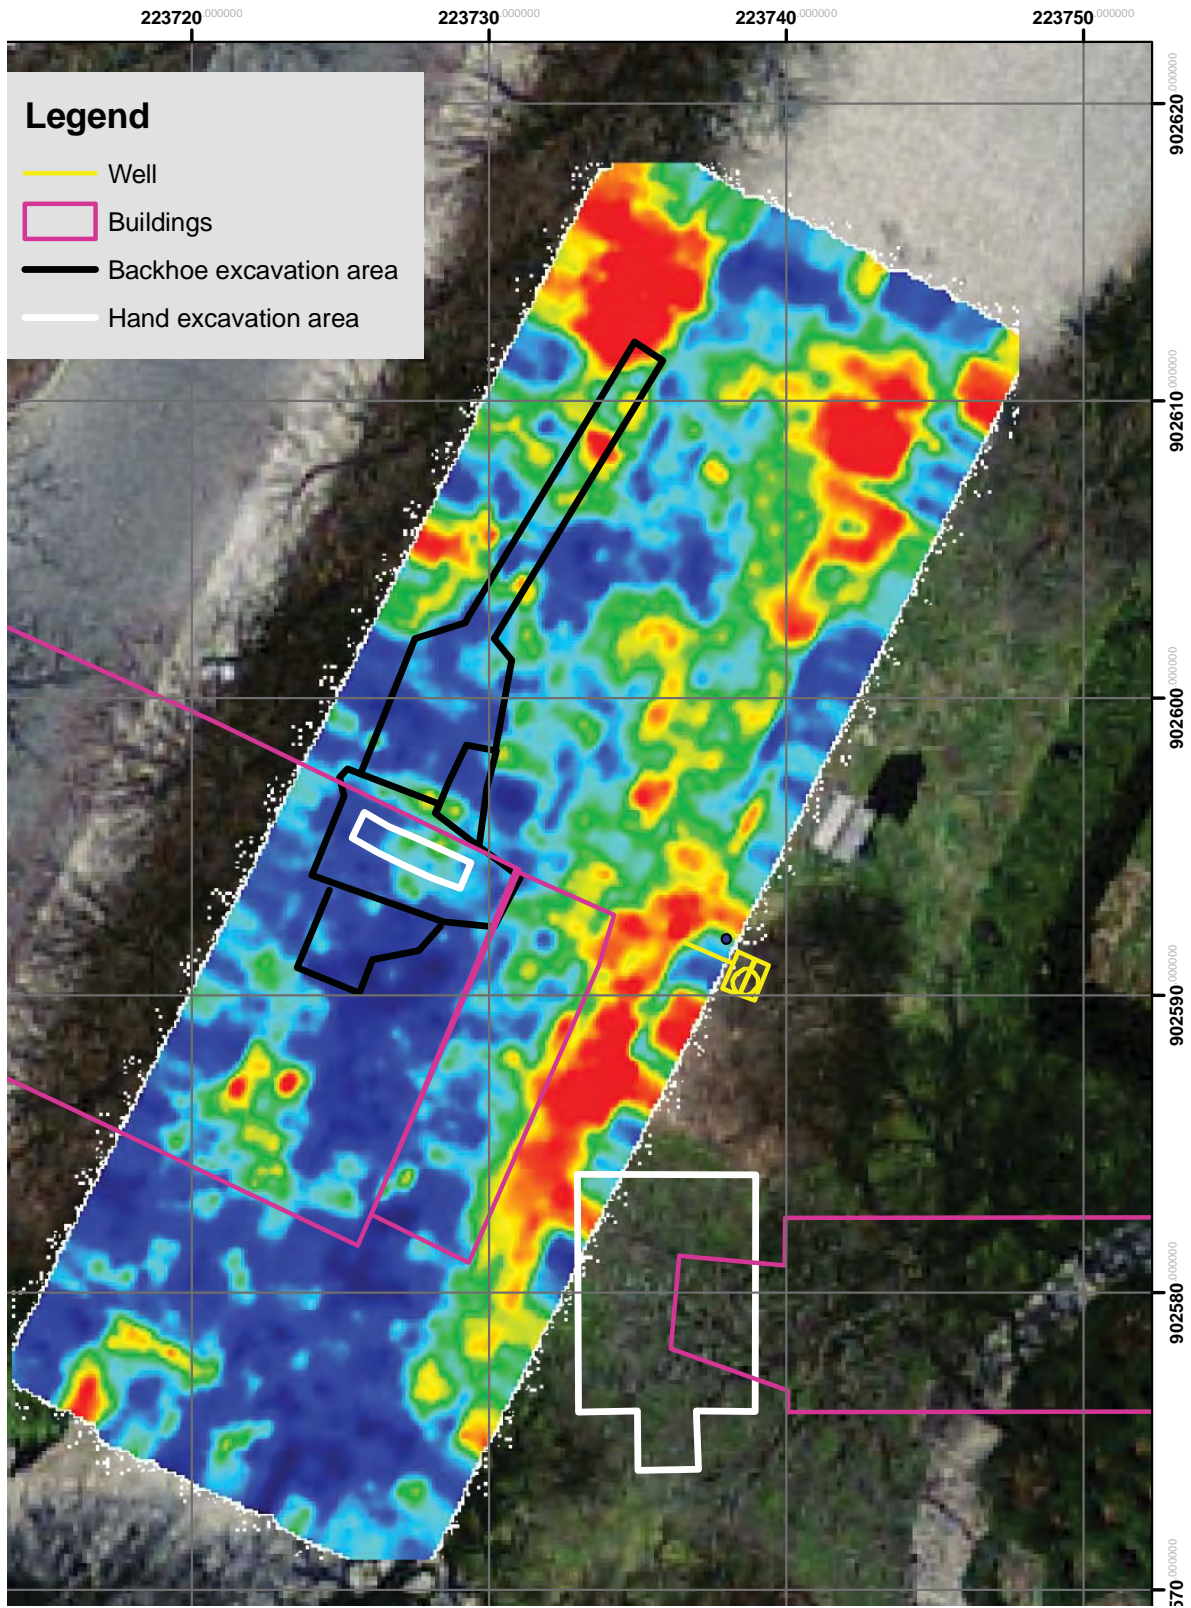
Figure 4.7. GPR slice at 35 cm below the ground surface showing the roadway between the carriage house and greenhouse.

transects separately (one example is used in Figure 4.7). In general, the separate and grouped slices showed the same pattern.

The road can probably be seen in some GPR slices (Figure 4.7). The 35 cm below ground surface slice shows a strong (red) reflector running southwest to northeast between the carriage house and greenhouse, ending or possibly turning east immediately north of the well (outlined in yellow). The interpretation of this GPR signature is difficult because it is near the edge of the survey area and the roadbed is shallow and parallel to the transects. This interpretation is made less secure by the fact that the angled lines (not used to generate the slice in Figure 4.7) do not bring out this feature. The identification of this feature as the road is our best interpretation of this strong signature; however, other possibilities exist. Note the eastern edge of the GPR slice, which shows alternate areas of red and blue. The source of this varied signal is not clear. It may represent the reflection from the sloping edge of the road, which we encountered in the excavation units. Or it may be that the predominantly blue area along the eastern edge represents the remains of a roadway which ends at the well. North of the well, the reflections are less consistent, and it is not clear if the broken yellow, red, and green area represents a continuation of the roadway or not.

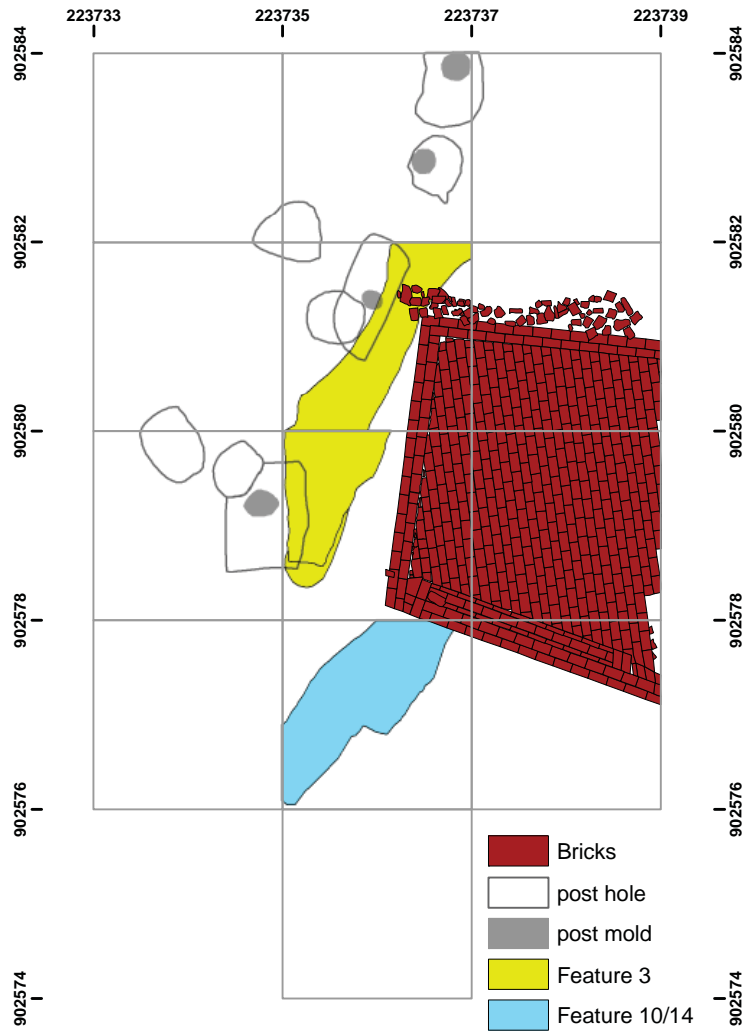
Figure 4.9. Features contemporary with the greenhouse: the brick floor of the extension; Feature 3, a band of compact sandy clay; Features 10/14, the stone drain, and the post holes and post molds.

Feature 3, excavated as context 684, was a long patch of very compact sandy clay with small angular gravel that ran roughly north-south, just outside the west end of the greenhouse extension (Figure 4.9). It sat directly on the old ground surface. It was preserved for 420 cm of length, was 45 cm wide, and 3 cm thick. It had few artifacts associated with it, with the exception of 31 nails and 16 pieces of window glass, not surprising given its location adjacent to the building. At only 45 cm wide, the feature seems to be a little narrow to have been a walking path; it may have been some form of surface treatment immediately outside the greenhouse to prevent mud from developing along the drip line of the eaves or to prevent grass and weeds from growing close to the building.

A line of post holes and molds (the indication of the post itself) runs in a northeast to southwest direction and divided the greenhouse area from the roadway discussed above and the carriage house (Figure 4.9; Table 4.4). Four of these appear to run in a single line with two in a second line to the west. These two lines might represent a fence and a gate; from the size of the post holes, the fence that they supported would have been substantial with posts 20 to 30 cm (8 to 12 inches) in diam-

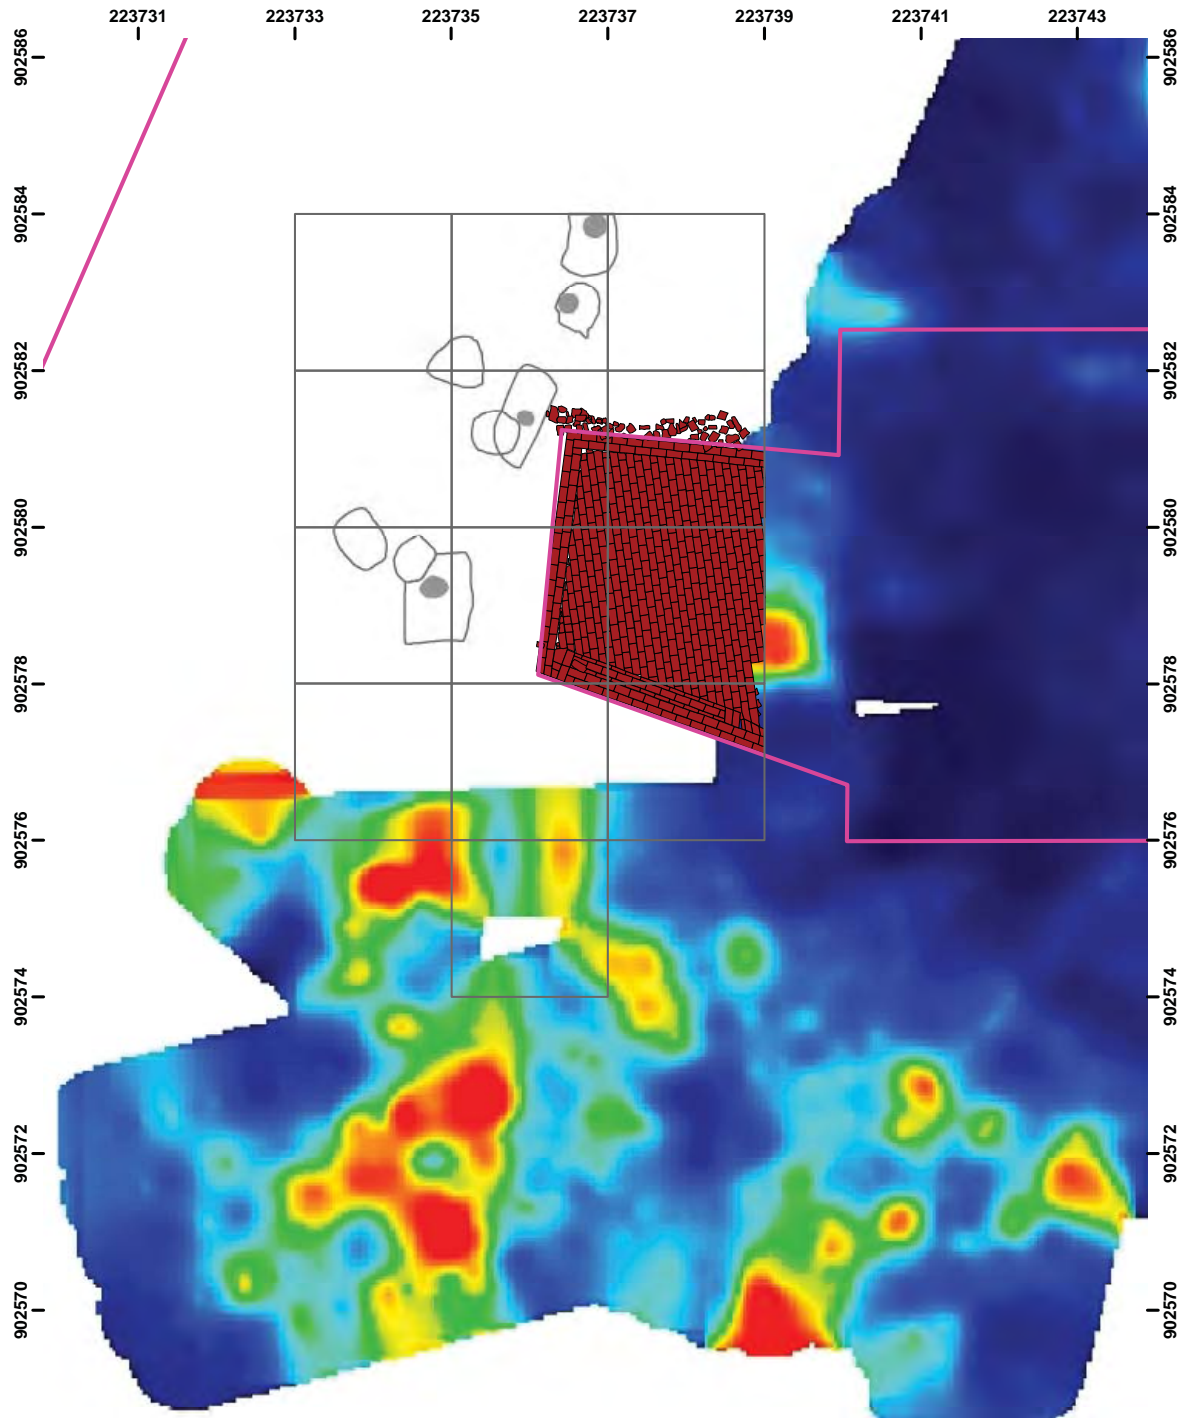
Figure 4.10. Excavated post holes and signatures of possible post holes south of the brick floor, visible in the GPR slice at ca. 90 cm below the surface.

Additional post holes south of the greenhouse extension may be visible in the GPR slice data. These appear as a series of four or five reflective features in a line south of and parallel to the brick floor of the greenhouse, forming a right angle with the existing post holes discovered west of the greenhouse (Figure 4.10). Further excavation is needed to confirm that this GPR signature is, in

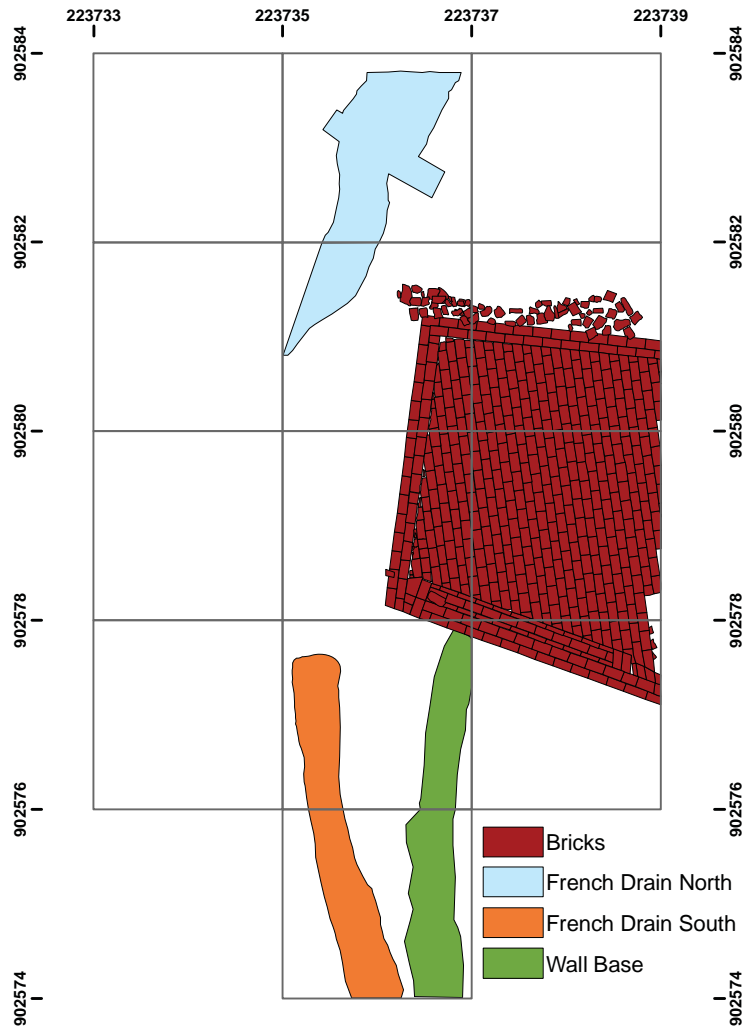
Figure 4.11. Later features around the greenhouse extension: the northern French drain (Feature 2), the southern French drain (Feature 8), and the curving wall base (Feature 9).

This curving support for a wall begins at the southwest corner of the greenhouse extension (near the stone drain) and curves away to the south and slightly east (Figures 4.11 and 4.12). The foundation consists of a single course of a rather irregular assortment of stones, bricks, and mortar that is 45 to 50 cm wide. We exposed 3.75 meters

called “French drains” (Feature 2 in the north; Feature 8 in the south; see Figure 4.11). Agricultural drainage channels can be divided into three types: open ditches, covered channels (which are filled with a loose material to allow water to percolate through), and hollow channel drains (Baugher 2001-2002). The Gore Place drains are the second type: channels or trenches cut into the surrounding ground surface and filled with large debris to allow water to percolate through them then probably filled back over with dirt. The two drains had very different kinds of material as fill and seem to be unrelated to each other and created at different dates. These drains are more recent than all of the features discussed above because they cut into layers that bury the old ground surface and other features. In the north, a new ground surface built up around the greenhouse extension, burying older landscaping features. The area was then re-landscaped and the northern drain was dug. The southern drain seems to have been installed later, after the curving wall surrounding the greenhouse was taken down. Drains such as these are common on 19th-century agricultural sites, and farm journals and agricultural improvement literature described the methods and benefits of constructing them. Although agricultural drainage was probably employed in the 18th century, covered drains are first mentioned in the advice literature in 1790 (Baughner 2001-2002: 27).

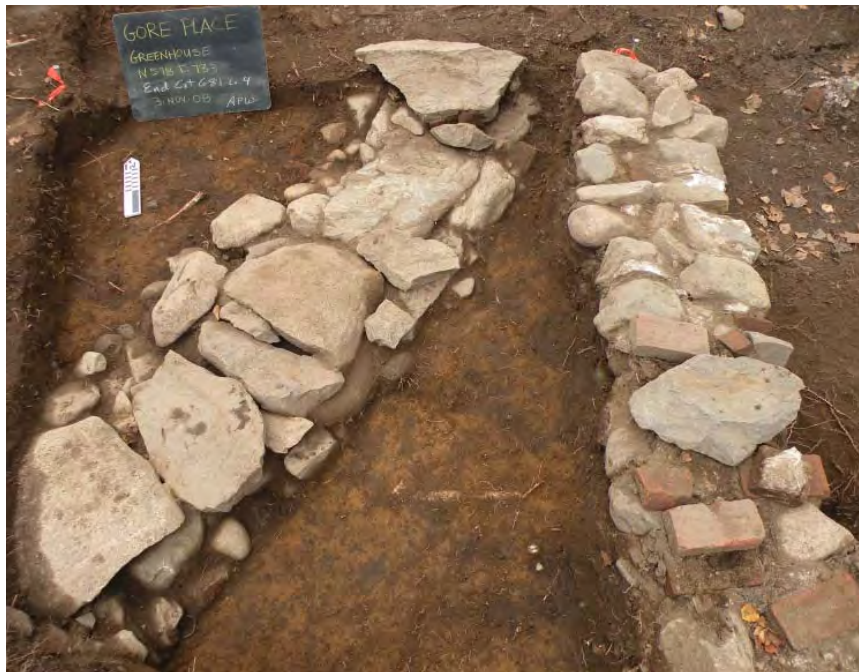
Figure 4.12. Feature 10, the stone drain (left) and Feature 9, the curving wall base (right). North is to the top. See Figures 4.2, 4.9, and 4.11 for the relationship between these features and the greenhouse extension floor which had not yet been uncovered when this photograph was taken).

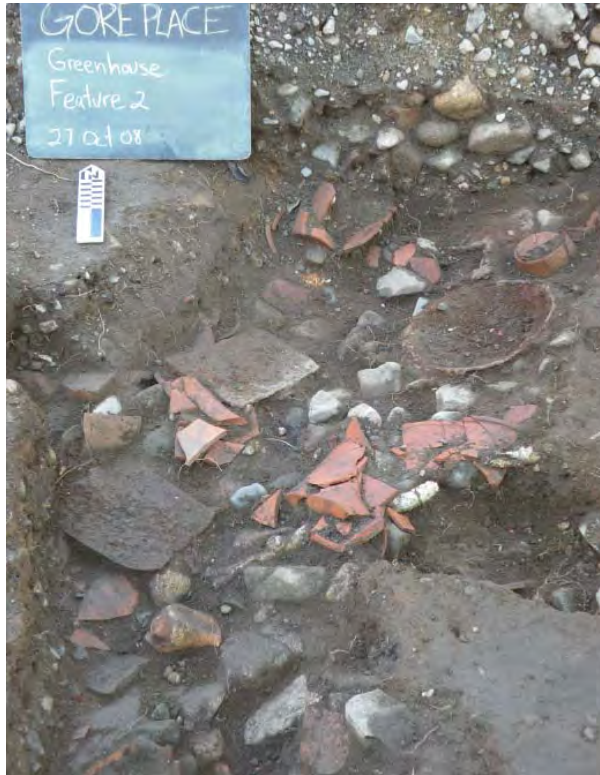
Figure 4.14. Objects placed in the fill of the northern drain to allow water to pass through, including shovel blades and planting pots.

blades and a colander, and then covered with a layer of smaller cobbles and broken bricks (Figure 4.14). Other objects in the fill included an ox shoe, lock pieces, nails, bottle glass, slate and marble tile fragments, creamware, pearlware, porcelain, fragments from glass tablewares, and stoneware bottle fragments. While the planting pots, agricultural tools, and other items associated with the greenhouse such as window glass seem to have been deposited in large pieces, the other ceramic fragments of refined earthenware and stoneware were in very small fragments, as if they were incidental or secondary to the fill.

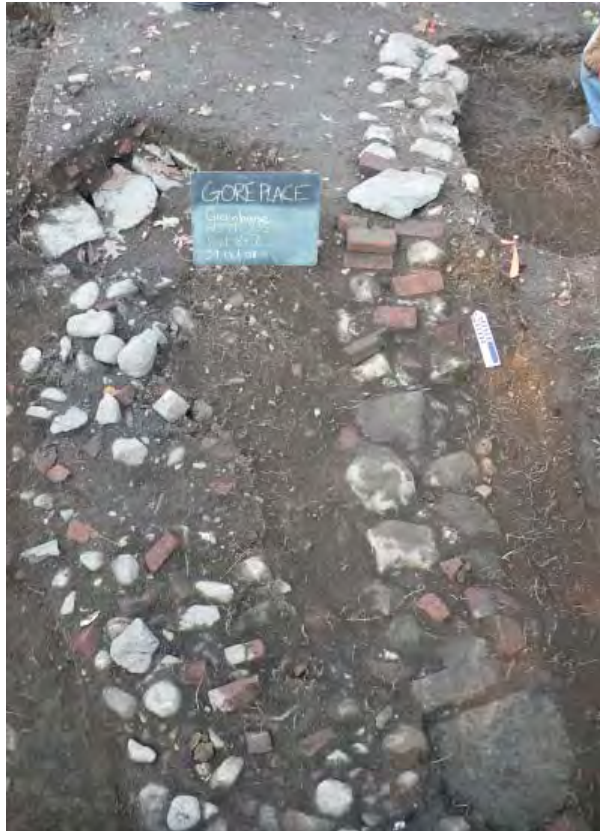
Figure 4.15. The top of the southern French drain, Feature 8 (left), which crosses on top of the curving wall base, Feature 9 (right).

It was uncovered primarily in unit N574 E735 and the unit to the north and was 60 to 70 cm wide and 3.5 m long. It ran over both the curving wall base and the stone drain leading away from the greenhouse, indicating that it was dug after the wall was dismantled, and therefore, presumably after the greenhouse had been taken down. The fact that it did not include the same kinds of specialized greenhouse material as the northern French drain suggests that it was put in at a different time, possibly later, after the greenhouse material had already been disposed of. It also does not have the same clay lining as the northern French drain. The GPR slice data show this drain as a hard (red) reflector running north-south in the southernmost excavation unit and continuing beyond the excavated area to the south and southwest (Figure 4.16).

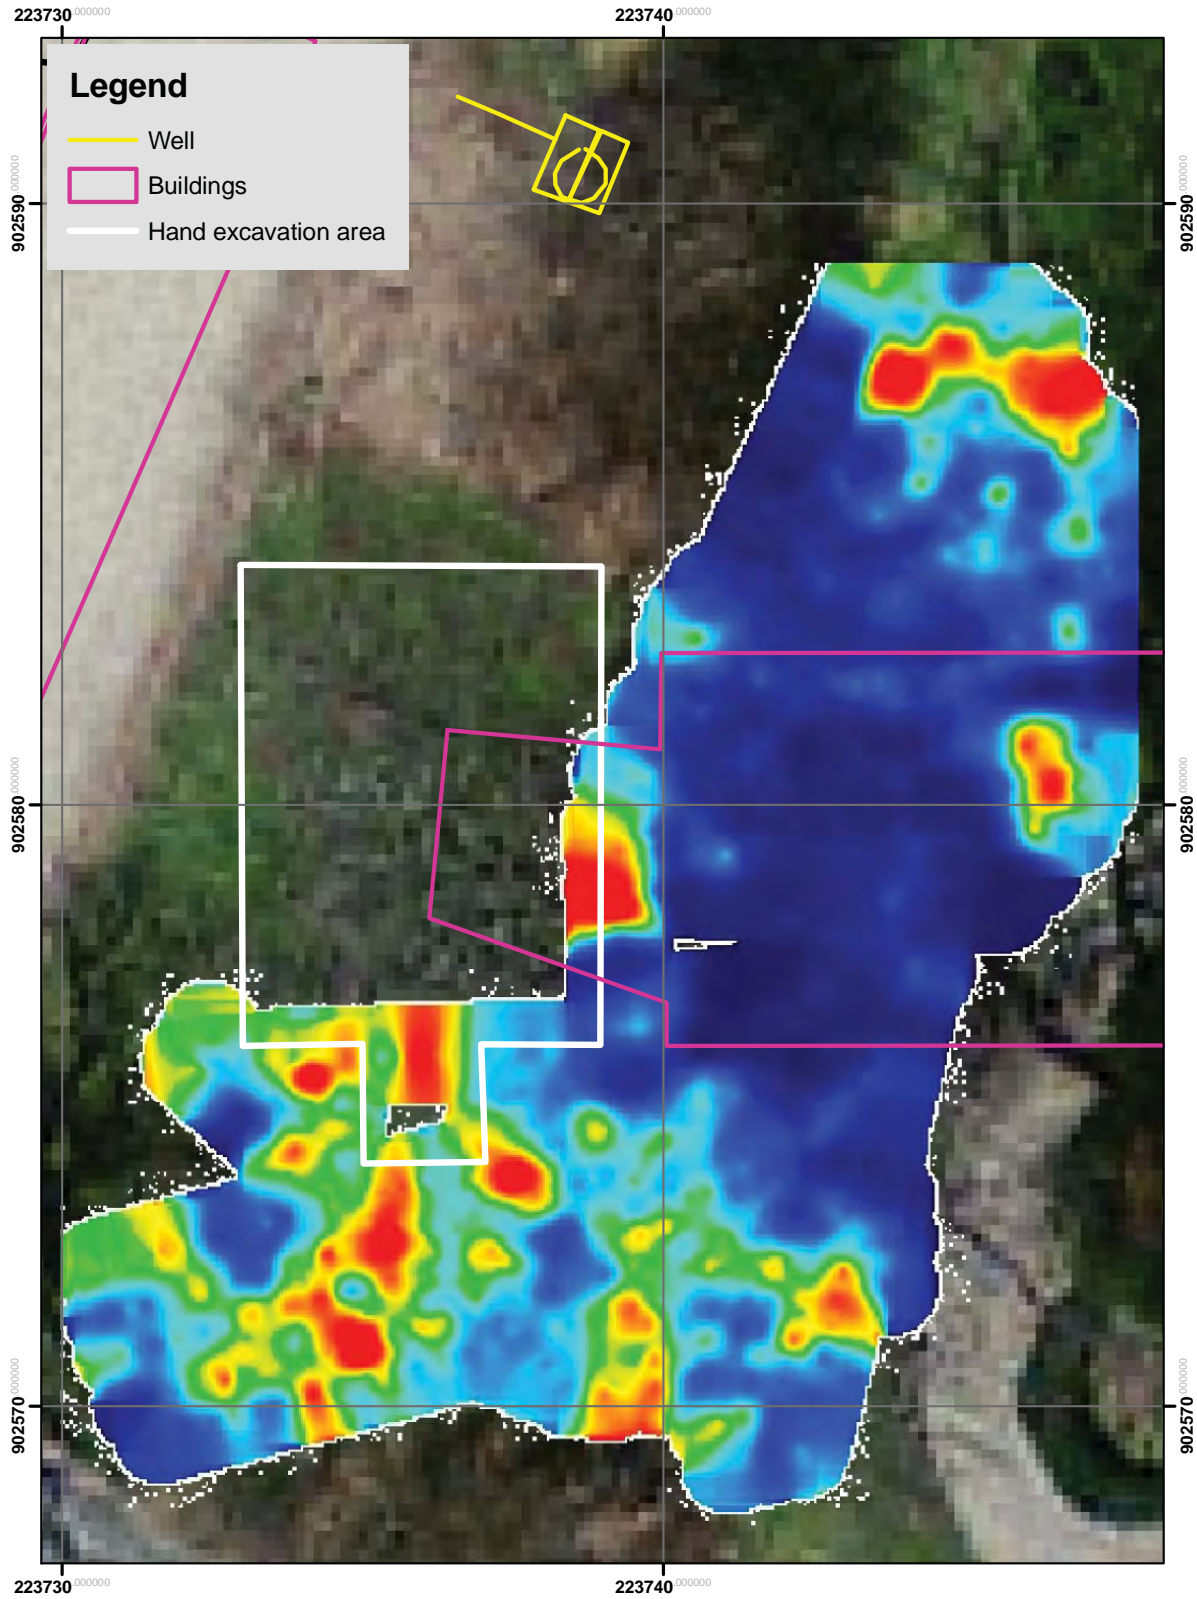
Figure 4.16. The continuation of the southern French drain in the GPR slice data at 90 cm below the surface, seen as the red reflector running N-S in the southernmost excavation unit and continuing south and slightly west.

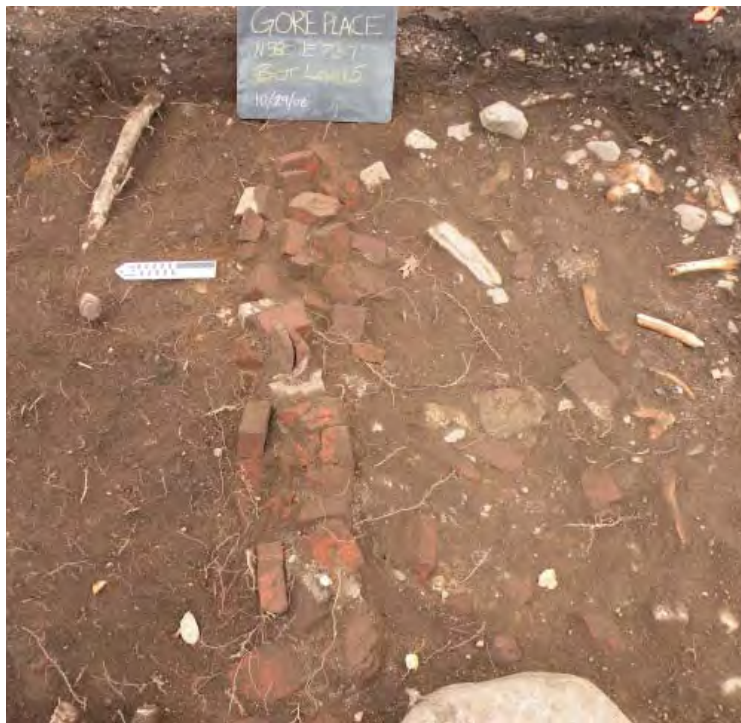
Figure 4.17. The top of the rubble deposits over the greenhouse extension floor. The line of broken bricks (Feature 11) marks the north edge of the floor. Compare the relatively clean deposit outside the greenhouse (Feature 6, left) with the brick, rubble, and bone laden deposit over the floor (right).

low in most places. Along the north wall, a distinct deposit of broken bricks (Feature 11, contexts 680, 745) was left along the line where the wall had once been (Figure 4.17). There was a similar deposit of rubble (Feature 17, context 701, 708) along the west wall boundary. The deposits that covered the brick floor of the greenhouse extension were varied and contained different types of rubble and artifacts (Table 4.7). Some were broad, covering most of the interior area, and others seemed to represent individual bucket loads of fill. There were also large pieces of bone throughout these deposits. The faunal collection is analyzed in Chapter 5. Immediately on top of the brick floor of the extension were dense deposits of coal (Figure 4.18).

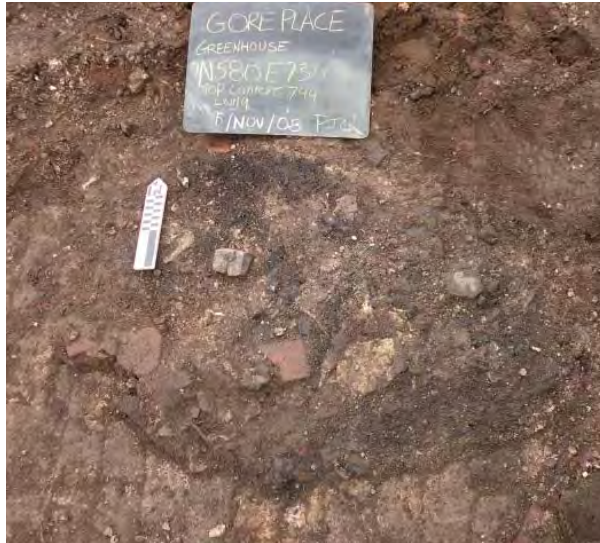
Figure 4.18. Coal deposits immediately on top of the greenhouse extension floor.

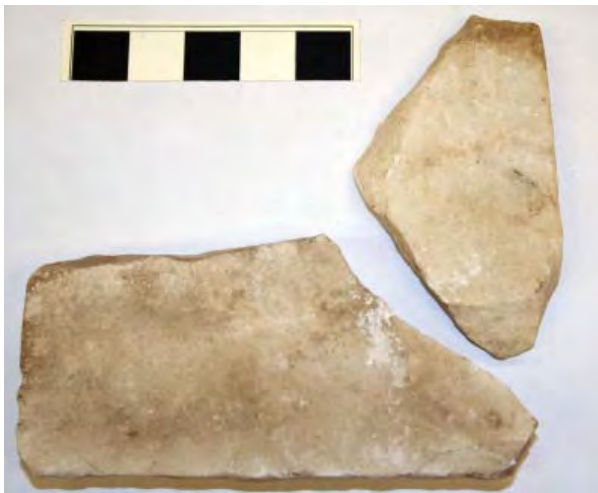
Figure 5.2. Fragments of white marble floor tiles. Scale is in inches. Photograph by Heidi Krofft.

The floor of the greenhouse extension that was uncovered in 2008 was paved in brick. Pieces of white marble tiles (and one piece of black slate tile) provide evidence that the floor of the main body of the greenhouse, however, was paved with marble (Figure 5.2) and possibly some slate. Additionally, pieces of mortar with brick and stone rubble aggregate were found with marble tile impressions. This may have been an attempt to lift the floor above ground level as suggested by the historical literature. The difference between the brick floor of the extension and the marble tile believed to have been used in the main body of the greenhouse underscores the difference between the functional work and storage space and the more formal or display oriented main space.

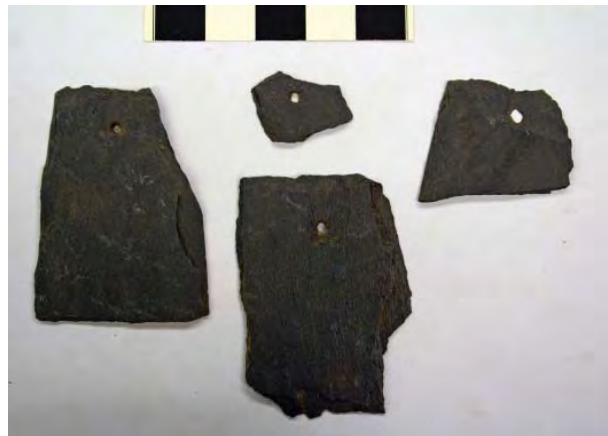
Figure 5.3. Roofing slate with nail holes. Photograph by Heidi Krofft.

The greenhouse excavations yielded 128 slate fragments of various sizes. Historically, slate was used for both paving and as a roofing material and the fragments suggest that both were present in the greenhouse. Several of the larger fragments of slate possessed nail holes (Figure 5.3), suggesting

that the roof of the extension and possibly portions of the main structure had slate shingles.

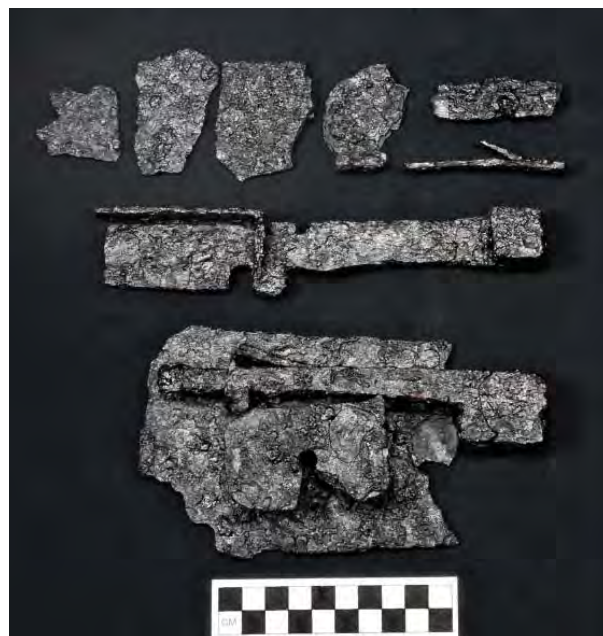
Figure 5.4. Rim and stock lock fragments.

A stock lock consisted of several iron parts creating the lock mechanism and attached to a wooden housing. Stock locks are mounted to the surface of the door and usually consist of only one bolt, the dead bolt. Although stock locks are not often found intact, according to Priess, their parts are distinctive and are not found on other types of locks (2000: 83). Three different parts of a stock lock were recovered: the lock bolt, the main ward,

and the spring. It is also possible that a portion of the tumbler is attached to the lock bolt by iron corrosion.

With a rim lock, another surface-mounted lock, the components of the lock are fastened to an iron main plate with rims or sides to complete the housing. These locks were also attached to the surface of the door and often required keepers or a staple for the bolt to lock into. At the very minimum, a rim lock needed one bolt, a lock bolt or dead bolt, to function and was called a dead lock or a closet lock (Streeter 1974: 67). Often times, rim locks also had latch bolts and sometimes even another lock bolt. The rim lock from the greenhouse excavations is simple in its form and only has one bolt (Figure 5.4).

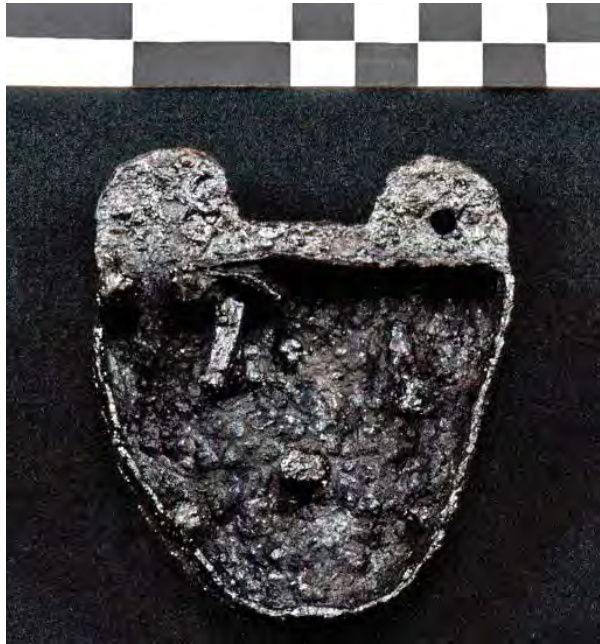
Figure 5.5. Padlock.

The padlock (Figure 5.5) is different from the stock lock and the rim lock in that it was portable. The padlock consists of a main housing enclosing the locking mechanism and a curved bow to secure the lock (Priess 2000: 79). The example from the greenhouse excavations is symmetrical with its widest dimension at the top of the lock. It has two lobes at the top to accommodate the bow. The lobe on the right has a hole where a pin would have passed through to attach the bow and to create a

pivot point. There is a void in the top of the housing where the opposite end of the bow would have been engaged in the mechanism to secure the lock closed. The general shape of the padlock dates it roughly to the 19th century (Priess 2000: 81). In addition, the presence of a pivoting brass keyhole cover also provides evidence for a date. According to Noël Hume, the brass keyhole covers were not used on iron padlocks until the 19th century with most of them dating after 1840 (1969: 251). Although the keyhole cover is not attached to the padlock, it was recovered from the same context and the two are likely associated with one another.

Padlocks of this size and simplicity would not have been very secure. Because more secure, surface mounted locks were also recovered, it is likely that this padlock was not used on an exterior door. Instead, it could have been used to lock an interior door or a small compartment door, possibly relating to storage.

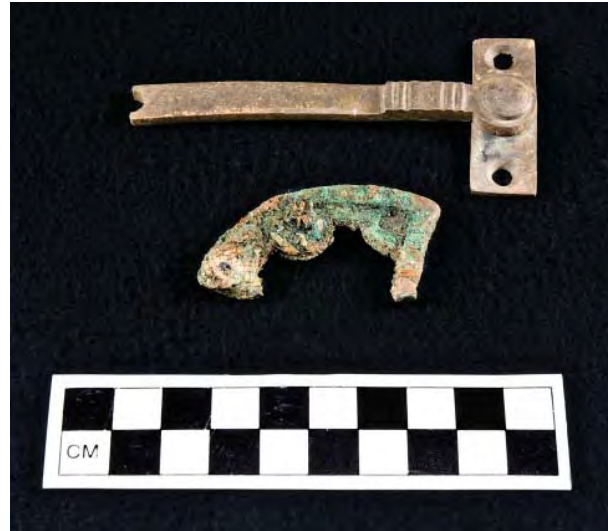
Figure 5.6 Copper alloy latch (top) and escutcheon (bottom) recovered during the 2005 excavations.

The 2004-05 survey of the greenhouse area also recovered some more decorative hardware that might also be from doors: a copper alloy latch and escutcheon (Figure 5.6). The latch came from an STP located on the north side of the greenhouse, and was probably discarded after it broke at the point where a small knob would have been

present to move it up or down. A second STP yielded a portion of a cast brass escutcheon. It is difficult to determine what type of hardware this fragment is from. It may be an attachment for a drop pull or the top end of a door handle. Regardless, it represents another example of the hardware potentially used in the greenhouse. The escutcheon in particular is one of the more ornamental pieces of hardware found on the greenhouse site. Therefore it is likely that it would have been used in a publicly visible space.
