# Data Recovery Excavations of the Carriage House, Greenhouse, and Greenhouse/Carriage House Well at Gore Place, Waltham, Massachusetts

**Cultural Resources Management Study No. 45**

**March 2011**

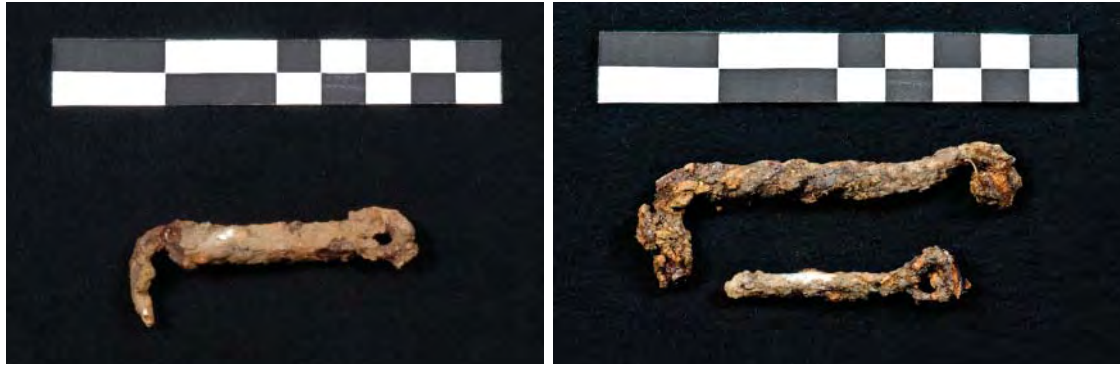
Figure 5.7. Two simple iron latches, context 614 and 714.

Hardware was also necessary to secure the shutters in a closed position. It is possible that the two latch hooks that were recovered from the excavation could have served this purpose (Figure 5.7). Although both of the latch hooks that were recovered were wrought iron they are in different styles. One of the latch hooks is plain and is about

The different styles and sizes of the latch hooks may represent a difference in use. Latch hooks may also have been used to hold cabinet or small compartment doors closed. Although both latch hooks are hand wrought, their different styles may also represent different periods of use. Although the potentially older hook is not broken and does not show obvious signs of wear, it may have been replaced if the entire door or shutter it was attached to was replaced.

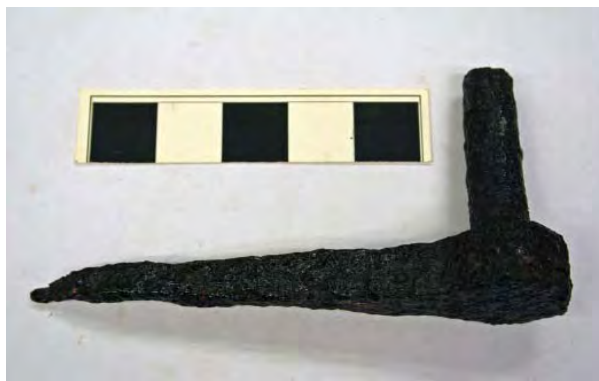
Figure 5.8. Iron pintle, context 669. Photograph by Heidi Krofft.

Overall, the excavations of the greenhouse area resulted in the recovery of at least six different hinges of three different types: strap hinge, H-type hinge, and snipe hinge. The strap hinge is represented by a wrought iron pintle (Figure 5.8). An iron strap would be attached to a shutter or door and had a joint that would fit over the pin of the pintle. The pintle would have been driven into the window frame or door frame or directly into the masonry work to fix the hinge in place.

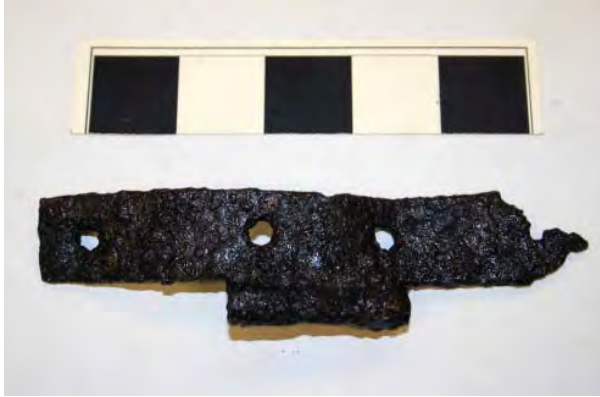
Figure 5.9. Strap from an H-hinge, context 669. Photograph by Heidi Krofft.

Fragments from at least five different H-type hinges were also recovered, none of them complete (Figure 5.9). These hinges are all made of iron and are hand wrought and represent two different sizes. The fragments provide evidence of at least two hinges of a similar size and may be a pair

of hinges from the same door or shutter. The straps measure about 16 cm (6.3 inches) long and about 2.2 cm (1 inch) wide. Both straps have four holes used to affix the hinge to a door or to a doorframe. Both of these examples are the side of the hinge with a single knuckle measuring about 4.9 cm (2 inches) tall. H-type hinges commonly had 3-part joints, so the associated strap would have had two knuckles that straddled this one (Priess 2000: 59). This center knuckle would have carried the weight of the door (Streeter 1973).

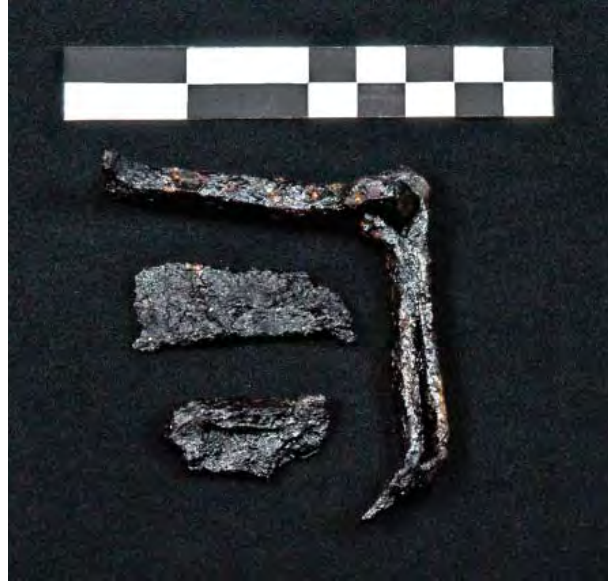
Figure 5.10. Snipe hinge, context 683.

The final type of hinge that was recovered is a snipe hinge. This consists of two eyes that are connected and form a pivoting point (Figure 5.10). These eyes would be driven into the door edge and the frame. One complete snipe hinge was recovered from the greenhouse excavations. This example shows evidence of clinching on the eye that was driven into the frame. Another snipe hinge was found during the 2005 survey. Only one eye from this hinge remains and due to the lack of clinching most likely represents the eye that was driven into the door. This type of hinge is much smaller than those previously discussed and it is unlikely that it would have held the weight of a full sized door or even a large shutter. It is more likely that this hinge would have been used for a small cabinet or compartment door. The presence of small cabinet or compartment doors indicates a need or desire to organize or separate tools in the workroom.

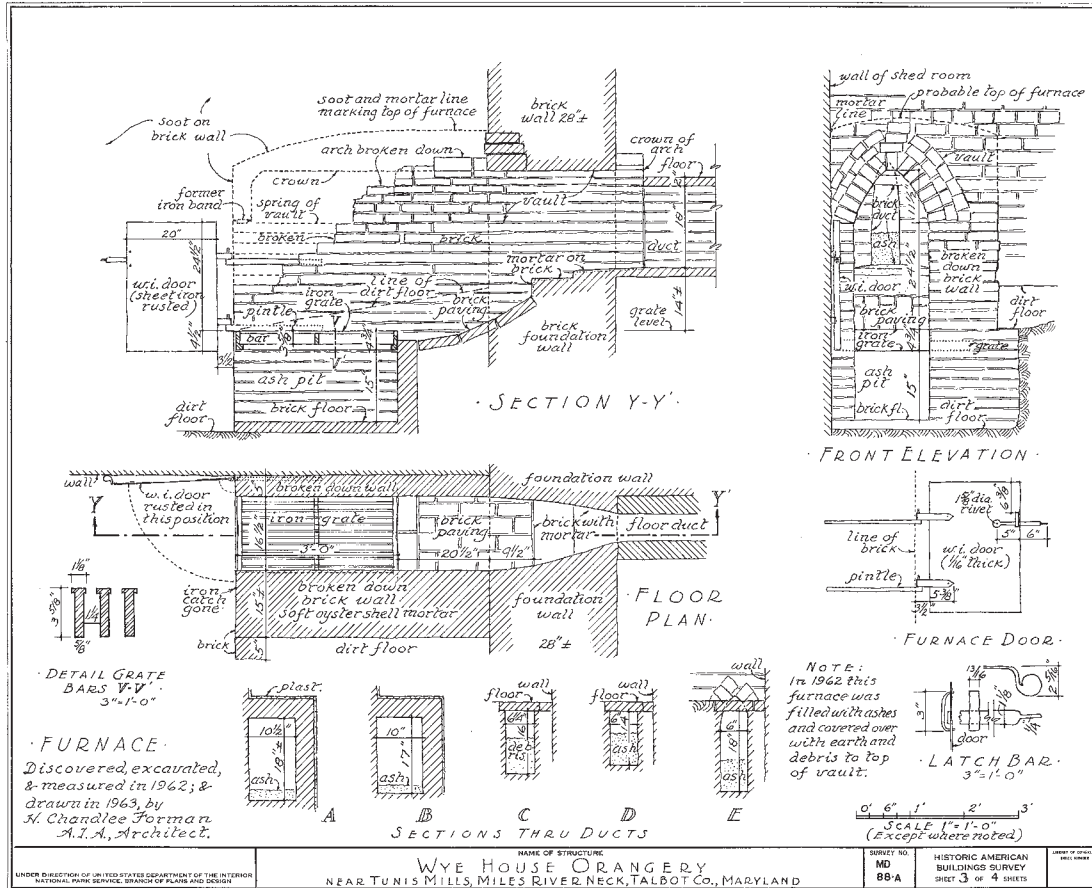
Figure 5.11. Diagrams of the Wye House Orangerie furnace, Maryland. Drawn by the Historic American Buildings Survey.

The arrangements of heating systems varied a great deal. An 18th century heating system survives at the Wye orangerie in Maryland (Figure 5.11). The main body of the furnace measures 16.5 inches wide and extends 3 feet deep. At that point it begins to rise and narrows as it becomes a flue. The furnace itself consists of an iron grate roughly at floor level. Below the grate is an ash pit that extends 15 inches into the floor and has a brick floor. This furnace has a wrought iron door that measures 20 inches wide by 29 inches tall.

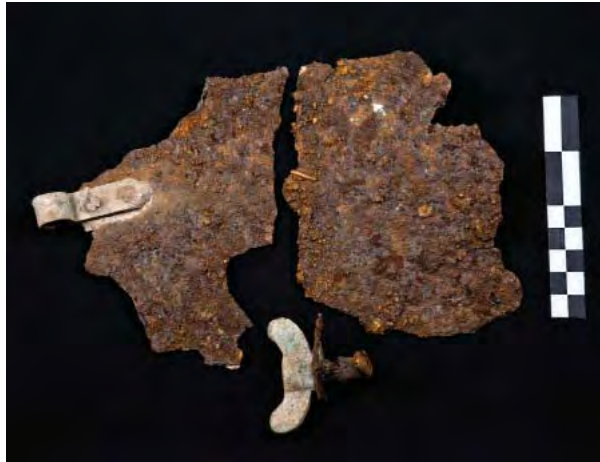
Figure 5.12. Possible furnace door fragments. Compare to the furnace door depicted in Figure 5.11.

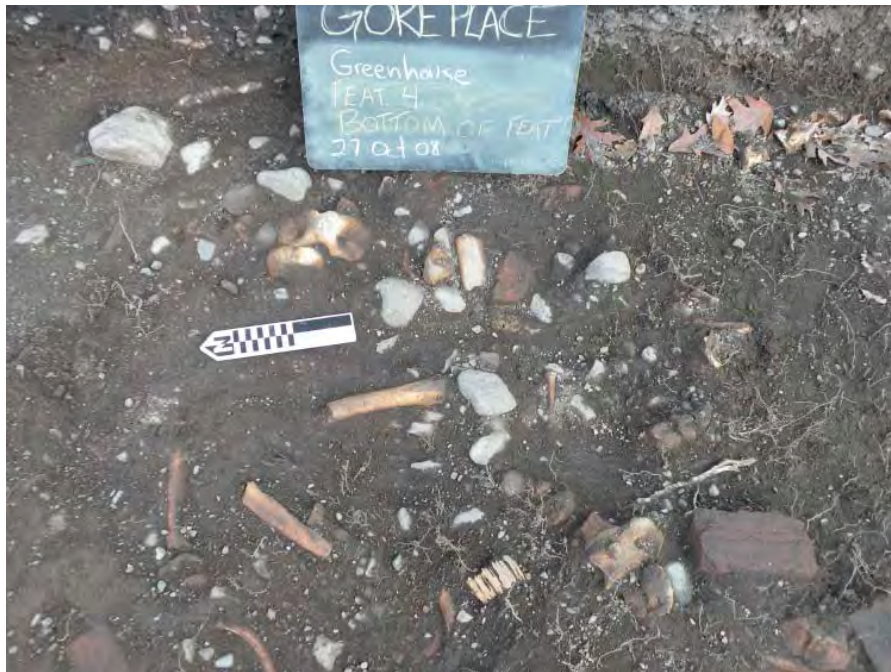
Figure 5.13. Artifacts and faunal remains *in situ* in the interior greenhouse rubble deposit.

well as other refuse associated with the activities of the greenhouse (Figure 5.13). Before considering in depth the bones comprising the 19th-century assemblages, a few quantitative methods are discussed to understand the processes involved in the analysis of the faunal remains from the northern French drain, the deposits associated with the roadway, the destruction layers, and the rubble on the interior of the greenhouse. Standard calculations employed by zooarchaeologists, including NISP (number of individual specimens) and Skeletal Part Representation, were used to move from a summary of raw data to an examination of activities associated with the production of bone manure or fertilizer.

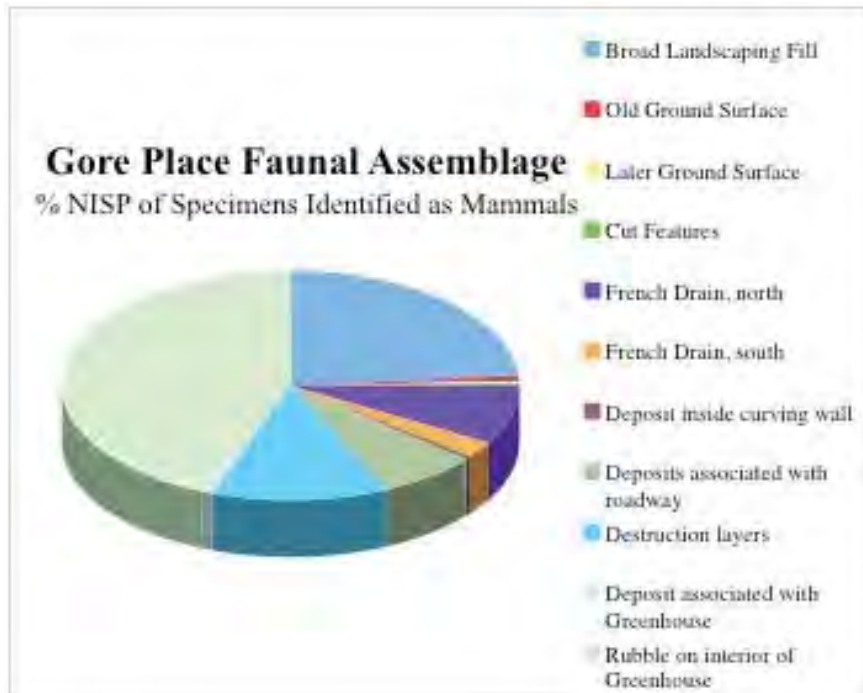
Figure 5.14. Distribution of the identified specimens among the 11 analytical units.

The faunal remains from the 11 analytical units, which included 1067 specimens, represent various time periods, household occupations, and activities in the history of the Gore Place property. Figure 5.14 shows the percentages of bones comprising each unit with the five largest assemblages found in the layers of broad landscaping fill, the French drain north, the deposits associated with the roadway, the destruction layers, and the rubble on the interior of the greenhouse.

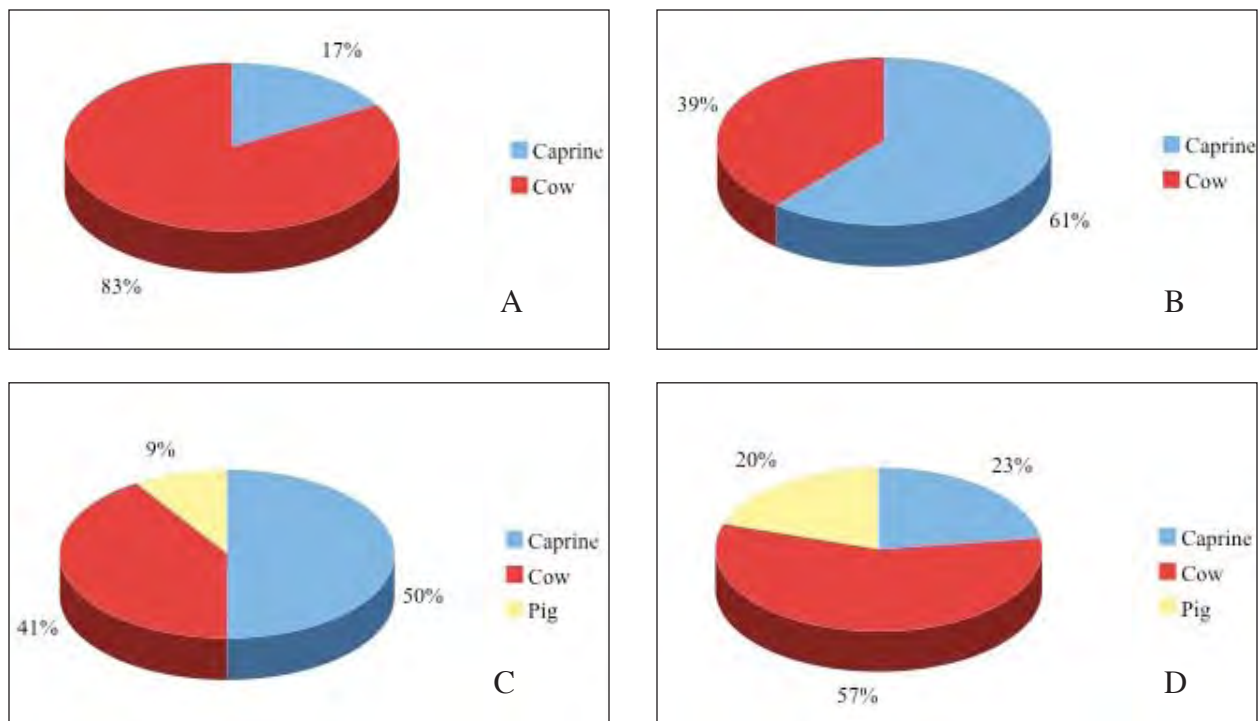
Figure 5.15. Percentages of cow and caprine bones in the different deposits. A) Northern French drain; B) deposits associated with the roadway; C) destruction deposits outside the greenhouse; D) destruction deposits over the greenhouse floor.

The vertebrate taxa found in the northern French drain included two caprine and ten cow bones (Figure 5.15a). The caprine bones were identified as two nearly complete right astragali. The identifiable cow bones in the collection included two complete carpals, one complete atlas, four ilia, one radius fragment, the proximal end of a tibia, and a piece of a sacrum. Minor butchery marks were noted on four of the ten cow bones. It is difficult to draw any specific conclusions from the small collection of bones in this context.

The deposits associated with the roadway contained 59 specimens identified as mammals, two described as birds, and an additional 74 bones recognized only as the remains of vertebrates. The two bird bones, which were the only bird remains found in the entire Gore Place assemblage, were identified as the proximal and distal ends of chicken humeri. Caprine bones comprised 61% of the mammal bones identifiable to class (11 specimens) (Figure 5.15b). These included one astragalus, one calcaneus, one carpal, three femur fragments, two

A total of 109 bones were found in the destruction layers associated with the greenhouse demolition sometime after 1841 (Figure 5.15c). The assemblage contained 11 caprine bones, including one complete astragalus, one calcaneus, one metatarsal, one complete tarsal, a distal and proximal tibia, one proximal femur, the shaft of a humerus, one pubis, a complete calcaneus, and a fragmented ischium. Additionally, nine cow bones were found in these layers. The bones were identified as the fragment of an axis, a distal humerus, two tibia pieces, three tooth fragments, and one ilium. Pig bones were also present in this context and included a right proximal femur and a proximal metapodial.

The rubble layers found on the interior of the greenhouse contained the largest assemblage of faunal remains with 376 bones identified as mammal and seven bones described as the remains of vertebrates. A total of 195 bones or approximately 52% of the mammal remains were cataloged as unidentifiable bones. The rubble layers yielded a total of 17 caprine bones constituting various skeletal parts, including one innominate, one complete right femur, two distal femurs, a fragmented femur shaft, one complete phalange, four ischium fragments, a proximal metatarsal, two pubes, the shaft of a right radius, a right proximal tibia, one fragmented scapula, and one piece of a right ulna (Figure 5.15d).

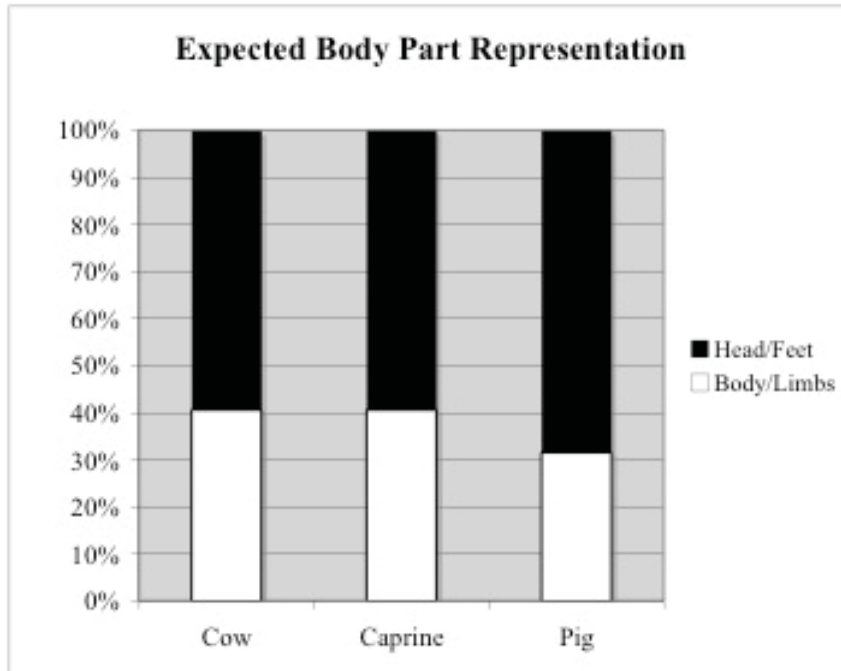
Figure 5.16. Expected anatomical proportions for complete skeletons of cows, caprines, and pigs.

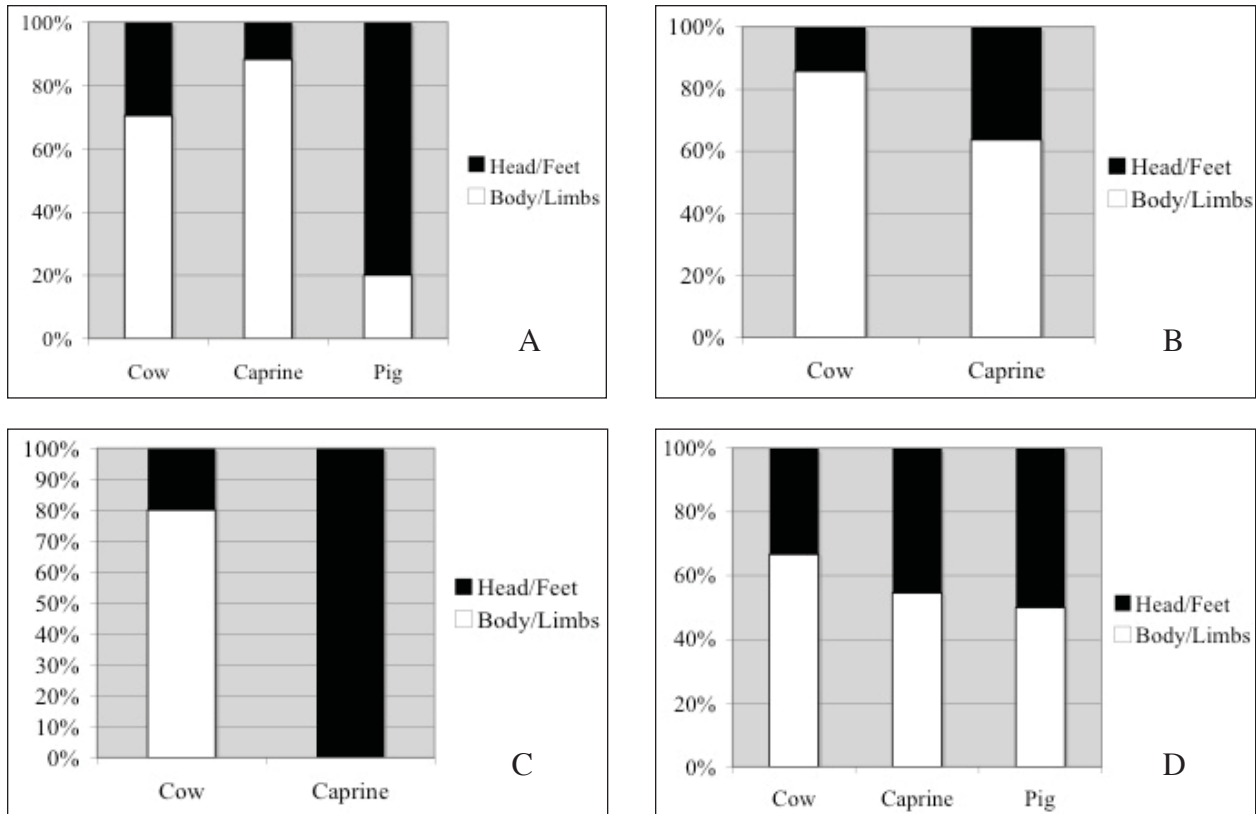
Figure 5.17. Body part distribution in the different deposits. A) Destruction deposits over the greenhouse floor; B) roadway; C) northern French drain; D) destruction deposits outside the greenhouse.

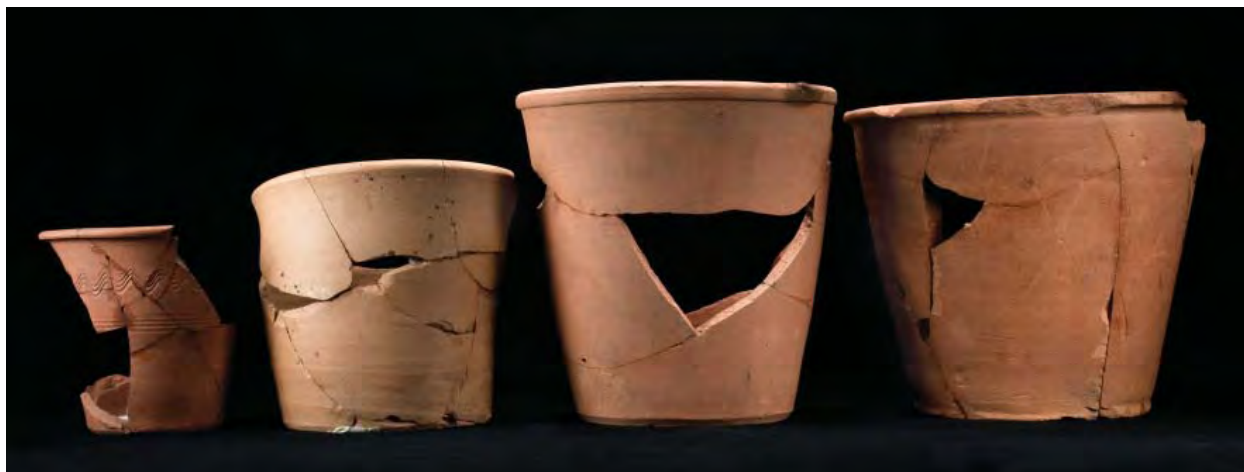
Figure 5.18. Reconstructed planting pots; left to right, vessels 41, 50, 36, and 35.

The 2008 excavations yielded 2083 planting pot sherds from at least 149 separate redware pots which constitute a large collection of a common yet little studied artifact type (Figure 5.18). The fragments from the 2005 STP survey are not included in these counts. Based on both archaeological and documentary evidence, the greenhouse seems to have fallen out of use in early 1840s. The

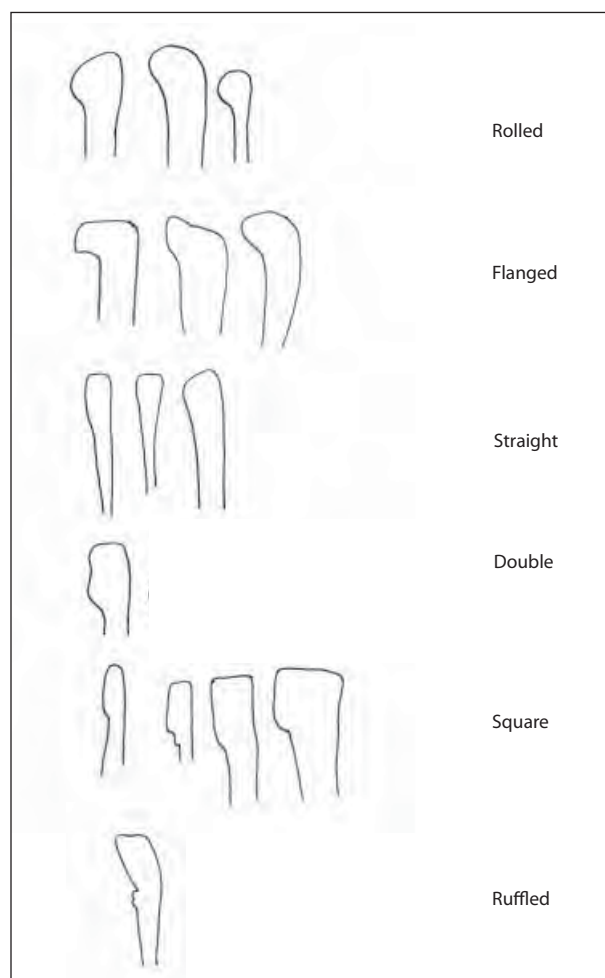
Figure 5.19. Representative planting pot rim profiles.

yellow or yellowish red with no inclusions visible to the naked eye. Based on variations in rim style and diameter, there are at least 149 pots represented (see Appendix B). There are six different basic rim profiles, but significant variation within each of those categories (Table 5.7; Figure 5.19). The pots range in diameter from 2 to 30 cm with most of the intervening values represented by at least one pot (Figure 5.20). Twelve of the 149 identified vessels are decorated (Figure 5.21): 11 with tooled or engine-turned bands of straight and/or wavy lines (none in identical patterns, however) and 1 with texturing that seems to have been created by sponging the exterior. Additional fragments not associated with one of the 149 distinct rims are also decorated, most with similar combed patterns. One unassociated sherd, however, is painted with white and black slip; the fragment contains part of a white circle, surrounded by black dots, with a white band at the top (Figure 5.22). One vessel had a combination of letters, numbers, and symbols scratched onto the exterior, presumably during its use-life (Figure 5.23). Another shard from a different vessel is scratched with an X. The meaning of these scratches is not clear, but they may have recorded information about the plant, as advised by gardening manuals.

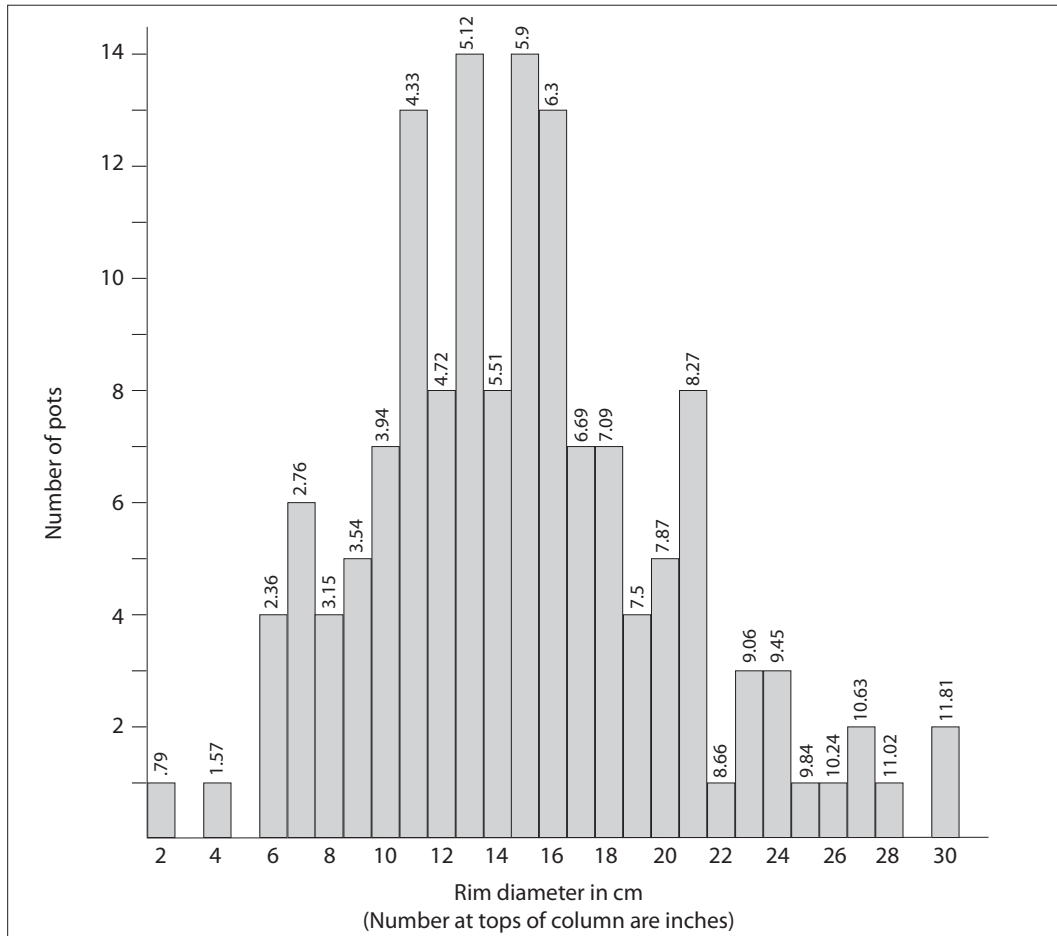
Figure 5.20. Planting pot rim diameters.

Most of the pots in the Gore Place collection were between 10 and 21 cm (roughly 4 to 8 inches) in diameter at the rim, with the biggest concentration between 12 and 16 cm (or 4.3 to 6.3 inches). Having a range of mid-size pots was important for proper re-potting; 19th-century gardening manuals recommended constant repotting into gradually, incrementally larger pots as a process integral to plant health (e.g. Henderson 1884: 61).

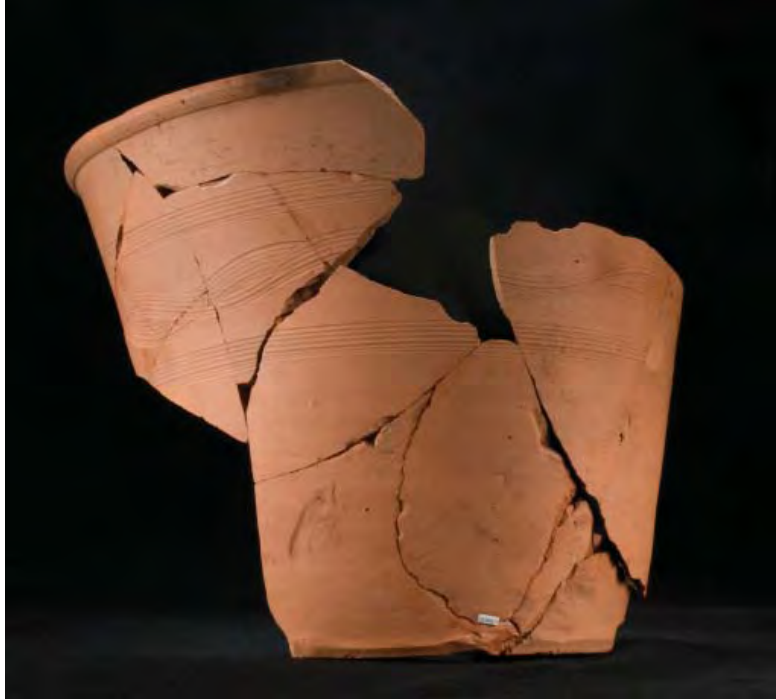
Figure 5.21. Detail of tooled decoration, vessel 39. Another style of tooling is visible on vessel 41 in Figure 5.18.

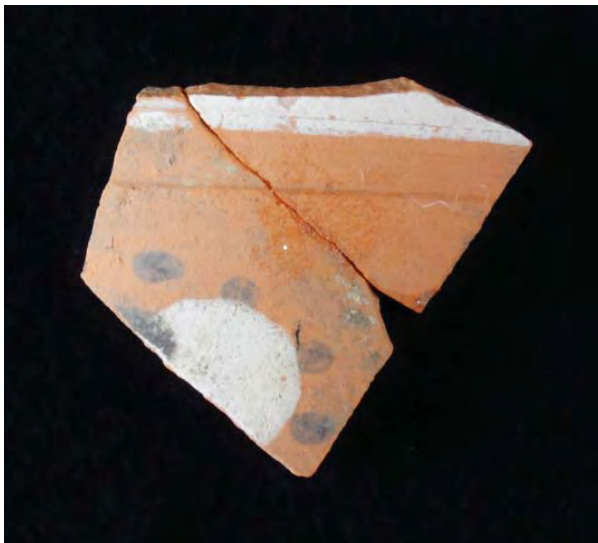
Figure 5.22. Slip decorated fragment. This piece is the sole example of this type of decoration in the collection.

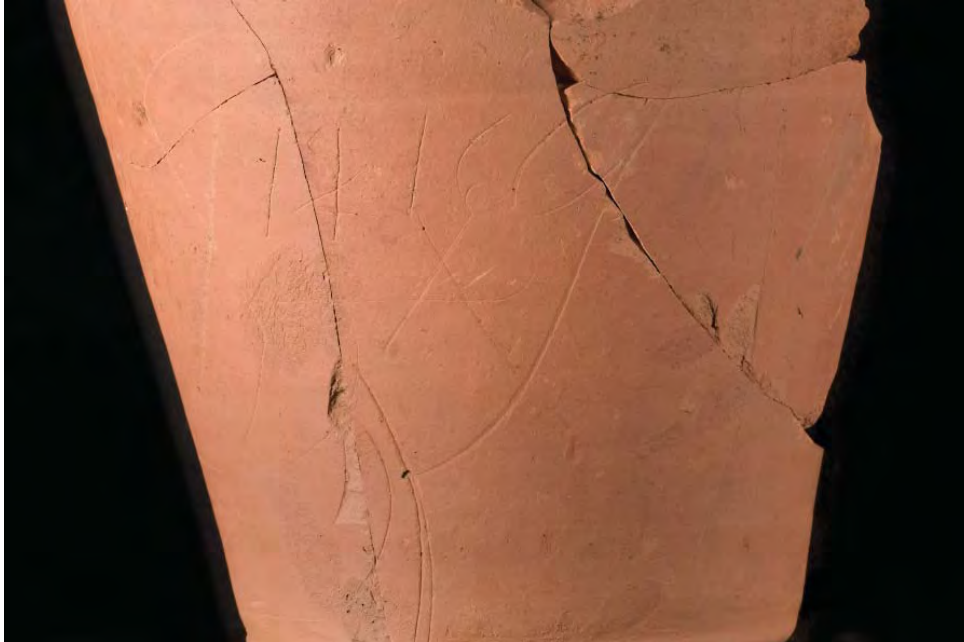
Figure 5.23. Scratched letters and numbers on vessel 35. The scratches include an X and a sequence which may read “1716g.”

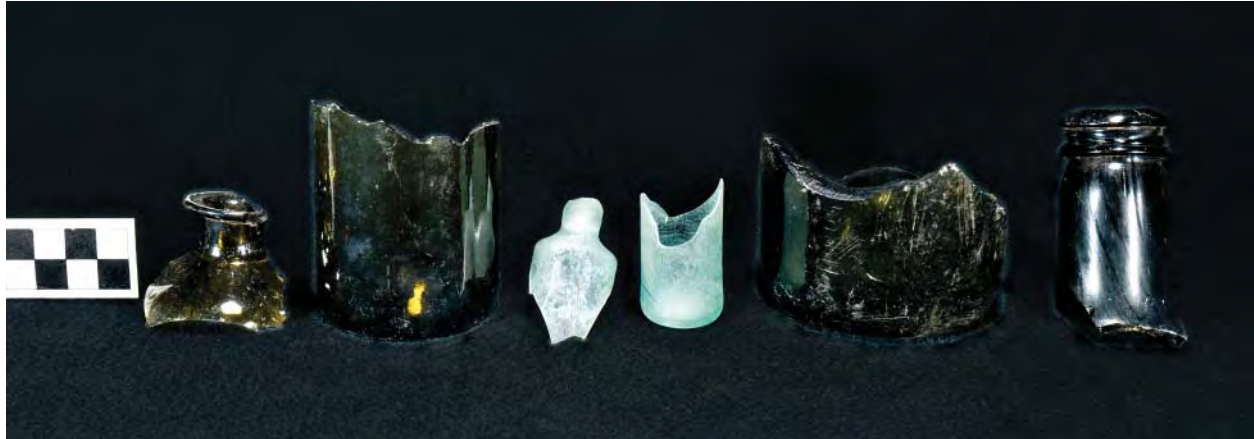
Figure 5.24. Glass bottle fragments from the northern French drain, Feature 2. These are the only large fragments of vessel glass recovered during the 2008 excavations.

Other than window glass, almost all of the glass from the greenhouse area is bottle glass, primarily necks and bases (Figure 5.24). There is one globe from a lamp represented, but no table glassware such as tumblers or stemware. Among the bottles are at least two small vials (base diameter = 2.5 cm) with flanged lips of the type that commonly held liquid medicines. Here,

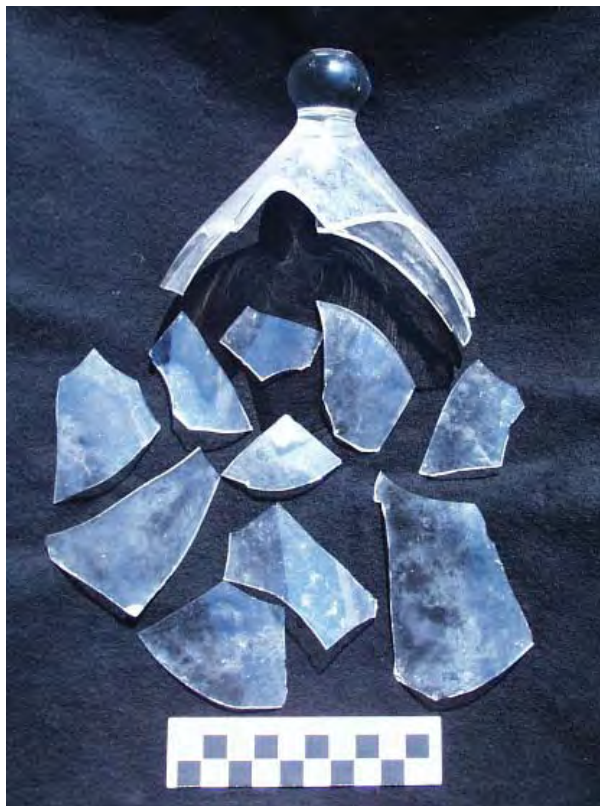
Figure 5.25. Glass bell jar fragments recovered in 2005. Photograph by Leith Smith.

postulate a greenhouse-related function for these because of the large pieces that are present; in the ceramic collection, only large pieces of planting pots (related to the greenhouse function) survived, while other vessels were much more fragmentary. In the 2005 text excavations, a fragmentary bell jar was recovered from the mouth of the stone lined drain (Figure 5.25). Bell jars protected delicate plants in pots or planted outside.

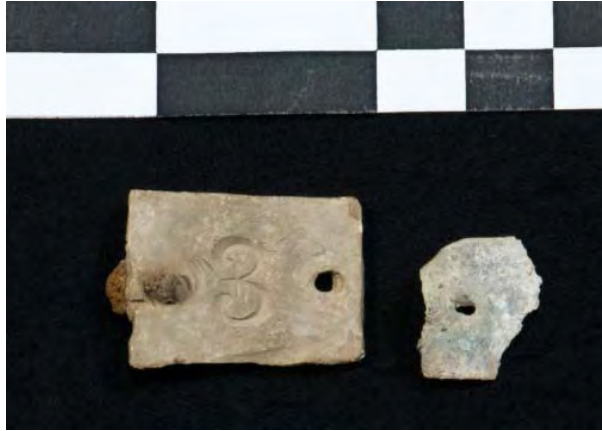
Figure 5.26. Lead tags from contexts 627 and 628.

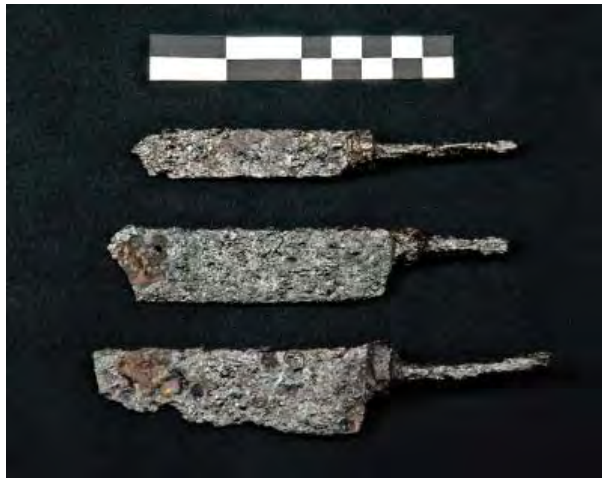
Figure 5.27. The three more complete knife blades; contexts 633, 634, and 799.

Four partial (Figure 5.27) knife blades were also recovered from the greenhouse area. One is represented only by a blade tip (and may in fact come from a pair of scissors or shears); three are comprised of a partial blade and tang. All of these would have had wooden or bone handles, now decomposed, surrounding the metal tang. Table knives of the early 19th century typically had broad, slightly curved blades with rounded ends. Unfortunately, these are not complete enough to determine their shape; the three that are most complete lack their tips, and the single tip fragment is pointed rather than rounded. They may have served as pruning knives, though they lack the distinctive backwards curve of the pruning knife (French: *serpette*) blade shown in Diderot's encyclopedia (Figure 5.28) and other period publications. No forks or spoons were recovered, which lends some support to the idea that the knives had a function in the greenhouse and were not simply domestic utensils redeposited here.

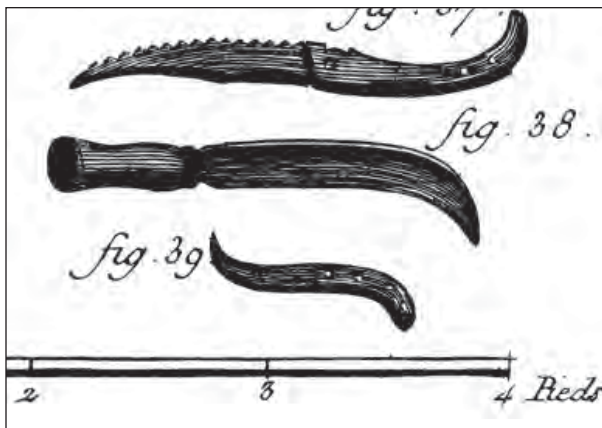
Figure 5.28. Pruning knives, illustrated in Diderot's late 18th-century *Encyclopedia*.

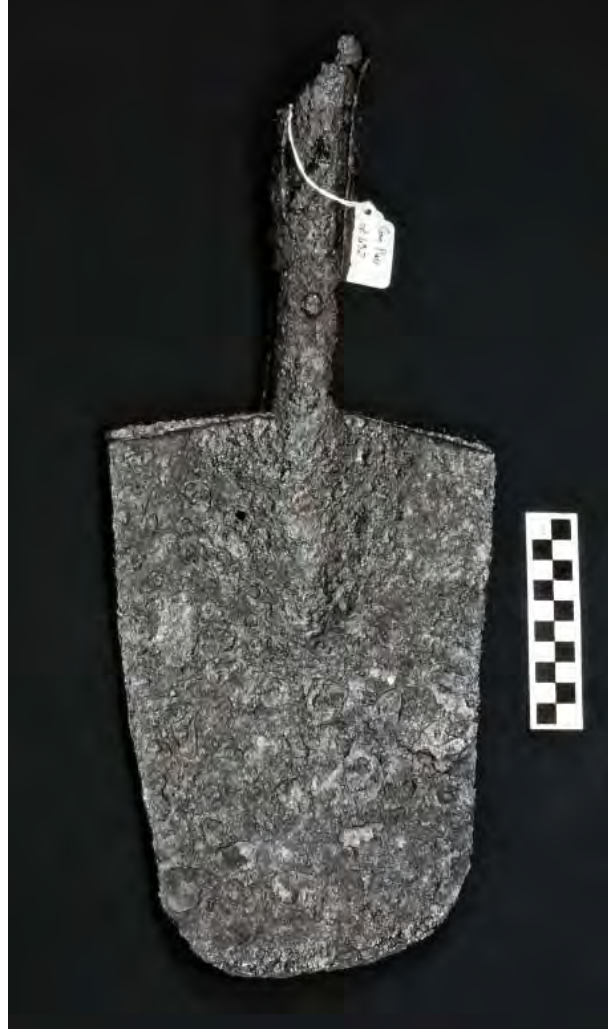
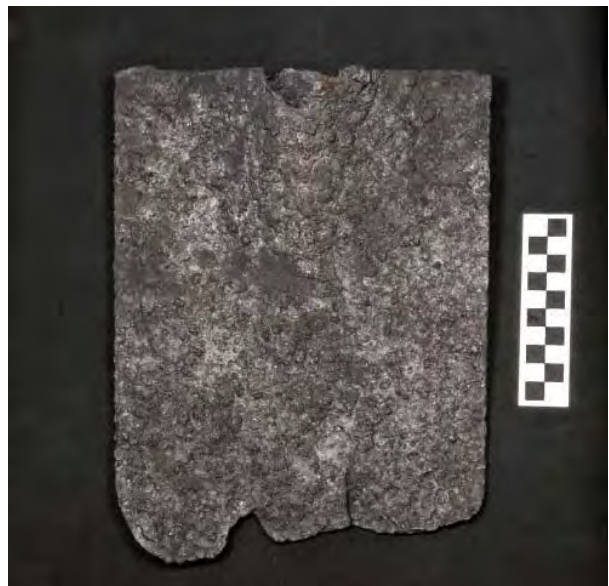
Figure 5.29. Iron spades from the northern French drain fill.

The fill of the northern French drain contained a number of large items, presumably placed there to promote drainage. In addition to several almost intact planting pots, there were three iron spades and a colander in the fill. These spades may not have been used in the greenhouse itself, but might have been used to turn soil or composting piles nearby. The greenhouse extension might have served as general purpose storage space for garden tools used in the area, though other general-purpose garden and farm tools such as hoes, rakes, and scythes were not found in the greenhouse area. Two of the spades were rectangular; one was rounded (Figure 5.29). The rounded example is the most complete and consists of two iron plates that are worked together for the blade of the spade, but which separate as they move towards the handle. The triangular iron plates that formed the top edge

of the shovel are intact, as is the beginning of the iron fitting that would have surrounded the wooden handle. The blade is 26 cm long and 19 cm wide at the top, tapering to a gently rounded point. Only the blades of the square spades survive. They are also both formed from two plates that separate near the handle. The top components are partially present on one example and missing on the other. Neither has a preserved handle attachment. These blades are 27 cm long, 21 cm wide at the top, and about 18 cm wide at the bottom.

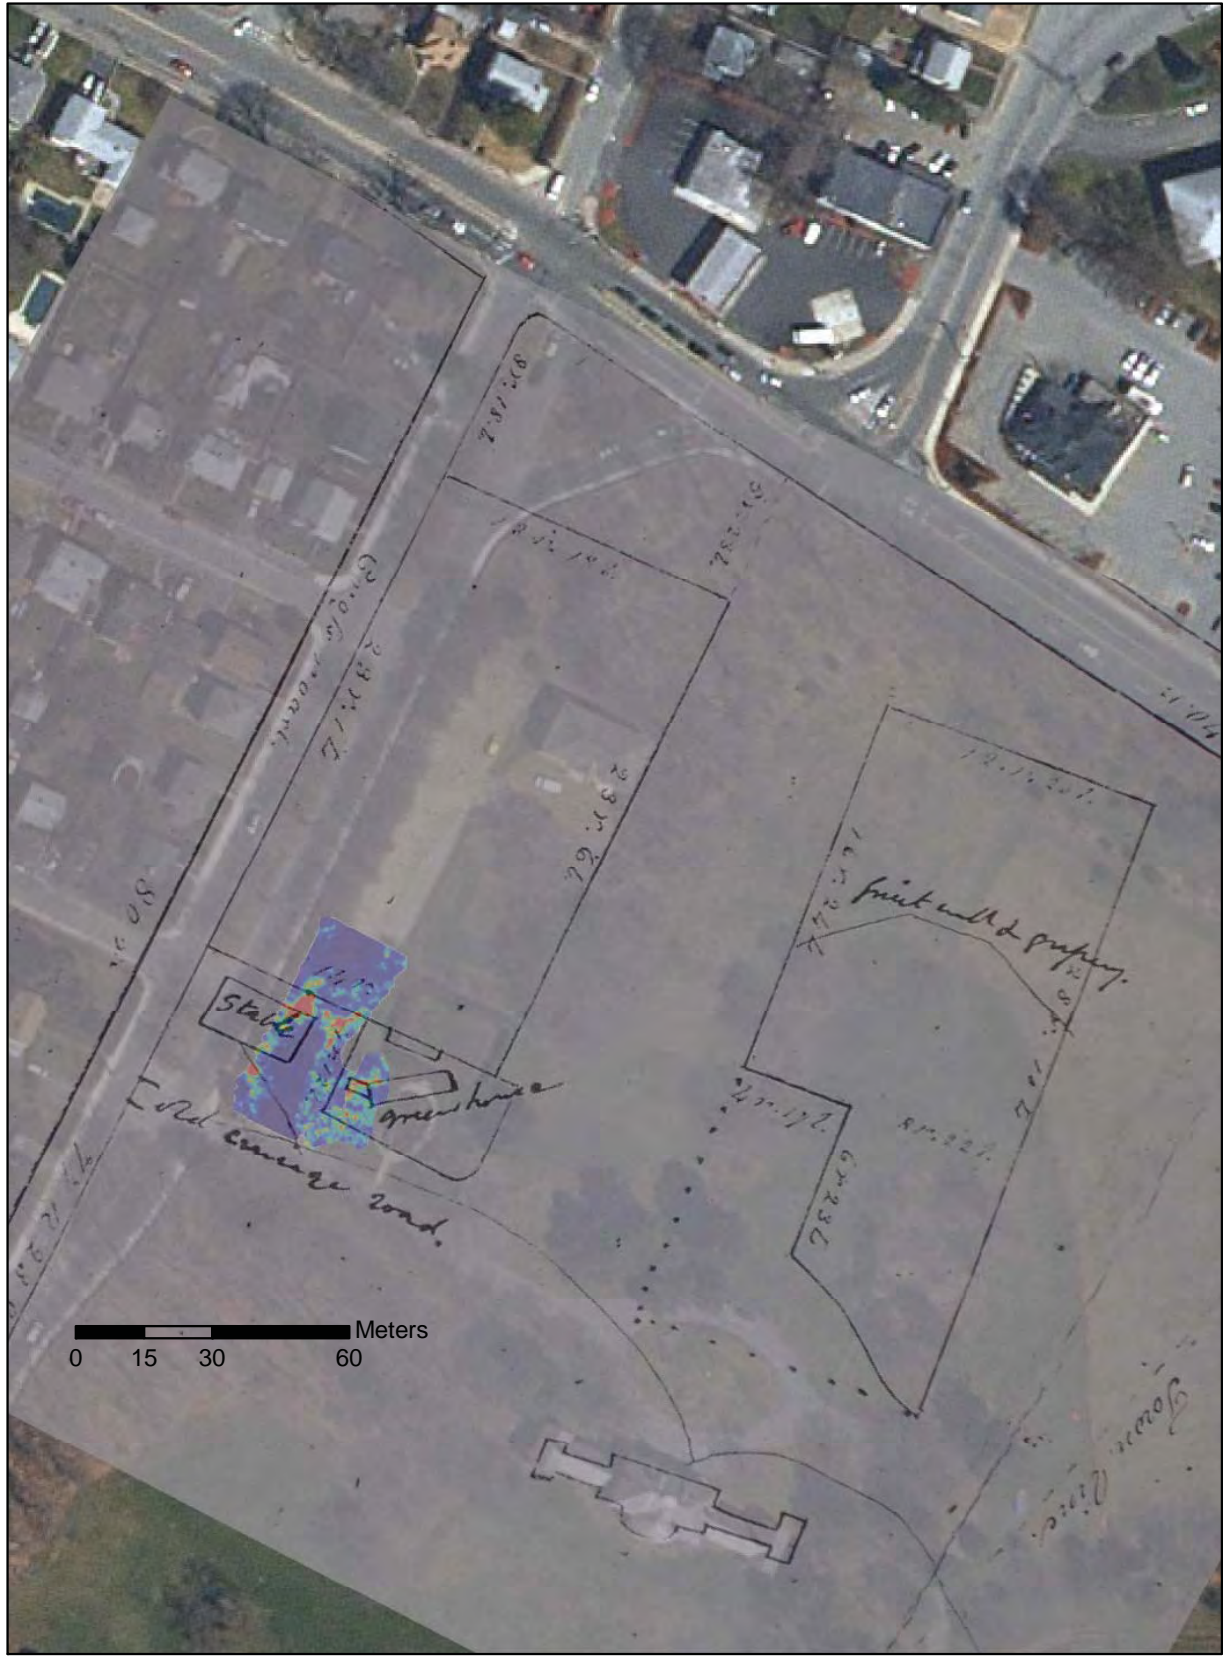
Figure 6.1. Property-wide georeference of the 1834 Lyman map. See Figure 2.3 for a detail.

While the 1834 Lyman map could be georeferenced to the whole property (Figure 6.1), with

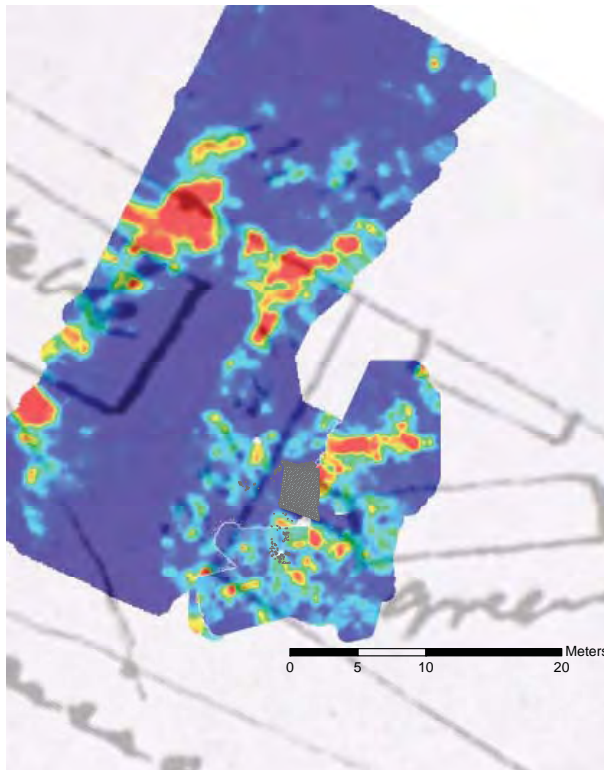
Figure 6.2. The 1834 Lyman map, GPR slice, and excavated brick floor.

In Figure 6.2, the Lyman map was georeferenced using the northeast corner of the carriage house and the southwest corner of the brick floor of the greenhouse addition. This projection shifts the greenhouse south of the east-west geophysical anomaly interpreted as the north wall. It does, however, have the fronts of the stable and greenhouse extension flush with each other. In Figure

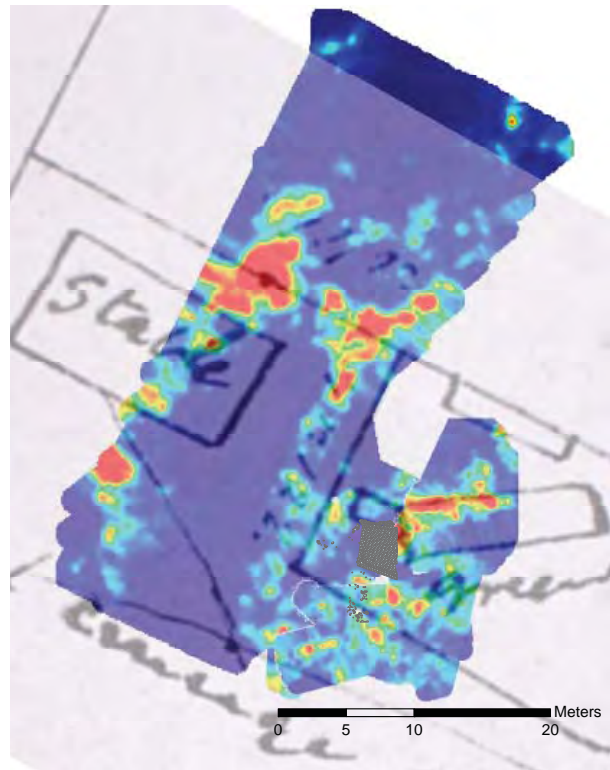
Figure 6.4. The 1834 Lyman map, GPR slice, and excavated brick floor.

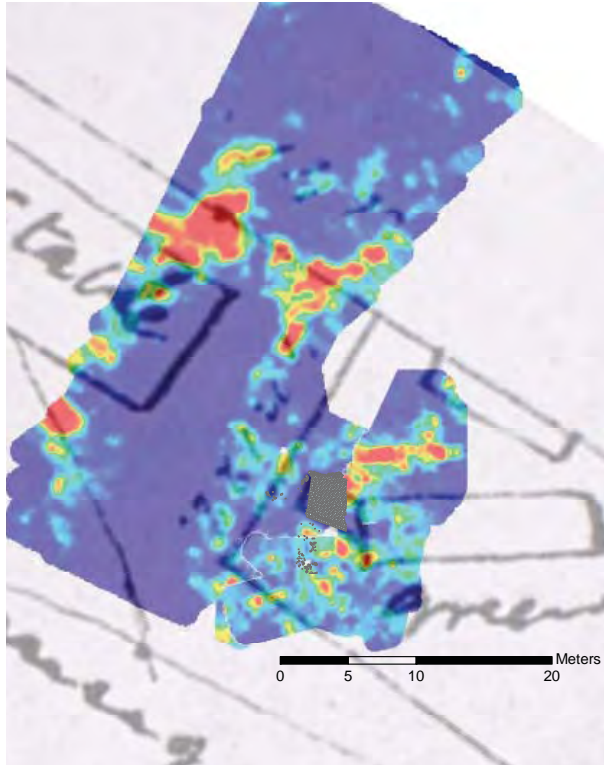
Figure 6.3. The 1834 Lyman map, GPR slice, and excavated brick floor.

6.3, the georeferencing used the northeast corner of the stable and the northwest corner of the brick floor. This projection again shifts the greenhouse south of the east-west geophysical anomaly interpreted as the north wall. It also shrinks the buildings so that they appear approximately 86% of their real size. (This is based on the known size of the carriage house, and assumes that rendering the buildings using a consistent scale was important to the map's author.) In Figure 6.4 the map was georeferenced using the northeast corner of the stable and aligning the east-west geophysical anomaly with the north wall of the greenhouse. This version also shrinks the buildings substantially, and it takes the fronts of the stable and the greenhouse extension out of flush alignment.

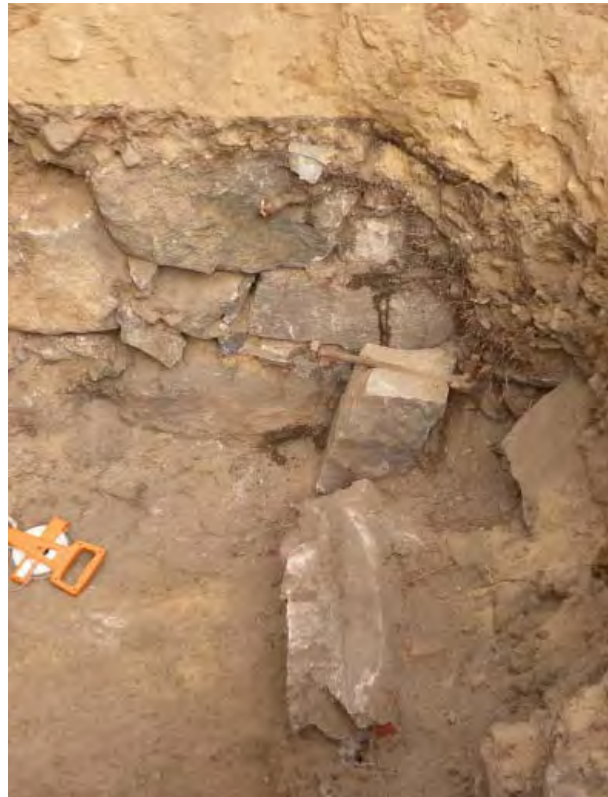
Figure 6.6. Granite door post for carriage house cellar entrance

Excavation of a portion of the carriage house cellar revealed the lower portion of at least the rear (north) foundation wall to be well preserved along with the cellar floor. The wall is constructed of large and small rubble or field stones mortared in place. Wall height ranged between 55 and 85 cm above the floor surface, indicating that at least 80 cm of wall was missing from the highest preserved portion. The rear wall is approximately 60 cm (2 ft) in thickness and probably extended eastward past the granite door support post to form the north and east walls of the entrance ramp. The opening for the cellar entrance was defined by the split granite post directly against the stone wall (Figure 6.6). Although the top half of the post was missing, the lower portion was dug into the cellar floor and retained an iron pintle that passed through the post. The exterior portion of the pintle would have held the door hinge, while the interior portion was fitted with a nut and washer that indicated a wooden post was once present against the interior side of the granite post, and probably served as part of the door framework. The door sill consisted of concrete with fragmented brick that appeared to fill the space of a former wooden sill. Below the concrete was fieldstone that the wood sill would have rested on. The presence of the brick
