Undurraga R., Barluenga G.; Architectural analysis of the Antezana Hospital: a 15th century noble house in the historic city of Alcalá de Henares (Madrid, Spain). Proceedings of the 6th International Congress on “Science and Technology for the Safeguard of Cultural Heritage in the Mediterranean Basin”, A. Guarino Ed., Athens (Greece). Oct. 2013, Vol. III, pp. 104-111. ISBN: 978-88-97987-05-5

ARCHITECTURAL ANALYSIS OF THE ANTEZANA HOSPITAL: A 15TH CENTURY NOBLE HOUSE IN THE HISTORIC CITY OF ALCALÁ DE HENARES (MADRID, SPAIN)

This paper presents a multidisciplinary study of the Antezana Hospital, a former mid-15th century noble house. The aim is to identify the appearance, the construction techniques and the materials of the original house before becoming a hospital, highlighting the historic value of the building

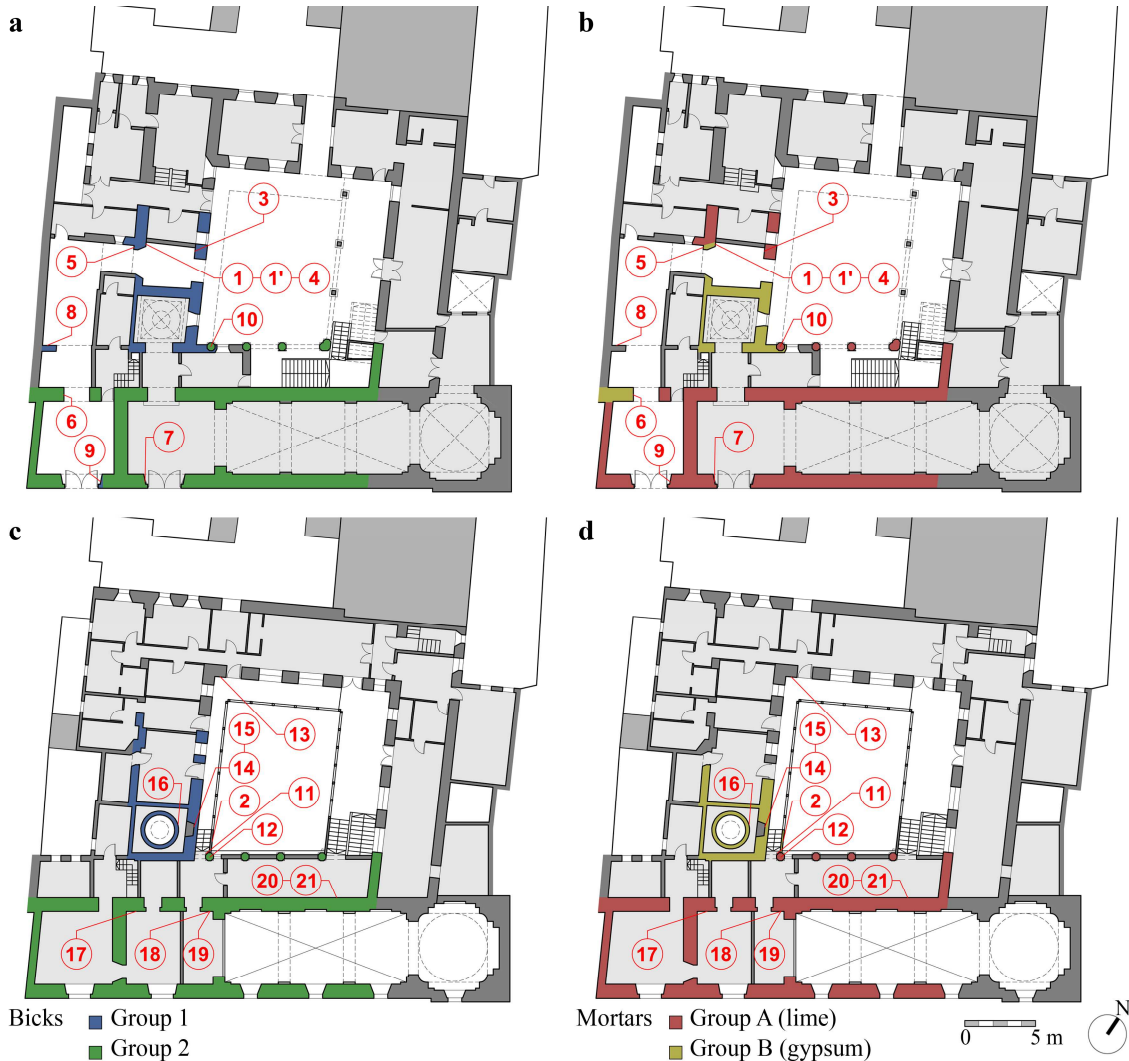
Figure 1. Ground floor plan (a, b), first floor plan (c, d) of the Antezana Hospital and samples location.

The building had a central courtyard with two storeys (fig. 1) and was originally built with rammed earth and brick masonry. The south side of the patio has a gallery of brick columns (fig. 1a) and the other three sides have wooden corridors (fig. 1c). On the west side of the courtyard, there is a baroque chapel dedicated to St. Ignatius of Loyola. The front piece, facing the main street, is occupied by a church which was built in 1800 and, in the north side, there is an attached volume raised in the twentieth century.

In summary, group 2 correspond to the bricks used in the original house (15th century) and the interventions of the 16th century, while Group 1 correspond to the bricks used in the interventions of 1669, when the St. Ignatius's chapel was built (fig. 1a, 1c). Mortars group B are associated exclusively with the works of the chapel of St. Ignatius and specific interventions around it, as the opening of the hall to the access courtyard and the plaster of the pillar in front of the chapel. While mortars group A, are related to 15th and 16th centuries works (figure 1b, 1d).

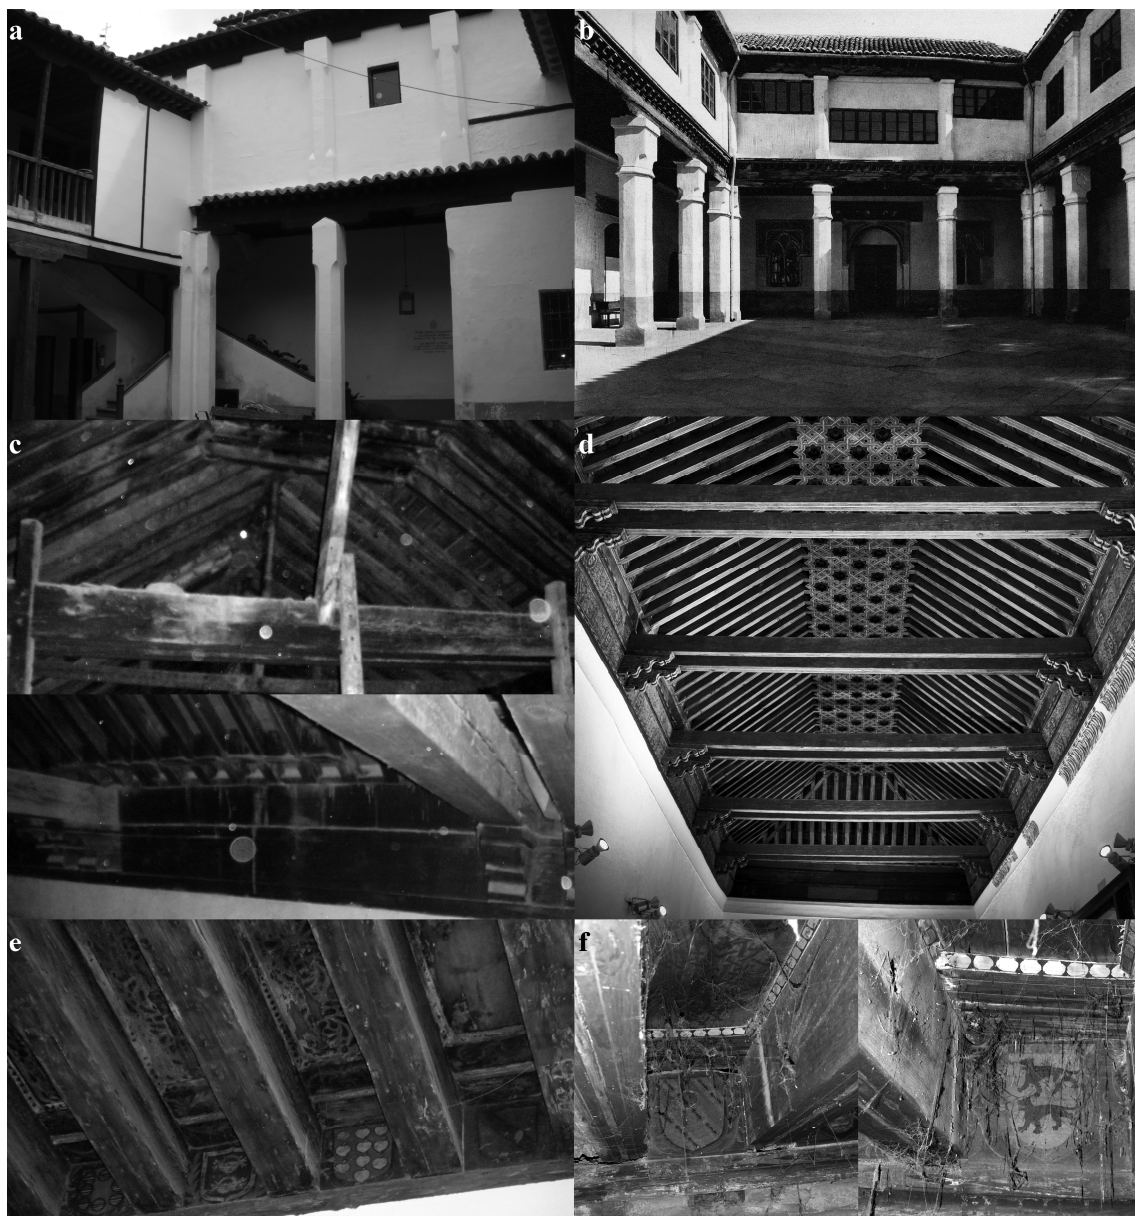
Figure 3. Comparative analysis between the Antezana Hospital (a, c, e) and the Palace of Fuensalida in Toledo (b, d, f): two-storey courtyard with galleries of octagonal masonry column (a, b); woodwork ceiling of the upper main hall (c, e) and decoration based on heraldic shields (e, f).

The octagonal masonry columns (square floor plan and chamfered corners) without capitals from the original gallery are conserved, although the voids were brick up in the first modification of the house, when the hospital was established in the late 15th century (fig. 3a).

The church was built in the two large rooms of the front piece of the original house. The woodwork ceiling of the upper main hall conserved above the dome of the church also corresponded to this period (fig. 3c). According to the length of the south volume, the courtyard originally would have been larger and the masonry gallery would have had five bays, although only four columns remain.

The gallery with chamfered masonry columns (fig. 3a) and wooden elements, the eave and roof (fig. 3c) that still remain on the south volume, matches with the characteristics of a *Mudéjar* house of the fifteenth century. *Mudéjar* is a Spanish style influenced by Islamic architecture. In Alcalá de Henares, this is the only house of its kind preserved, although other contemporary examples can be found in Toledo. In the 15th century, Alcalá was a lordship of the Archdiocese of Toledo, a high point of the *Mudéjar* art. Some examples are the Palace of Fuensalida (fig. 3b, 3d, 3f) built in the early fifteenth century and the Palace of Don Gutierre de Cardenas in Ocaña built in the in second half of the fifteenth century [6].

Both buildings are organized around a central two-storey courtyard with galleries of octagonal masonry columns (fig. 3b), as those preserved in the hospital. Also the woodwork ceiling of the upper main hall of the hospital (fig. 3c) has the same construction elements of the ceiling as the main hall of the Palace of Fuensalida (fig. 3d). Another shared characteristic is the second hall of the hospital and its decorative elements based on heraldic shields of the owners (fig. 3e), which are closely related to those found in the Palace of Fuensalida (fig. 3f). Additionally, the façade eave of the hospital is very similar to the eave of another *Mudéjar* building of Toledo: the *Carcel de la Santa Hermandad*, [7].

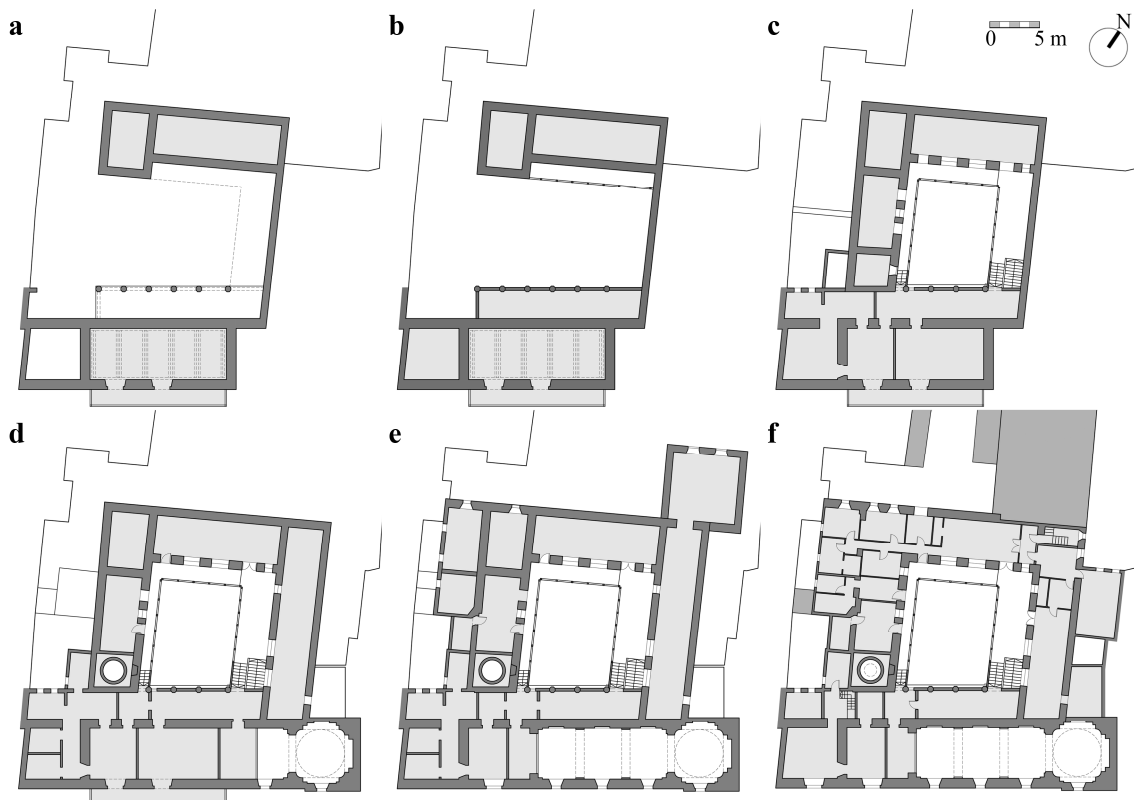
Figure 4. First floor plan. Hypothesis of the building transformation: a) 15th century. b) 1483. c) 16th century. d) 17th century. e) 19th century. f) Current state.

This study combines an architectural and an archaeometric analyses and allows to propose a hypothesis of the changes occurred in the Antezana Hospital during the last 500 years (fig. 4).

The results suggest that the original courtyard of the house was not built as it is nowadays and the original parts were only the north, south and the octagonal columns gallery (fig. 4a, 4b). The original construction was built with rammed earth boxes between brick piers and lime mortar. However, materials characterization cannot differentiate bricks and mortar of the 15th century from those of the 16th century. The mid-17th century materials were clearly identified and they were related to the construction of the St. Ignatius' chapel (fig. 4d).
