Bridge-in-a-Backpack™ Task 6: Guidelines for Long Term Inspection and Maintenance, 2016

Technical Report 16-12

Bridge-in-a-Backpack™

Task 6: Guidelines for Long Term Inspection and Maintenance

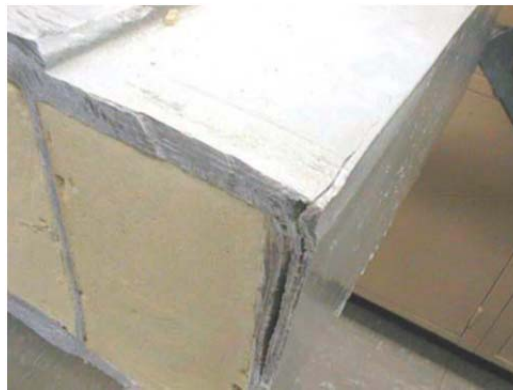
Figure 2: Voids resulting in surface cracks (Ryan et al [3])

Ryan et al [3] describes voids and delaminations are regions where the FRP shell or layers of the FRP shell have separated from each other. Voids could be present from construction when air pockets form between the concrete and FRP shell. Delaminations could be caused by impact, excessive flexure or poor quality control during manufacturing. Figure 2 shows a void and resulting surface crack of a foam filled FRP structure. Figure 3 shows a delamination due to a puncture.

Fiber exposure often occurs along with other types of damage, such as punctures, abrasion, fire, or scratches and gouges. This is a serious condition due to the significant exposure to fibers and should be remedied. Along with the fiber exposure shown in Figure 2, Figure 4, Figure 5, Figure 9, and Figure 10, fiber exposure due to fire is shown in Figure 8.

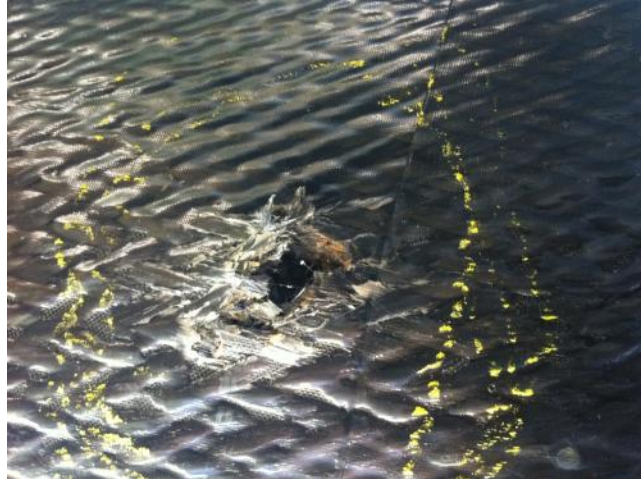
Figure 5: Full puncture/hole in carbon fiber laminate

According to the **BRIDGE INSPECTOR'S MANUAL**, Ryan et al [3], punctures, holes, and cracks may result from impact of vehicles, debris such as logs or rocks, or other deficiency left untreated. Full or partial punctures may result in additional cracking and delaminations. A puncture in a BiaB composite CFFT with a puncture can be seen in Figure 5. The damage shown in Figure 5 is quite small and not an immediate structural concern, but would need to be sealed with a small surface patch to prevent the ingress of water or chemicals and which could cause future degradation of the FRP.

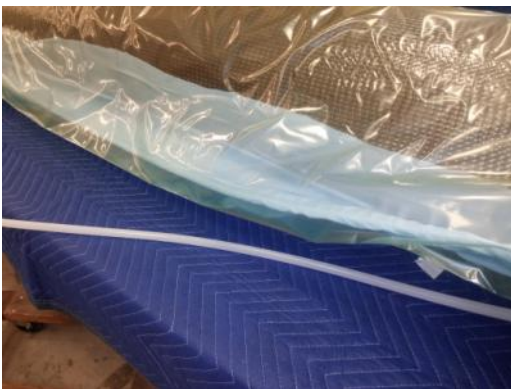
Figure 6: Bagging film wrinkles acceptable in the resin layer of a BiaB FRP tube

Wrinkling can occur in multiple areas of the FRP. This can occur in the fabric in the lamina itself, which is generally due to fabrication control issues, and is evaluated for acceptance prior to shipment of the FRP tube. Another type of wrinkling can occur in the bagging film as shown in Figure 6, causing a resin wrinkle as shown in Figure 7. This type of wrinkling is normal for this type of FRP tube structure and not a structural concern. Wrinkling can also be due to high compression stresses in a thin composite, which results in buckling of the tows or fibers. While tow buckling is certainly a sign of structural distress, it is highly unlikely that it would occur in a BiaB tube since the concrete carries the vast majority of the compressive stresses.

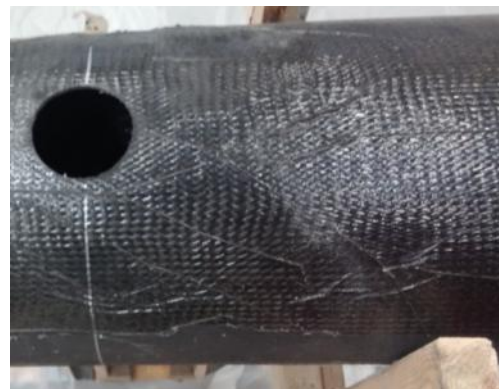
Figure 7: Acceptable wrinkling in the resin layer of a BiaB FRP tube

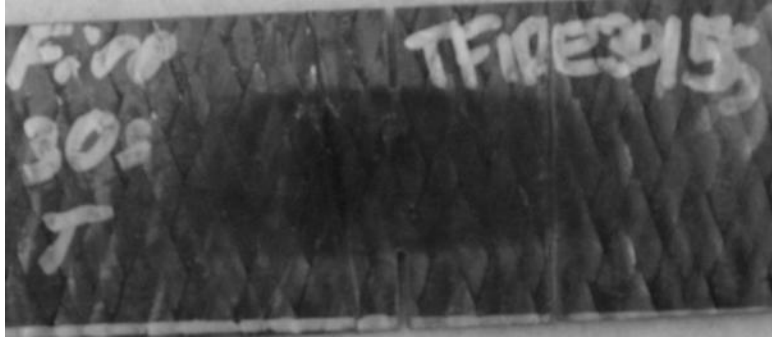
Figure 8: Fibers exposed due to fire damage

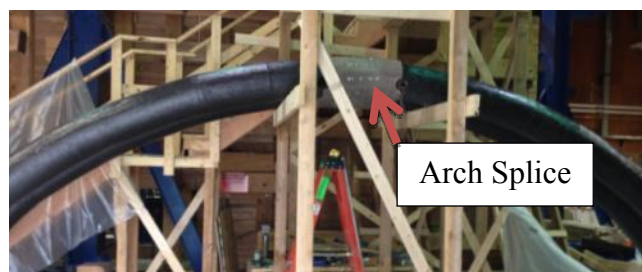
Figure 12: Key inspection location, spliced arch in laboratory

Key locations for inspection of the tubular composite arches include the crown, shoulders (approximate quarter span), and bases of arch where they are embedded in the foundation. Dagher et al [1] has described these are the locations of peak moments and stresses. Additionally, any splices and connections to FRP headwalls and decking are areas to inspect. These areas are shown in Figure 11 and Figure 12.

1. Crown – area of peak moment. Look for distress, particularly discoloration due to excessive strain or excessive deflections
2. Shoulders – area of peak moment. Look for distress, particularly discoloration due to excessive strain or excessive deflections
3. Arch bases – area of peak axial load. Look for distress, particularly discoloration due to excessive strain or splitting of cross section or foundation
4. Splices (as applicable) – look for signs of increased separation of splice components, delaminations, cracks or other deficiencies.
5. Headwall and Deck connections (as applicable) – look for signs of increased separation of connection components, delaminations, cracks, punching or other deficiencies.

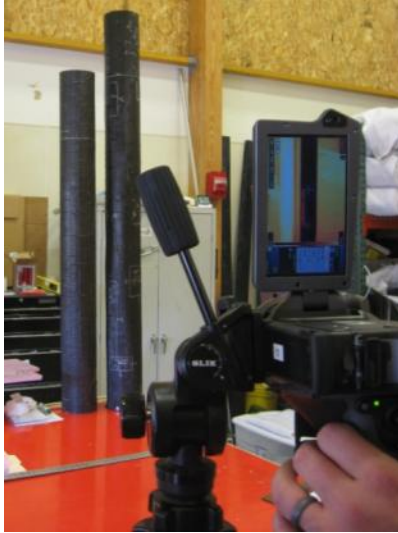
Figure 13: Infrared camera in use

As described by Kittridge et al [11], a FLIR SC620 infrared (IR) camera for conducting thermography inspections was used by the Composite Center. This portable camera along with the accompanying ExaminIR analysis software is a high performance IR system used for science and research applications. It has 640×480 resolution, a temperature range of -40°C to 500°C (-40°F to 932°F), accuracy of ±2°C (±3.6°F), 0.65 mrad spatial resolution, and a thermal sensitivity of ≤55 mK. Data (including full field radiometric temperature measurements) are captured either as still images or streaming video. Changes in heat transfer rate (and therefore surface temperature) due to internal flaws create an image that highlights various defects. A photograph of the SC620 is provided in Figure 13.

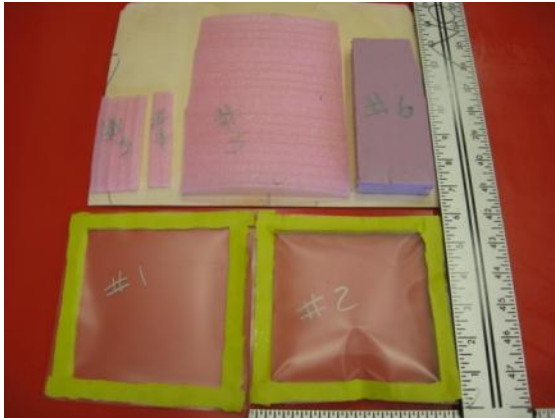
Figure 14: Materials used to create artificial voids

The specimens were 6.5 inch diameter hybrid glass/carbon fiber FRP tubes, nominally 6 feet long, with multiple artificial voids directly on the inside of the FRP shell. All tubes were mapped for actual locations, only two are marked on the exterior for locations of actual voids. To produce the voids several materials were used that included $\frac{3}{4}$ inch Foamular 250 foam board insulation, $\frac{1}{4}$ foam sill seal, and air pockets formed by sandwiching plastic film with tacky tape. Two different thicknesses of the plastic film air pocket were created. Various size foam blocks were used as well for simulating air voids between concrete and CFRP tube. These materials can be seen in Figure 14 prior to installation. The installed materials can be seen in one tube in Figure 15.

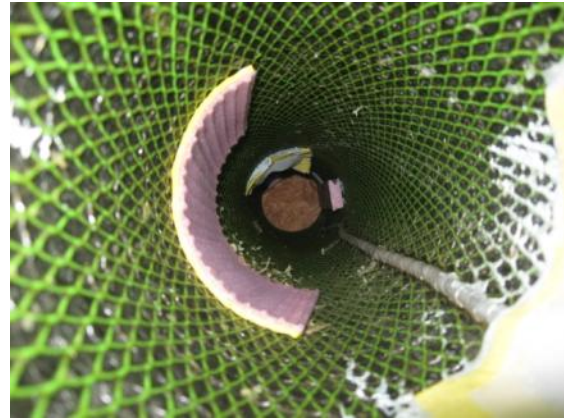
Figure 15: Inside of tube with artificial voids

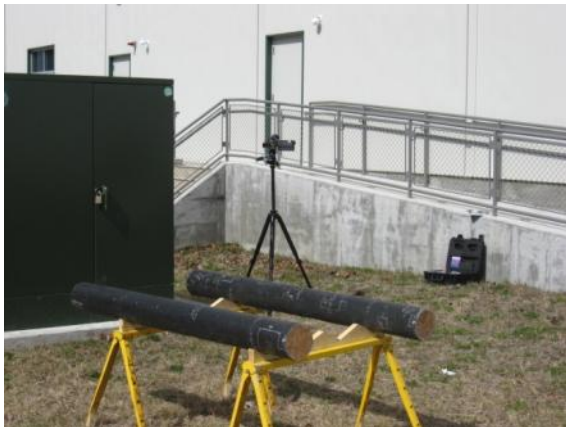
Figure 22: Tubes outside of lab

Concrete filled tubes were placed outside on several occasions for inspection with IR thermography. This simulated in place conditions for BiaB inspections. Various environmental conditions were evaluated including direct sunlight, overcast conditions and early and late day conditions with relatively rapid changes in ambient air temperature. Figure 22 shows the CFFTs outside of the laboratory for inspection. Tubes were checked for effects of thermal changes in air temperatures and direct radiation heating from the sun. As can be seen from the thermal photo in Figure 23, 2 voids were seen by their darker color indicating a temperature variance.

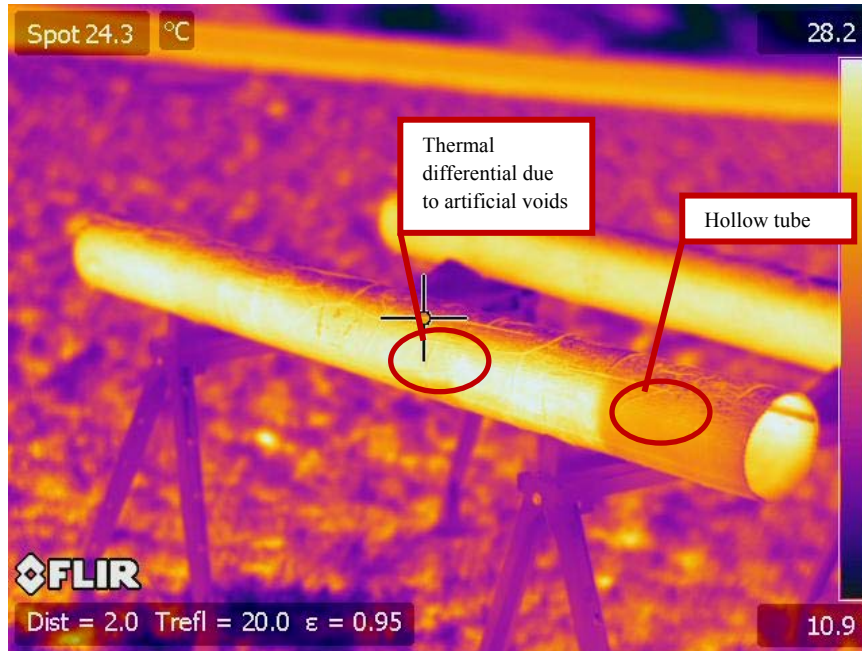
It was difficult to detect the voids on sunny days where there was direct heating of the surface of the FRP as is shown in Figure 24.

Figure 24: Tubes in direct sunlight
