A Risk Management Approach to Pillar Extraction in the Central Appalachian Coalfields

**Thesis submitted to the
College of Engineering and Mineral Resources
at West Virginia University
in partial fulfillment of the requirements
for the degree of**

**Master of Science
in
Mining Engineering**

Keywords: Coal Pillar Extraction, Retreat Mining, Central Appalachia, Mining Engineering, Risk Management, Coal Mine Safety

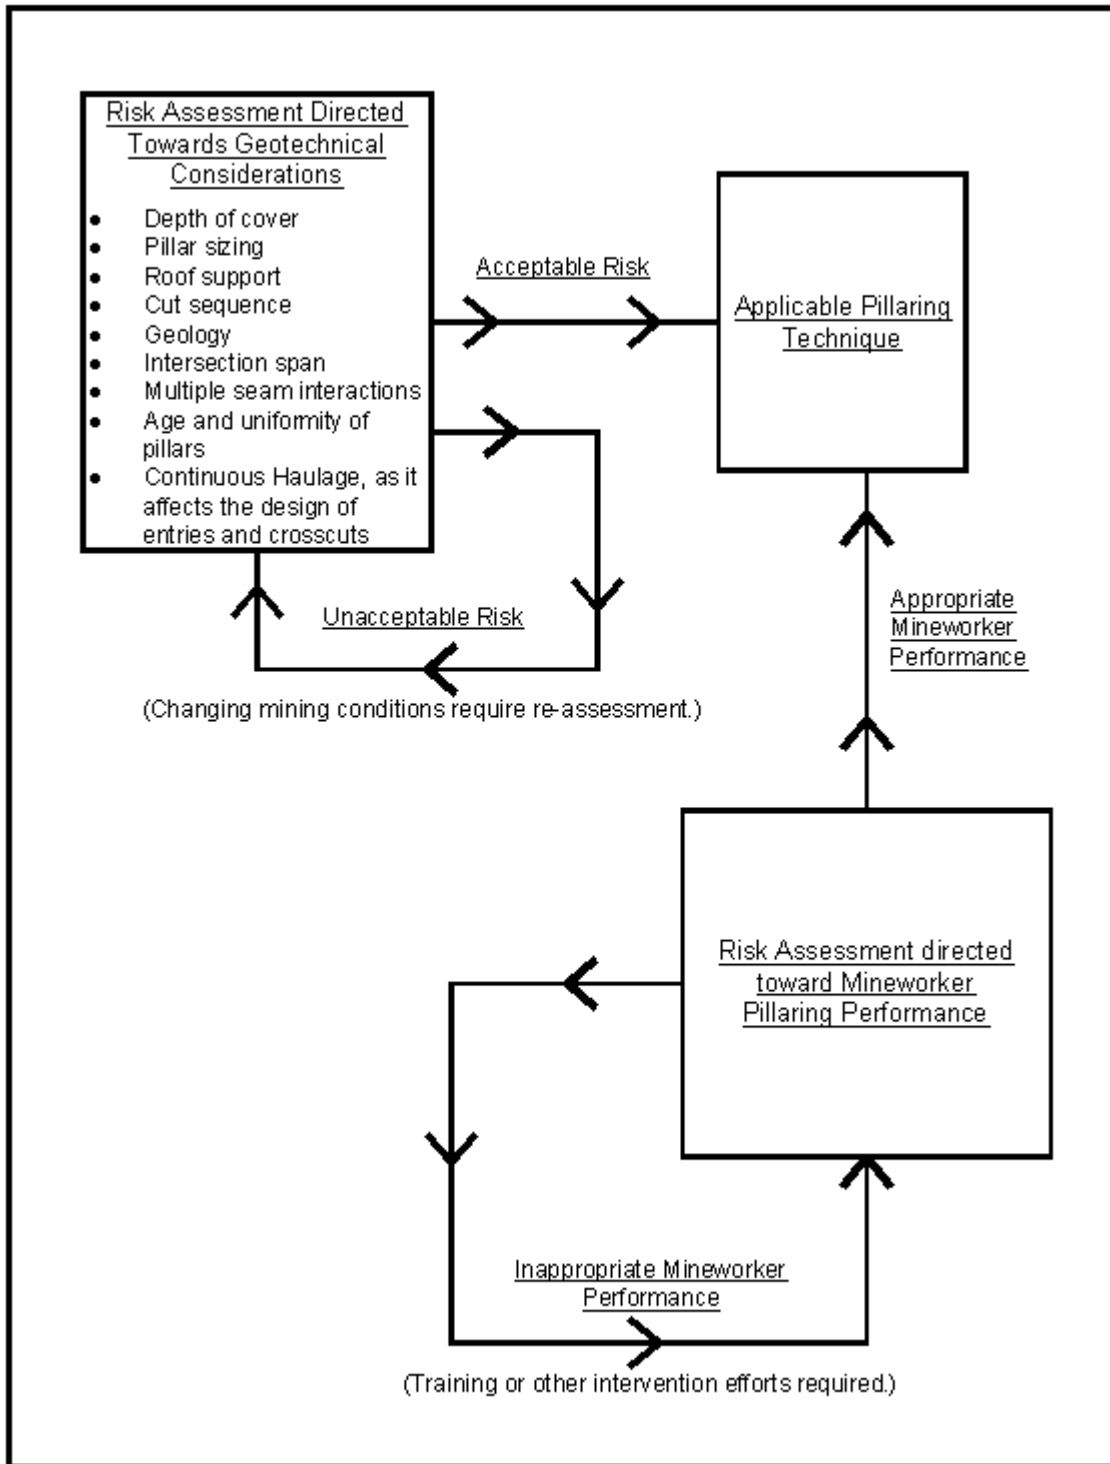
Figure 1.7. Risk Management Flowchart for Pillaring (Bise, 2007)

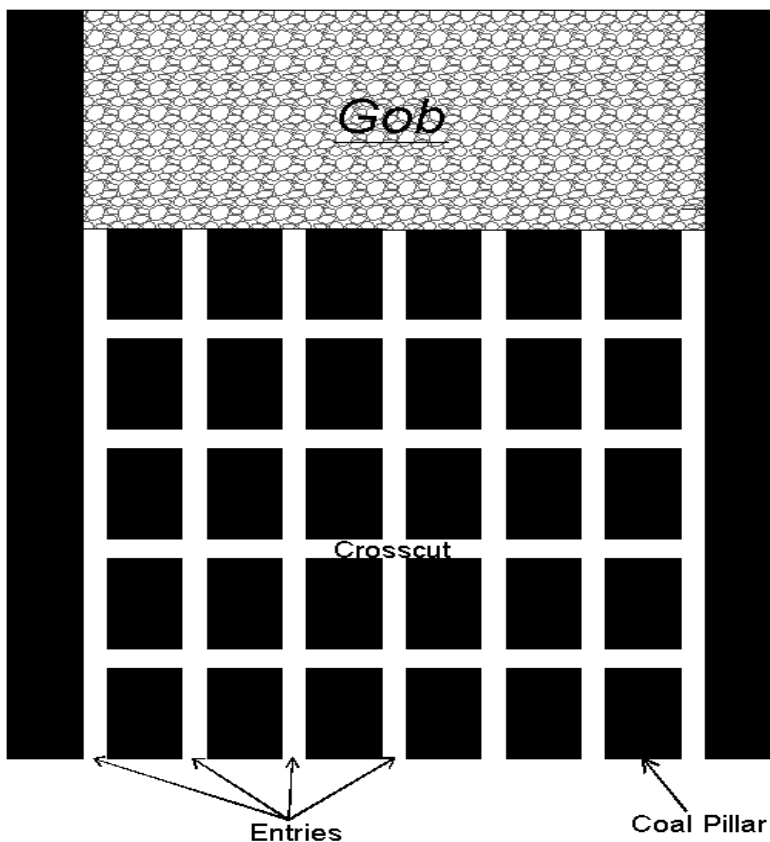
Figure 2.1. Typical Pillaring Section

As a coal mine is developed, entries and crosscuts are driven into the coal seam. These entries and crosscuts result in coal pillars that are left in place to support the overburden (Figure 2.1).

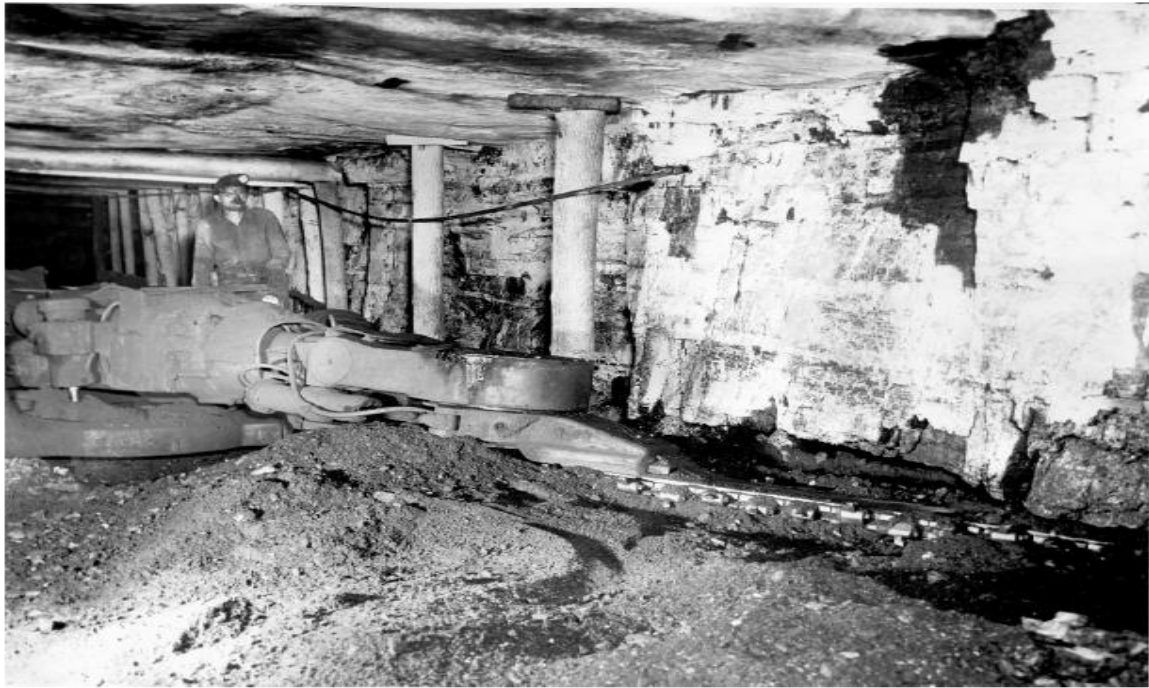
Figure 2.2. Early Coal Cutter (Courtesy of www.coalwoodwv.com)

In mechanized conventional mining, the coal was cut using a coal cutter that resembles a giant chainsaw. The coal cutter was equipped with a cutter bar, usually 9 to 11 ft long, with bits capable of cutting a 6-in slot or "kerf" at the bottom of the seam (Stefanko, 1983). While, in some instances, coal cutters were track mounted, most were rubber tired to provide better mobility (Figure 2.2). The process required the coal cutter to be moved to the face, and then it was used to make one and in some cases two horizontal cuts in the coal face to prepare it for blasting. The cutting of a coal seam prior to blasting is necessary because the kerf left by the cutting process permits the expansion of the coal during the blast, thereby requiring much less explosives than if the coal was shot from the solid (Stefanko, 1983).

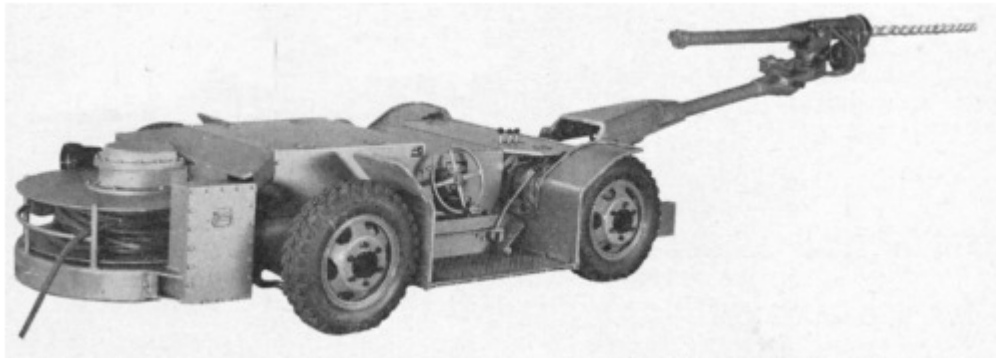
Figure 2.3. Early Coal Drill (Courtesy of www.coaleducation.org)

After the coal was undercut, a mobile coal drill was brought to the face in order to prepare holes for blasting (Figure 2.3). The coal drill was a rubber-tired vehicle with an auger-type drill mounted on a hydraulic boom which enables the drilling of holes parallel to the entry direction over a range of widths and heights without repositioning of the entire unit; the auger bit length was usually matched to the coal cutter bar length (Stefanko, 1983).

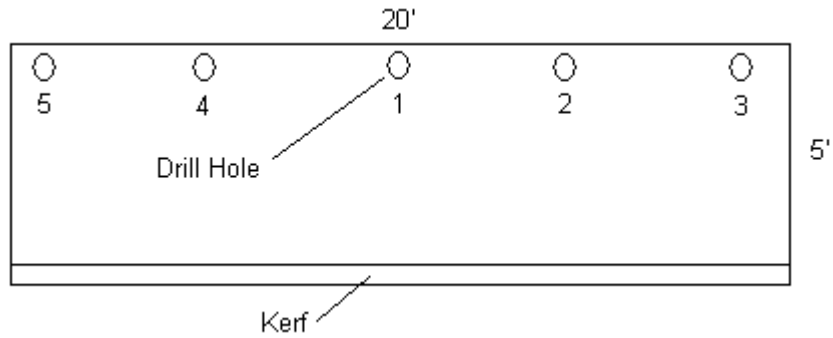
Figure 2.4. Typical Face Prior to Blasting (Stefanko, 1983)

After the coal face was cut and drilled, blasting operations commenced (Figure 2.4). According to Stefanko (1983), blasting/shooting the coal was accomplished using either permissible chemical explosives or with compressed air. In both cases, the only equipment required were hand tools to load the explosives into the holes and, possibly, a small cart to transport the supplies.

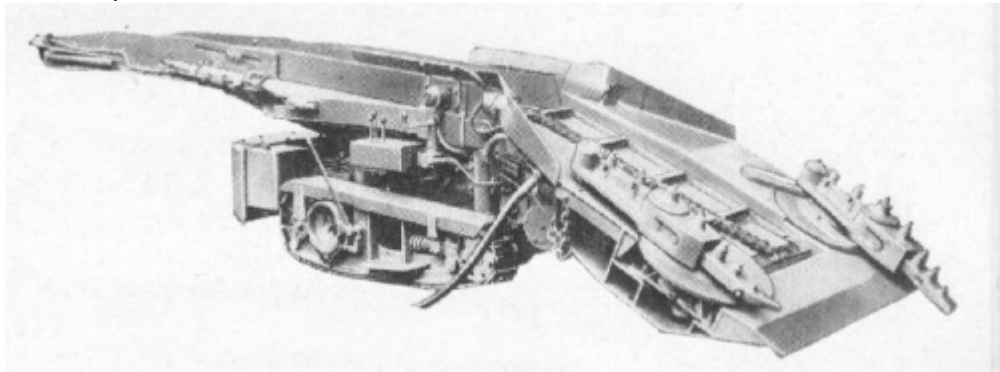
Figure 2.5. Early Joy Loading Machine (Courtesy of www.coaleducation.org)

After the coal was shot from the face, it was loaded into a shuttle car or other type of transportation mechanism. A typical loading machine was equipped with two eccentric gathering arms that collected the coal as the machine was advanced into the fragmented pile (Figure 2.5). A chain conveyor then moved the coal from the loading head to the boom on the rear of the machine. The coal was then discharged from the boom to a haulage vehicle (Figure 2.6); in most cases the haulage vehicle was a shuttle car (Stefanko, 1983).

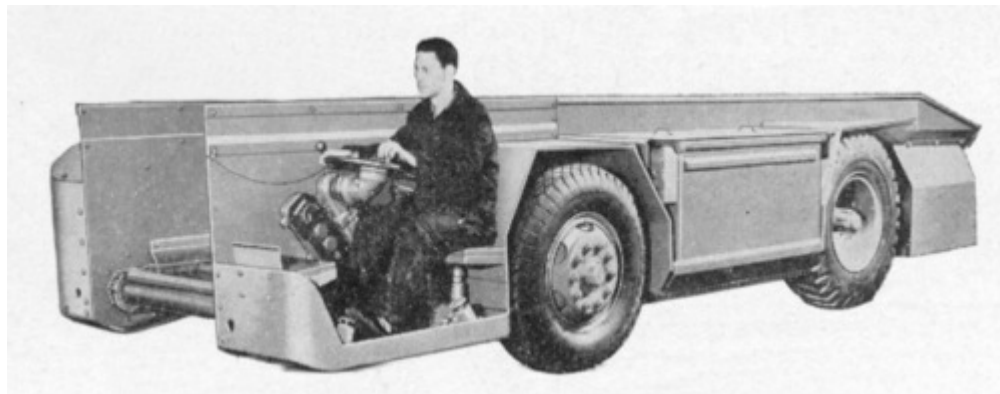
Figure 2.6. Early Joy 42 Shuttle Car (Courtesy of www.coaleducation.org)

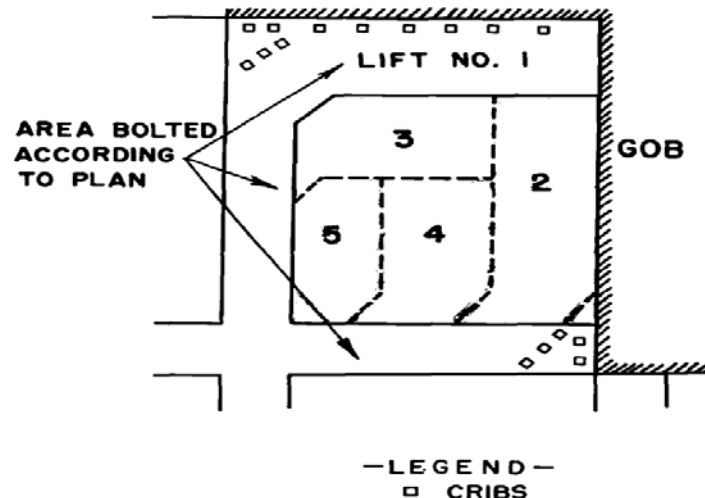
Figure 2.7. Open-End Method (Schroder, 1981)

Open-End Method. Initially utilized during the hand-loading days before being incorporated into conventional mechanized mining methods, the open-end cut sequence provided a transition which bridged the gap between hand loading and conventional mining. When mining with the open-end method, lifts were mined off the gob side of the pillar (Figure 2.7).

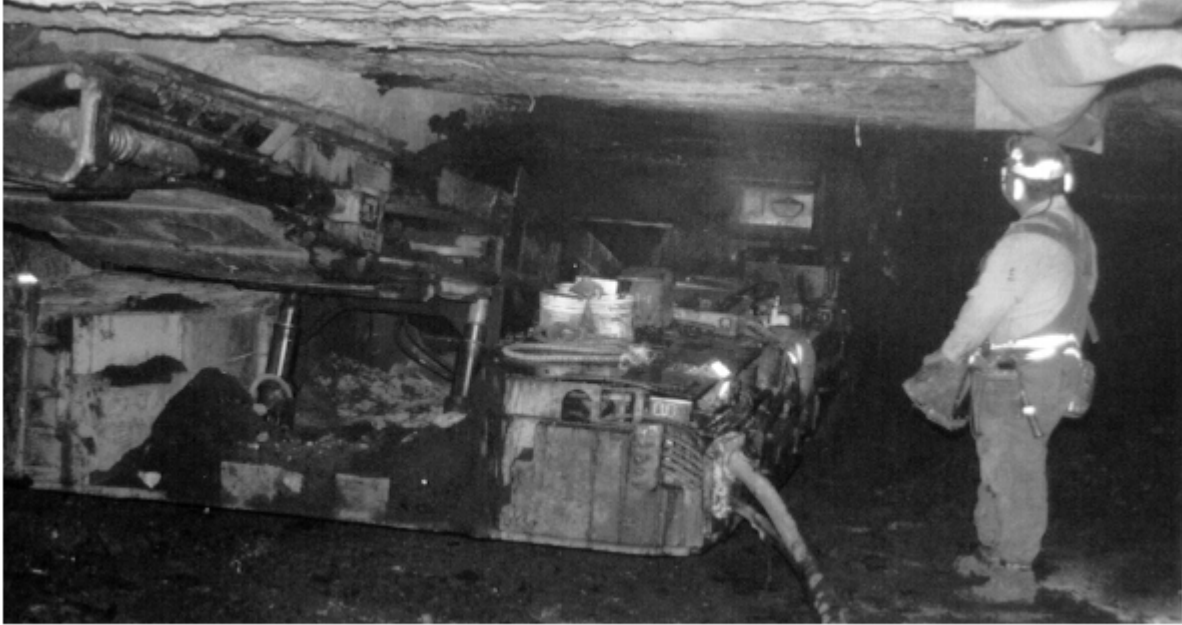
Figure 2.10. Remote Controlled Continuous Miner (Courtesy of www.wvminesafety.org)

Remote-Controlled Continuous Miner. Initial versions of the continuous miner were operated by controls mounted on the machine and, therefore, the allowable depth of cut was limited in order to reduce the exposure of the operator to hazardous roof conditions. The development of the remote-controlled continuous miner and extended cuts permitted cut sequences that required little to no roof bolting. The remote operation also moved the operator further outby, reducing operator exposure to hazardous conditions (Bise, 2007). Figure 2.10 shows the operation of a remote-controlled continuous miner, similar to any that would be found on a modern pillaring section.

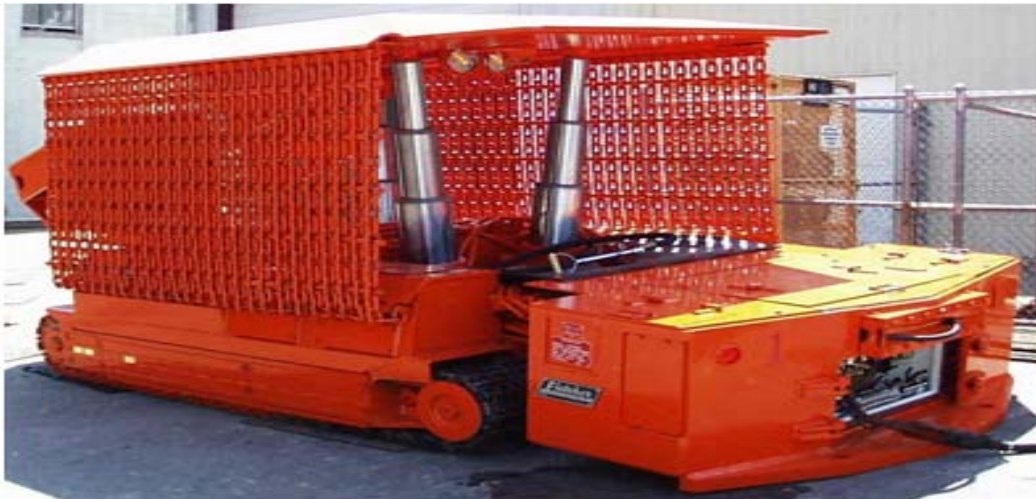
Figure 2.11. Fletcher Mobile Roof Support (Courtesy of Fletcher Mining Equipment)

Mobile Roof Support (MRS). The most significant advancement in pillaring, in the past 20 years, has been the development of the MRS (Bise, 2007). MRS units are large, mobile, remotely operated hydraulic shields that are pressurized against the mine roof. MRS units (Figure 2.11) are utilized in place of the wing, roadway, and, in some cases, the breaker posts.

While there are currently different brands of MRS units in service, the only current manufacturer of MRS units is the J.H. Fletcher Company. New models are designed to operate in seams ranging from 42 in. to 16 ft, with load ratings of either 600 or 800 tons, and they provide protection for the mine personnel and the face equipment while pillar

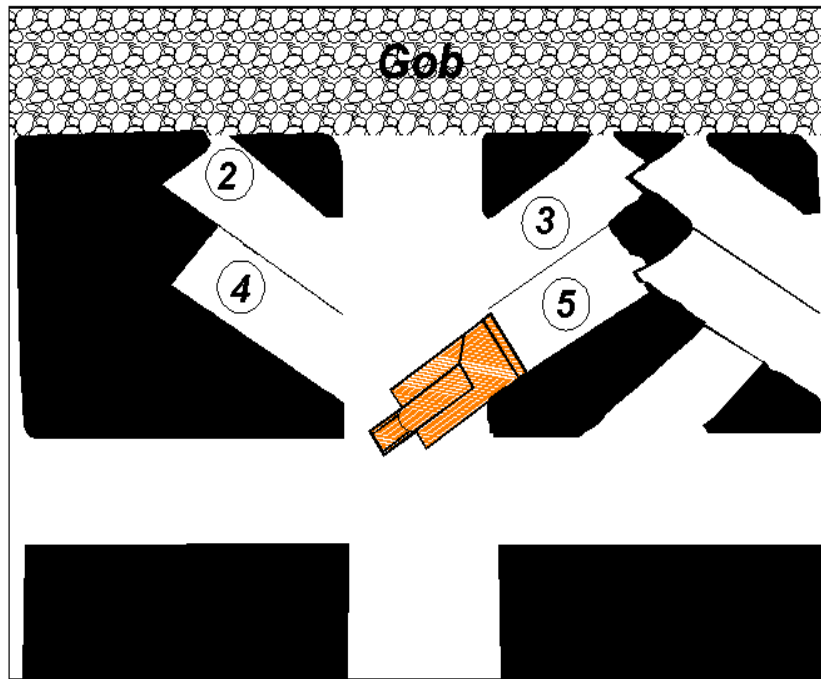
Figure 2.12. Example of the Christmas-Tree Cut Sequence (Mark, et al., 2002)

- wider unsupported spans are mined,
- more time is spent in the same location, and

- the continuous-miner operator's location is not optimal for mining either the left-side or the right-side cut.

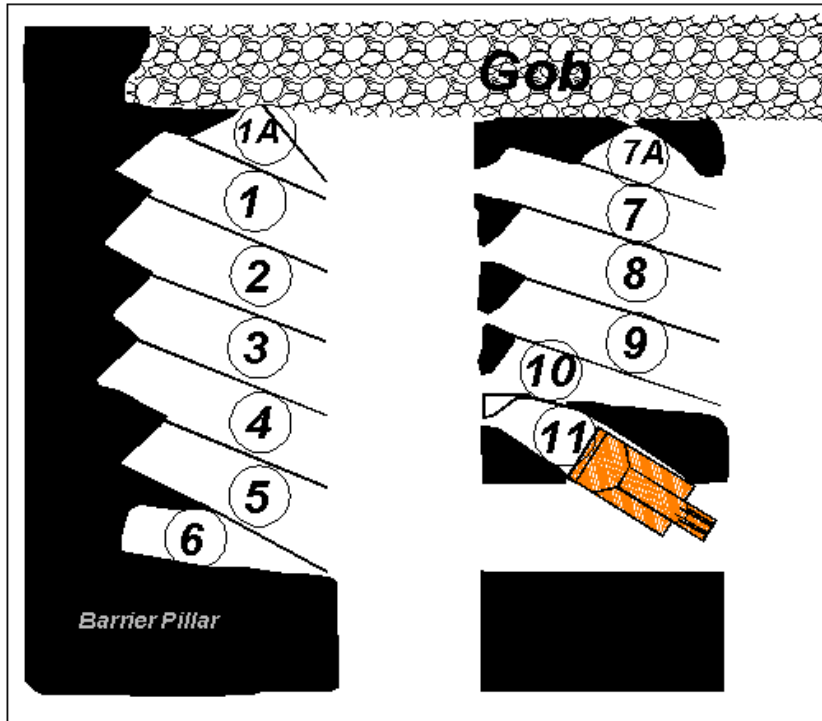
Figure 2.13. Example of the Outside-Lift Cut Sequence (Mark, et al., 2002)

The outside lift method (Figure 2.13) is the second most utilized modern pillaring cut sequence according to Mark, et al., 2002.

The outside-lift method also has particular advantages and disadvantages. Like the Christmas-tree method, the outside-lift method requires no additional roof bolting. Another advantage of the outside-lift method is the positioning of the continuous miner operator. In this cut sequence, the operator always has a solid coal pillar at his back. Local stability is enhanced, due to the fact that unsupported spans are minimized, in comparison to the Christmas tree sequence, by mining one pillar at a time and leaving a solid pillar adjacent to the one being mined. Also, this method extracts a very high percentage of the pillar. However, there are several drawbacks to the outside-lift method. In order for the outside-lift method to optimize extraction percentages, the allowable depth of cut must be equal to, or greater than, the pillar width. This usually limits its usage to shallow seams, where pillar dimensions are typically narrower (Kauffman, et al., 1981). If the outside-lift method is used in thick seams or under deep cover where large pillars are used, a large remnant pillar must be left. It also requires taking a deeper cut than the Christmas tree method. This deeper cut makes the continuous miner much more difficult to retrieve if it is trapped by a roof fall (Mark, et al., 2002).

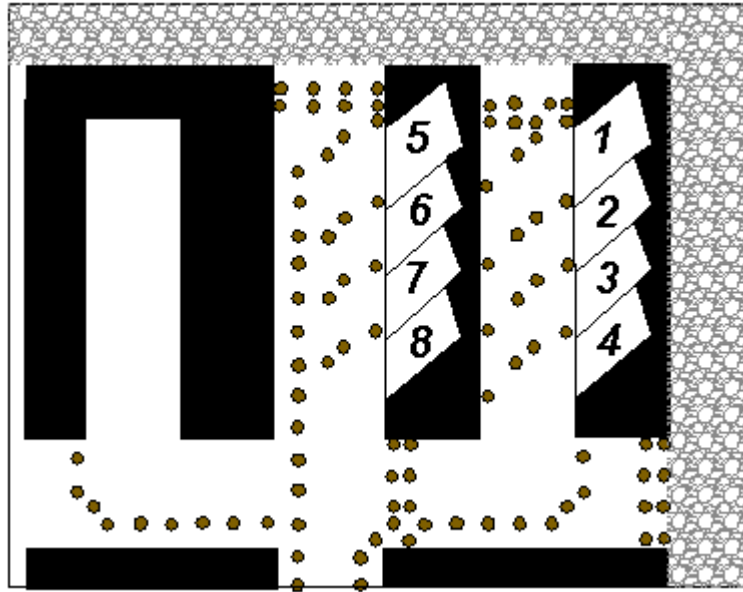
Figure 2.14. Split-and-Wing Cut Sequence (Mark, et al., 2002)

Other cut sequences, such as the split-and-wing (Figure 2.14) and pocket-and-fender (Figure 2.15), have been utilized in Central Appalachia, but to a minimal extent, as indicated in Table 2.1. This is presumably due to the requirement of additional roof bolting and the subsequent additional cost of the roof bolting. Due to their continued existence, they were included in this thesis but, because they are seldom used in Central Appalachia, they will not be discussed any further.

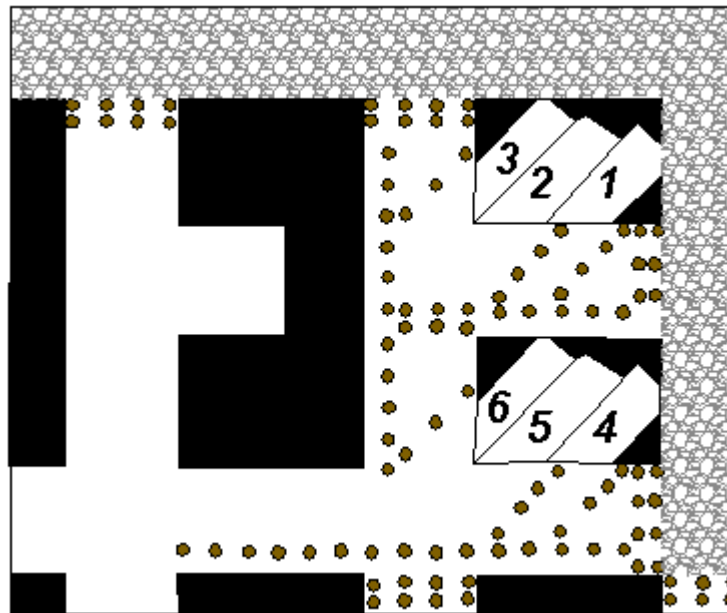
Figure 2.15. Pocket-and-Fender Cut Sequence (Mark, et al., 2002)

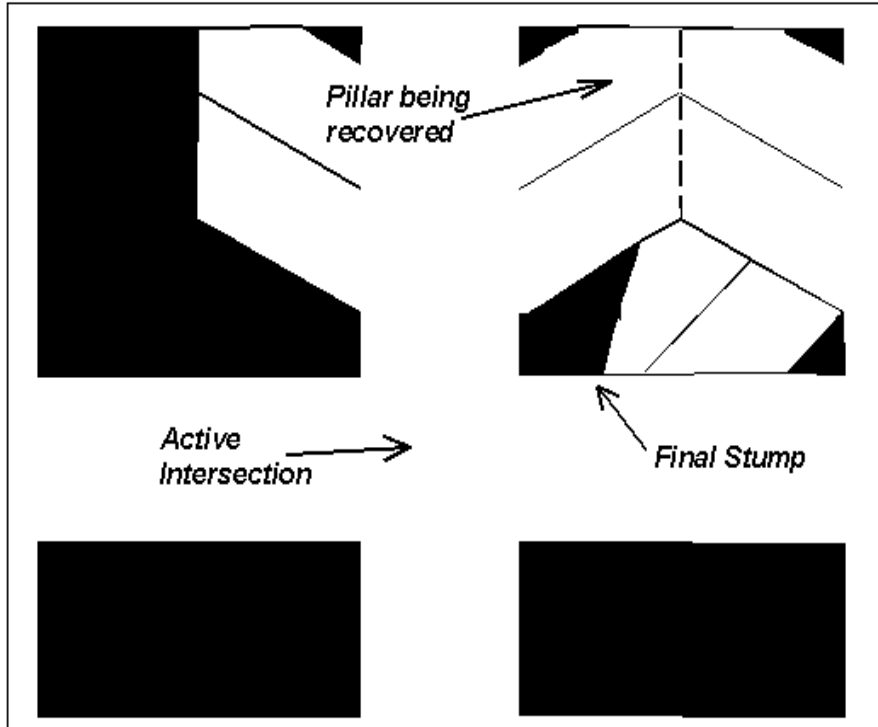
Figure 2.16. Final Stumps (Mark and Zelanko, 2001)

Final Stump. When left unmined, the final stump provides support for the active intersection (Figure 2.16). If the final stump is removed or undersized, the active intersection may become unstable. Final stump removal is a very high-risk activity that has been practiced not only to recover more coal but also because operators suspected that leaving a stump would prevent the gob area from caving, and might also reduce higher stresses from being transferred to the remaining pillars. Recent experience (Table 2.2) suggests that fears about stump removal may have been exaggerated (Mark, et al., 2003). Nonetheless, during recent mine visits conducted as part of this thesis and discussed in the next chapter, miners continue to express concern that not mining the final stump does prevent proper caving.

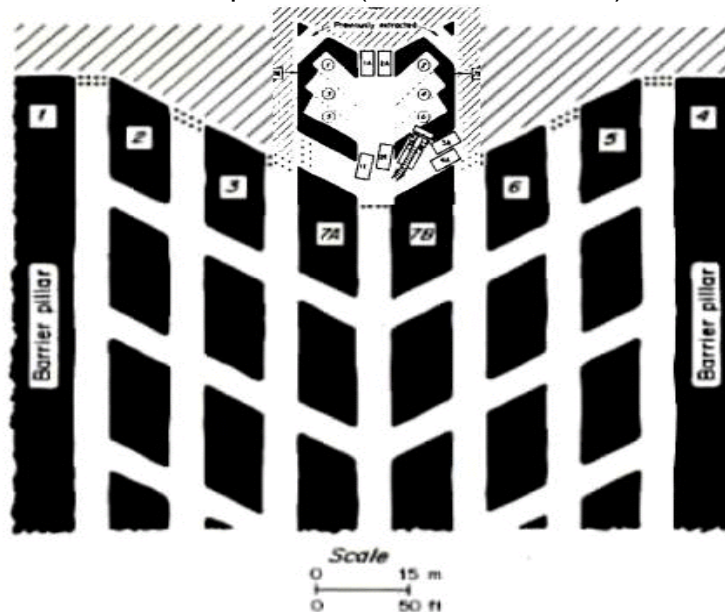
Figure 2.17. Continuous-Haulage Section Layout (Mark, et al., 2002)

Continuous Haulage. In a continuous haulage system, the pillars are typically retreated from both sides toward the center (Figure 2.17). This results in a pillar point in the middle of the active pillar line. The increased stress on this pillar point, due to the removal of adjacent pillars as well as the increased center entry width to accommodate haulage equipment makes the mining of the two center pillars a very high-risk task. An additional mobile bridge unit should be added to the haulage system, permitting the pillars to be worked from the outby intersection and permitting the unidirectional removal of pillars, thereby eliminating the pillar point. Also, if a continuous haulage system is planned with the intent of extracting pillars after development, then the crosscut angles should be minimized as much as possible (Mark, et al., 2003).

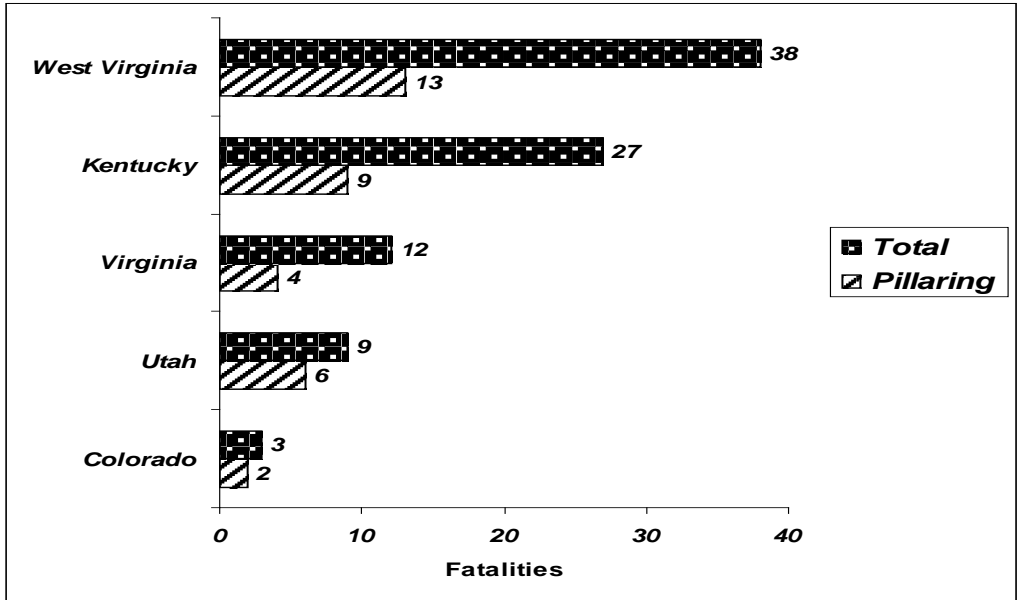
Figure 2.18. Fatalities Related to Falls of Roof or Rib (1995-2007) (MSHA, 2008)

Figure 2.18 compares the pillaring-related fatality statistics for the five states. It is interesting to observe that pillaring represents approximately 33% of the fall-of-ground underground-coal-mining fatalities in each of the Central Appalachian states. Production and active mine information is presented in Tables 2.3 and 2.4.

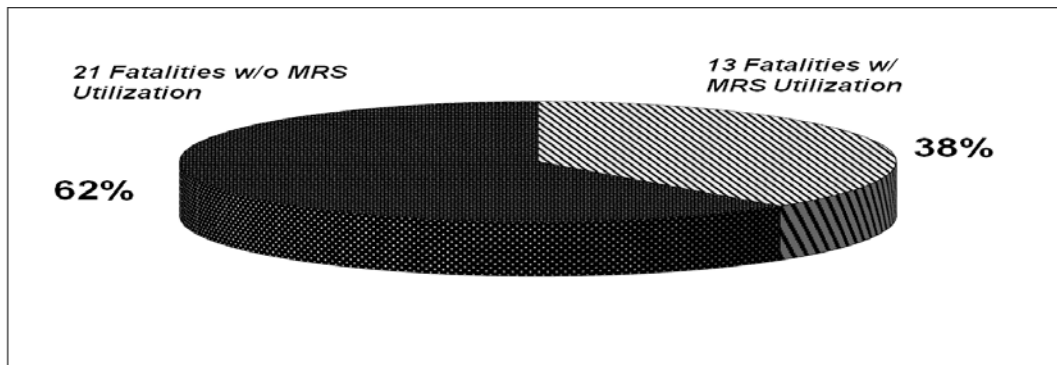
Figure 2.19. Mobile Roof Supports Fatality Statistics 1995-2007 (MSHA, 2008)

New technologies have been developed that have had major impacts on the mining industry both in the areas of production and safety. The pillaring aspect of mining is no exception. Mobile Roof Supports (MRS) are considered by most to be the most recent significant technology applicable to pillaring. As part of the fatality review conducted during the course of this thesis, fatalities were categorized into two types: 1) fatalities where MRS units were utilized and 2) fatalities where MRS units were not utilized. Figure 2.19 and 2.20 show that, although, MRS units do improve safety, fatalities are still occurring, even with the implementation of this technology. The fact that fatalities continue to occur, despite the implementation of advanced technologies such as the MRS, indicates there may be deficiencies in safety training.

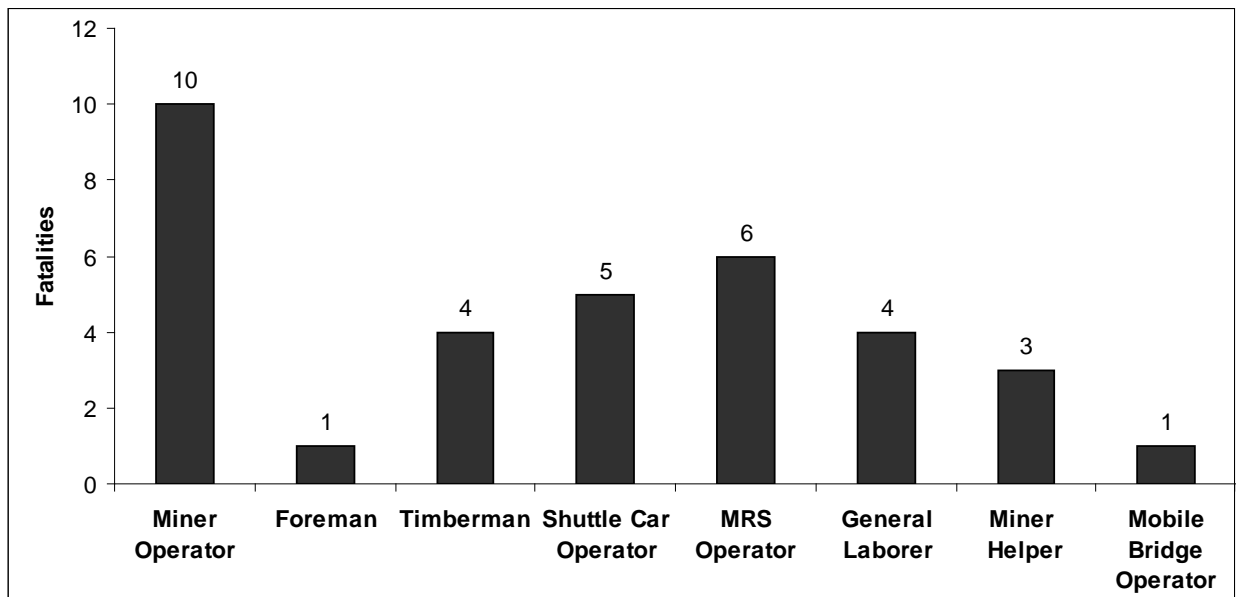
Figure 2.21. Fatality Statistics by Job Description 1995-2007 (MSHA, 2008)

In order to better understand the risks facing each job description, fatalities were also categorized by job description. Figure 2.21 presents pillaring fatalities between 1995 and 2007 on the basis of job classification.

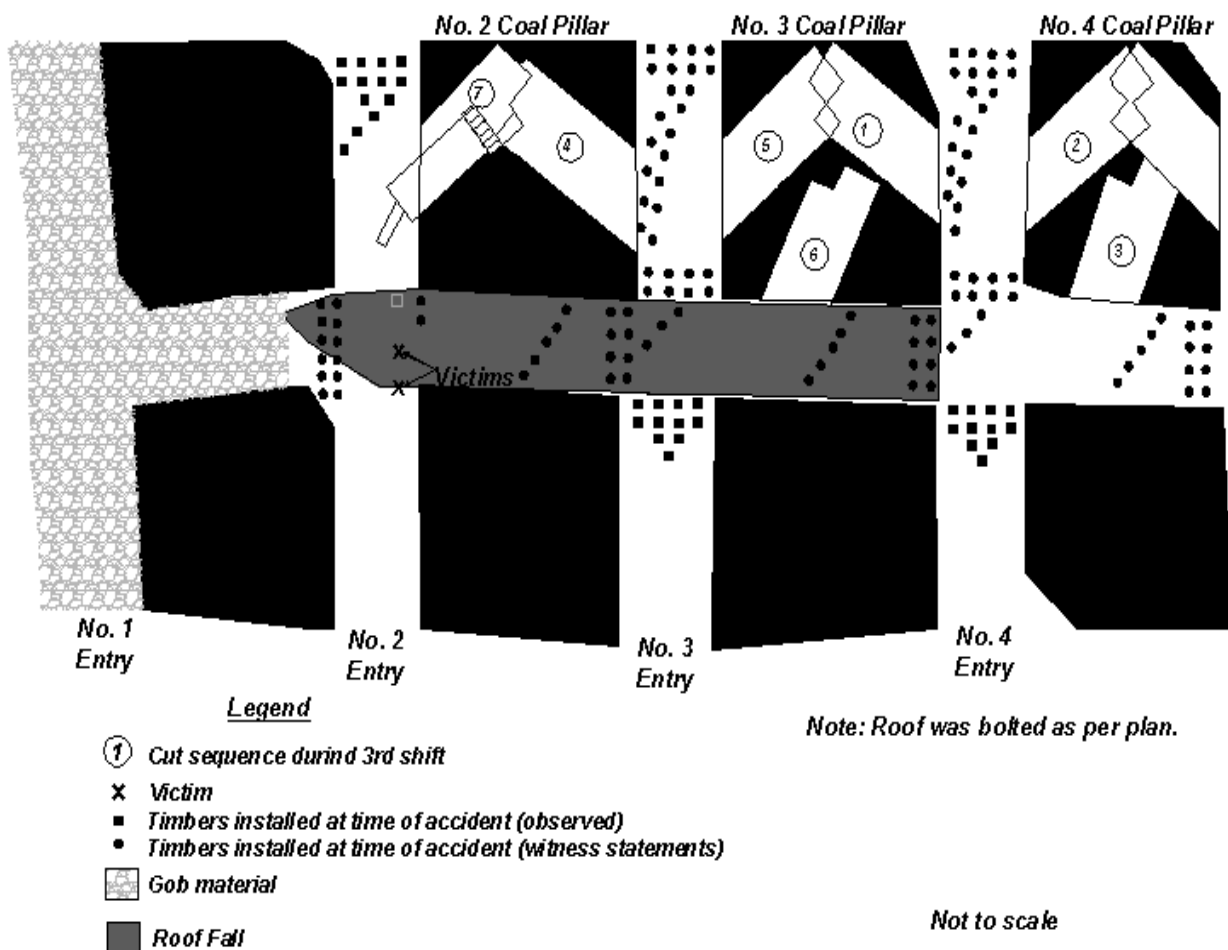
Figure 2.22. Roof Fall Fatality Drawing (MSHA, 2009)

This incident being analyzed represents a double fatality. A section foreman, as well as a continuous miner operator helper (CM helper), were fatally injured as a result of a massive roof collapse. The section foreman and the CM helper will be referred to as Victim 1 and Victim 2, respectively. The full fatality report obtained from the MSHA fatality database is presented in Appendix A of this thesis.

There are two particular characteristics that make this incident worthy of further investigation: 1) the roof control plan was approved using only timbers as opposed to mobile roof supports, and 2) MSHA determined that there were no violations contributing to the incident. These two characteristics are significant because they support the use of mobile roof supports over timbers, as well as identify the increased risk associated with non-essential personnel congregating in the active mining zone.

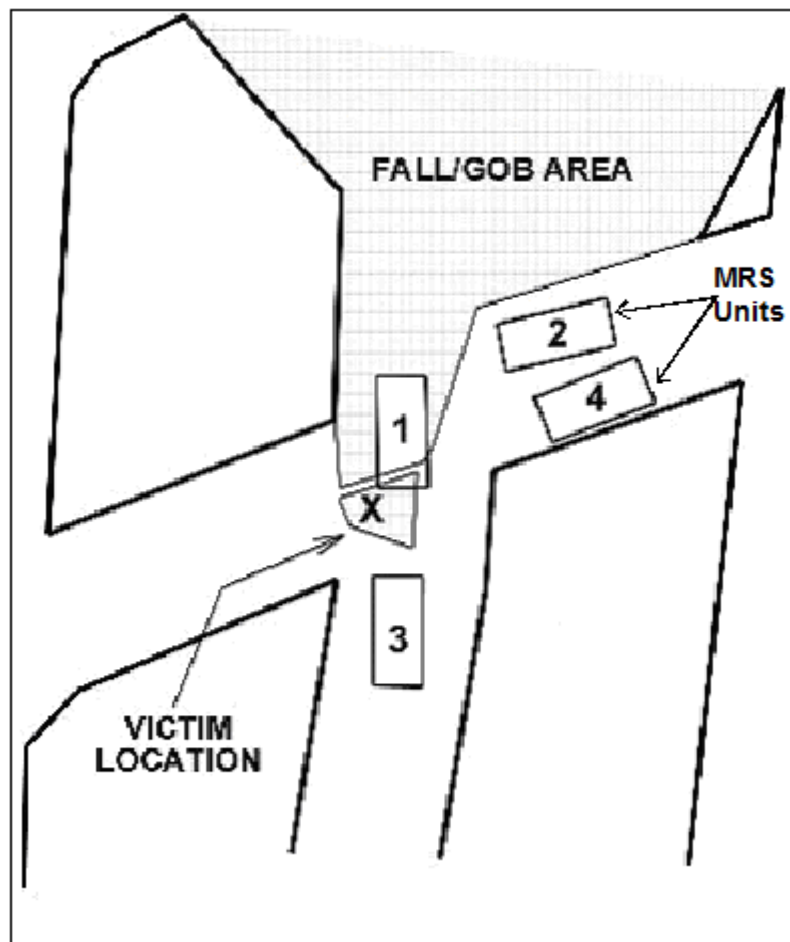
Figure 2.23. Roof Fall Fatality Drawing (MSHA, 2009)

During the course of performing a risk assessment, time of exposure is an important factor. In this case study, a mobile-bridge operator was fatally injured by a roof fall while standing in the active mining zone. The reason for his presence there could not be determined by any of his coworkers; therefore, it can be assumed that he was simply observing from a favorable vantage point.

This case study has been selected because of the fatal injuries sustained by a miner whose presence was not required in the face area at the time of the incident and was, therefore, unnecessarily exposed to hazardous conditions. Exposure of non-essential personnel is an occurrence that was noticed repeatedly both during the evaluation of fatality reports and during mine-site observations (Discussed in Chapter 3). This case study also supports the hypothesis that MRS units may provide a false sense of security. As can be seen in Figure 2.23, the victim positioned himself between the No.1 and No. 3 MRS units prior to the fatal roof fall.

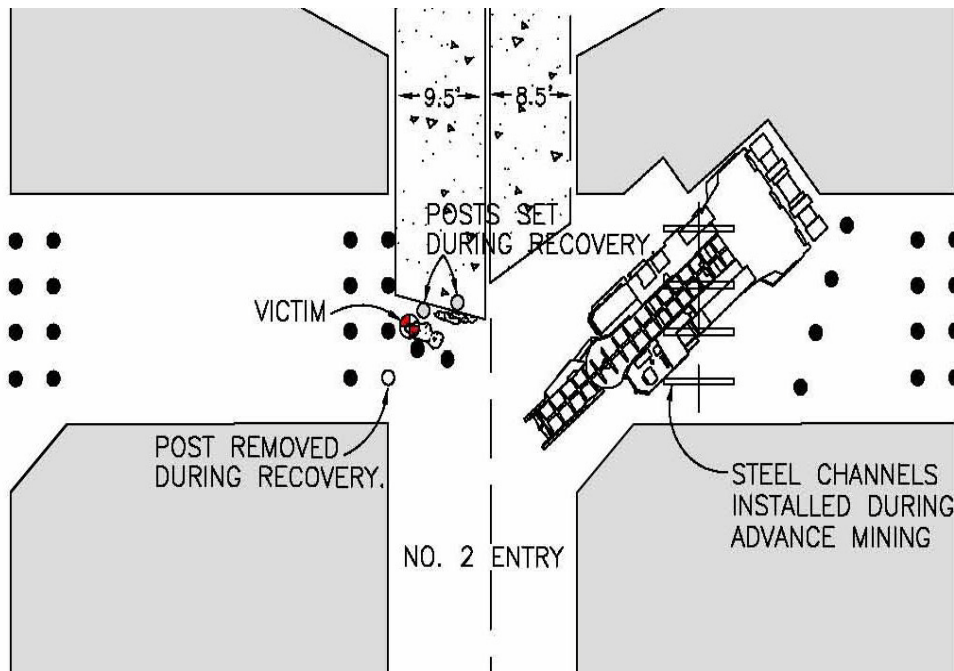
Figure 2.24. Roof Fall Fatality Drawing (MSHA, 2009)

In this fatal incident a roof-bolter operator (functioning as a timberman) was killed by a roof fall, while observing roof conditions during the mining of the final cut on a pillar. As can be seen in Figure 2.24, the roof fall overran the turn posts that had been set during the mining of previous lifts and struck the victim. The victim was assigned to monitor the roof, making his presence in the active mining zone necessary, but his position in by the miner may also have been a contributing factor.

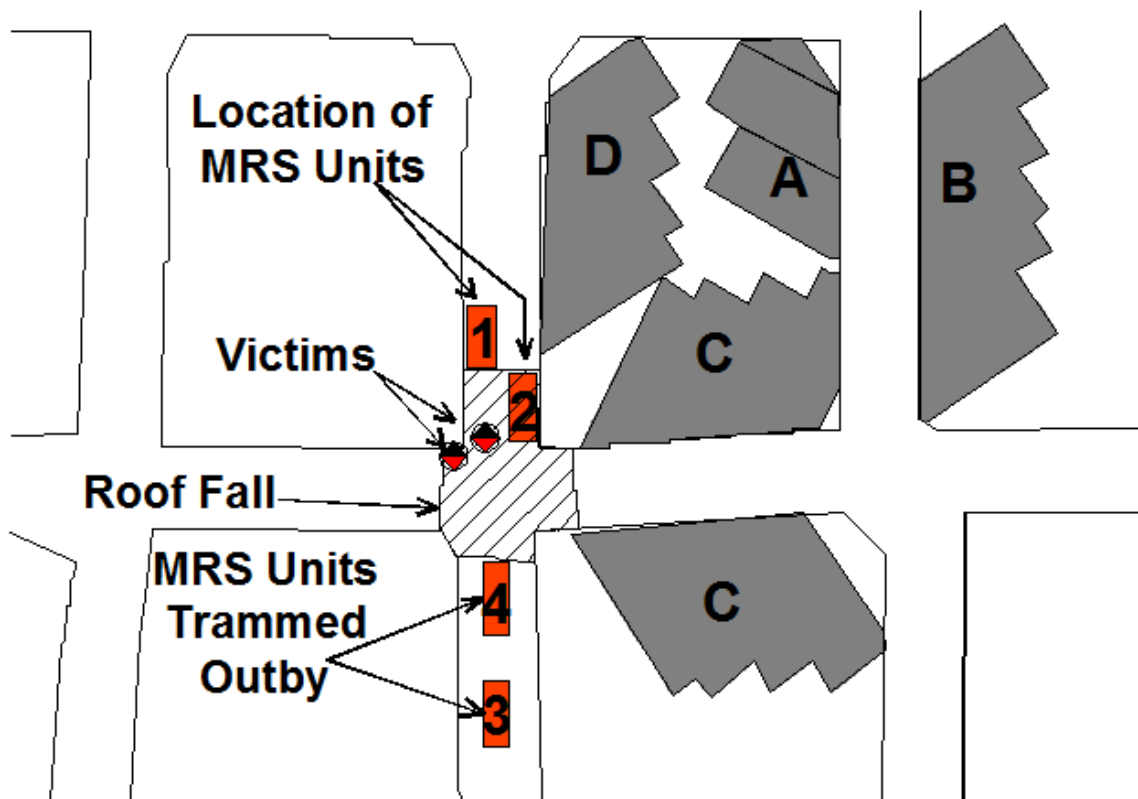
Figure 2.26. Roof Fall Fatality Drawing (MSHA, 2009)

While repositioning MRS units, one section foreman and one scoop operator, both functioning as MRS operators, were fatally injured by a roof fall. Both victims were located in close proximity to the MRS units, the manual controls were being used to operate the MRS unit immediately prior to the fall, and improper spacing of the MRS units during the repositioning may have contributed to the instability that resulted in the roof fall. The position of the victims and MRS units are shown in Figure 2.26.

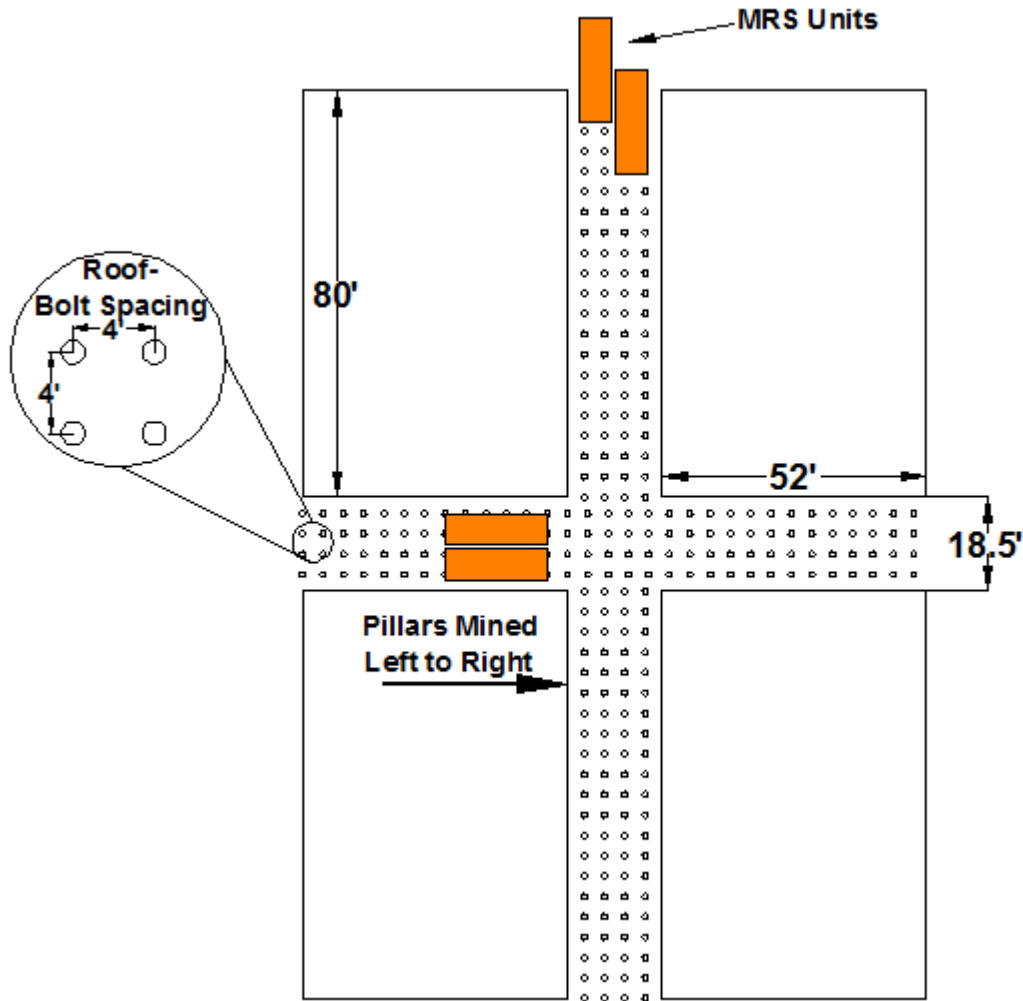
Figure 3.1. Mine A Observed Dimensions and Roof-Bolting Pattern

Mine A was located in southern West Virginia. It was extracting pillars with a mining height ranging from nine to eleven feet. The immediate roof consists of approximately 8 feet of massive sandstone, while the floor was predominately fireclay. The section was under approximately 400 feet of cover. Overmining and undermining of the active seam have both occurred with 80 and 90 feet of innerburden, respectively. The fireclay floor proved to be problematic because it did not facilitate the drainage of groundwater through the mine. Water and thick mud accumulation in the floor was often as deep as 10 inches, and required the construction of sumps, as well as constant pumping. Entry spans were designed at 18.5 feet and pillars were sized at 80 by 52 feet. Crosscut angles were driven at 90 degrees. The active section was three months old and pillars showed little sign of degradation. The roof bolting consisted of 6-ft torque-tensioned bolts on a 4-bolt pattern across the entry with approximately 4 feet between rows. In places where irregularities in the roof were encountered, steel straps were used in conjunction with the bolts.

Pillars were extracted in the section from left to right, utilizing the Christmas-tree cut sequence with an approximate cut depth of 26 feet. Two sets of Fletcher 800-ton mobile roof supports were utilized in conjunction with the setting of breaker posts in the next crosscut outby prior to a lateral move to the next pillar. The coal was extracted using a remotely operated Joy 12CM27 continuous miner. Coal was hauled using two cable-reel shuttle cars and one battery-powered car. The mine operated two daily production shifts and one daily maintenance shift for six days per week. A ten-man crew operated on the section; the crew consisted of two mobile roof support operators, an electrician, a scoop operator, two cable-reel shuttle car operators, a battery-powered coal hauler operator, a continuous miner operator, a continuous miner helper, and a foreman.

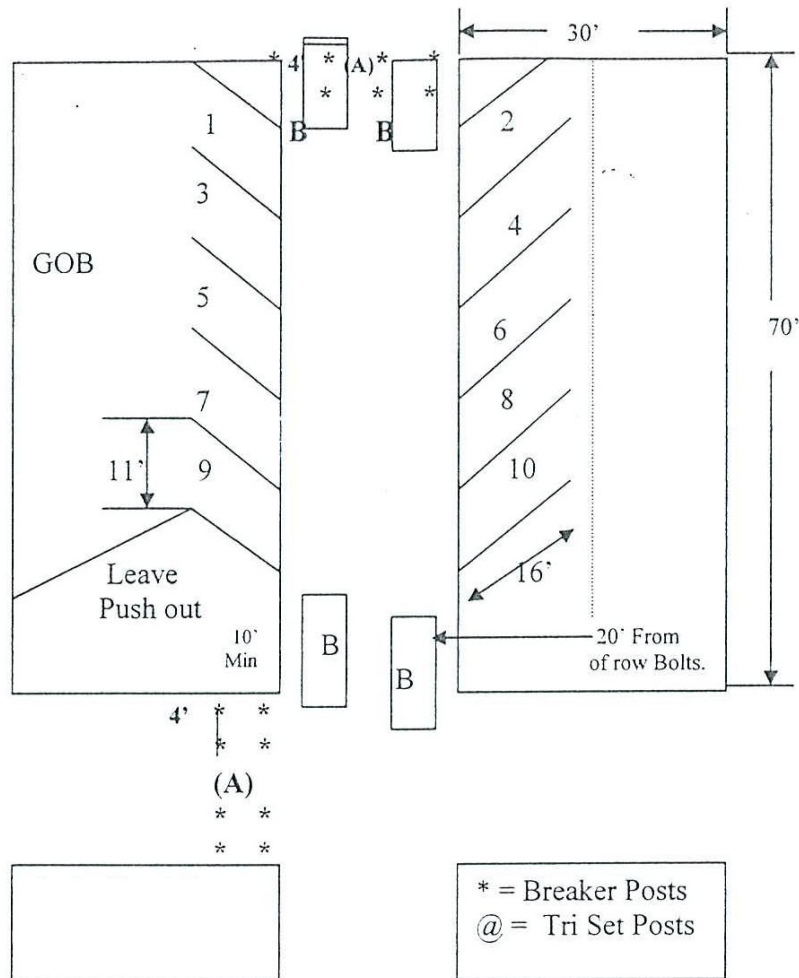
Figure 3.2. MSHA Approved Christmas-Tree Cut Sequence Utilized at Mine B

Christmas-tree (Figure 3.2) and Outside Lift (Figure 3.3) cut sequences were both utilized.

1. A minimum of eight (8) breaker posts shall be installed at locations (A) promptly after mining is complete inby.
2. MRS's shall be installed at location BB prior to mining lift No.1. and shall advanced in like manner for each subsequent lift.
3. The continuous miner shall operate in remote mode only.
4. All posts are to be installed on 4'ft maximum spacing.
5. 30'ft by 70'ft minimum block dimension. Blocks of larger dimensions can be mined using this sequence.
6. No persons shall be permitted inby the miner operator while the continuous miner is mining coal.
7. The pushout will not be mined.
8. This plan will not be used on 60-degree crosscuts.
9. When tree top mining, no mining will be done in any entry if more than half of the block has been removed from the adjacent entry.

General Observations for Visit #1. The working area around the face was well maintained and free of clutter and debris. The floor was in good condition despite a significant flow of groundwater into the mine. The cut sequence observed incorporated the Christmas tree method, as shown in Figure 3.2. The two MRS units were utilized in place of conventional turn posts, while conventional breaker posts were used in lieu of two more MRS units.

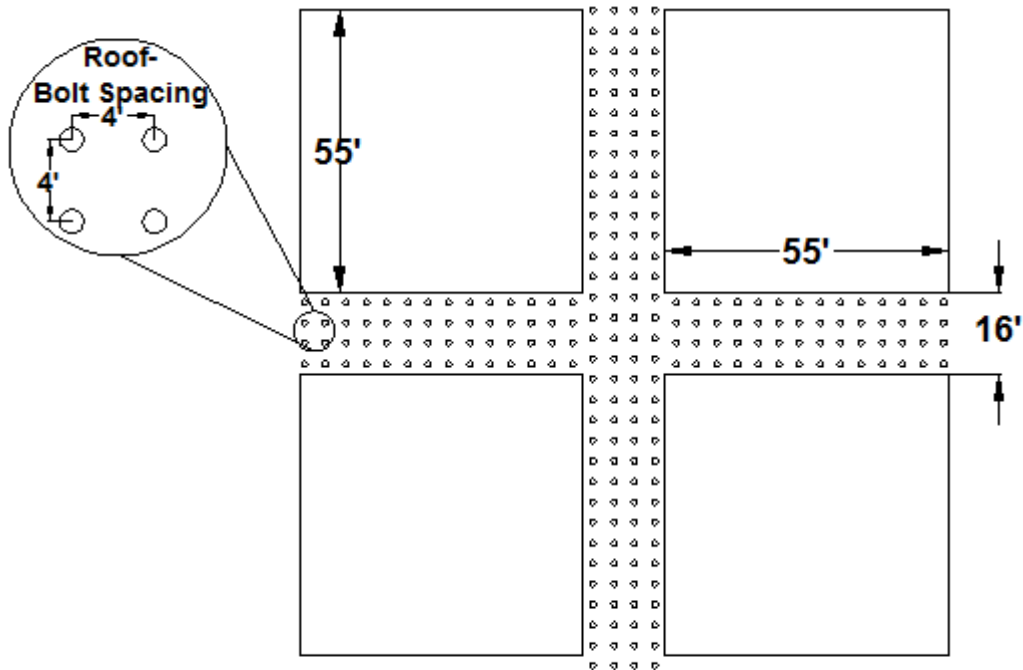
Figure 3.4. Mine C Observed Dimensions and Roof-Bolting Pattern

Mine C is located in northern West Virginia. At the time of the observations, the mine was extracting coal with a mining height of approximately 45 inches. The immediate mine roof was black shale overlain by siltstone. Entries at the mine were developed to a width of approximately 16 ft. Pillar dimension was approximately 55 ft by 55 ft. Primary roof support consisted of 4-ft fully grouted roof bolts, on 4-ft centers (Figure 3.4).

Supplemental support was provided by 8-ft cable bolts. Maximum overburden at this mine was approximately 500 ft. Undermining had occurred within 100 ft of the seam being mined. This particular mine had a significant inflow of groundwater, causing the floor conditions to be very muddy and made walking somewhat difficult in places. Working conditions in this mine can be described as difficult due to the low-seam height, combined with the challenges posed by marginal roof and floor conditions. The operation employed 80 miners and produced slightly more than one million tons of coal, annually.
