A Risk Management Approach to Pillar Extraction in the Central Appalachian Coalfields

**Thesis submitted to the
College of Engineering and Mineral Resources
at West Virginia University
in partial fulfillment of the requirements
for the degree of**

**Master of Science
in
Mining Engineering**

Keywords: Coal Pillar Extraction, Retreat Mining, Central Appalachia, Mining Engineering, Risk Management, Coal Mine Safety

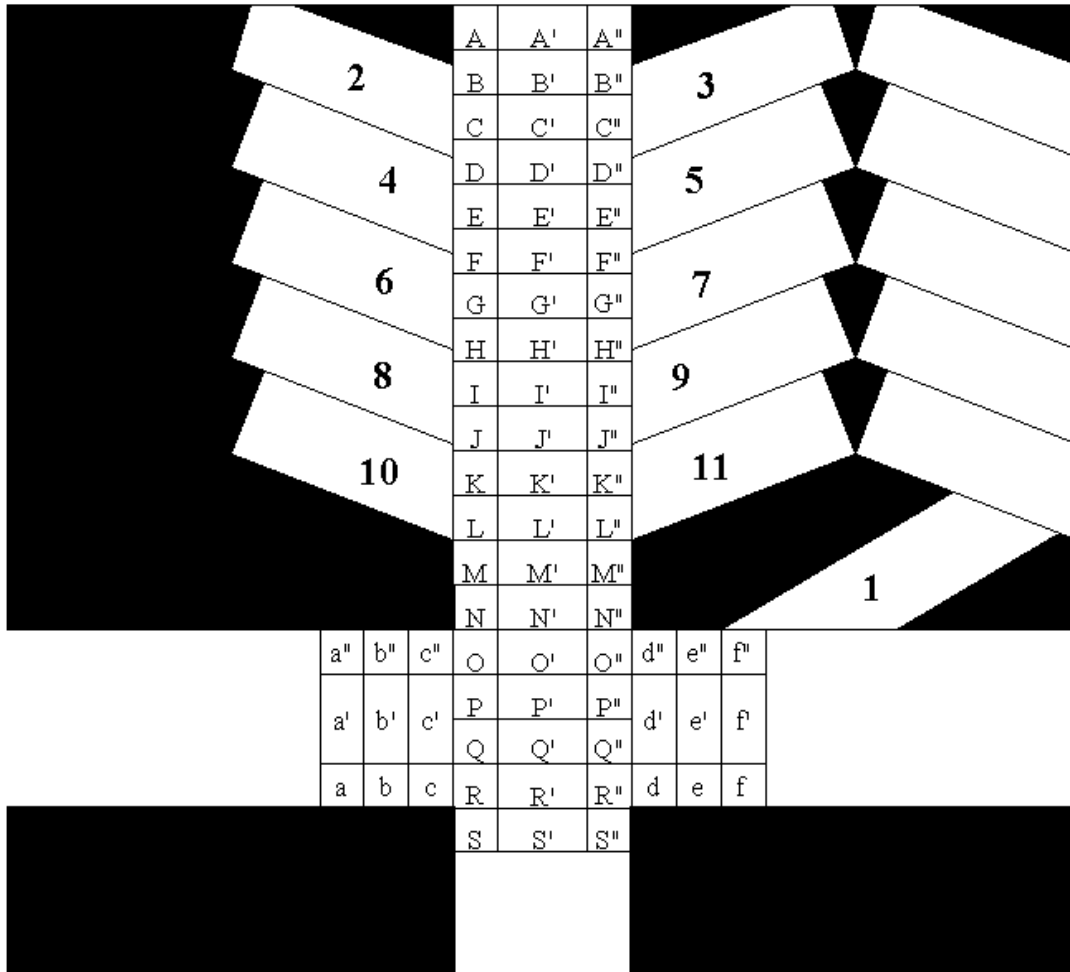
Figure 4.4. Example of the Zone Division for Continuous-Miner Observation

These quantitative results can provide management with not only with documented evidence of behavior trends or undesirable performance but, also can provide an accurate description of desirable or undesirable work patterns and times of exposure. This particular observation form divides the work area of the miner operator and miner helper into three zones across the entry and labeled alphabetically from the gob side to the active intersection (Figure 4.4).

The three zones, labeled X, X', and X'', are designed to identify the location of the operator or helper at anytime during the mining of the pillars. Zones X and X'' are located directly adjacent to the ribs and extend five feet or more out into the entry, and are five feet long parallel to the entry. The remaining middle section of the entry is also five feet long parallel to the entry and is labeled as Zone X'. The capital letters indicate zones that are designated for entry positions while lowercase lettering is reserved for positioning within a crosscut. Three zones were selected instead of two, because it is important to know if the operator or helper is positioned towards the middle or the side of the entry during certain tasks, rather than just noting whether they were on the right or left side. This is important because this worksite is very dynamic with frequent continuous miner directional changes, as well as varying loading angles to accommodate the position of the continuous miner. As a result, the operator and helper must continuously change vantage points and operational positions. This observation strategy enables the documentation of position, time, and tasks based on the logging of activity and location code onto the timeline designated for each cut. Identifying poor positioning and excessive hazard-exposure times enables safety managers to more accurately identify and address problem areas. The form (Figure 4.3) is arranged

As shown in Figure 4.4, the capital letters run parallel with the entry while the lowercase letters are in the crosscut. Any letter with the single prime designation is in the center of the entry. Capital letters without a prime, or double prime designation are located on the left side of the entry facing inby. The capital letters designated by a double prime are located on the right side of the entry facing inby. In the crosscut, the lowercase letters with the double prime designation are adjacent to the pillar or pillars being mined. The prime designated lowercase letters are in the center of the crosscut, and lowercase letters without any prime or double prime designation are located adjacent to the first pillars outby the pillar or pillars being mined.

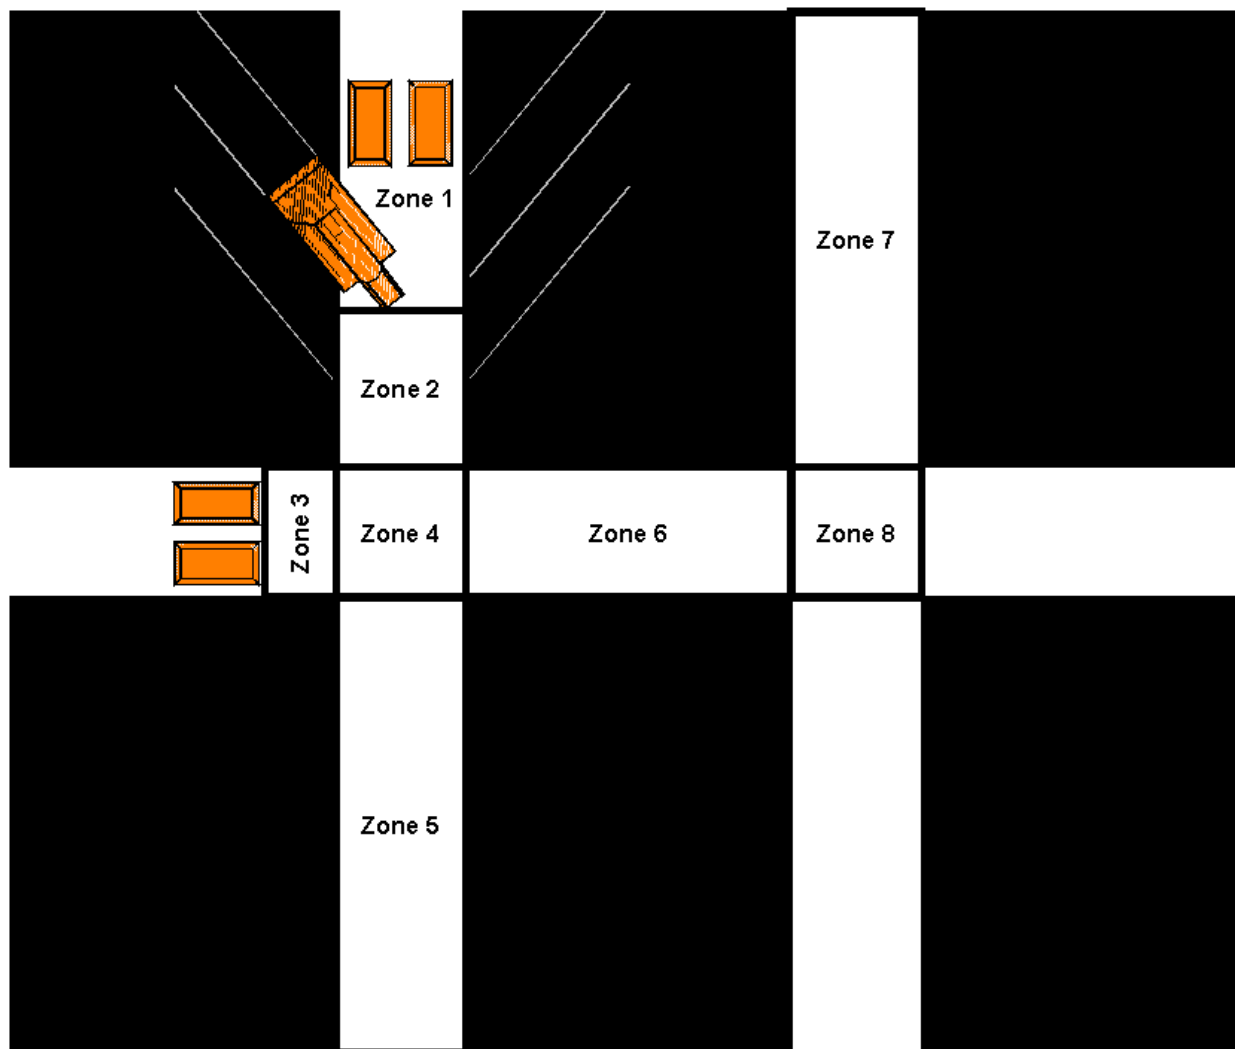
Figure 4.8. Division of Pillaring Section for Observation

Improvements in mechanization, strata control and communication have greatly contributed to reducing the risk of many hazards on a pillaring section. However, these risks cannot be eliminated, and they still have the ability to cause severe consequences. One simple and highly effective method of controlling risk is to minimize exposure of personnel to sources of risk. In the case of pillar extraction, the sources of risk are concentrated in and around the active mining zone. This observation strategy is similar to the previous strategies in that it accounts for the location and behavior of personnel but, unlike the previous strategies that target small areas and specific tasks or job titles, this strategy accounts for all personnel that pass through the active mining zone and the area adjacent to the active mining zone in the direction of mining. As shown in Figure 4.8, the active mining zone and surrounding areas have been divided into eight zones and are labeled on the section map.

These zones have been targeted as high-risk zones based on the proximity to the active intersection, proximity to active gob, likelihood of machinery traffic or other known hazards. Zone 1 is designated as the area inby the continuous miner, and Zone 2 is the area outby the continuous miner to the first outby intersection. Zones 1 and 2 will shift further outby as sequential cuts are taken; however, the remaining six zones will not change until a move is made to the next pillar in the mining sequence.

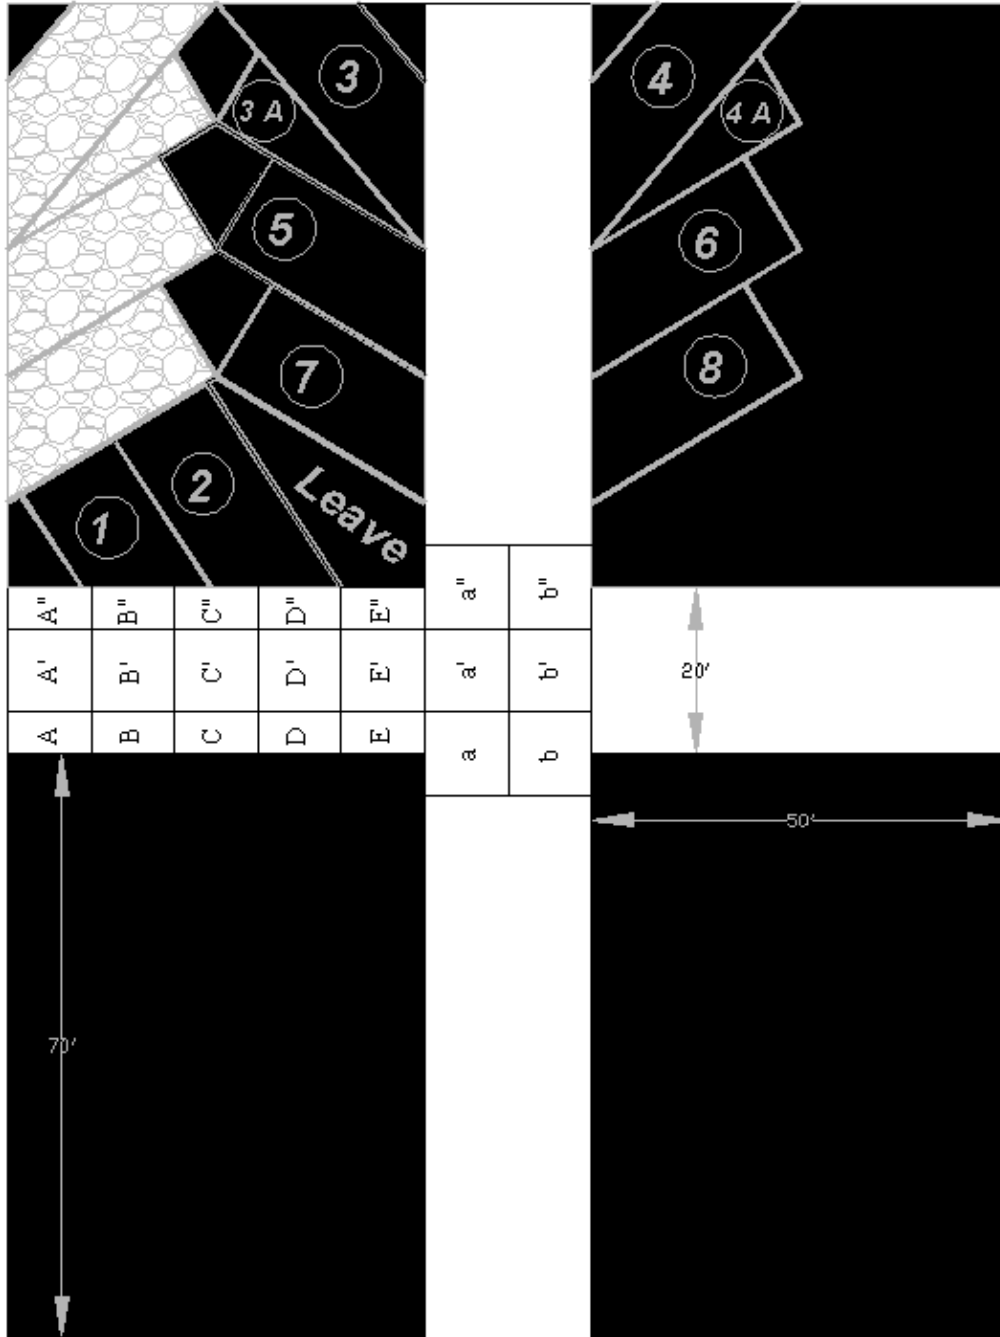
Figure 4.13. Area Division Example No. 1

Figure 4.13 represents an example of an area division for taking initial cuts when extracting pillars utilizing the Christmas-tree cut sequence. Notice that cuts 1 and 2 are both on the same side of the crosscut. These first two cuts are taken by the same technique that would be used in an Outside-lift cut sequence. Therefore, this example illustrates the zone division for an Outside-lift extraction, or initial same-side cuts on a Christmas-tree extraction. Figure 4.14 represents typical main cuts made during a

In order to record miner location, it is necessary to divide the active mining zone into smaller areas that can be identified on the observation form. While it is impossible to design a sampling form that is suited to every cut sequence and mining conditions, some basic examples have been developed that can be applied to most situations and are demonstrated in Figures 4.13 and 4.14.

As shown in the zone division examples, the zones in the entries and crosscuts are not uniform in size from left to right. This decision was made because haulage vehicles typically operated in the center of the entry or crosscuts, and if all zones were equal in width, the haulage would be occupying potentially two or more at a time and it would be difficult to determine if mine personnel were impeding or unnecessarily exposed to the hazard of the moving equipment. Based on this, it was decided that the middle zone would be twice the width of the left and right zones. For example, if an entry is 20 ft wide, the middle zone will be 10 ft wide while the zones closest to the coal ribs are 5 ft wide. This enables the observer to accurately indicate if a miner were to be standing tight up against the rib to avoid machinery or if the miner happened to be out towards the middle of the entry. The length of all zones in the crosscuts or entries was set at 10 ft. Anything smaller than 10 ft makes the estimation of the occupied zone much more difficult. The intersection is divided into six zones; all are identical in length and width and actually protrude slightly into the crosscut or entry, depending on where mining is occurring. The zones are all ten feet long and each zone's width is one half the entry width. By extending the zones slightly outside the intersection, it becomes possible to record the presence of any observers that occasionally place themselves just barely out of the active intersection. It is correct that they are technically not in the intersection, but their extremely close proximity does not really provide them any protection from the hazards of the active intersection, so by extending the zones to occupy these favored vantage points, an accurate measure of hazard-exposure can be recorded. Using the cut sequences and pillar dimensions at any given mine, an area division map such as in Figures 4.13 and 4.14, can be designed and used in conjunction with the Task and Location Monitoring form.

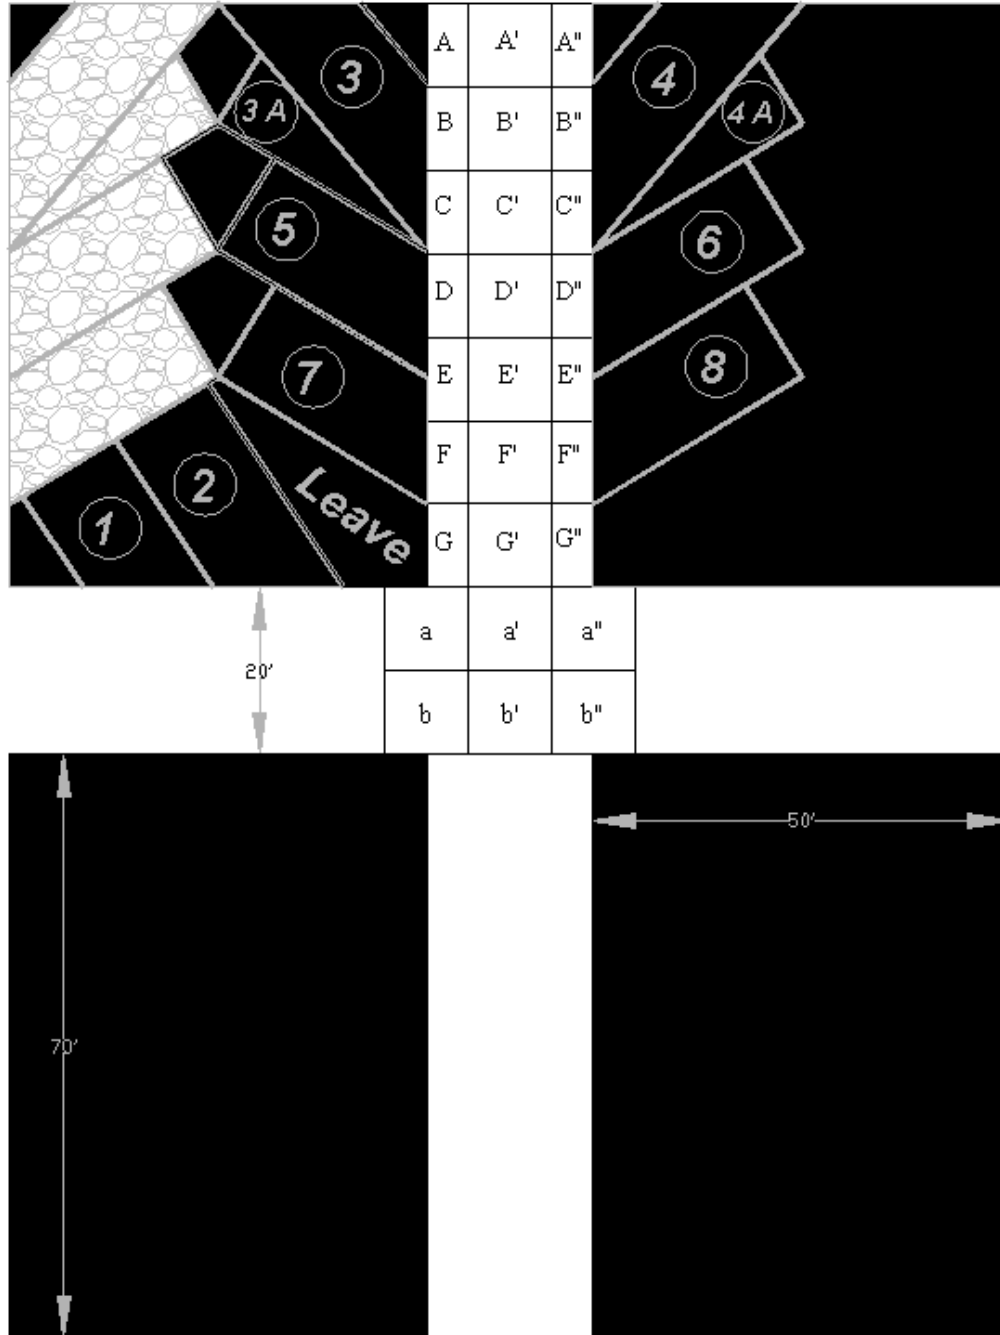
Figure 4.14. Area Division Example No. 2

Christmas-tree pillar extraction. The zone division is the same as shown in Figure 4.13, except that the zones are oriented down the entry as opposed to the crosscut.

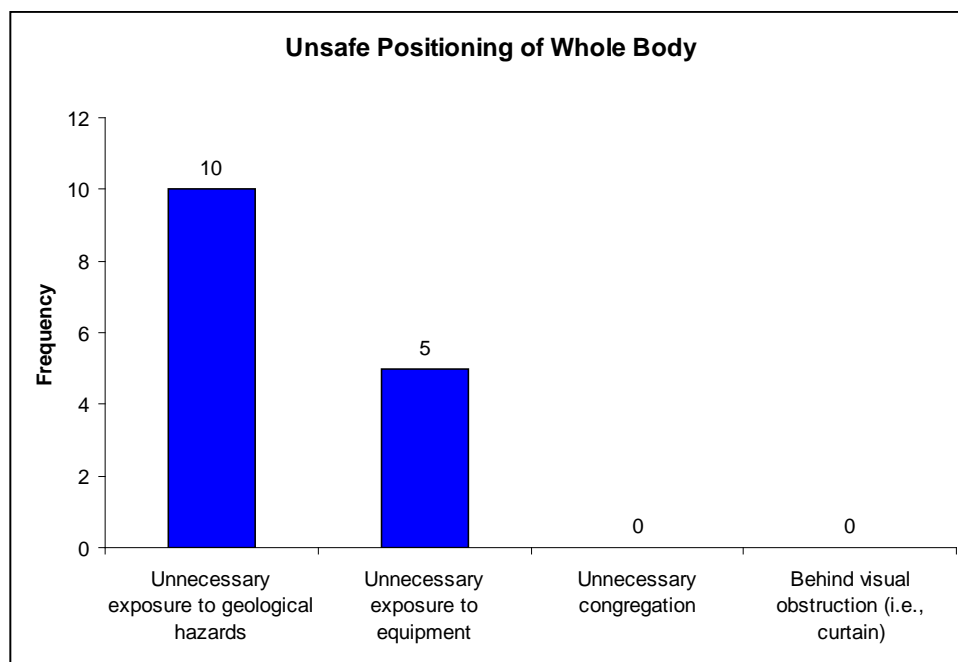
Figure 5.2. Unsafe Positioning of Whole Body

Figure 5.2 shows that there were fifteen observed occurrences of unsafe positioning of the whole body, falling into two categories, “Unnecessary exposure to geological hazards” and “Unnecessary exposure to equipment”. In this observation, unnecessary exposure to geological hazards typically consisted of moving in by the miner. Unnecessary exposure to equipment consisted of miners moving through known machinery pinch points while the machine was energized, or placing themselves in a position where they obstructed haulage and were at higher risk for being struck by moving equipment.

Understanding the results of a workplace sampling is critical to effectively making decisions based on the observations. One effective method of conveying the results to others is through graphical representation. The graphs can be useful for identifying problems and can also be used for establishing concrete justifications for safety-performance topics during safety training. The results of the unsafe performance observation form are shown in Figures 5.2 to 5.6.

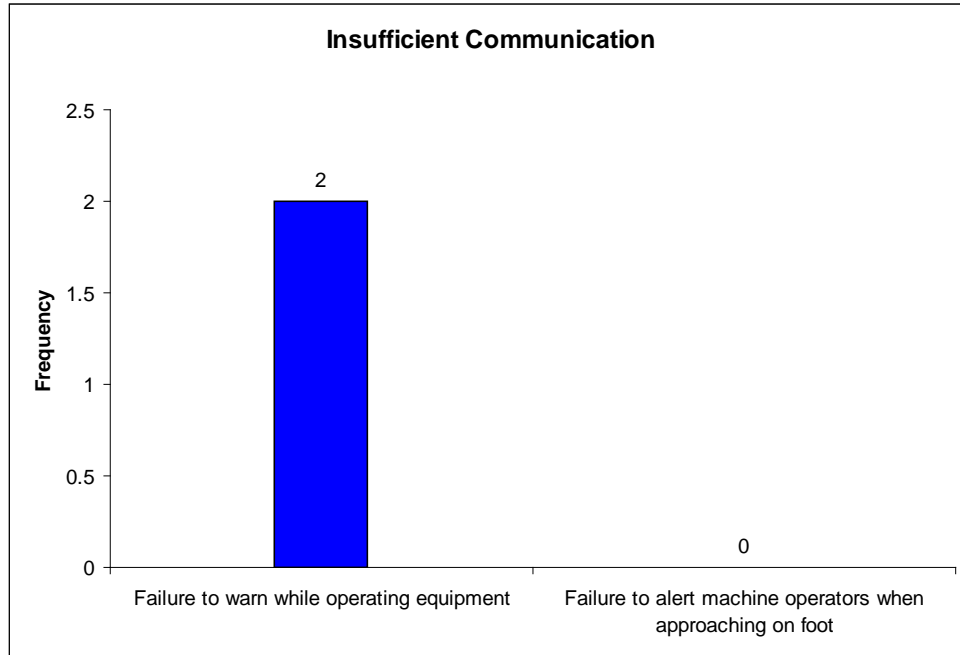
Figure 5.3. Insufficient Communication

Figure 5.3 demonstrates that, during this observation, two coal-hauler operators failed to warn while operating their machines. In this situation, both performances consisted of operators failing to give audible signals before proceeding through ventilation curtain.

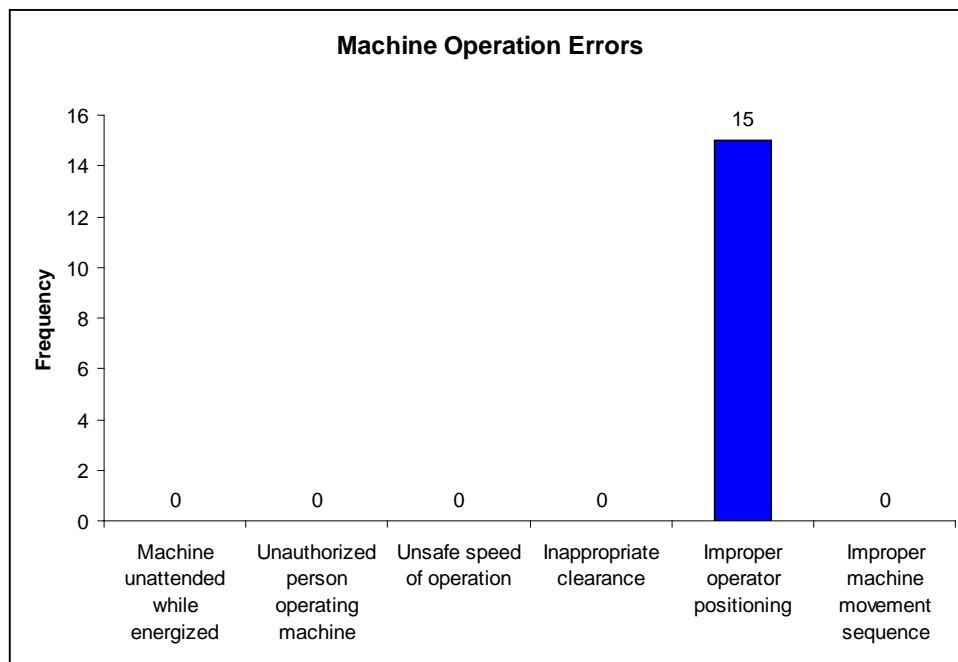
Figure 5.4. Machine Operation Errors

Figure 5.4 represents the frequency of machine operation errors. There were fifteen observed occurrences of poor operator positioning. By referring back to Figure 5.1, it is shown that MRS operators and miners operating outside their typical duties were most prone to improper positioning while operating machinery.

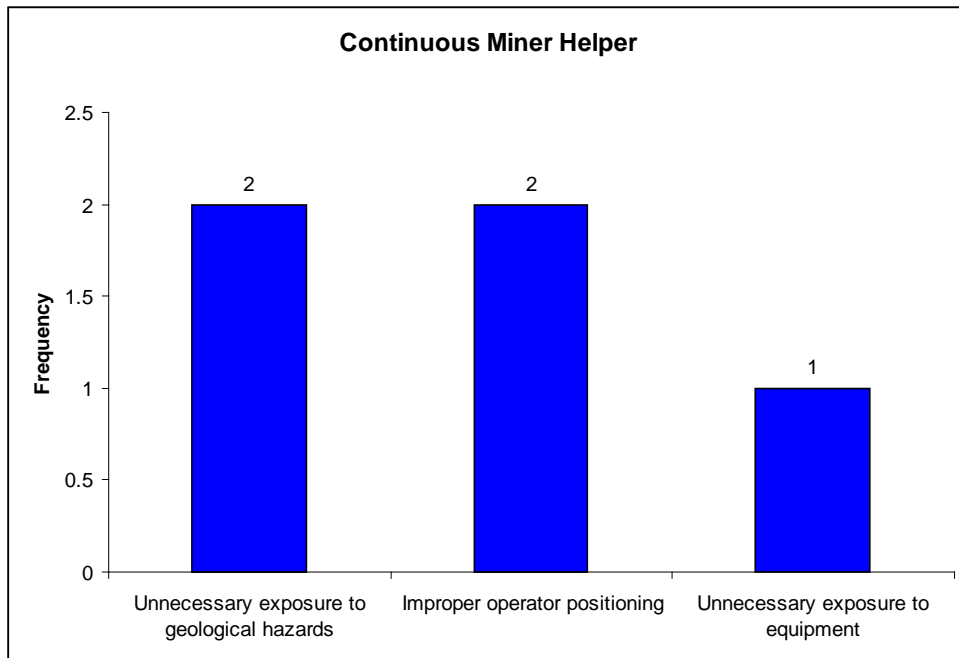
Figure 5.6. Continuous-Miner-Helper Evaluation

Figure 5.6 demonstrates the utilization of the unsafe performance observation results to focus attention on an individual, in this case the continuous miner helper. The ability to equally assess a group as well as an individual with one observation is a significant strength of this observation strategy. By performing the Unsafe Performance

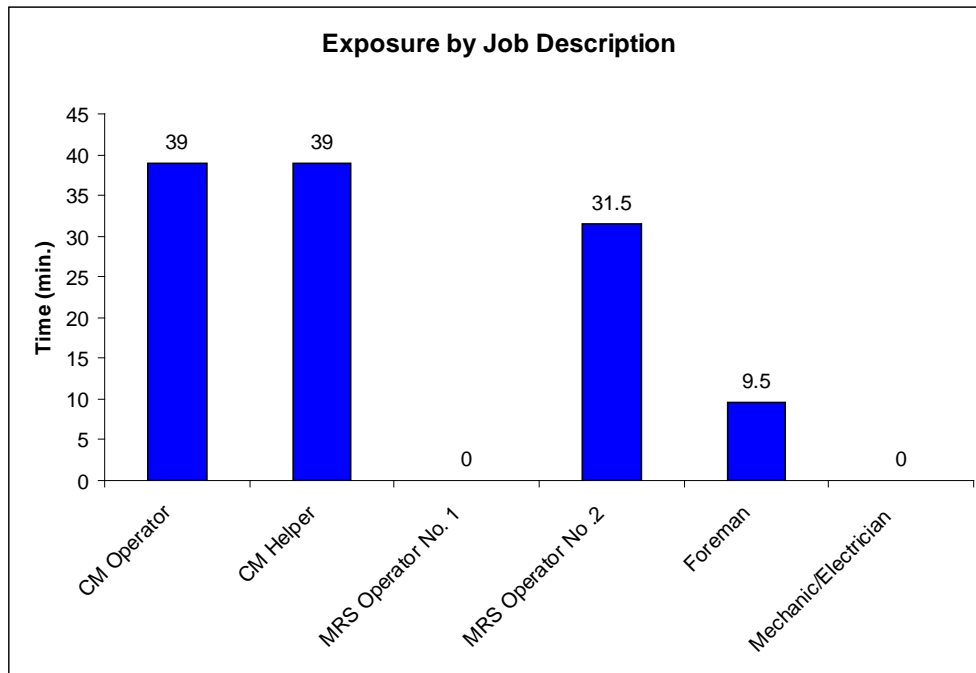
Figure 5.14. Exposure to the Active Mining Zone by Job Description

Figure 5.14 represents the exposure time in the active mining zone for members on the section crew (Operators of haulage equipment have been excluded due to the cyclic times in and out of the active mining zone, which made recording very challenging). After a job description's exposure rate is identified, it can be further analyzed to assess training needs. For example, the MRS Operator No.2 was exposed for 31.5 minutes in the active mining zone yet, according to Figure 5.21, only five minutes were spent operating the MRS units during this cut. This highlights a need to further investigate the activity of the MRS operator. This same type of investigation can be conducted for any member of the crew.

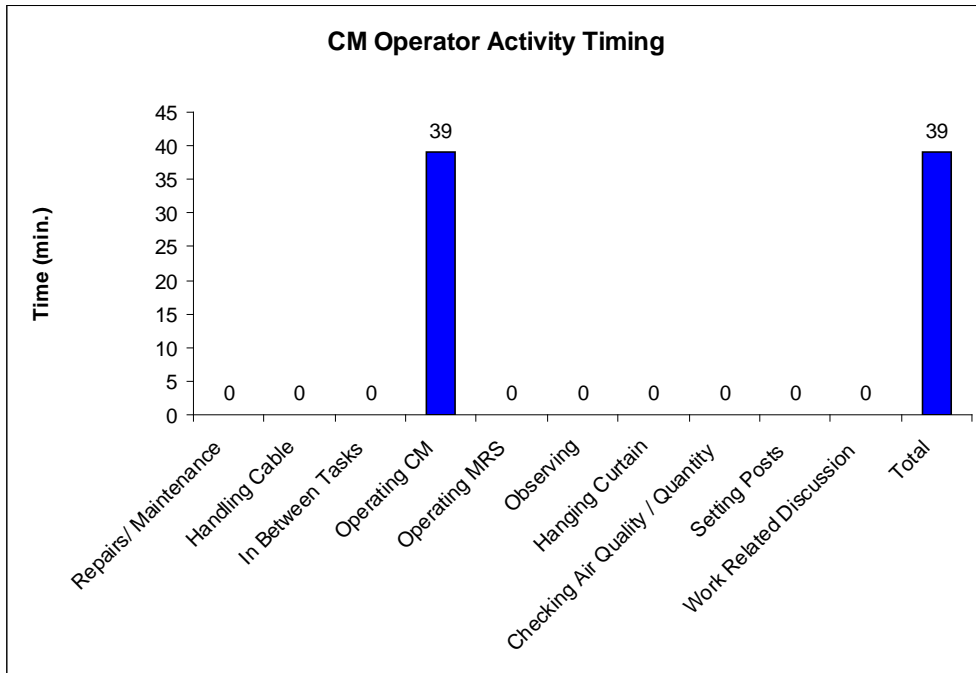
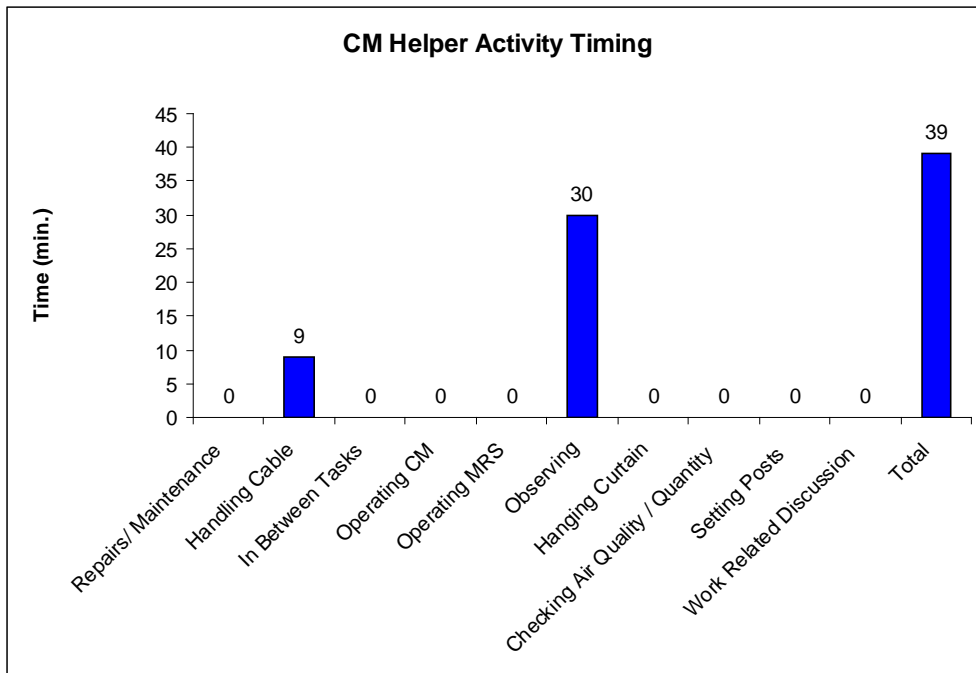
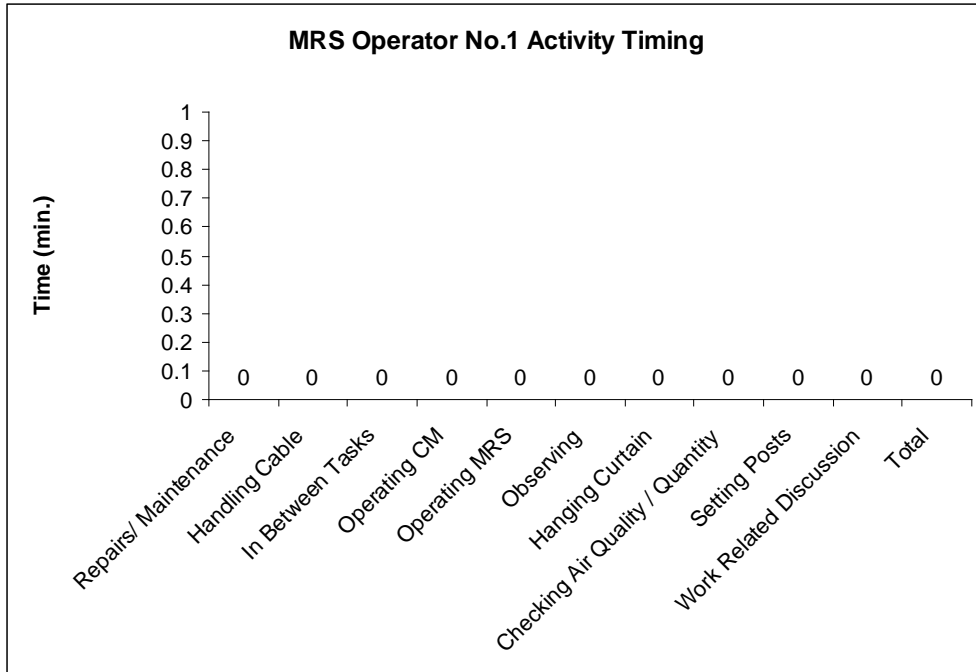
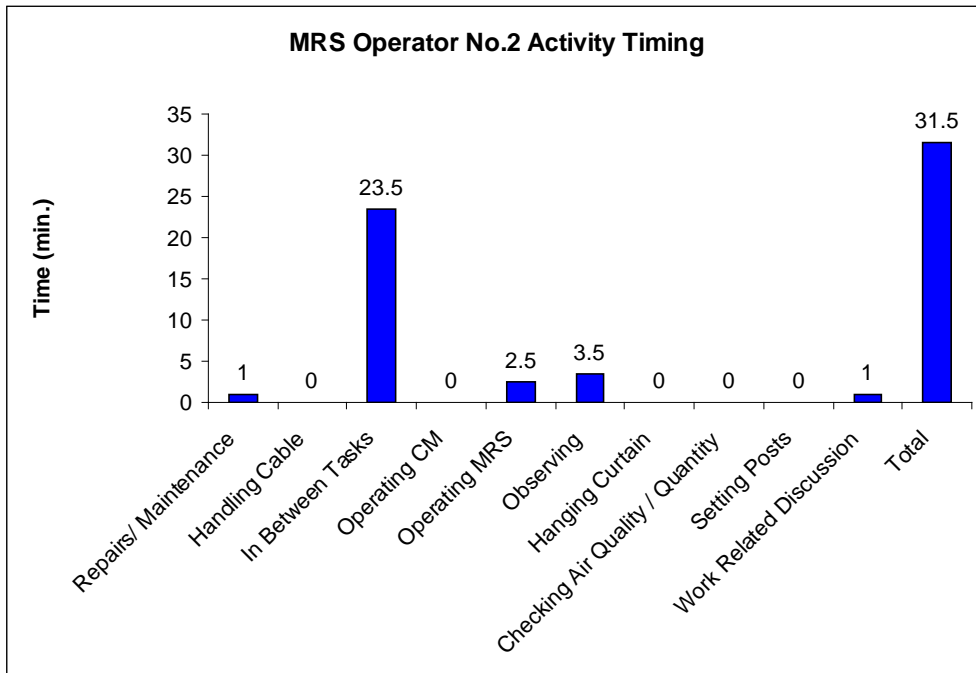
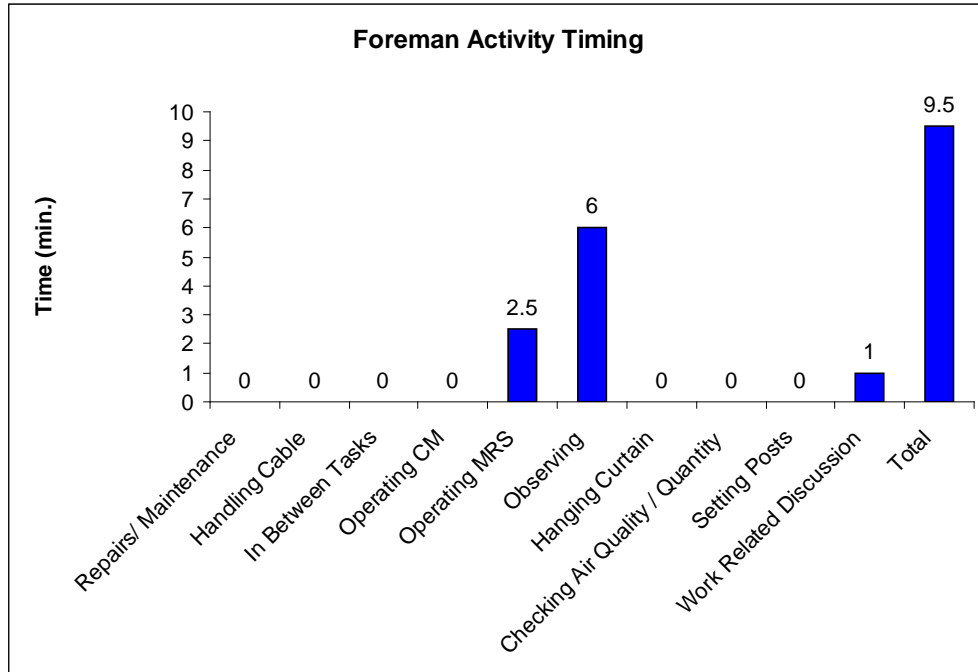
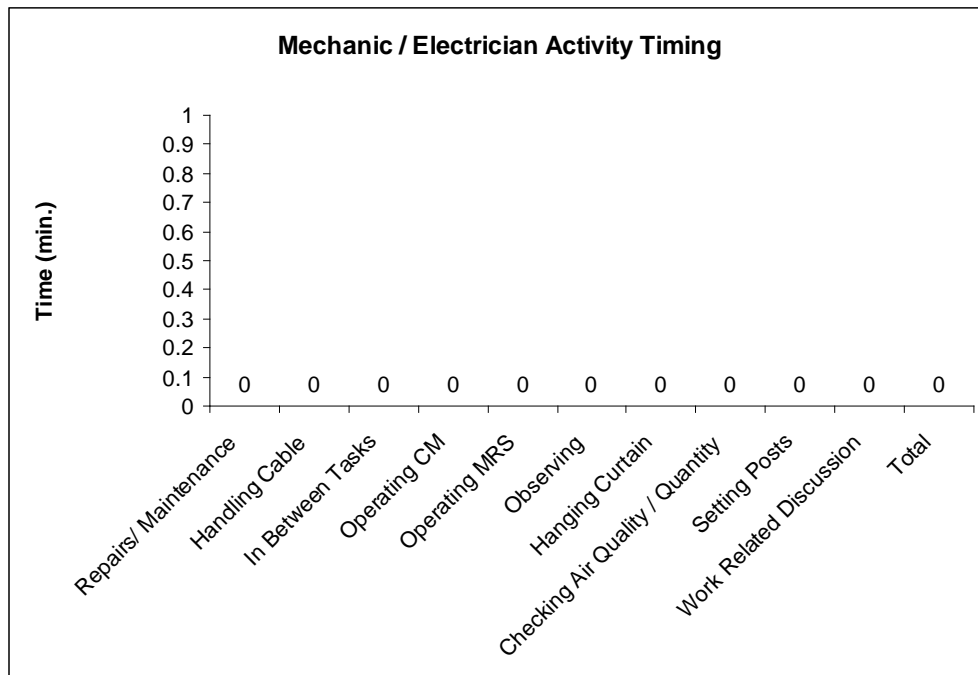
Activity Timing. As previously stated, once the amount of exposure to the active mining zones has been measured, it is useful to determine what miners are doing during their time in the active mining zones. Figures 15.15 to 15.20 represent the time spent performing various activities by each of the miners that were present in the active mining zone. While most activity descriptions are clear, the difference between the activities “In Between Tasks” and “Observing”, requires some clarification. The activity labeled “In Between Tasks” indicates that the miner was not participating in any mining-related task. The activity label “observing” indicates that the miner was monitoring various aspects of the active mining zone. Information regarding activity timing is useful for determining if hazard exposure times correspond to necessary work being performed. Again, using the MRS Operator as an example, 23.5 minutes were recorded in the active mining zone while the MRS Operator was in-between tasks, indication that he was not performing his specific job or serving any other type of function in place of another crew member. This is a strong indicator, for safety trainers,

that action can be taken to reduce the MRS Operator's hazard exposure by finding a more suitable location while in-between tasks.

This type of representation of the information gathered during the Activity and Location Monitoring Observation can serve dual roles, both highlighting needs for safety training as well as providing information that can lead to process optimization.

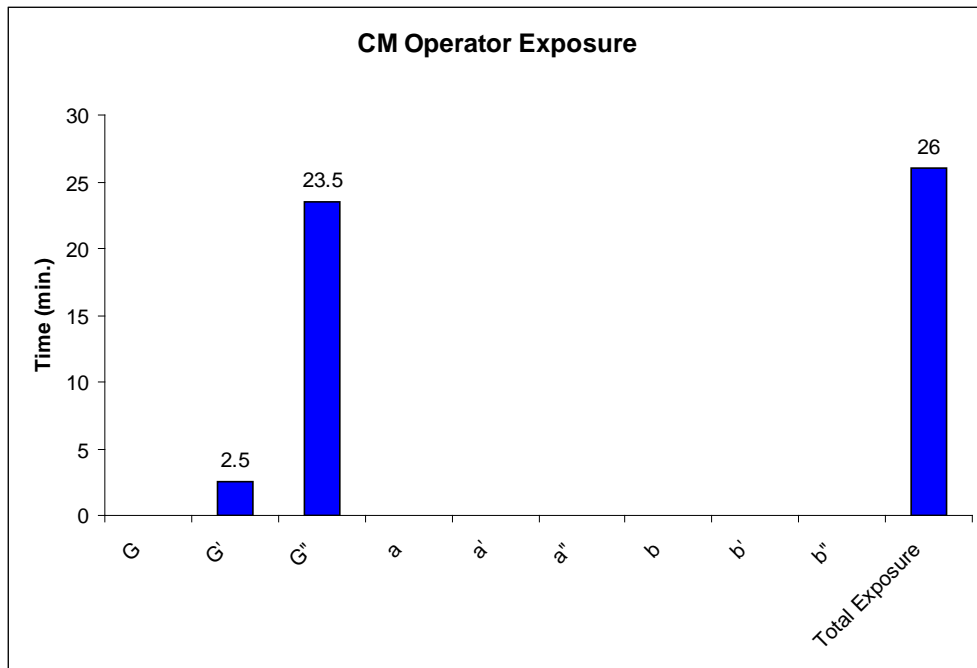
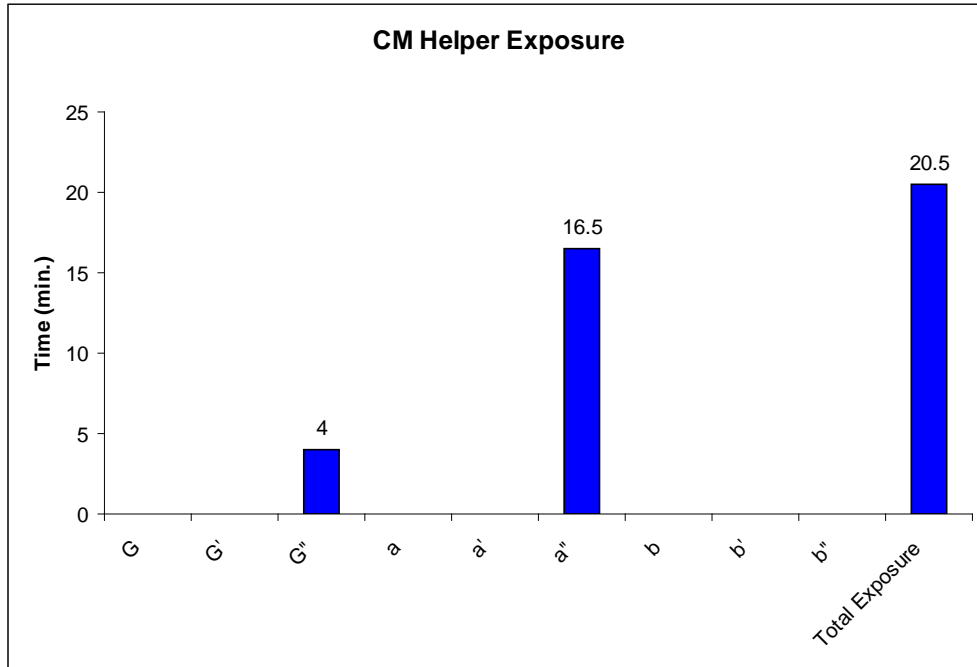
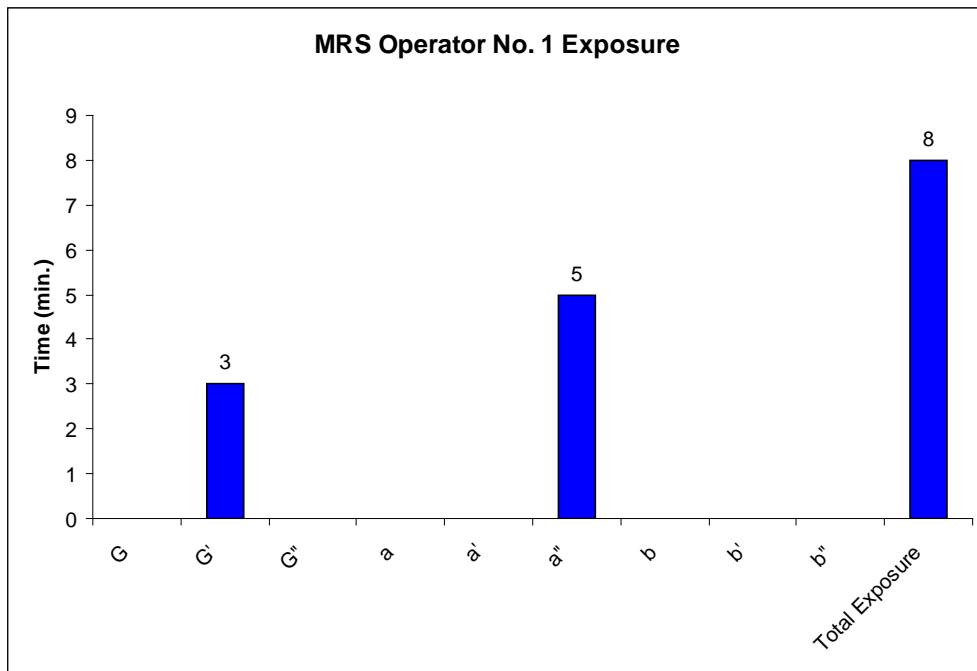
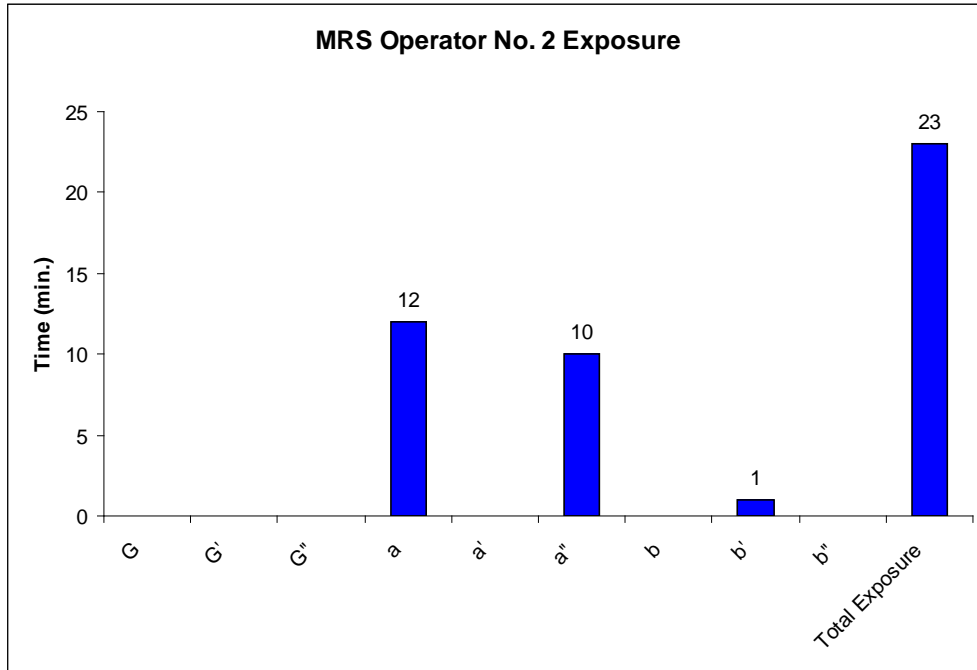
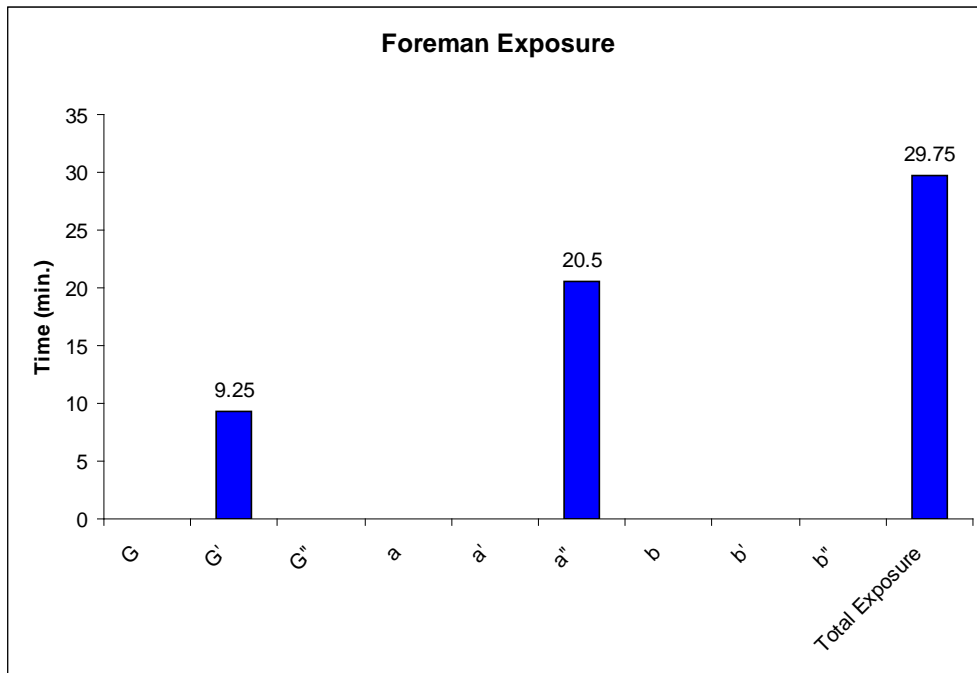
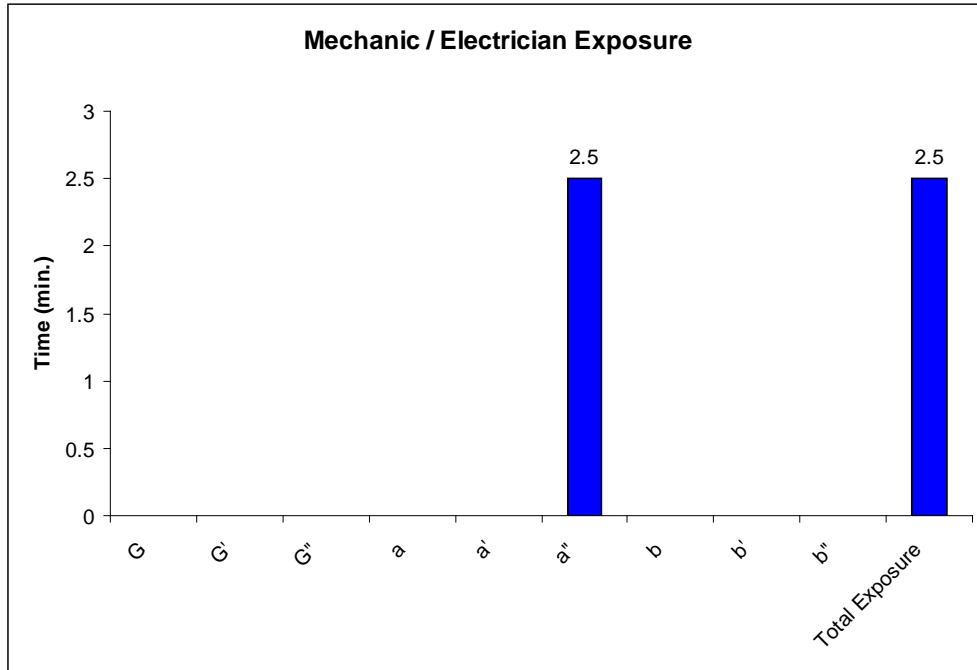
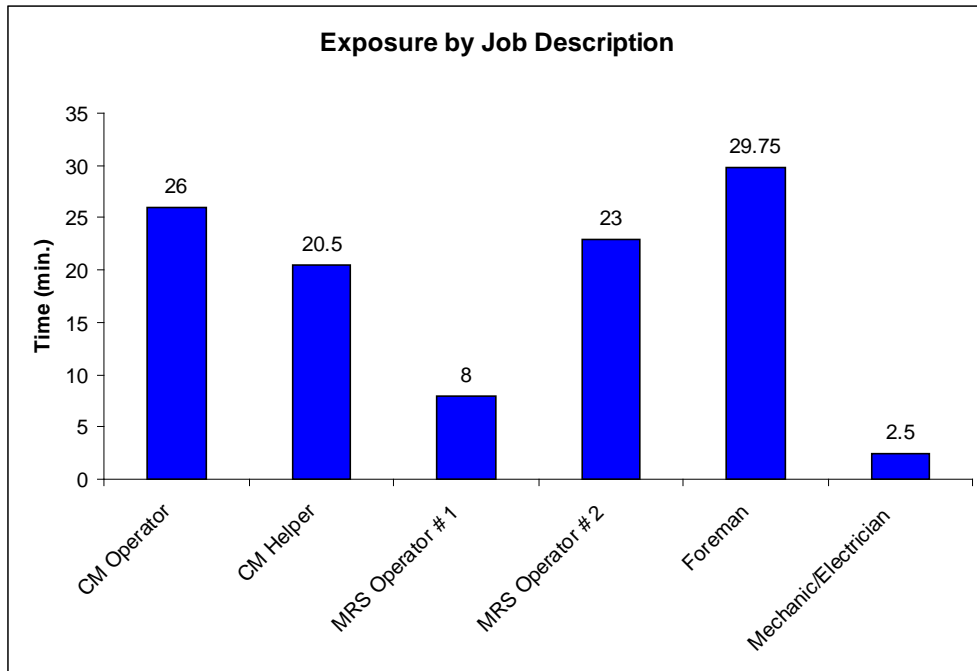
Exposure to the Active Mining Zone. As demonstrated previously in the Cut No. 2 analysis, graphs representing exposure times by zone have been created (Figure 5.22 to 5.28). For this cut, there were still significant levels of exposure by the continuous miner operator and helper as would be expected due to their job descriptions. There was also a level of exposure time by MRS operators that does not correspond to their typical job activities, as also witnessed in the previous cut. However, for this cut, the foreman remained in the active mining zone for the entire cutting process, as well as the MRS relocation, and as a result, the Foreman had the highest exposure time for this cut.
