A Risk Management Approach to Pillar Extraction in the Central Appalachian Coalfields

**Thesis submitted to the
College of Engineering and Mineral Resources
at West Virginia University
in partial fulfillment of the requirements
for the degree of**

**Master of Science
in
Mining Engineering**

Keywords: Coal Pillar Extraction, Retreat Mining, Central Appalachia, Mining Engineering, Risk Management, Coal Mine Safety

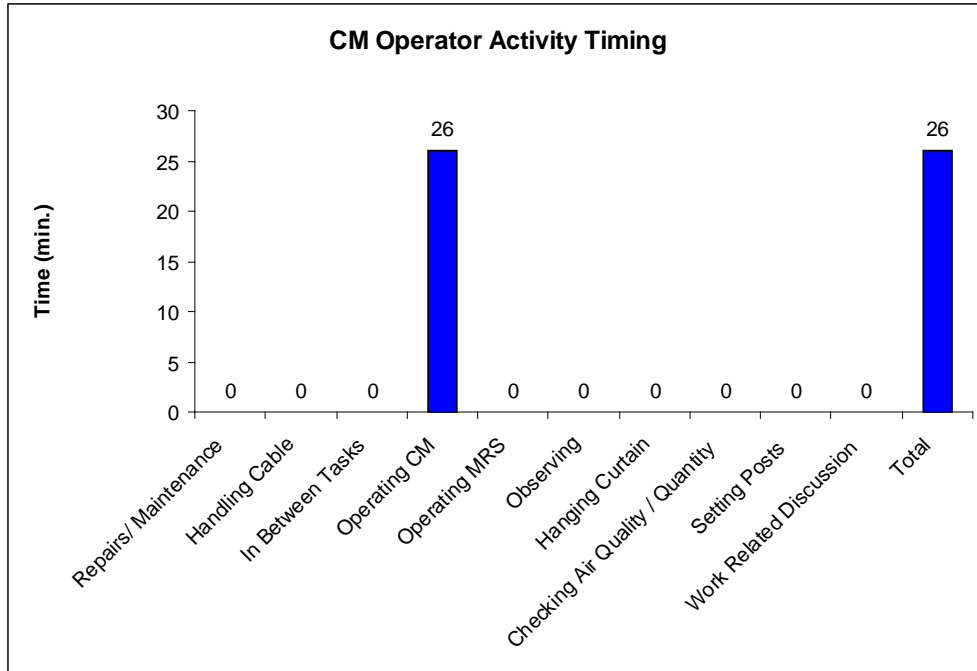
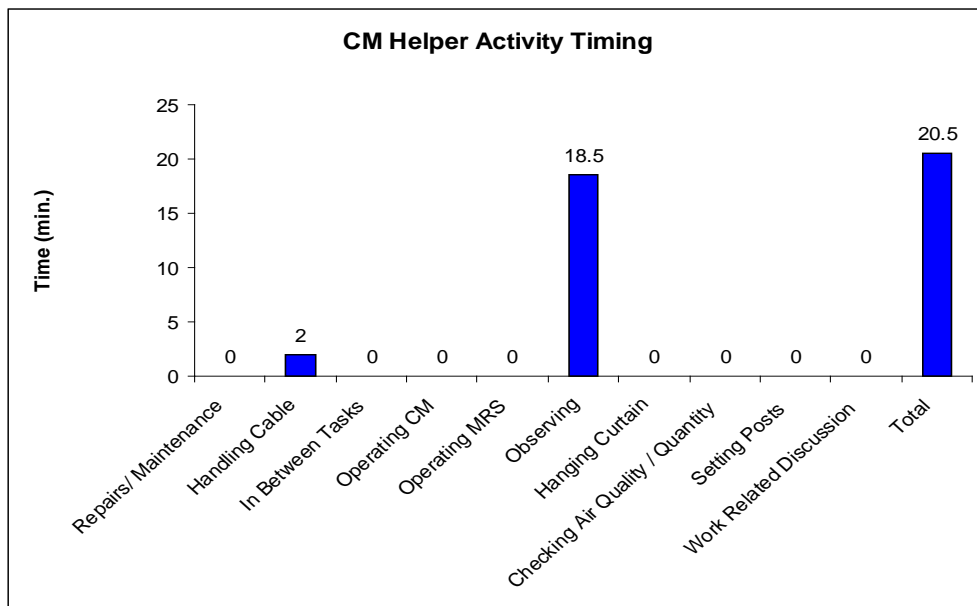
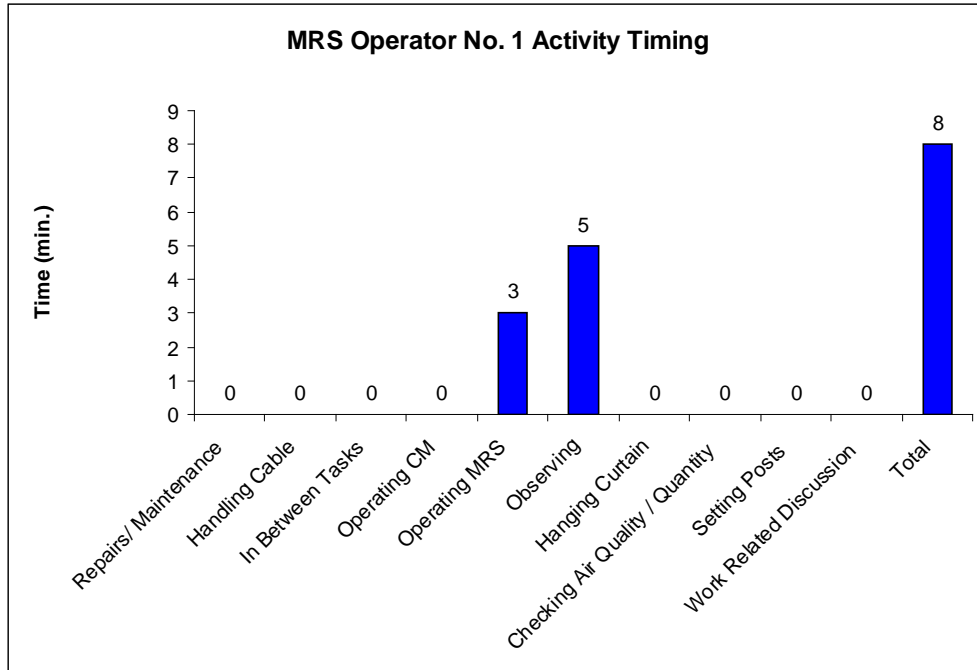
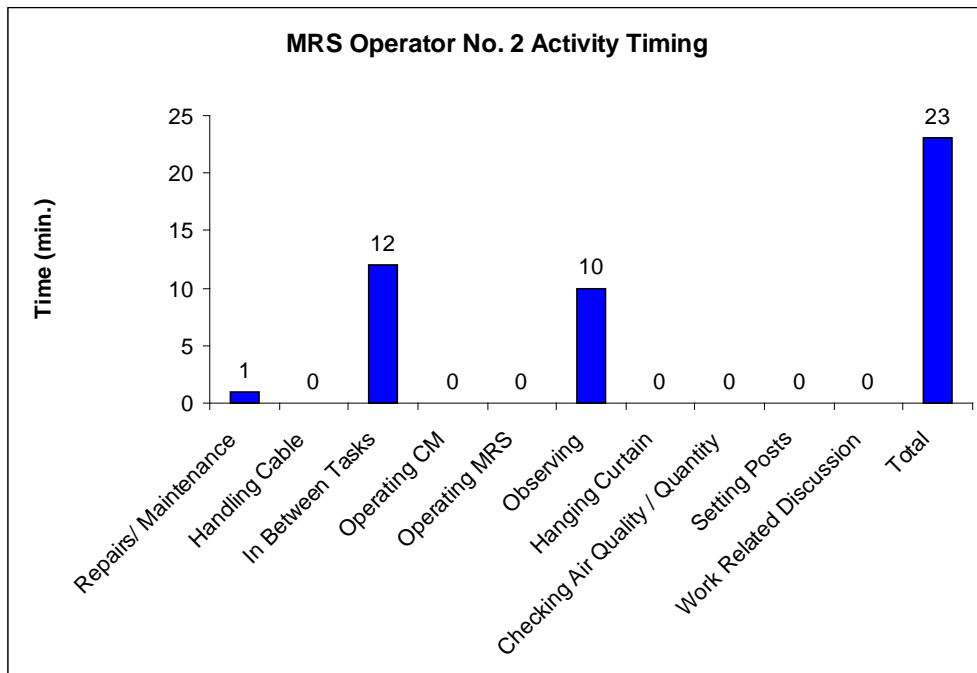
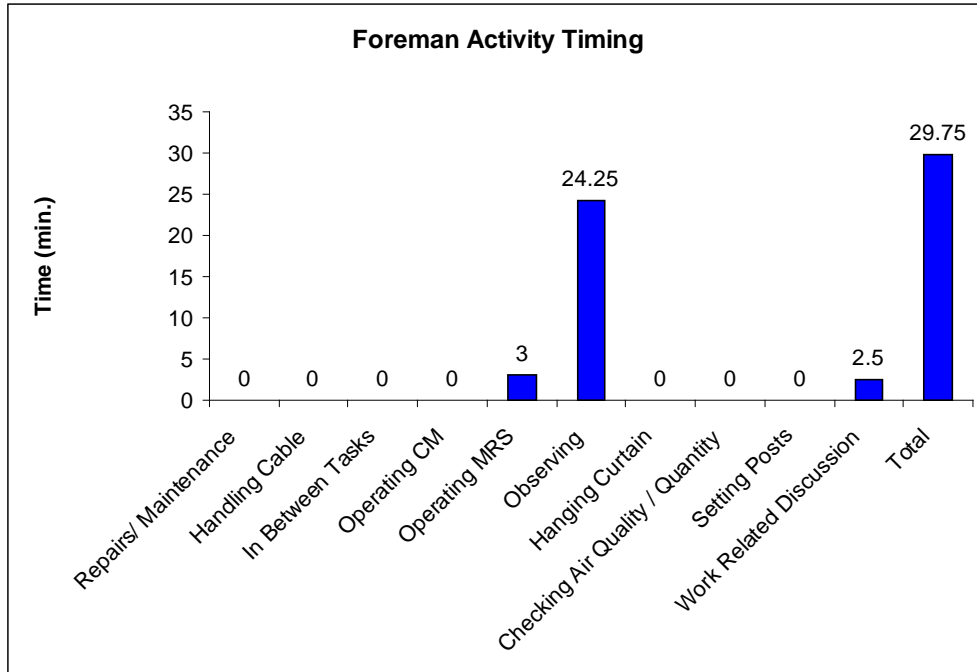
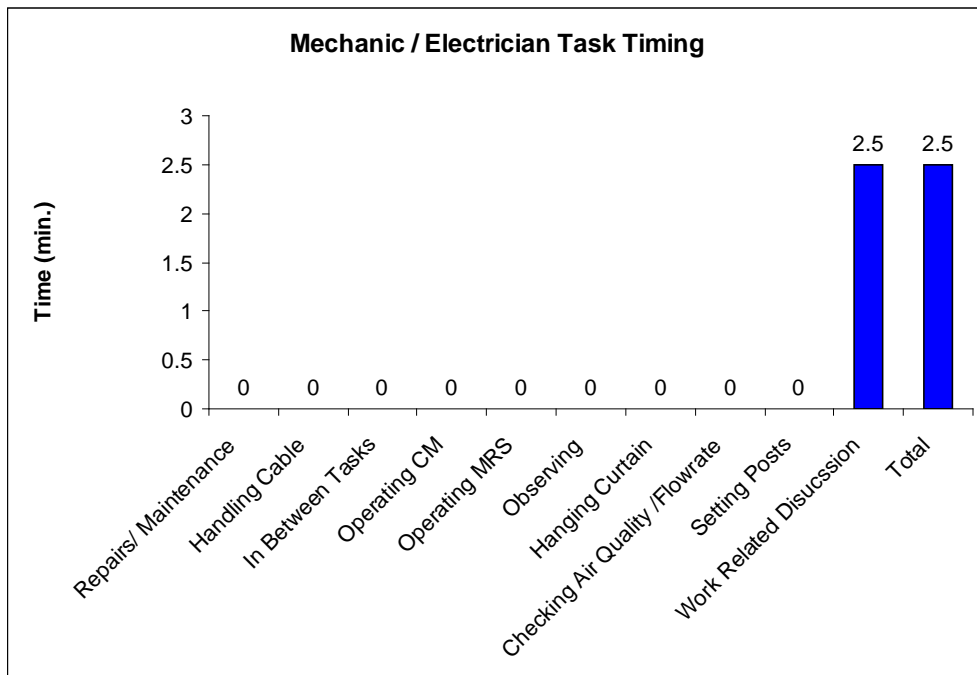
Activity Timing. Figures 5.29 to 5.34 present the amount of time each miner spent performing an activity. Consistent with Cut No. 2, the MRS Operator No. 2 had the most time “In Between Tasks” in the active mining zone for Cut No. 3. Even though the MRS Operator No. 1 was present in the active mining zone, the operator was actively engaged in a work activity during that time period.

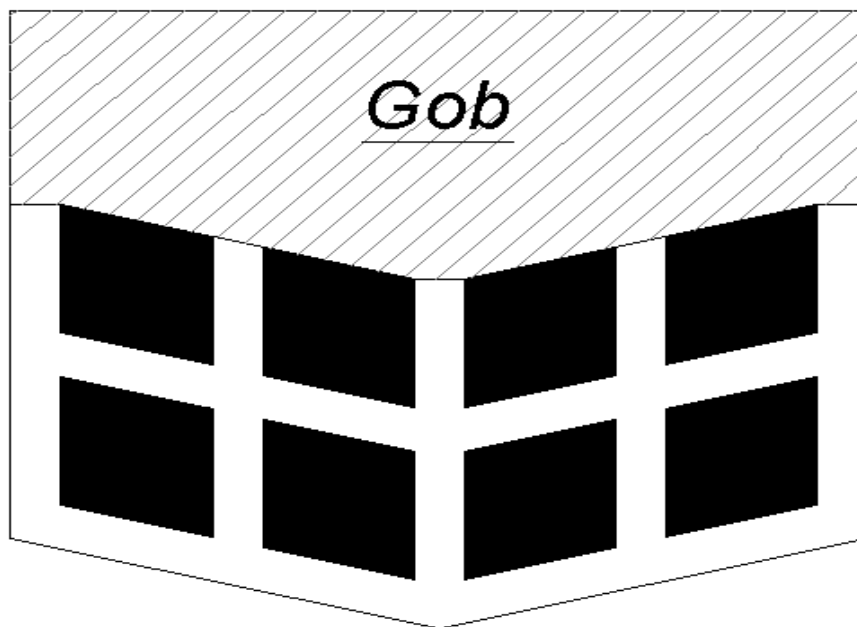
Figure 5.35. Mine No.2 Section Layout

Mine No.2 is located in Central Appalachia. At the time of the field application, the mining height varied between 4.5 and 6 feet. The immediate roof consists of 0 to 2 feet of shale, (depending on location within the mine), below an approximately 10 ft thick layer of sandstone. The bolting pattern utilizes a 4-ft-by-4-ft pattern primarily employing 48-inch roof bolts. The section contains a Joy Model 14CM continuous miner, a Stamler continuous-haulage system, a Long- Airdox scoop, and two 800-ton Fletcher mobile roof supports. The mine operates three shifts per day (two production, one maintenance), seven days per week. Each operating section is staffed by a crew of 12-13 miners; however, only 7 to 8 miners consistently work in the active mining zone. Pillar dimensions encountered during the field application were 60 feet wide and 60 feet long. Each entry and crosscut is 20 feet wide (Figure 5.35).

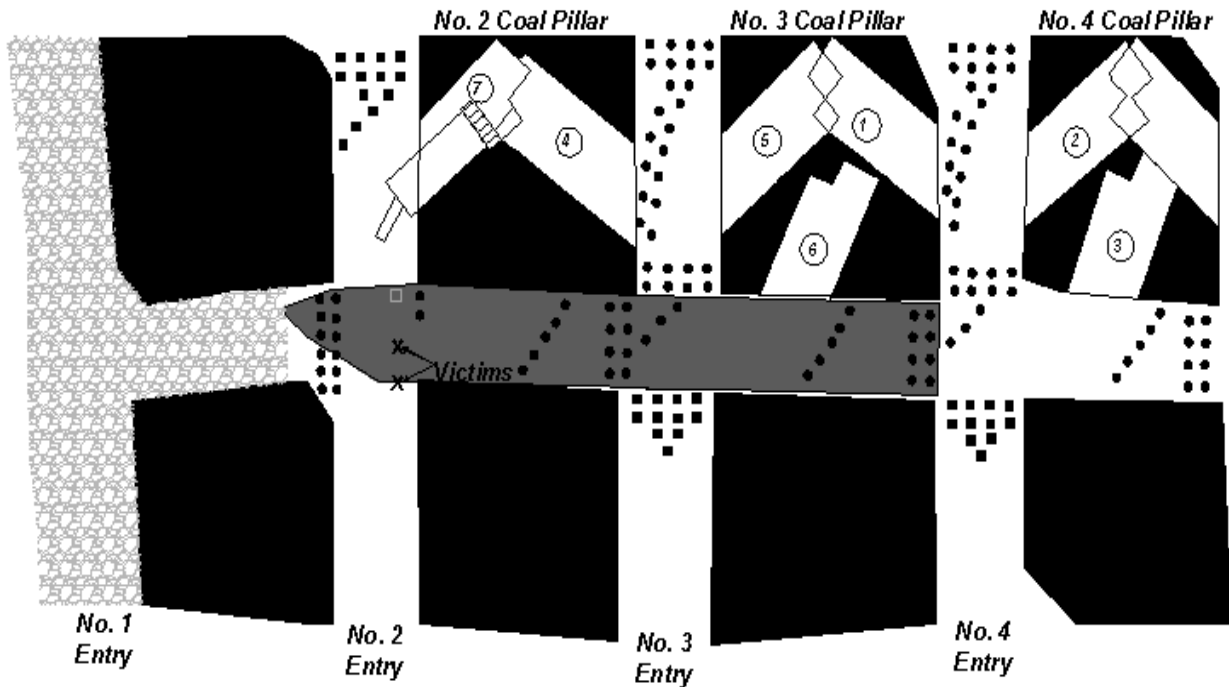
- ① Cut sequence during 3rd shift
- x Victim
- Timbers installed at time of accident (observed)
- Timbers installed at time of accident (witness statements)
- ▨ Gob material
- Roof Fall

The mine roof adjacent to a large geological anomaly (slip) fell causing fatal injuries to the continuous mining machine helper and section foreman. Although the slip had been detected the connecting crosscuts by crew members, it was not determined that it extended through of the Nos. 1, 2, and 3 entries thus presenting a much greater danger than other slips existing throughout the mine. Even though the section foreman had taken steps to install additional supplemental roof supports, the sheer size of the slip and the degree of hazard it presented was underestimated. The roof fell suddenly and, to a large degree, in a solid mass overriding the supplemental support. Continual observations of the roof and breaker posts by the section foreman did enable him to sound a warning which allowed four of the six miners in the area to escape almost certain injury.

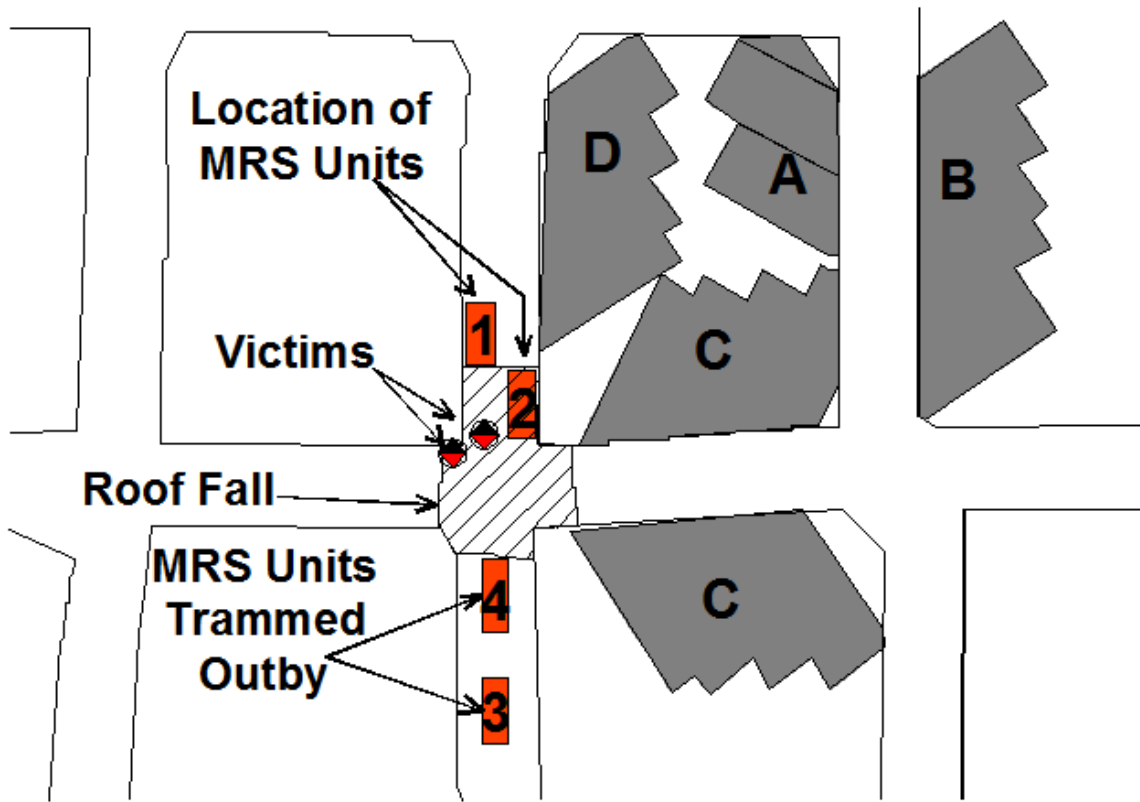
MSHA 2009

7. A 104 (a) Citation, S&S, High negligence, No.7554246, was issued for a violation of 48.7: Mine management failed to provide Clyde Russell with task training in the operation of MRS units. Russell suffered fatal injuries when a roof fall occurred while he was manually operating a MRS in an intersection.

Information was obtained by an on-site investigation and interviews conducted during a fatal accident investigation.

They next began moving the Nos. 3 and 4 MRS units out of the Submains No. 1 entry. Johnson lowered the No. 3 MRS, moved it forward into the intersection, and spun the unit so that the cable was facing the pillared portion of the 1 Left Panel. At this point, the unit lost traction in loose material on the mine floor. Russell started the No. 3 MRS on manual and freed the unit. Bantwell then took remote control of the No. 3 MRS and moved it to the midpoint of the crosscut between the Submains Nos. 1 and 2 entries. Johnson then lowered the No. 4 MRS and moved it into the intersection. He spun the MRS and began moving it into the crosscut behind the No. 3 MRS. McCoy and Baker met Bantwell and Johnson in the crosscut to help them continue moving the Nos. 3 and 4 MRS units.

remained set until the Nos. 1 and 2 MRS units were brought forward into the intersection. Also, the MRS operators were not in a remote location while moving the MRS units, they were in the intersection. This exposed Russell and Bradford to hazards associated with inadequately supported roof immediately adjacent to the incorrectly positioned MRS units and faulty cut sequence.
