Advances in Chemical and Structural Characterization of Concretion with Implications for Modeling Marine Corrosion

Donald L. Johnson

The Weins number model and concretion equivalent corrosion rate methodology were developed as potential minimum-impact, cost-effective techniques to determine corrosion damage on submerged steel structures. To apply the full potential of these technologies, a detailed chemical and structural characterization of the concretion (hard biofouling) that transforms into iron bearing minerals is required. The fractions of existing compounds and the quantitative chemistries are difficult to determine from x-ray diffraction. Environmental scanning electron microscopy was used to present chemical compositions by means of energy-dispersive spectroscopy (EDS). EDS demonstrates the chemical data in mapping format or in point or selected area chemistries. Selected-area EDS data collection at precise locations is presented in terms of atomic percent. The mechanism of formation and distribution of the iron-bearing mineral species at specific locations will be presented. Based on water retention measurements, porosity in terms of void volume varies from 15 v/o to 30

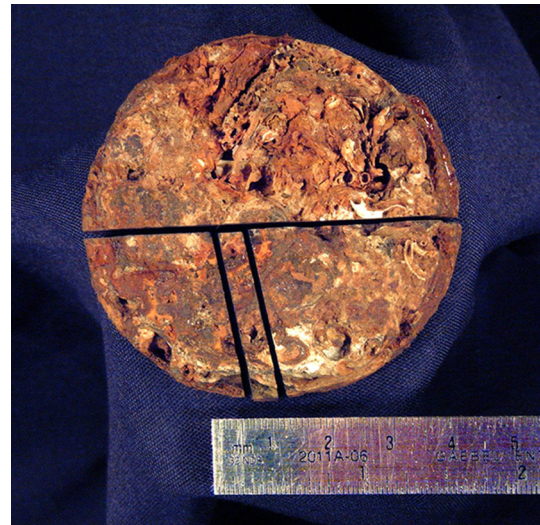
Fig. 1. Photograph of a concretion sample from the *USS Arizona*.

The concretion sample was obtained near midship on the vertical section of the *USS Arizona* hull. It was sectioned on a fine-toothed band saw into four sections as shown in Fig. 1. The sample in cross section is shown in Fig. 2.

Shell structures are visible in the seaside portion and in the cross-sectional view of the concretion. Considerable void population is also observed in the cross-sectional view in Fig. 2. The smallest piece of the concretion shown in Fig. 1 was prepared for observation on the ESEM.

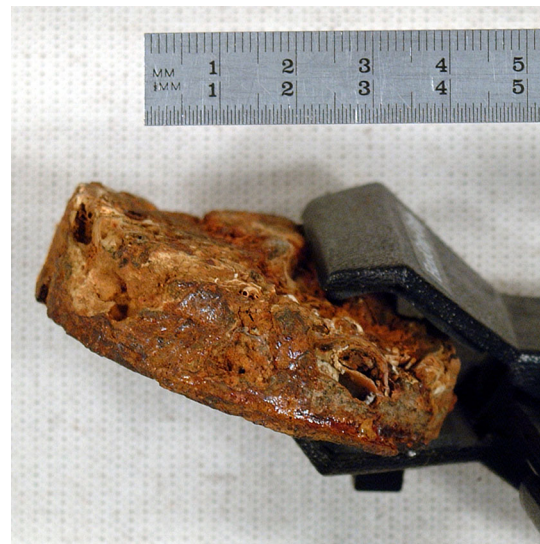
Fig. 2. Photograph of a cross section of the concretion sample.

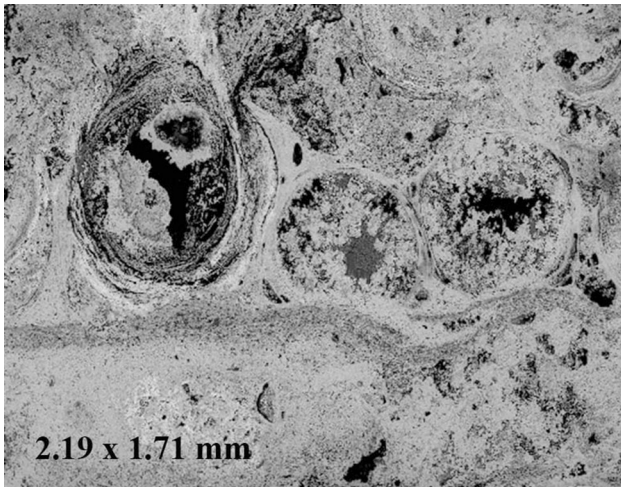
Fig. 3. No overlay. Shippside—bottom.

This preparation technique produced specimens of exceptional quality for ESEM imaging and data collection as shown in Figs. 3–12. The brighter contrast regions in the backscatter electron image of the concretion, shown in Fig. 3, are areas containing a high concentration of iron atoms, and the darkest regions are areas high in low-atomic-weight carbon present in the epoxy. The image has excellent definition and detail of the structure of the concretion indicating minimal damage was introduced during polishing. The void regions in the image containing epoxy are shown in red in the carbon map superimposed on the backscatter image, as shown in Fig. 9. Figures 3 through 9 are backscatter images of the exact same area overlaid with elemental maps of calcium Fig. 4, sulfur Fig. 5, silicon Fig. 6, aluminum Fig. 7, iron plus calcium Fig. 8, and carbon Fig. 9. Please note that the shippside position is at the bottom side of each image in Figs. 3–10a and the image size is 2.19 mm × 1.71 mm.

Figure 3 illustrates imaging without element identifying overlay. Inhomogeneity in the form of a near-circular embedded shell is noted in at least three locations. Figures 4 and 5 reveal identical overlays for calcium and sulfur indicating that the dominant specie in these areas is a calcium mineral containing sulfur. The specific minerals present are discussed below. Figures 6 and 7 reveal a thin layer of Si and Al, respectively, traversing the concretion cross section. Figure 6 shows the backscatter electron image overlaid with a silicon map. The image with an aluminum map is shown in Fig. 7. The aluminum is in the form of Al_2O_3 and silicon in the form of SiO_2 , which are both compounds found in

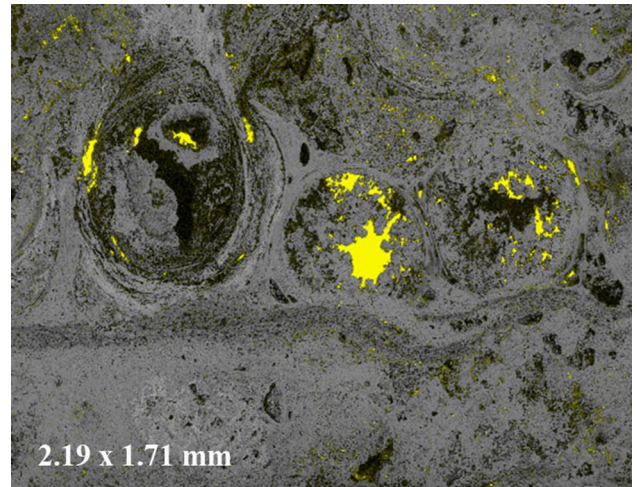
Fig. 5. Sulfur (yellow) map overlay. Shippside—bottom.

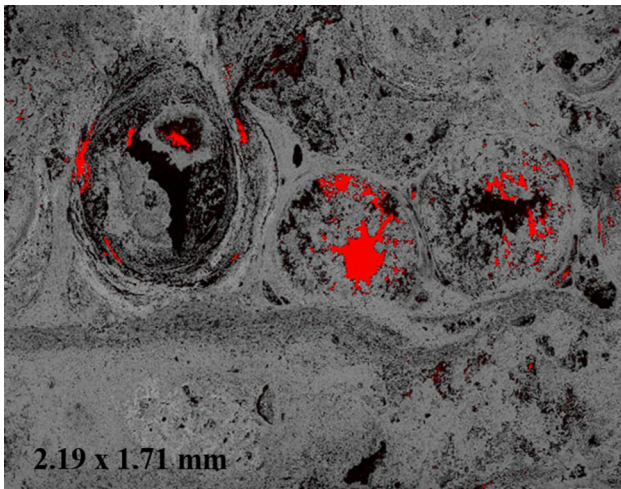
Fig. 4. Calcium (red) map overlay. Shippside—bottom.

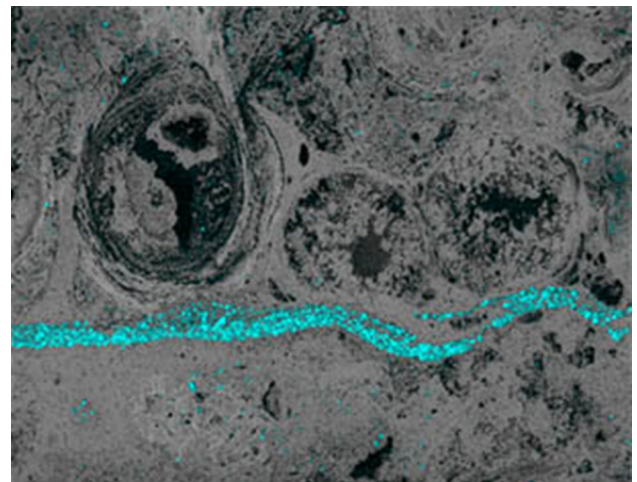
Fig. 6. Silicon (blue) map overlay. Shippside—bottom.

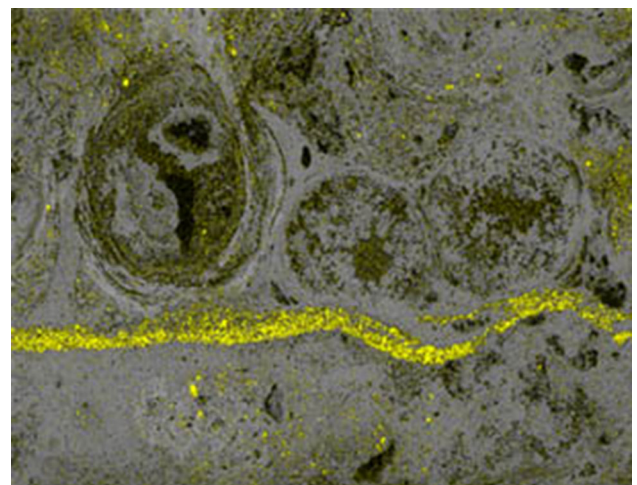
Fig. 7. Aluminum (yellow) map overlay. Shippside—bottom.

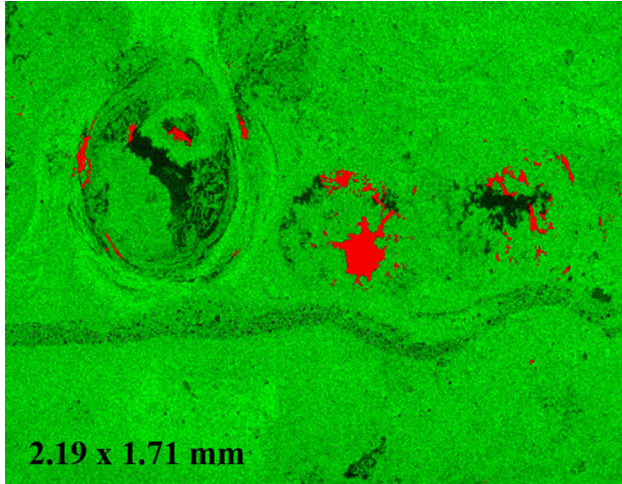
Fig. 8. Iron (green) and calcium (red) map overlay. Shiplside—bottom.

the attack and that the layer acts as an inert marker. His theory was confirmed from sediment taken adjacent to the *USS Arizona*. Specimens were washed and dried and found to contain silica and alumina particles of the same EDX chemical compositions and size as the particles embedded in the concretion removed from *USS Arizona*. These observations are exciting and point to further research into application of the Kirkendall effect to estimate corrosion rate as a function of the distance between the marker and the existing metal/concretion interface after a 60-year exposure. The Kirkendall effect was first reported from analysis of inert marker transport in metallic alloys.⁹ Figure 8 shows the distribution of iron in the concretion with the exception of regions containing calcium or void

in the vicinity of shell. This image confirms that iron is otherwise relatively uniform in distribution, constituting a primary sink for iron as corrosion proceeds. Such distribution is the basis for the CECR methodology. Figure 9 illustrates the extensive void presence in concretion and confirms calculations showing void volumes as high as 35%. Figures 10a and 10b illustrate complex element combinations, particularly the shades of blue to green representing the various iron oxides that occur throughout the image. Siderite, an iron carbonate, is dominant in XRD scans although it is not isolated in maps associated with backscatter detector images.

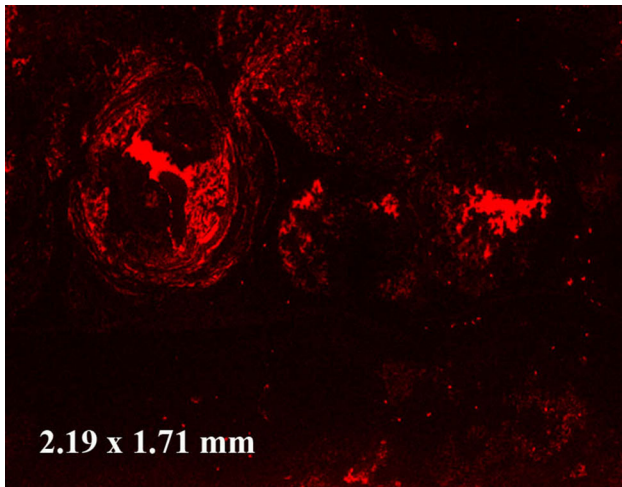
Fig. 9. Voids filled with epoxy showing carbon (red) map. Shiplside—bottom.

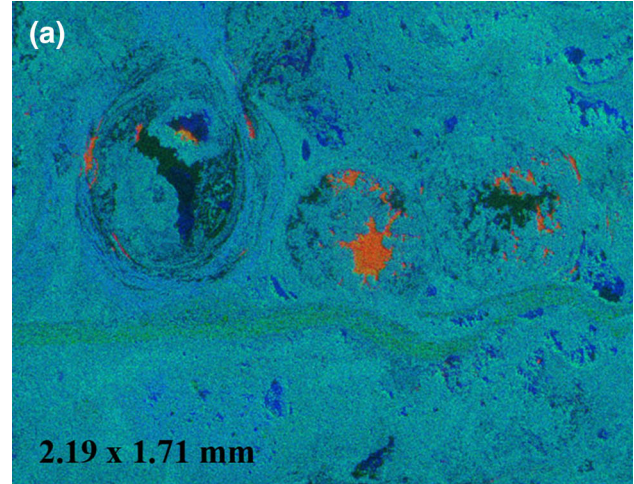
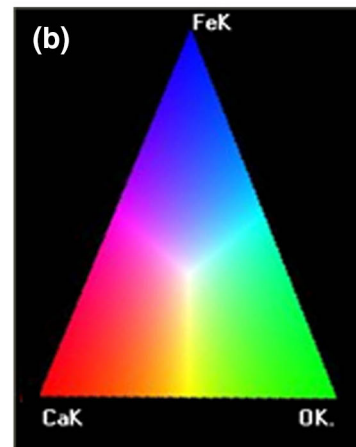
Fig. 10. (a) Calcium (red), iron (blue), and oxygen (green) RGB map. Shiplside—bottom. (b) Elemental combinations for Figs. 10a and 11.

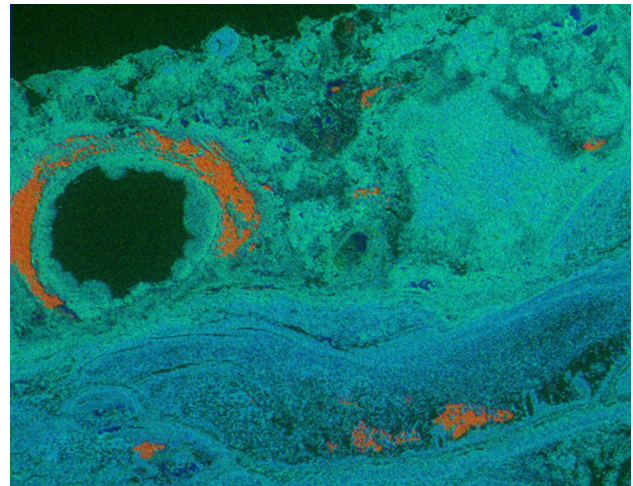
Fig. 11. Calcium (red), iron (blue), and oxygen (green) RGB map. Seaside—top. See Fig. 10b for elemental combinations.

Figures 11 and 12 are seaside images, and the image size is 2.36 mm \times 1.8 mm.

Seaside images are similar to shipside images with the dominant presence of iron in the form of oxide minerals, and siderite as has been observed near shipside. Embedded shells tend to concentrate toward seaside as illustrated in Figs. 11 and 12. The coloring of iron oxides in Fig 11 change with increasing distance from seaside from higher oxygen (greenish) to lower oxygen (bluish). Figure 12 clearly shows the dominance of calcium and void in the center surrounded by void and sulfur. This observation has led to a better understanding of iron distribution and avoidance of these areas in determination of oxygen diffusion thickness.

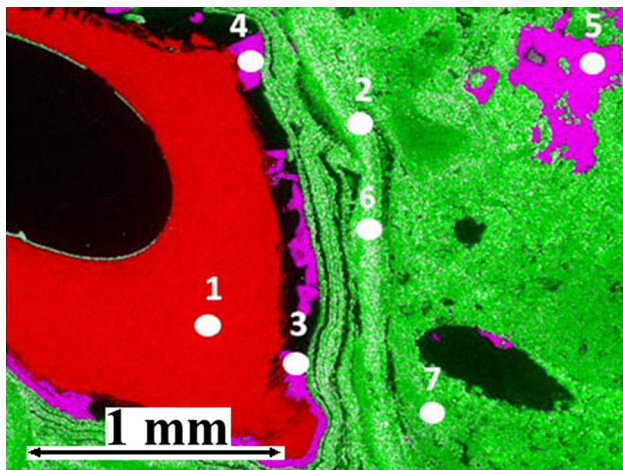
Fig. 12. Shell encased in concretion, calcium (red), iron (green), and sulfur (magenta). Seaside—top.

Superimposed on the Fig. 12 image are points at which chemistries were determined by EDS. The chemistries, in atomic percentages, at these locations are listed in Table I. Table II lists the stoichiometric atomic chemistries of identified minerals associated with common steel corrosion products.

Comparison of the tabulated data indicates that the composition of the shell at position 1, Fig. 12, is CaCO_3 and that positions 2 and 6 seem to have a composition of FeCO_3 . The latter positions are on portions of the seashell in which the calcium has been replaced by iron originating from the ship. Similarly, based on Tables I and II, calcium sulfate seems to exist in positions 3, 4, and 5. It is assumed that sulfite converts to sulfate in positions rich in oxygen. This raises the question of the source of the sulfur present in these regions. It is also interesting that the CaSO_4 encases the CaCO_3 portion of the seashell. This positioning is easily observed at positions 3 and 4; however, position 5 is at a location on an interface of a shell of a different orientation. Position 7, located in the green area represented by iron, is identified as $\text{FeO}(\text{OH})$ or Akaganeite, a stoichiometry that has been reported on other marine wreck sites as goethite or lepidocrocite,^{12,14} the latter a variable stoichiometry dependent on oxidizing conditions.
