Research Report

KTC-15-19/MTIC7-14-1F

Evaluation of Thermal Imaging Technology for Commercial Vehicle Screening

December 2015

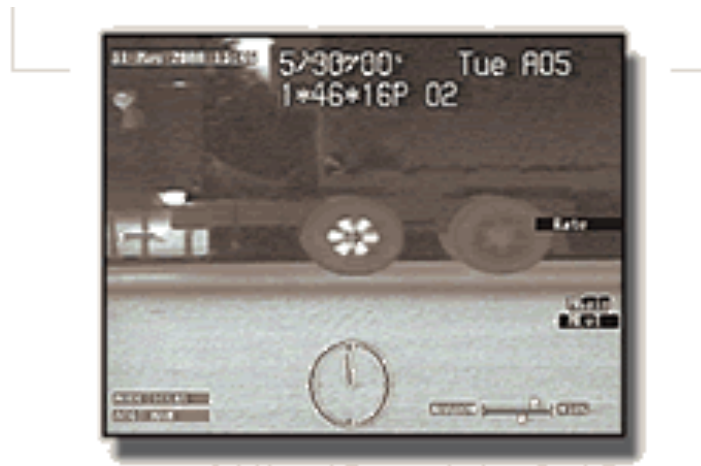
Of these technologies, only the thermal imaging camera provides information on possible real-time safety problems with the vehicle. This system can identify low or flat tires and can reveal a cold brake, which indicates it is not functioning properly. If no detectable heat emanates from the braking system, it suggests a failure, while a flat or low tire will generate a different thermal signature compared to a properly inflated tire. Figure 1 displays an image taken from a thermal camera, showing two axles from a commercial vehicle. On one axle, bright white shines through the wheel's hub, while the other hub is dark. The dark axle indicates an absence of heat, very likely due to a non-functioning brake.

Figure 1. Thermal Imaging Displaying an Inoperable Brake

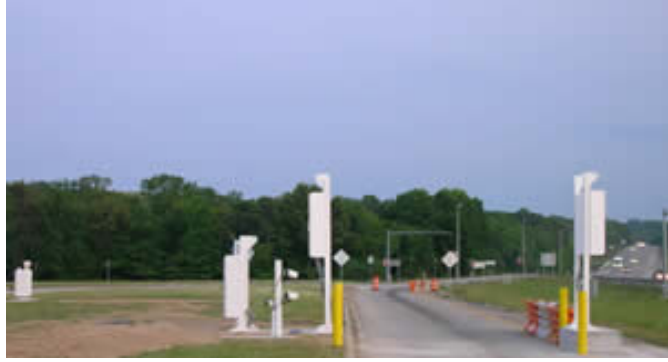
A thermal imaging camera was first installed in August of 2005 on I-75 northbound at the Laurel County inspection facility as part of the Integrated Safety and Security Enforcement System (ISSES). ISSES incorporated a suite of technologies aimed at identifying safety and security issues at weigh stations. The technologies included with the ISSES installation were a radiation detection system, an infrared brake monitoring system, and a license plate reader and USDOT number reader with optical character recognition. ISSES was also installed in 2006 at the Simpson County inspection facility on I-65 northbound as well as at the Kenton County inspection facility on I-75 southbound. Figure 2 depicts the ISSES installation on the weigh station ramp at the Laurel County northbound facility.

Figure 2. ISSES Equipment at Laurel NB

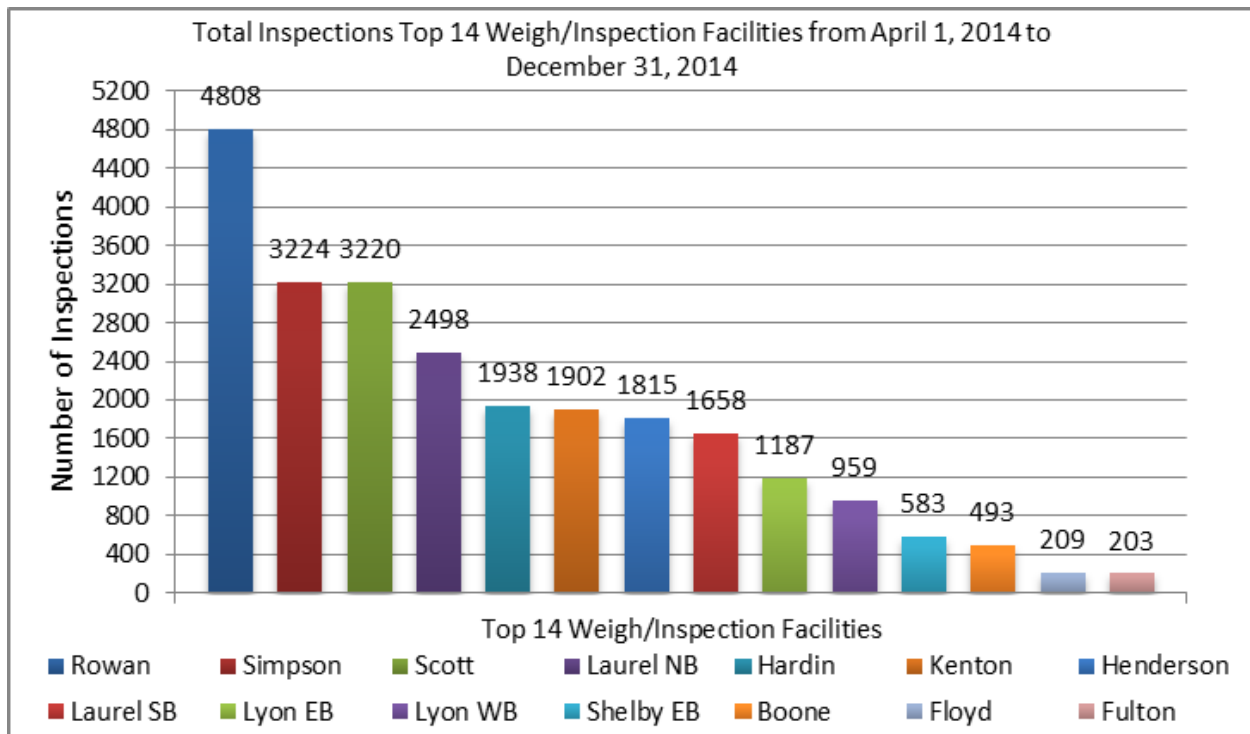
Figure 3 shows the total number of inspections performed at each weigh station over the study period. Staffing and hours of operation had the most significant impacts on these numbers. In general, the most inspections were performed at locations with the highest numbers of officers and inspectors. For example, Rowan County is a small facility with relatively light traffic, but four inspectors work at that location on a regular basis, whereas most facilities only have two inspectors on hand. Other facilities with a high number of inspections include Simpson, Scott, and Laurel northbound, each of which has higher staffing numbers than other facilities.

Figure 3. Number of Inspections at Inspection Facilities (April 1 - December 31, 2014)
