COMMONWEALTH OF KENTUCKY
DEPARTMENT OF TRANSPORTATION

Division of Research
533 South Limestone
Lexington, KY 40508
August 13, 1975

SUBJECT: Research Report No. 431; "Loads on Box Culverts under High Embankments:
Positive Projection, without Imperfect Trench;" KYHPR-72-68; HPR-PL-1(11);
Part II.

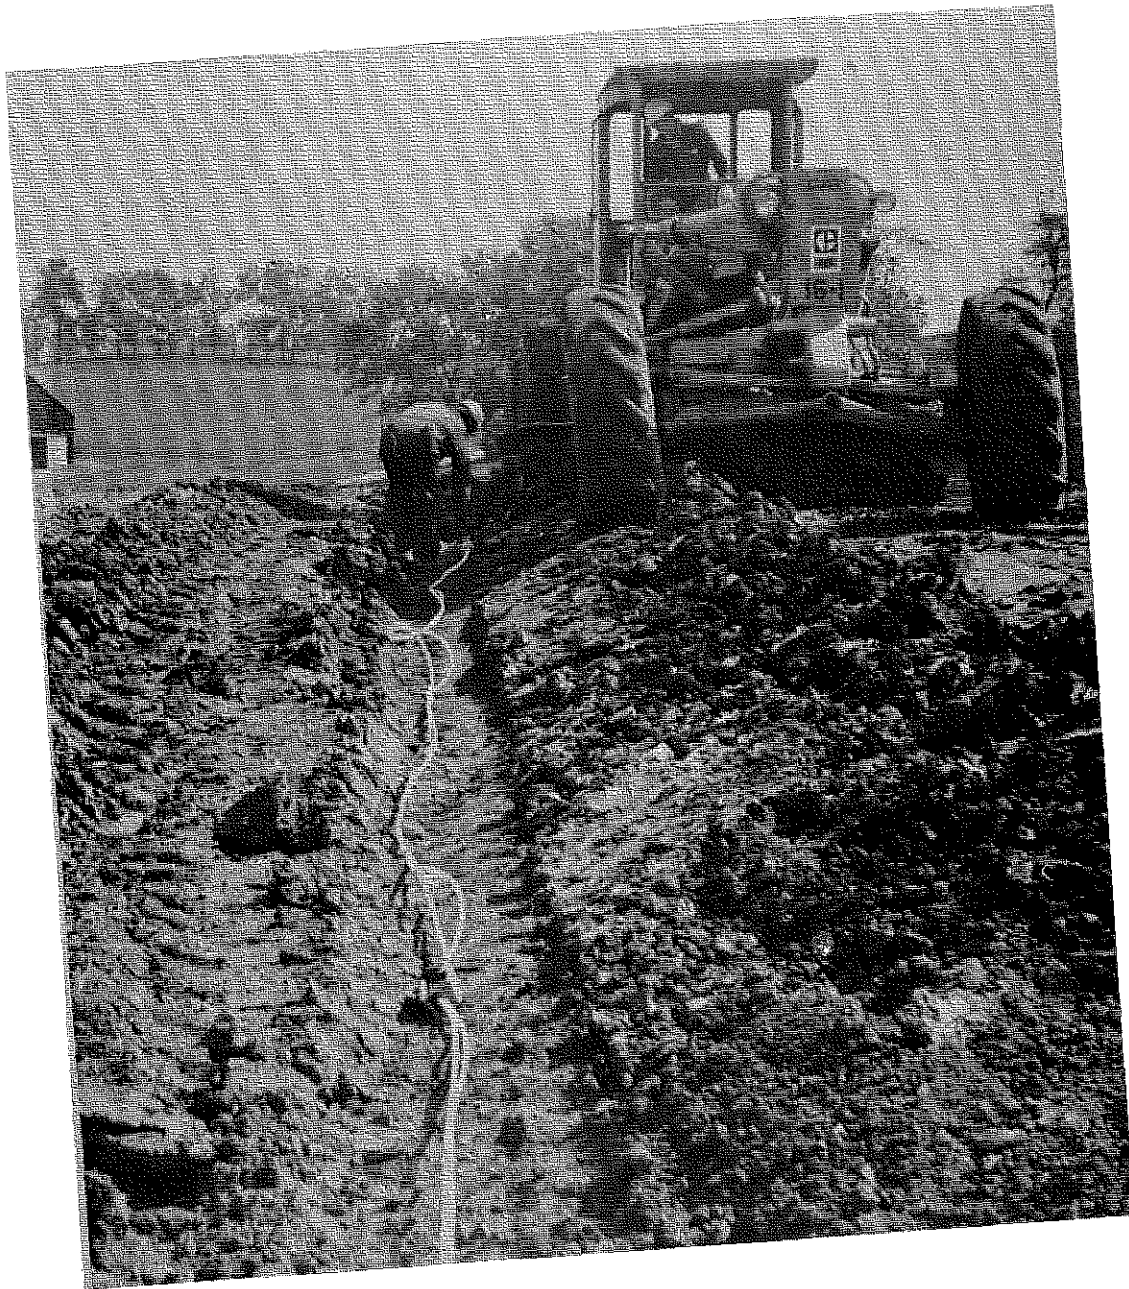
Figure 15. Formation of a Ditch Used in Installing a Settlement Gage.

Gages No. 2, 3, 4, and 5 were all installed in the following manner: When the embankment was constructed to a predetermined height, a ditch was cut directly over and parallel to the culvert barrel with the blade of a road grader (Figure 15). The settlement gages were subsequently placed in the ditches and covered.
