Urban-industrial shoreline restoration techniques: Duwamish Waterway and Elliott Bay

George Blomberg

Estuarine Restoration

Urban Industrial Context

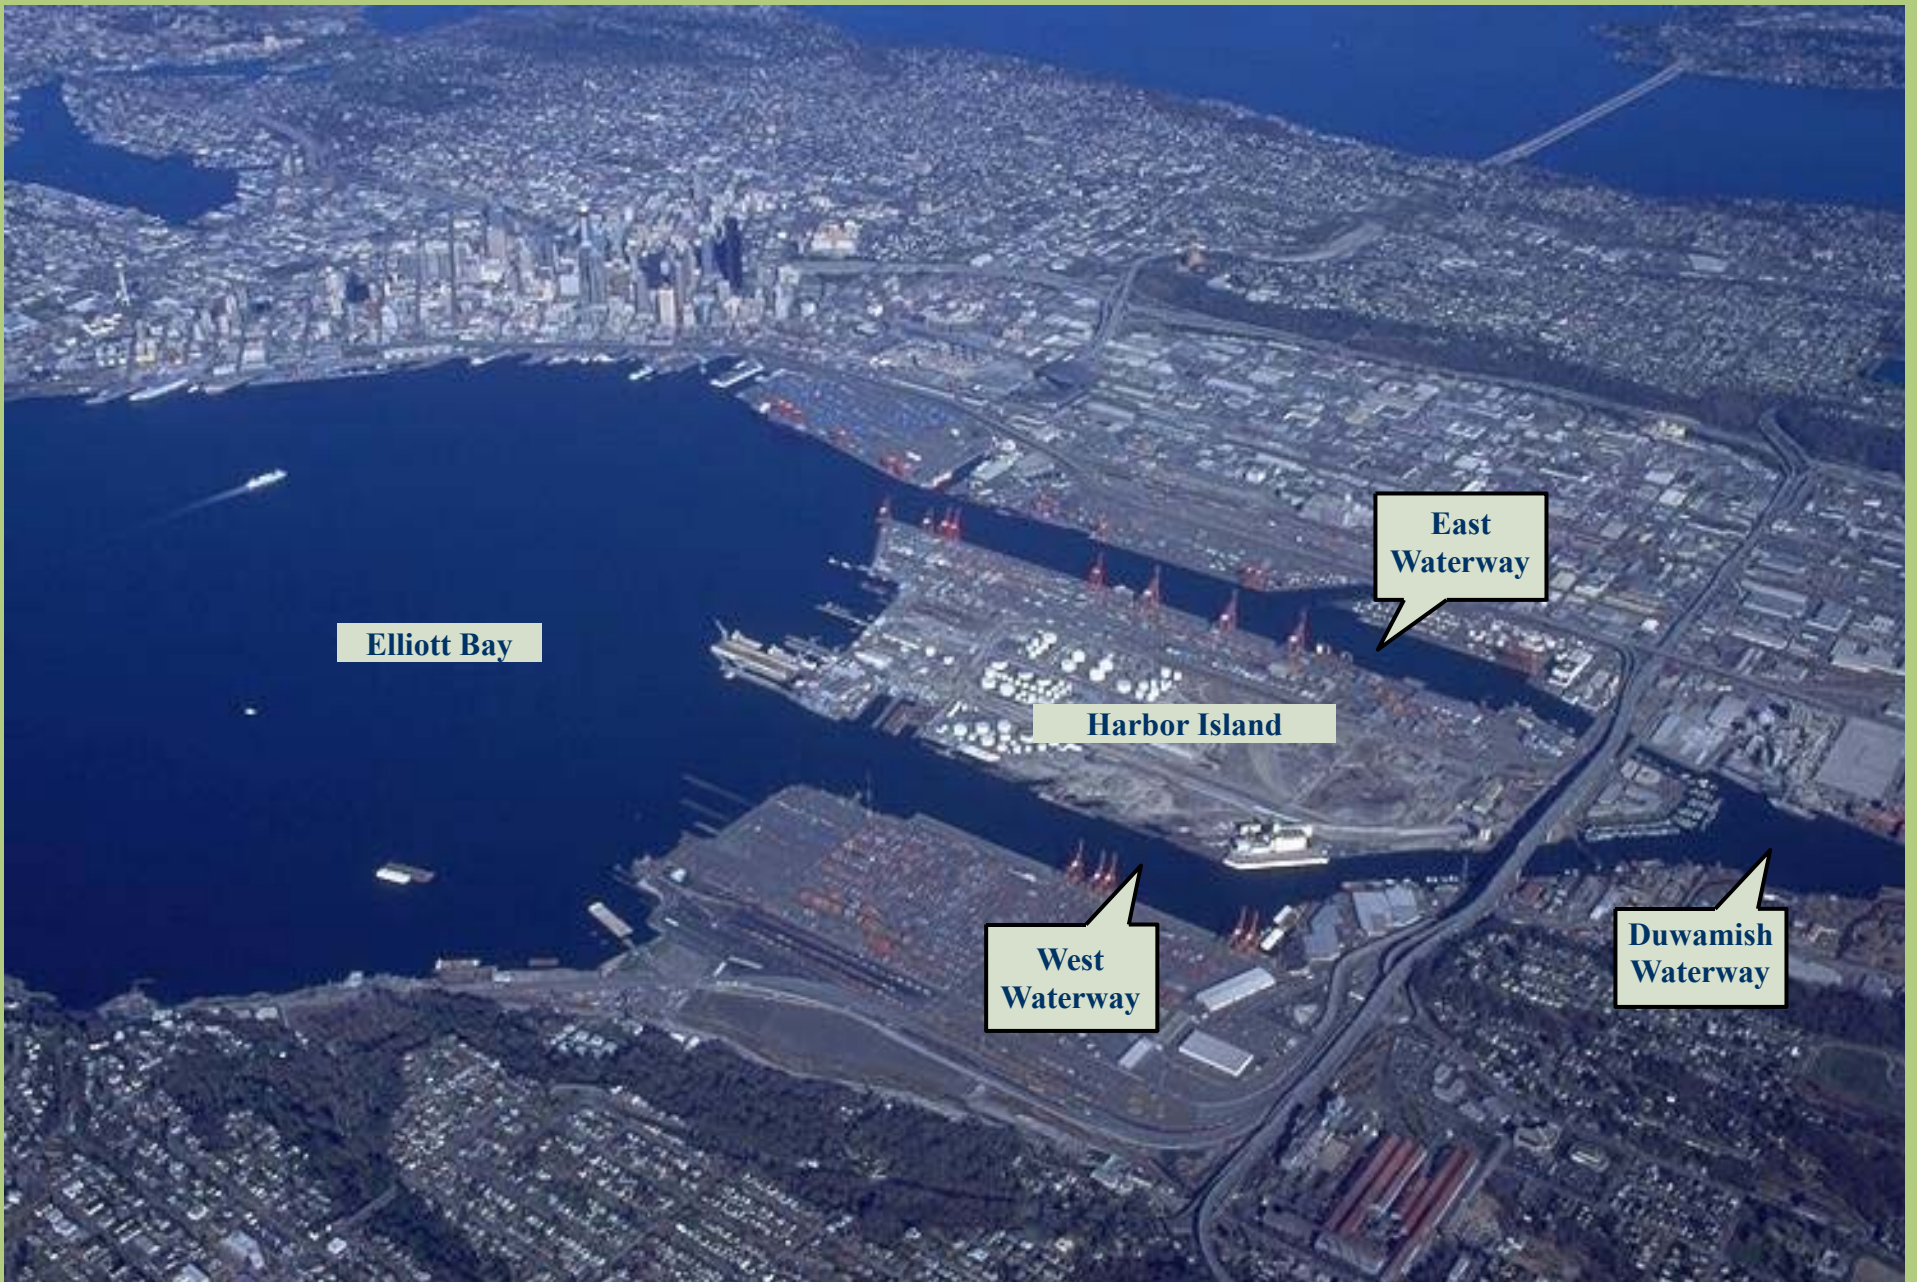
South Elliott Bay

View toward northeast with Seattle urban center in middle background. Harbor Island, the East and West Waterways, and the Duwamish Waterway are visible in the foreground.

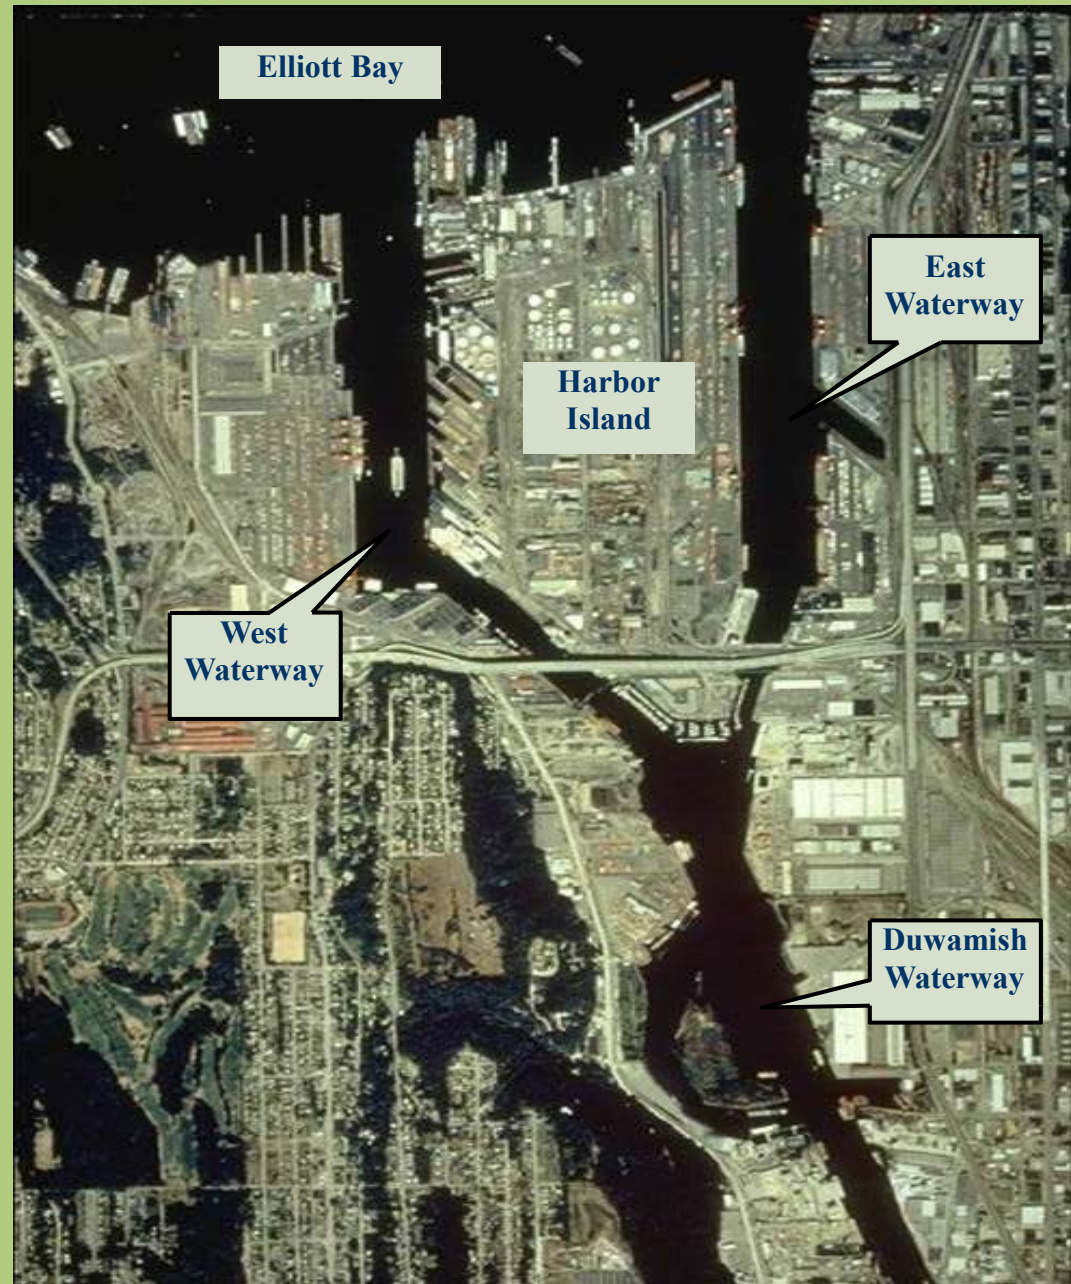
Present industrial area and historic river channel

This graphic contrasts the present urban industrial shoreline in south Elliott Bay and the Duwamish Waterway with conditions recorded in 1854. All existing marine terminal area, rail and vehicle access facilities, and industrial land in south Elliott Bay and Duwamish Waterway have been constructed in former intertidal and estuarine floodplain area (identified by the dark green shading).

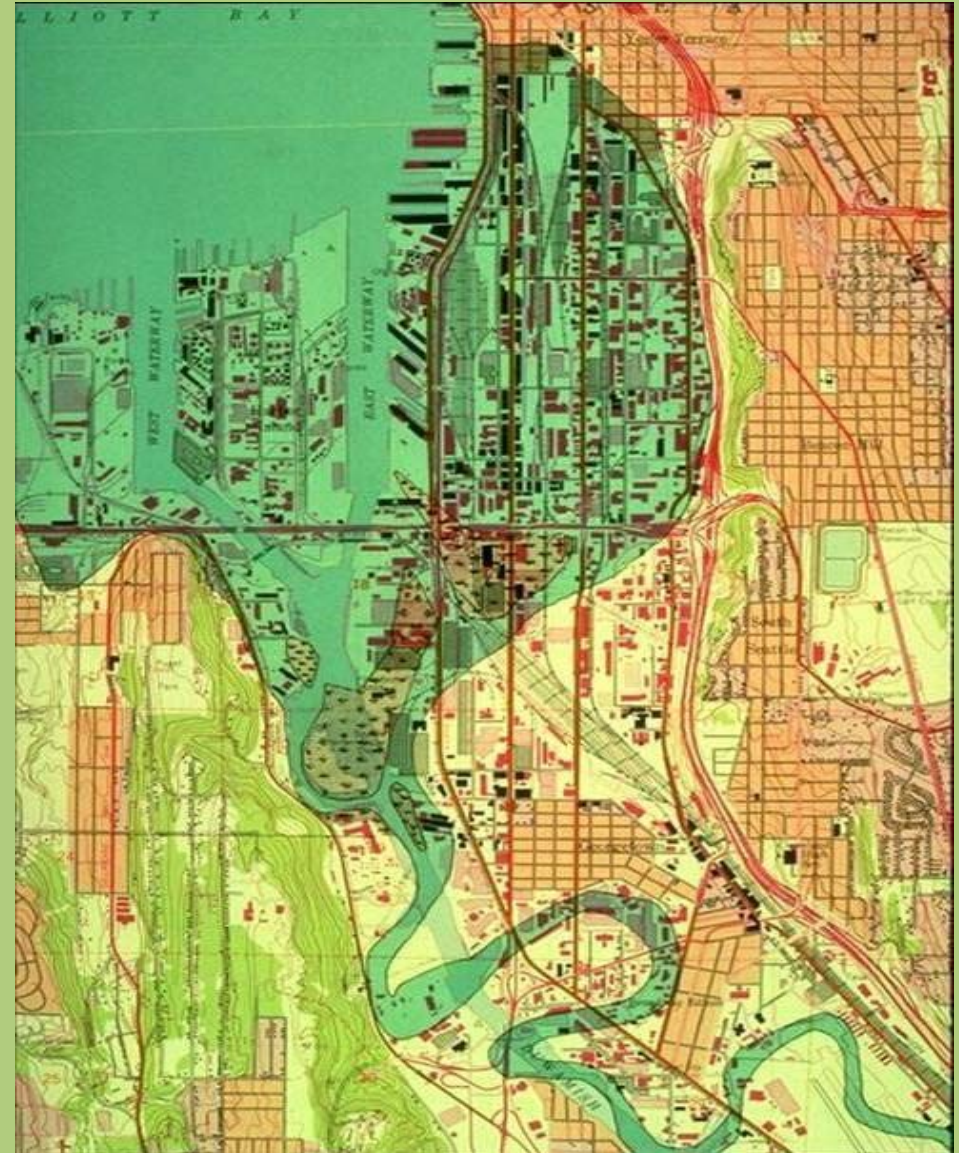
Historic estuarine environment in South Elliott Bay

The former estuary included approximately 1450 acres of intertidal sand and mud substrate, nearly 1300 acres of intertidal marsh, and approximately 1450 acres of tidal swamp (or forested wetland).

In addition, the meandering river channel included approximately 17 miles of riparian environment and estuarine floodplain. The combined intertidal and estuarine floodplain habitat area was approximately 5300 acres.

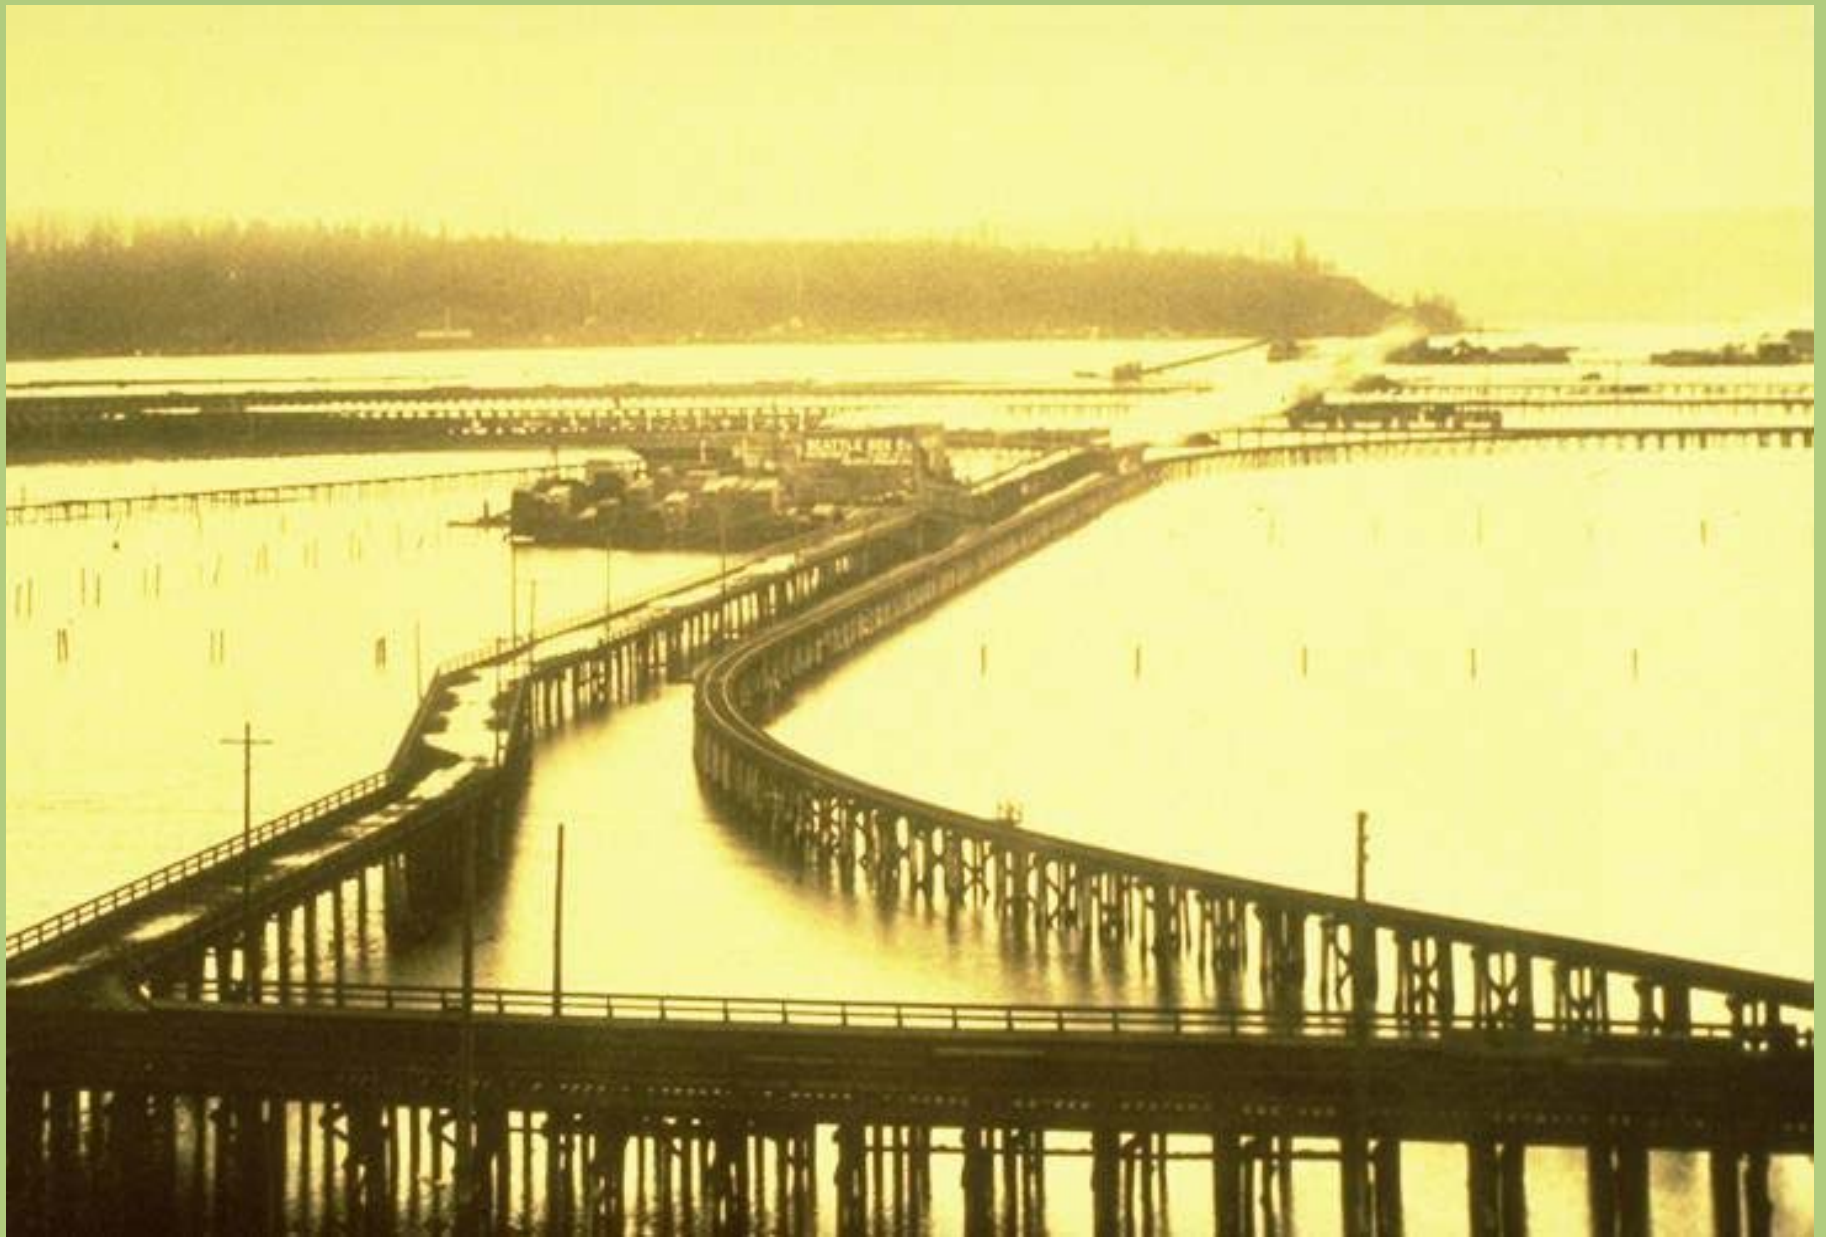
Westerly perspective, Spokane Street corridor in 1898

This figure illustrates the extent of intertidal area in south Elliott Bay prior to large scale industrial development. Note piling supported rail lines and vehicle access to west portion of south Elliott Bay.

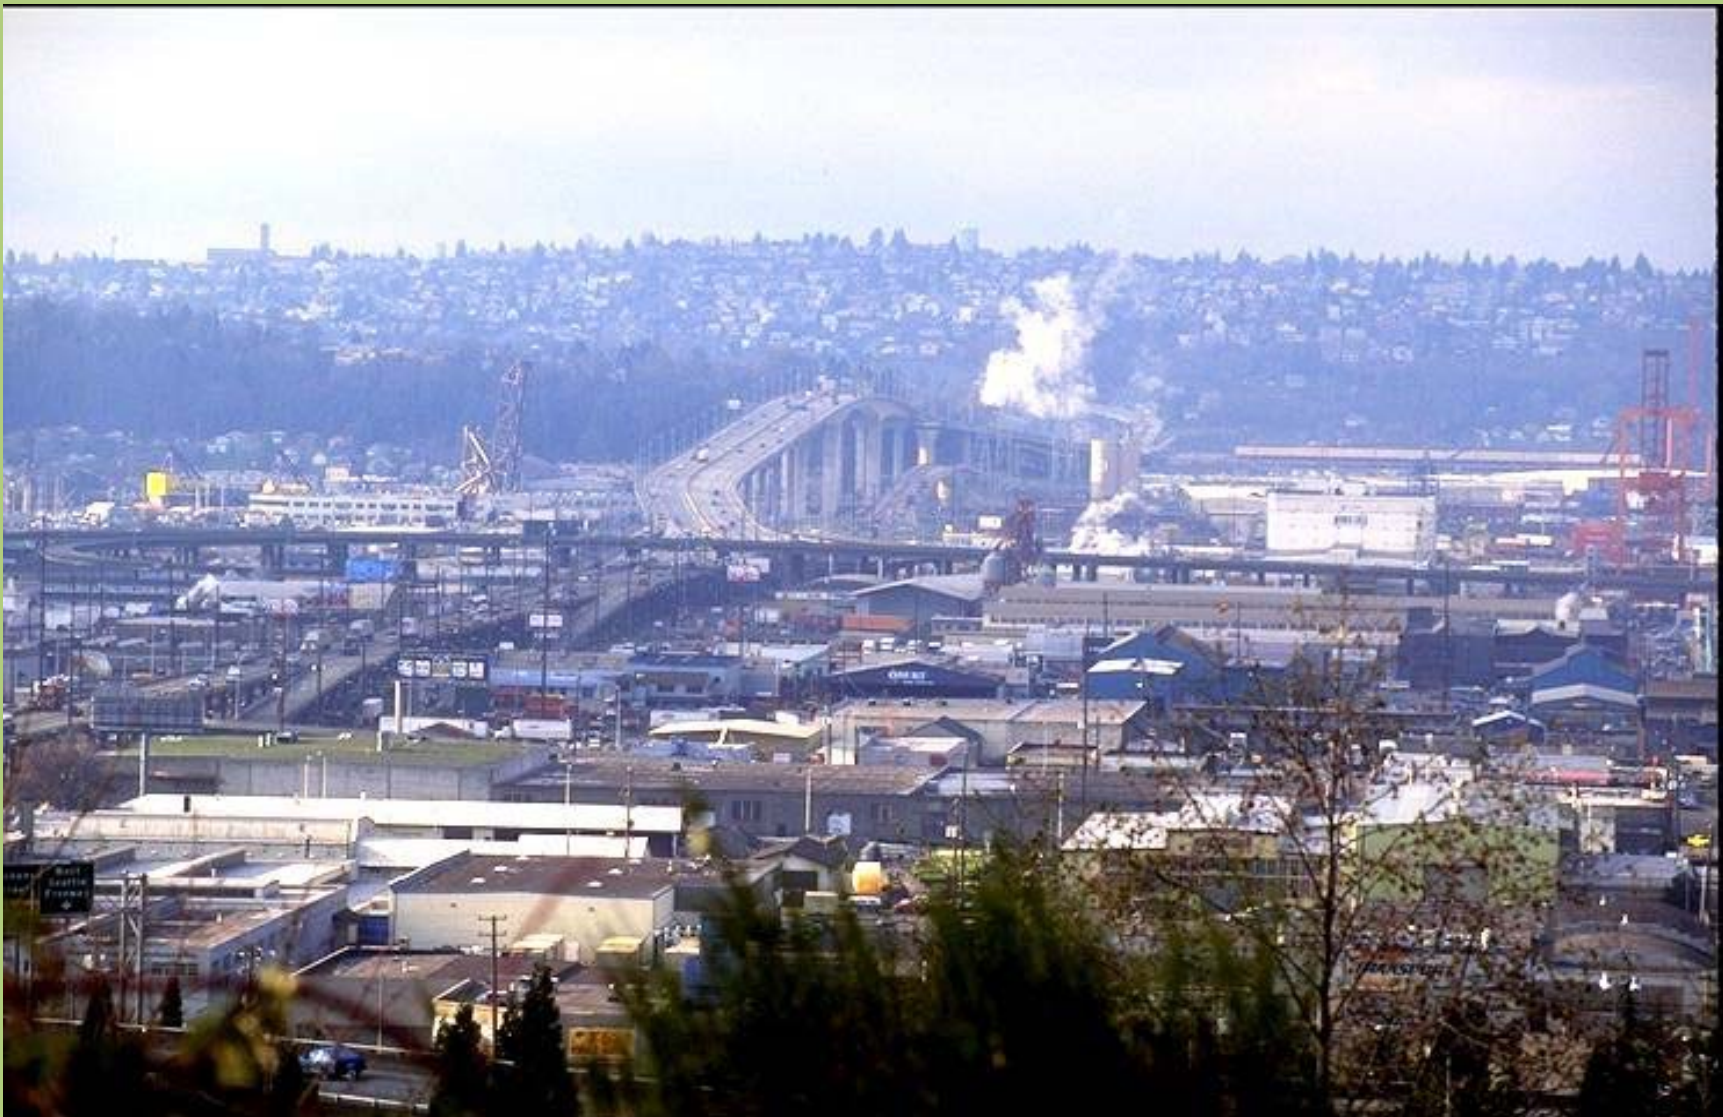
Westerly perspective, Spokane Street corridor in 1998.

This image is identical in location to the 1898 image. The elevated bridge structure, at the south end of present Harbor Island, occupies the alignment of the piling-supported trestle indicated in the 1898 photograph. The present industrial area, constructed entirely in former estuarine aquatic area, includes 75,000 to 80,000 industrial/manufacturing jobs, annual payroll approximately \$2.5 billion

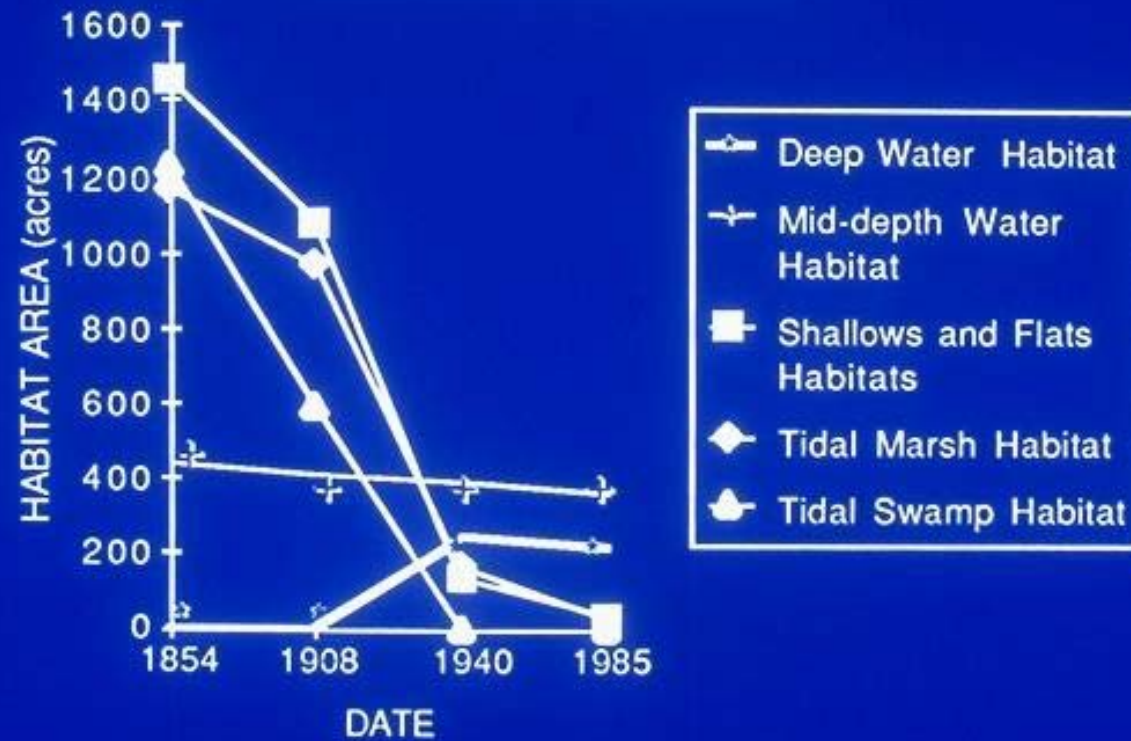
HISTORICAL CHANGES IN THE DUWAMISH RIVER ESTUARY, 1854-1973

HABITAT AREAL EXTENT

Graphic indicating scope of change in estuarine resource features—1854 to present.

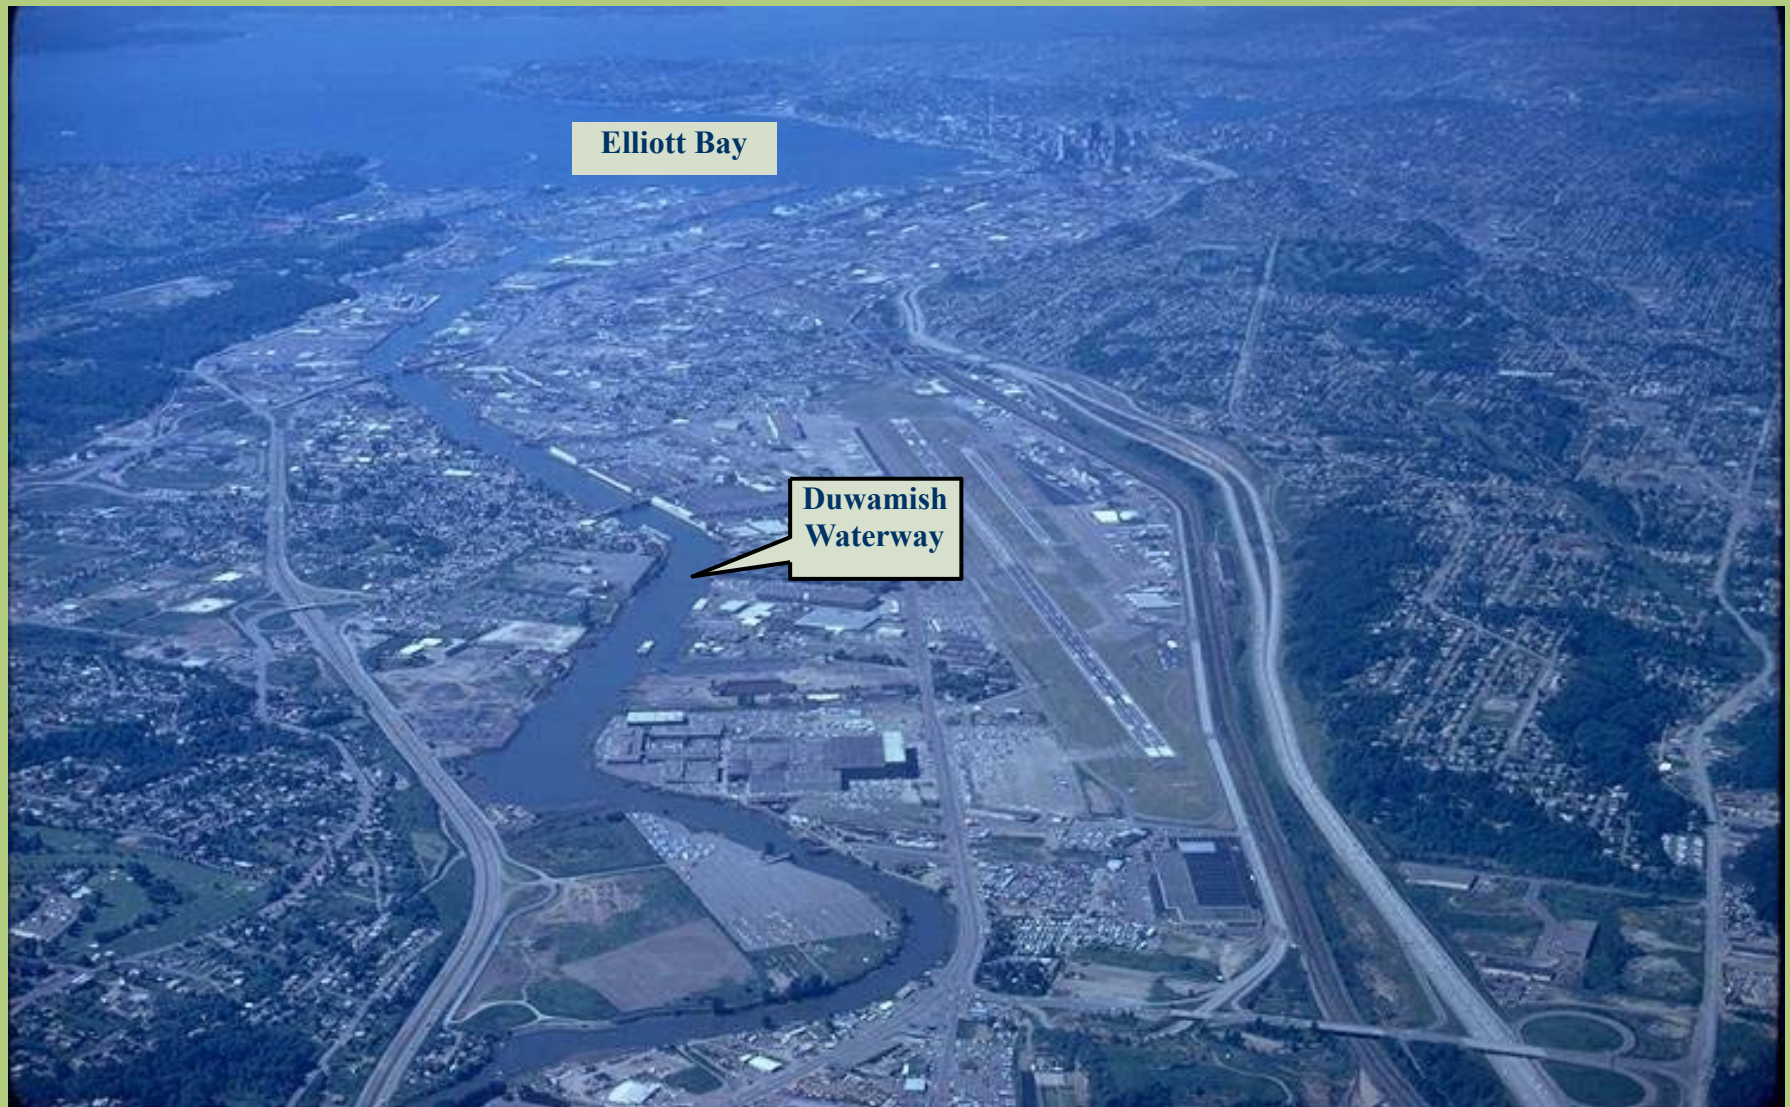
View to northwest illustrating the Duwamish Waterway, foreground, and south Elliott Bay, upper center photograph.

This is the present environmental context for the Port's long range marine cargo and industrial infrastructure needs. The Port's objective is to redevelop existing industrial area, expanding the capability of marine terminal facilities and delivering important economic growth opportunity, while providing coincident environmental improvements - often as project-specific mitigation - in the Duwamish Waterway.

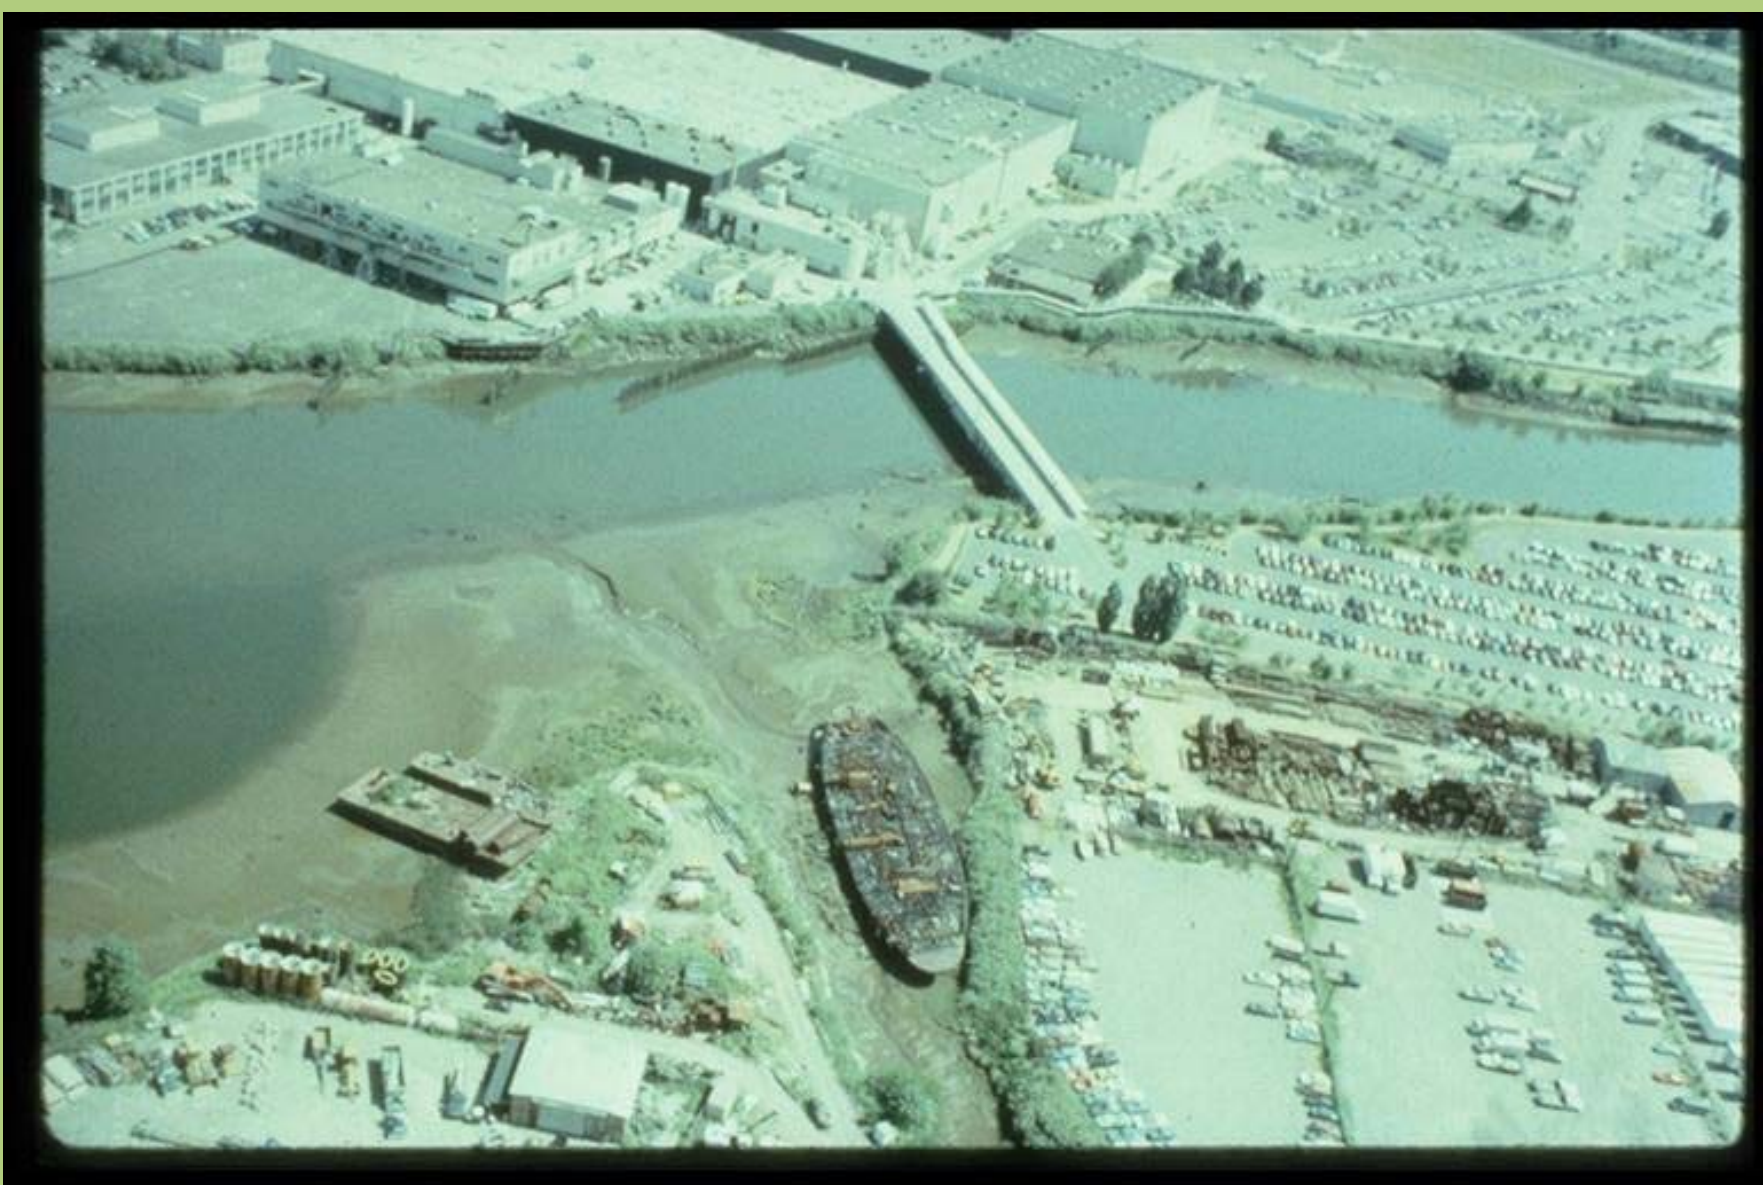
Turning Basin Number Three Demonstration Site.

Environmental conditions at the upstream end of the Duwamish Waterway (river mile 5.3) are evident in this 1995 photograph. Filled former aquatic area is occupied by industrial activities and shoreline areas include the legacy of more than 90 years of industrial use. This location became the focus for a cooperative intertidal habitat demonstration project, co-sponsored by the Environmental Protection Agency, U.S. Fish and Wildlife Service, Corps of Engineers, and the port.

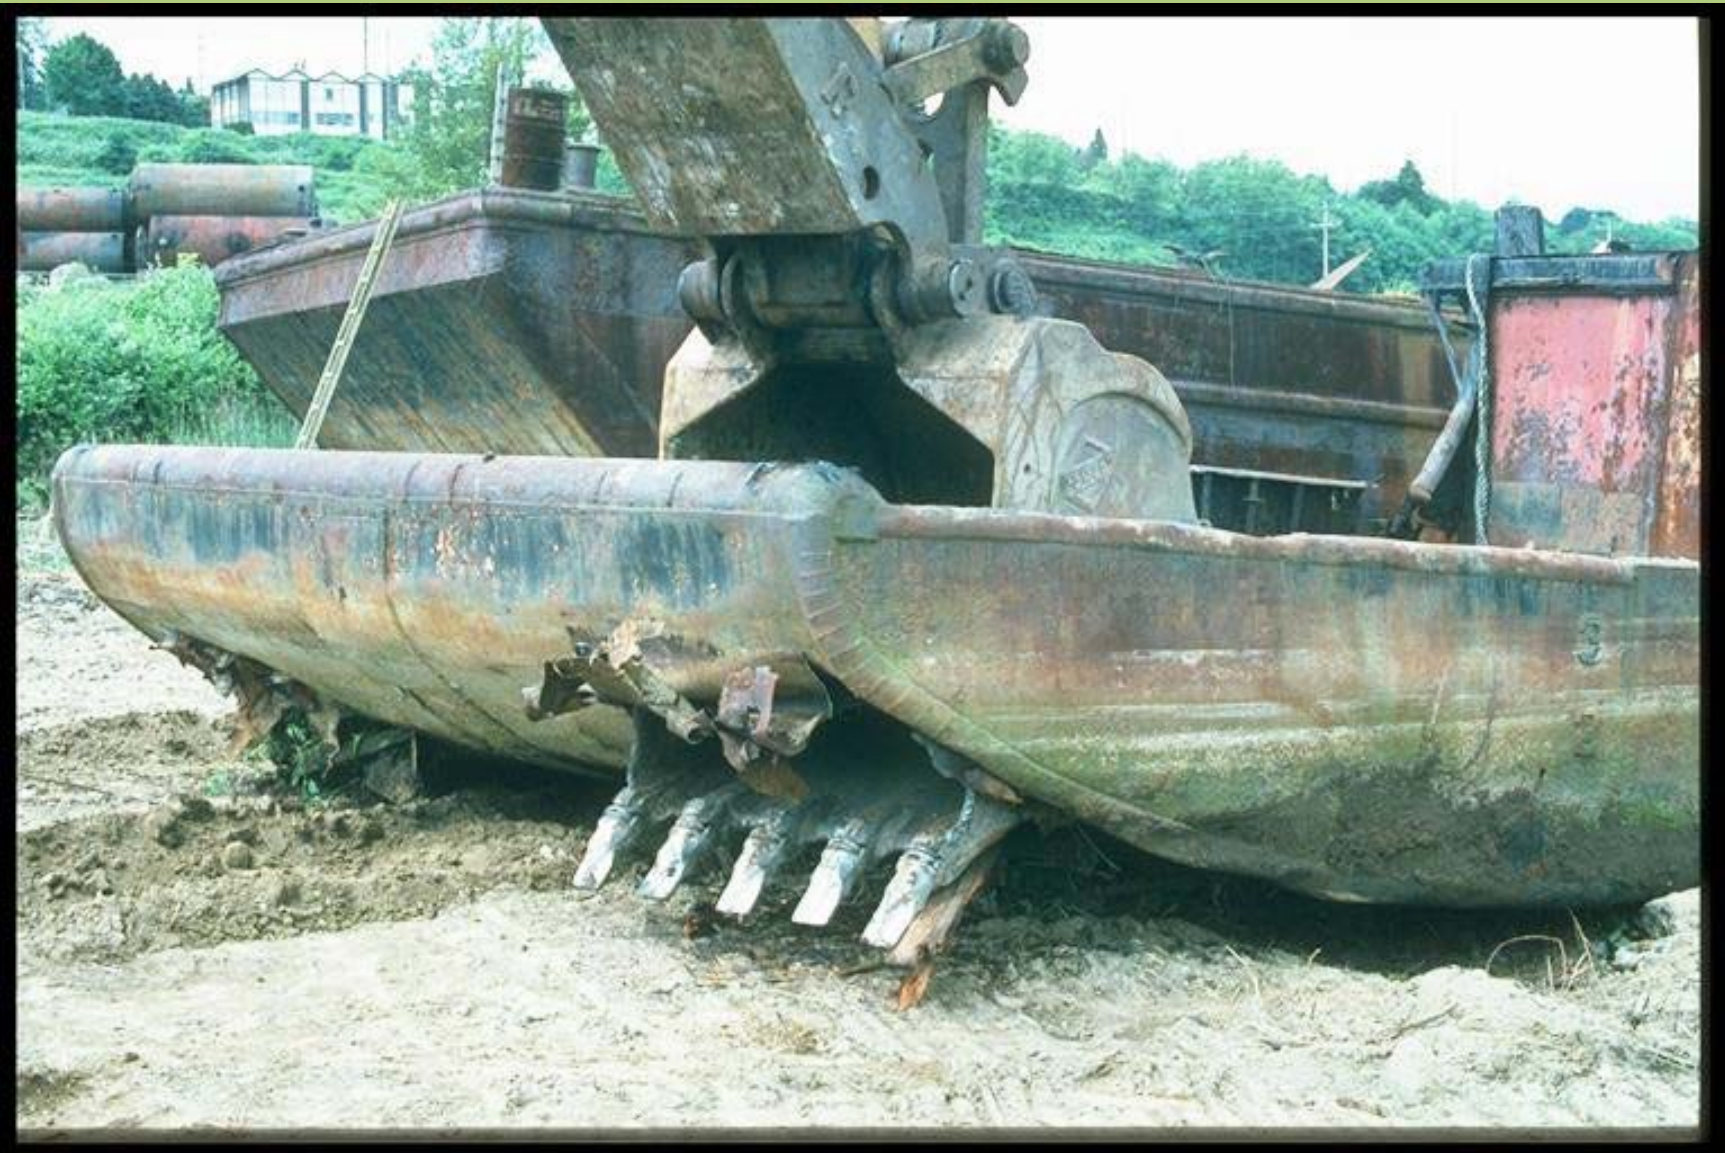
Turning Basin Number Three Demonstration Site Construction Activities.

The first step in restoration work at the turning basin site was to remove derelict vessels that had been abandoned at the upstream end of the navigation channel over a period of decades.

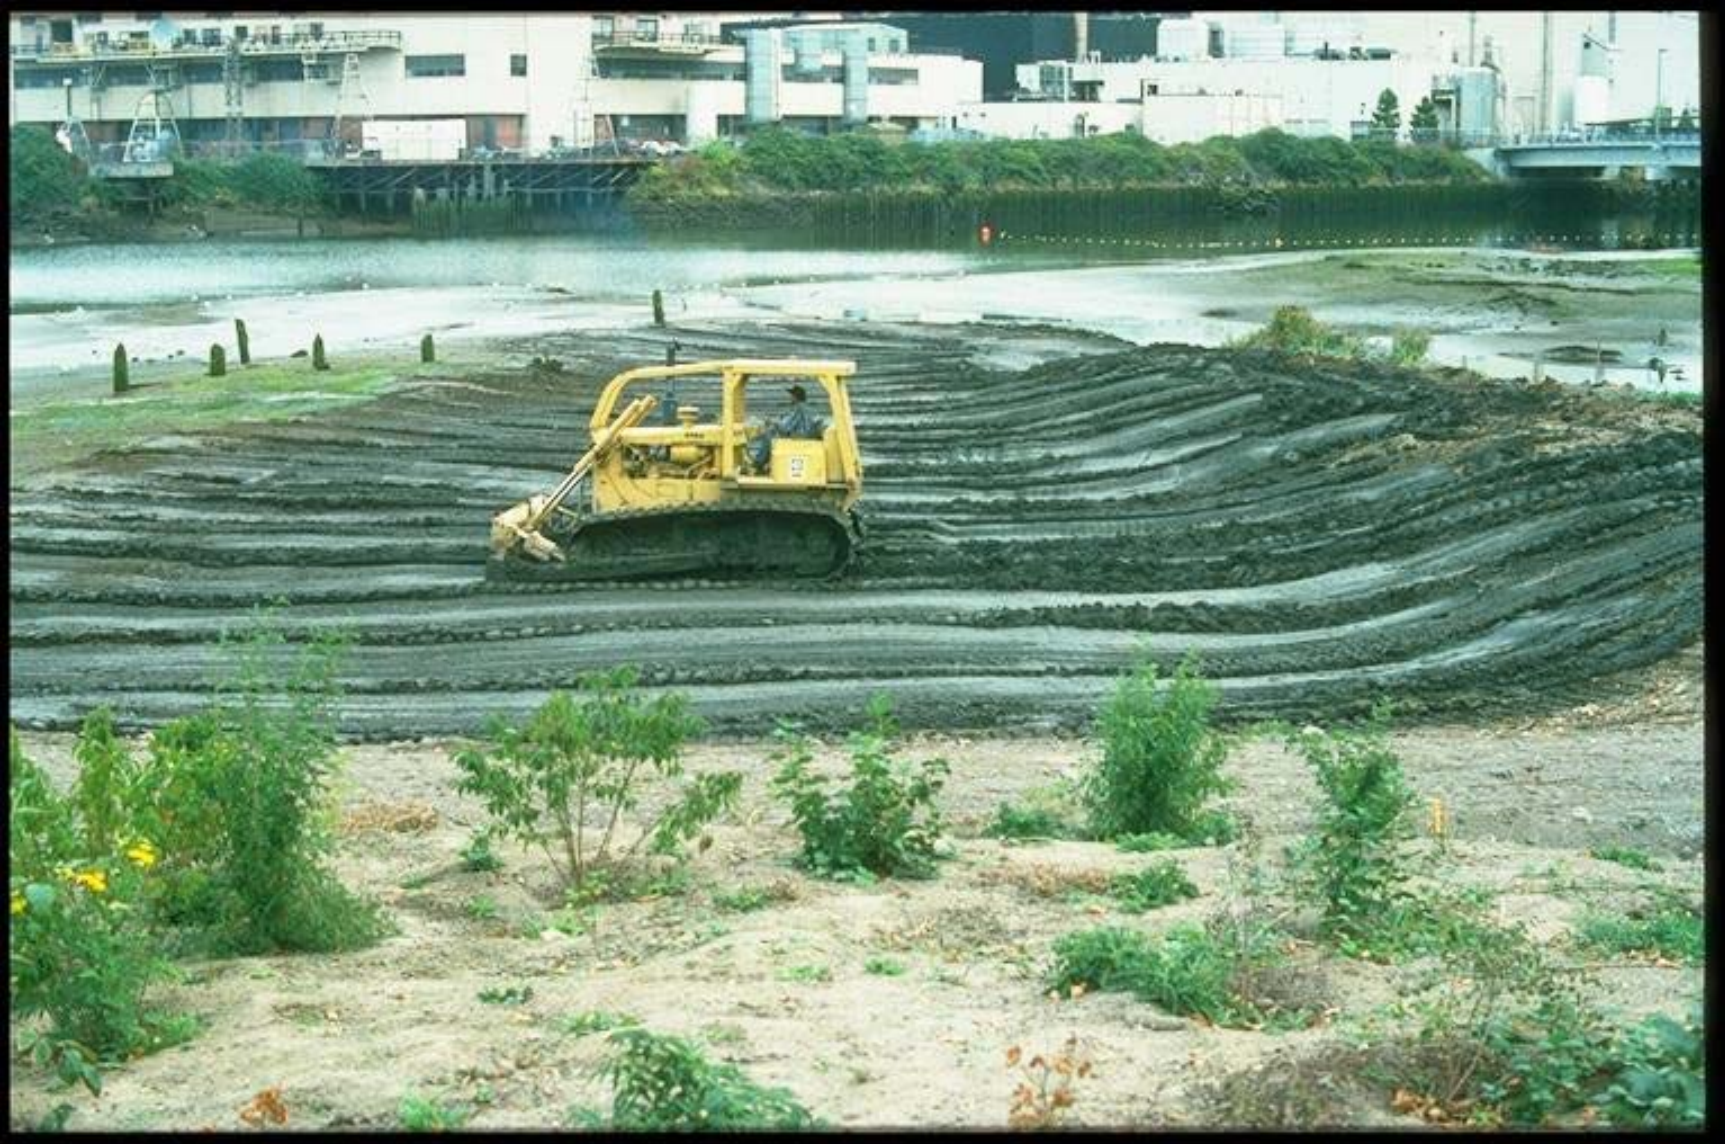
Turning Basin Number Three Demonstration Site Grading.

Restoration of aquatic habitat functions at the turning basin site included excavation of approximately 3500 cubic yards of previously placed fill material, restoring intertidal elevations at the site.

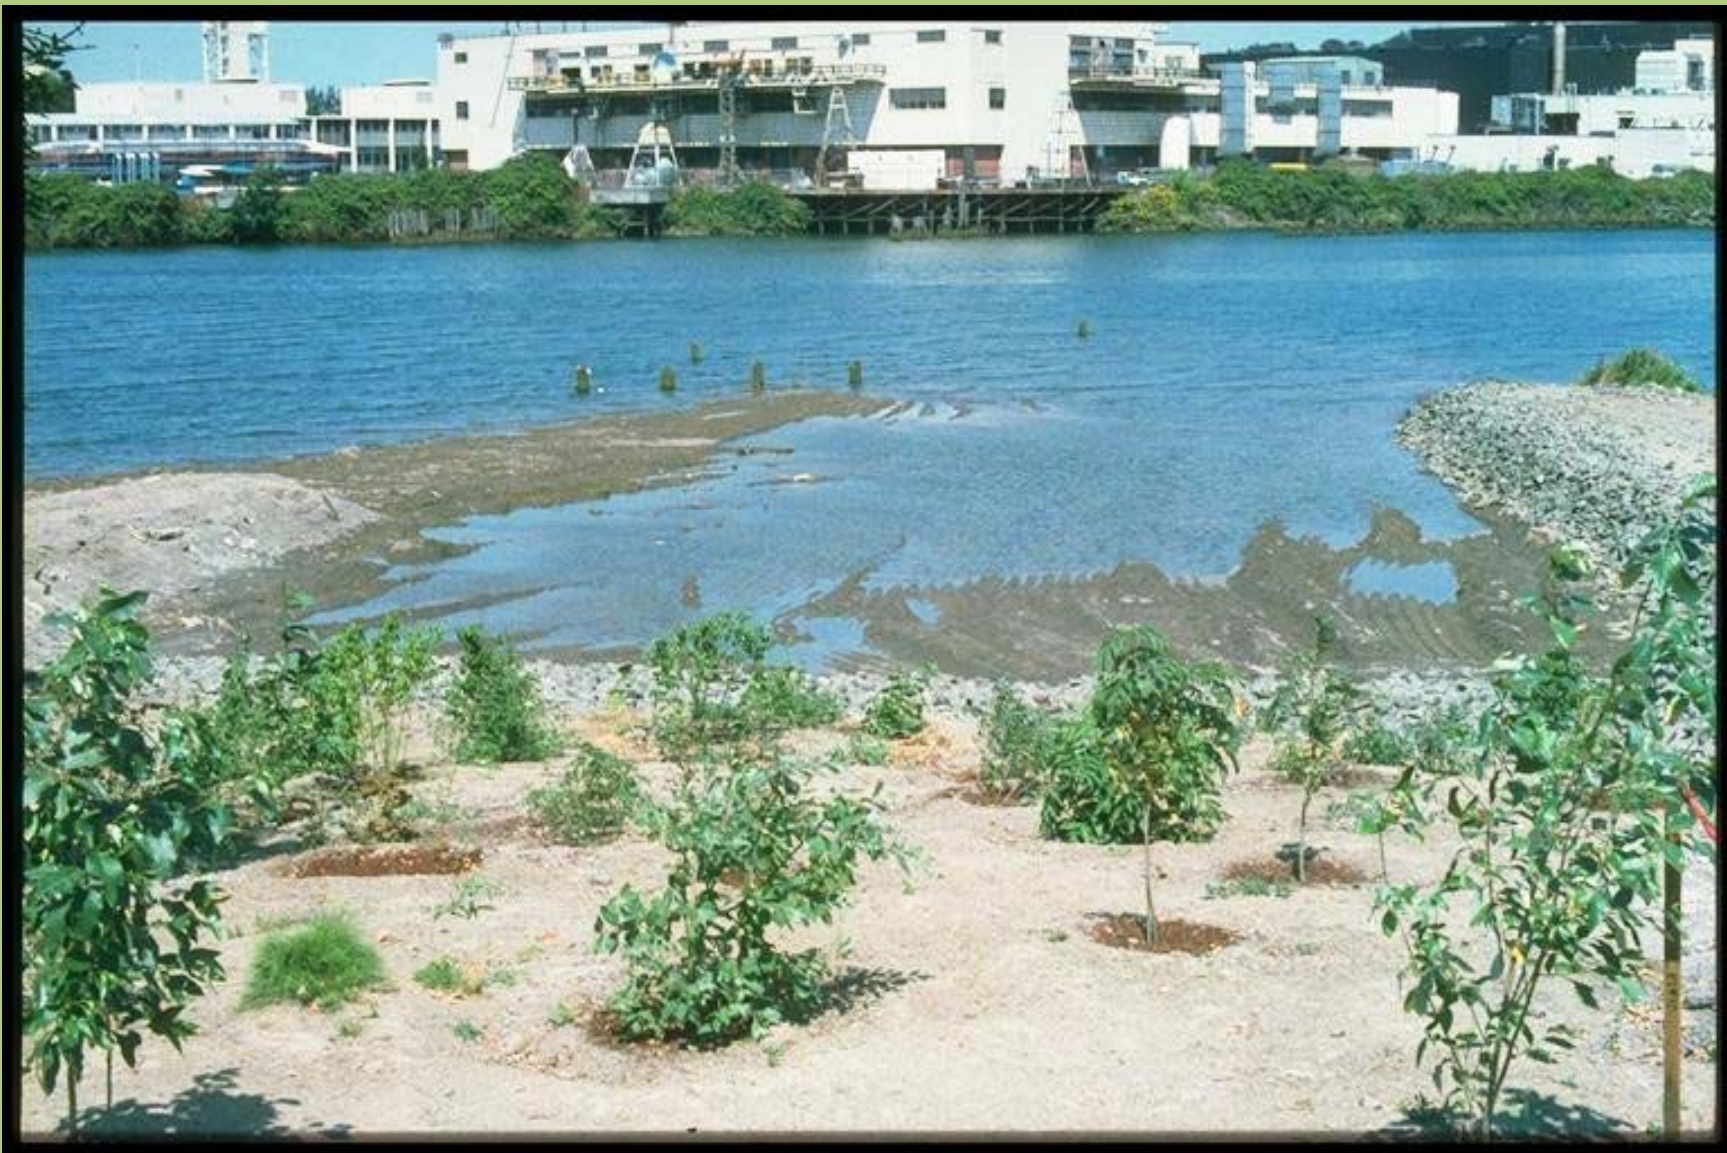
Turning Basin Number Three Demonstration Site following construction in 1996.

This photograph illustrates restored intertidal area, marsh plantings, and recently installed riparian vegetation.

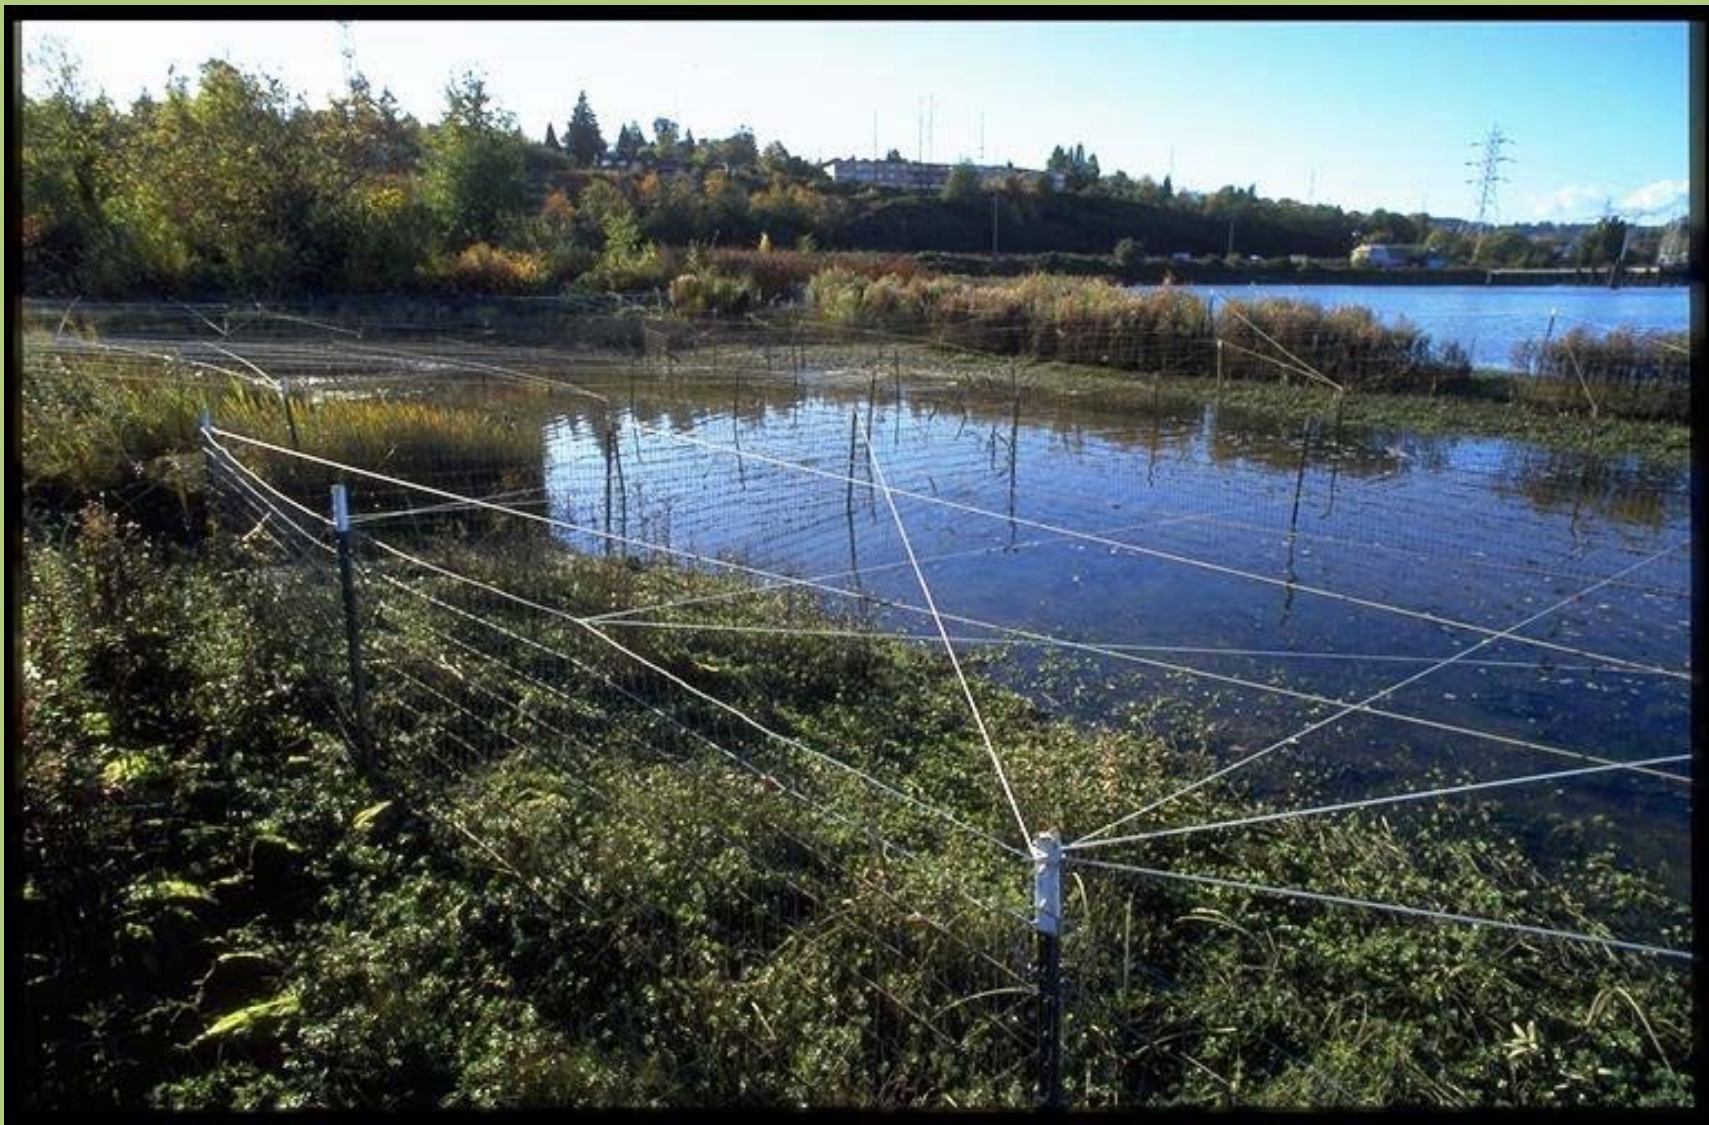
Turning Basin Number Three Demonstration site in 1999.

Intertidal marsh and native riparian plantings established at the demonstration site three years following completion of excavation and grading. Site illustrates functional fish and wildlife habitat restoration. Aquatic and riparian area provide feeding and refuge for resident and migratory fish and wildlife. Detritus and carbon export to adjacent shallow intertidal mud/sand substrate sustains benthic and epibenthic invertebrate production. Riparian vegetation supplies terrestrial insect food sources and small mammal and bird habitat.
