Urban-industrial shoreline restoration techniques: Duwamish Waterway and Elliott Bay

George Blomberg

Estuarine Restoration

Urban Industrial Context

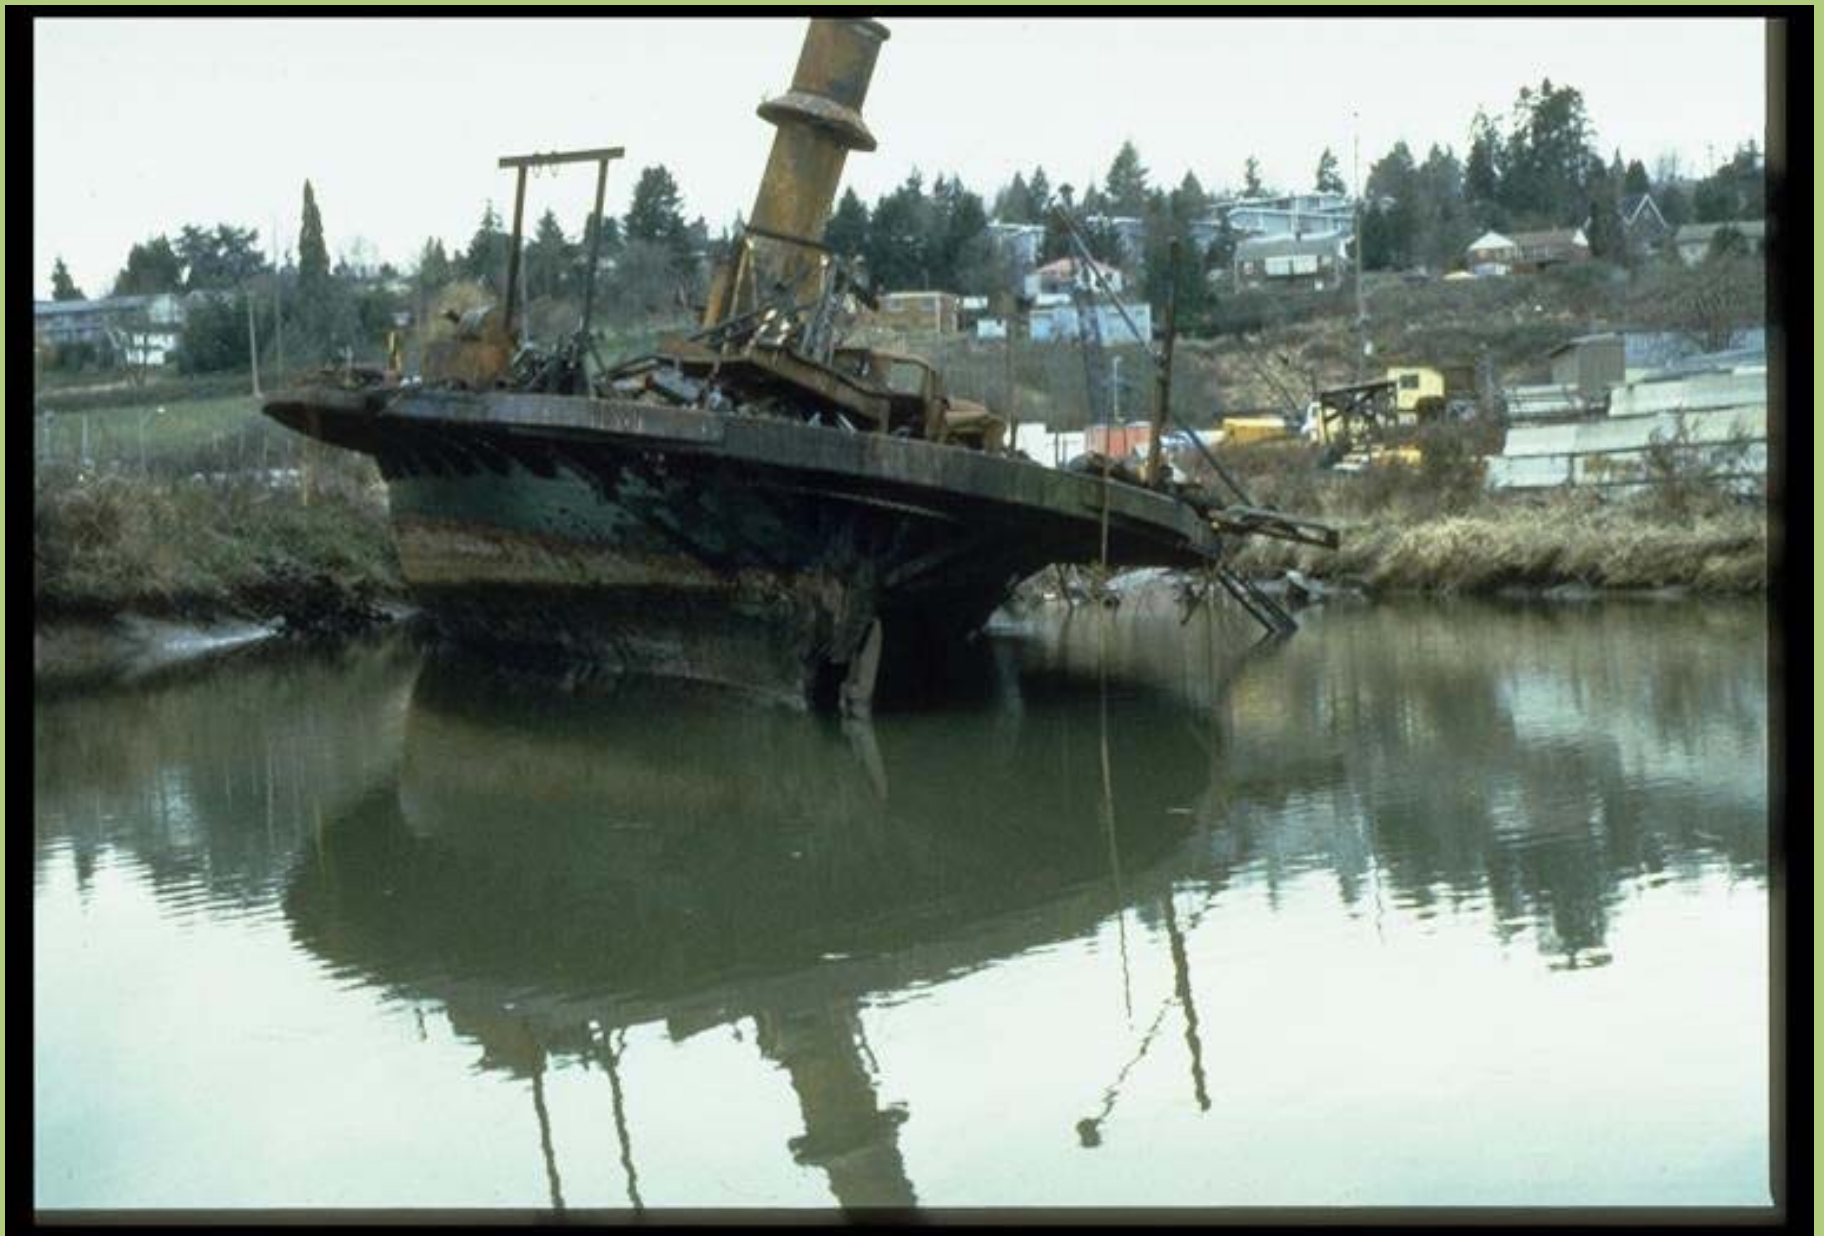
Removal of derelict vessel at Turning Basin Number Three, as portion of Terminal 5 redevelopment environmental restoration.

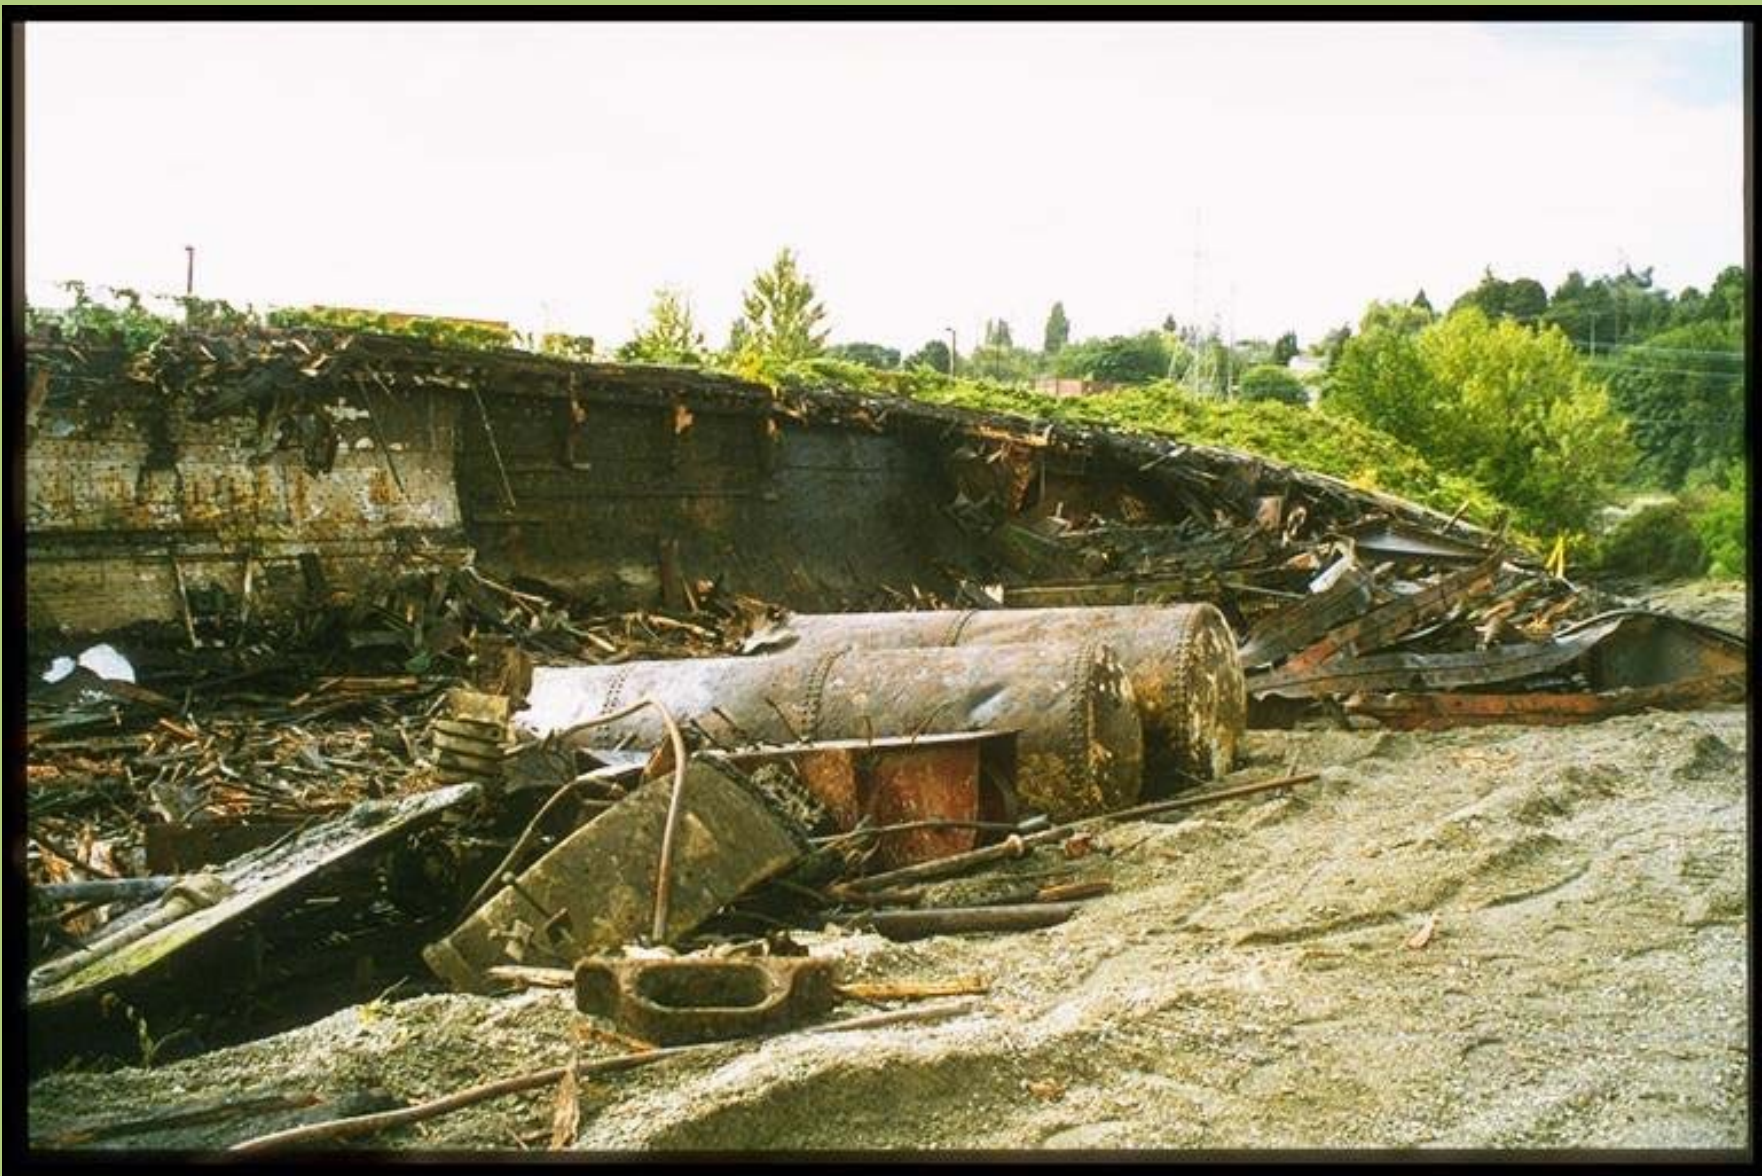
Removal of derelict vessel as portion of Terminal 5 redevelopment environmental restoration.

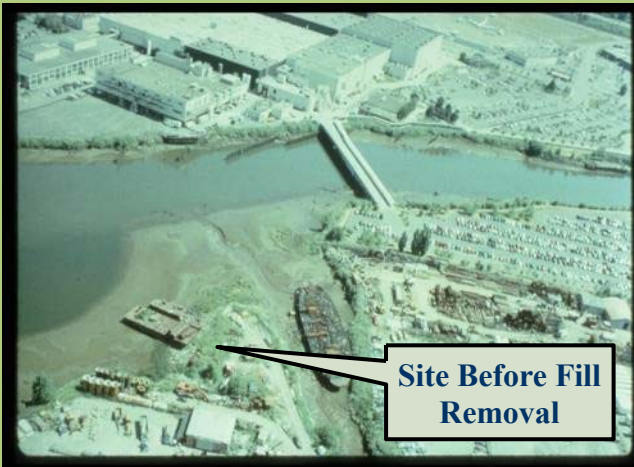
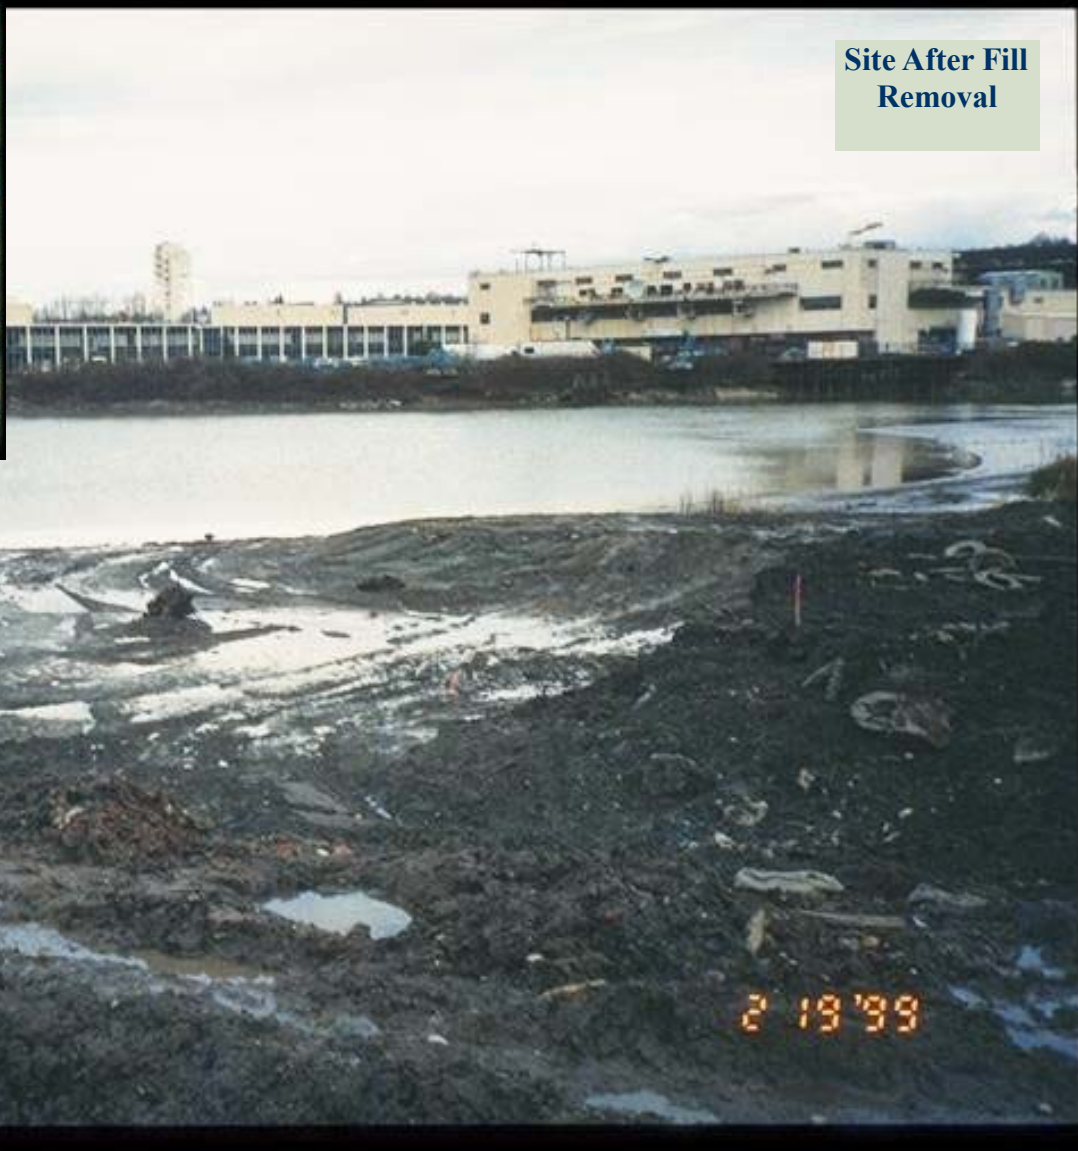
Turning Basin Number Three--Estuarine Fish and Wildlife Mitigation (1999)

Site Before Fill Removal

Site After Fill Removal

Illustrating restoration site excavation and grading nearly complete. Removed approximately 33,000 tons industrial fill placed in former estuarine wetland, 1915-1945.

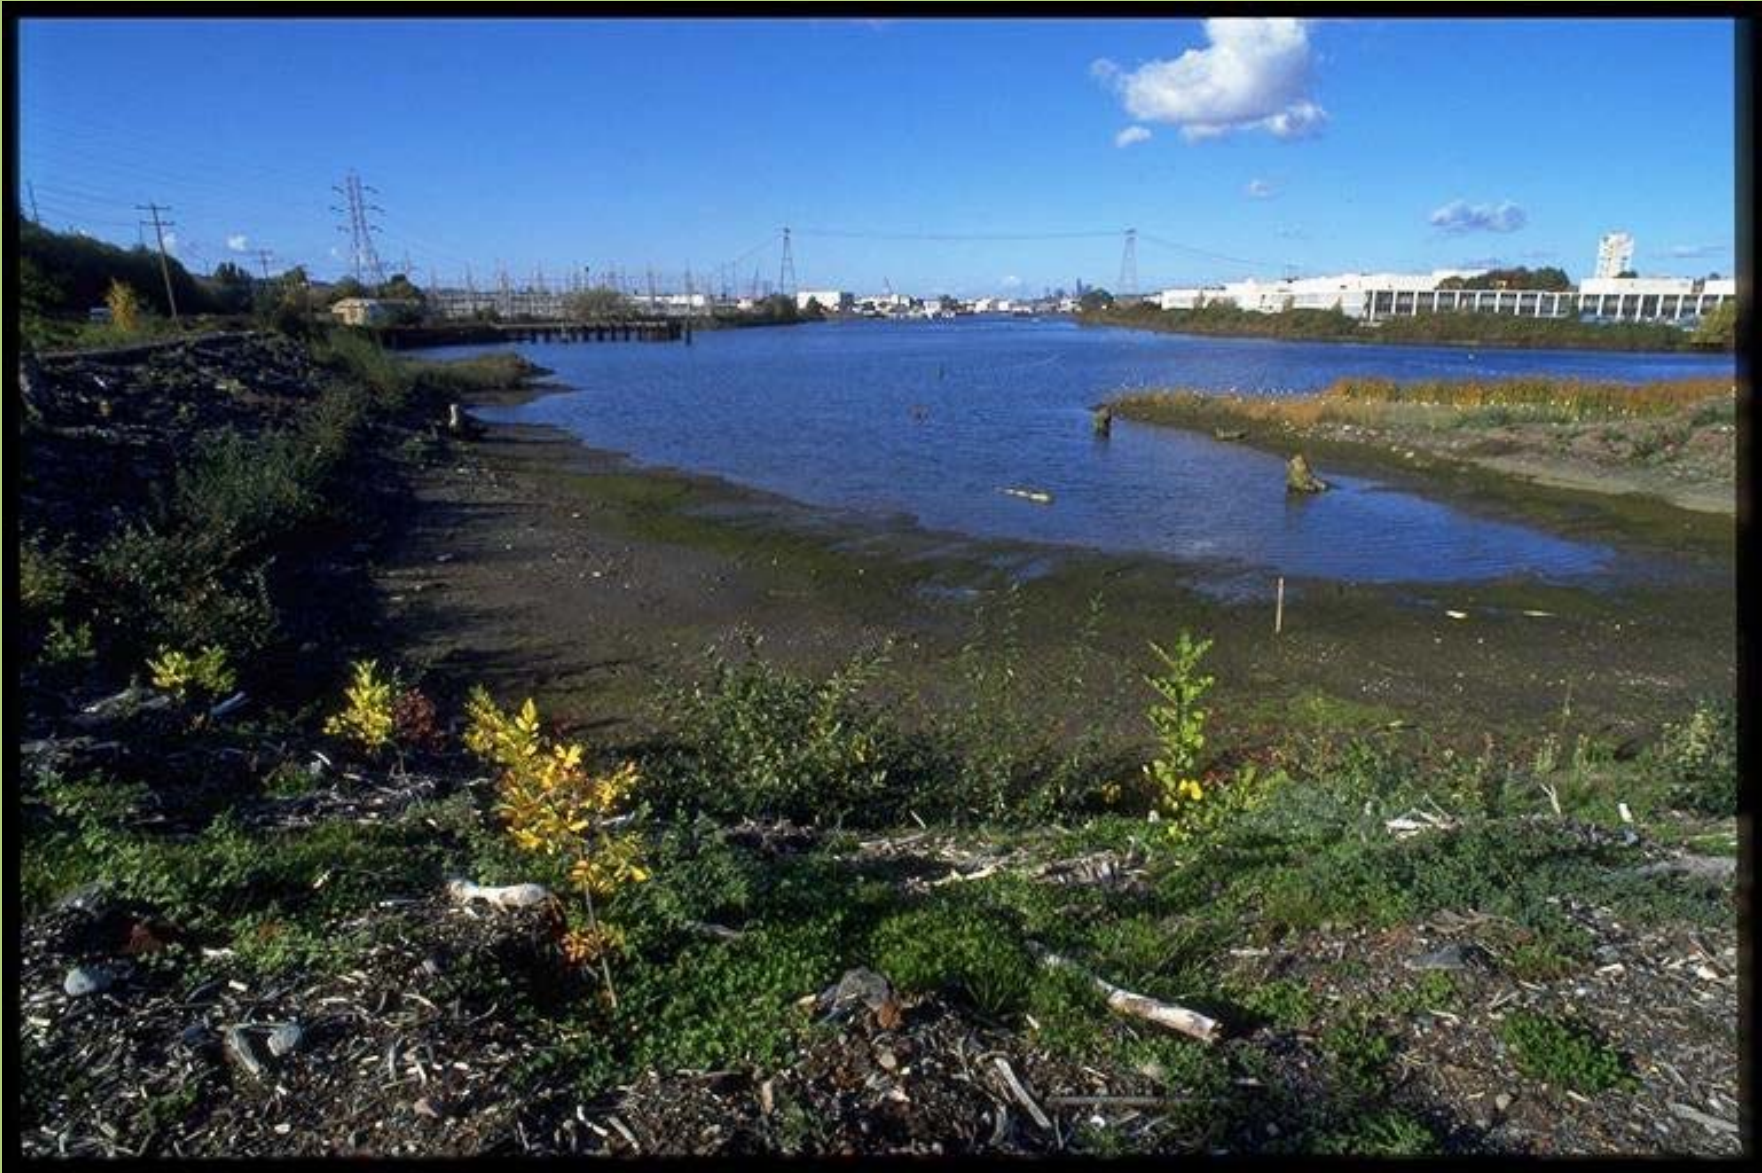
Turning Basin Number Three--Estuarine Fish and Wildlife Mitigation (1999)

Illustrating 1.3 acre restoration site four months following grading and excavation. Restored intertidal substrate bordered with marsh and riparian vegetation planting areas.

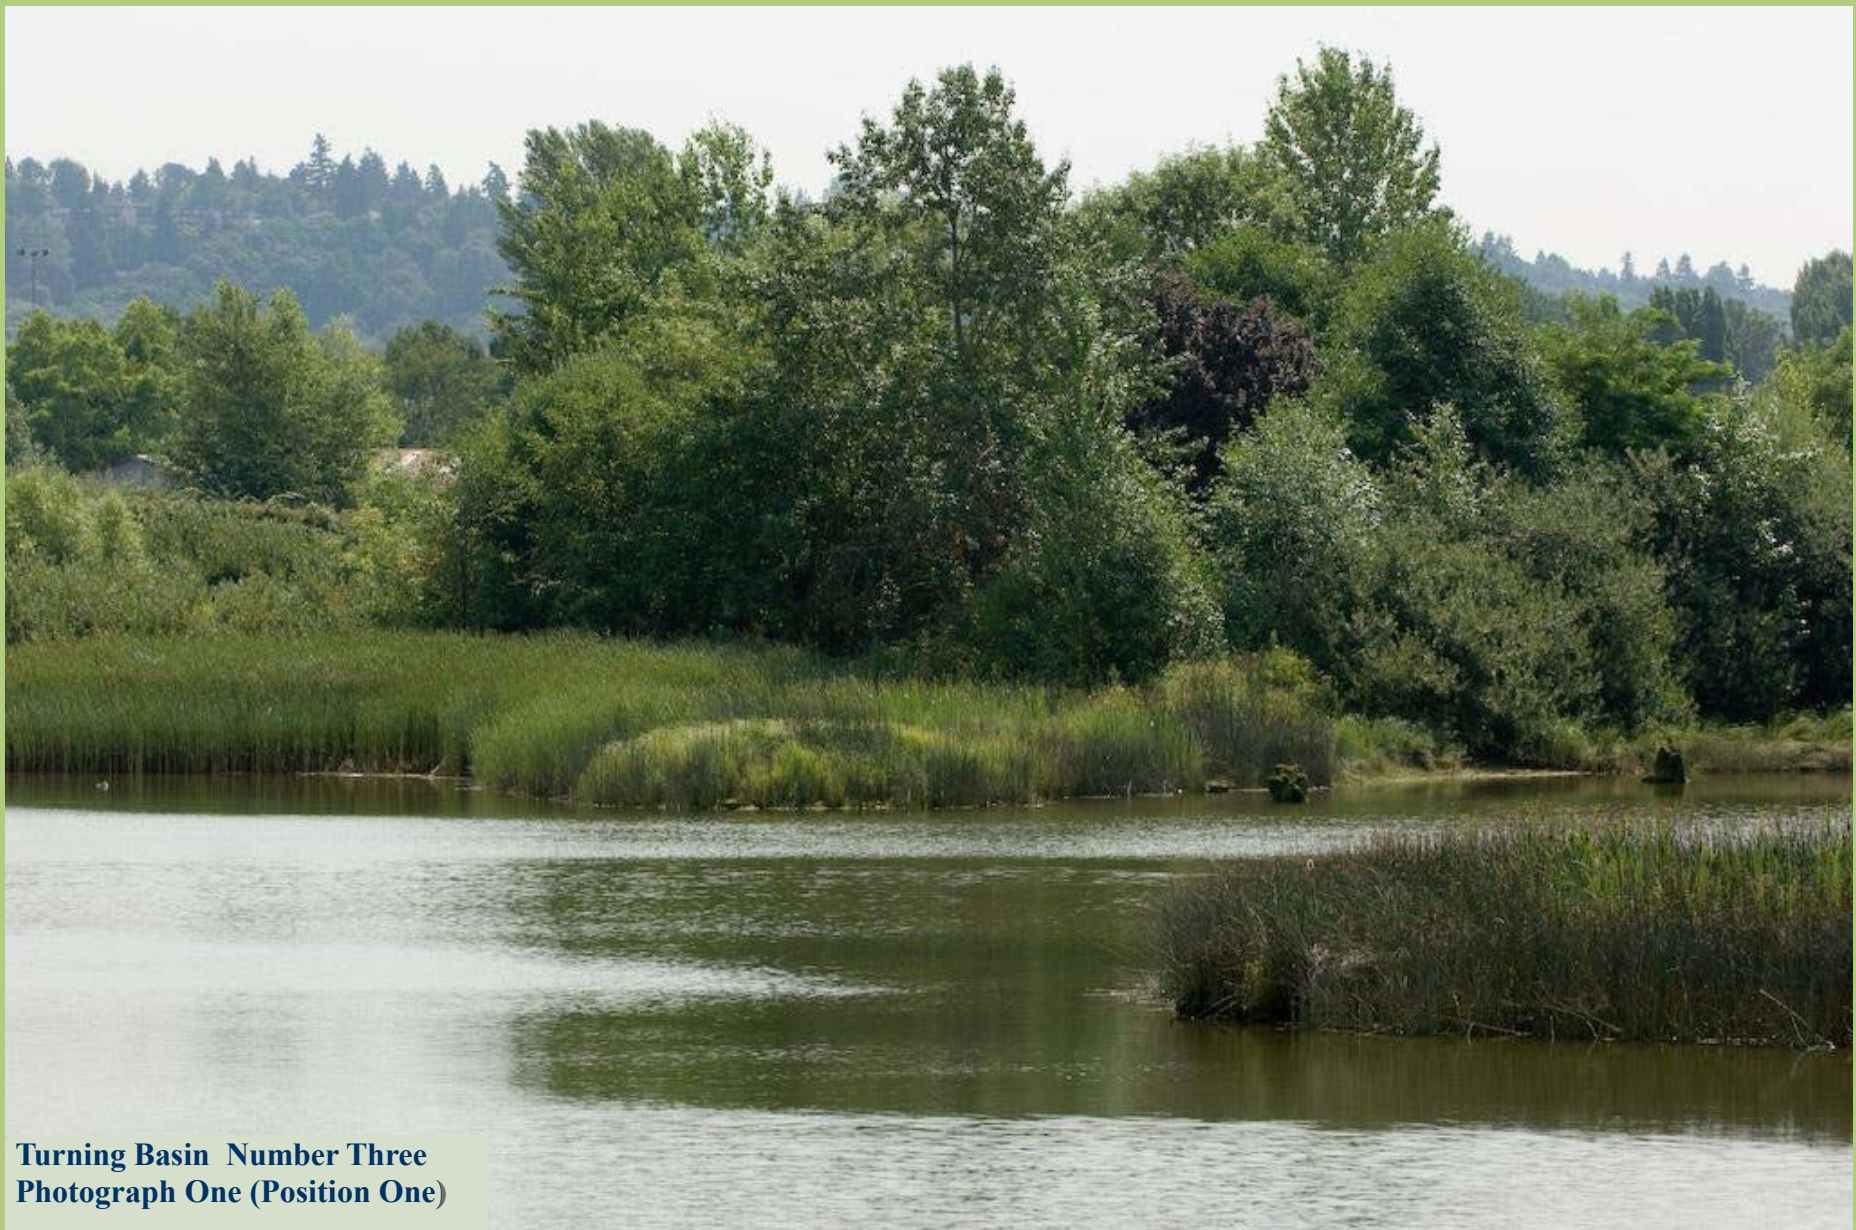
**Turning Basin Number Three
Photograph One (Position One)**

Turning Basin Number Three—Estuarine Fish and Wildlife Habitat (southeast perspective, 2008)

Illustrating north margin of restoration site, opening to Turning Basin Number Three aquatic area. Perspective is co-linear with location of pre-construction bank line. All emergent and riparian vegetation installed as elements of restoration action. Tidal elevation approximately plus nine to ten feet MLLW.

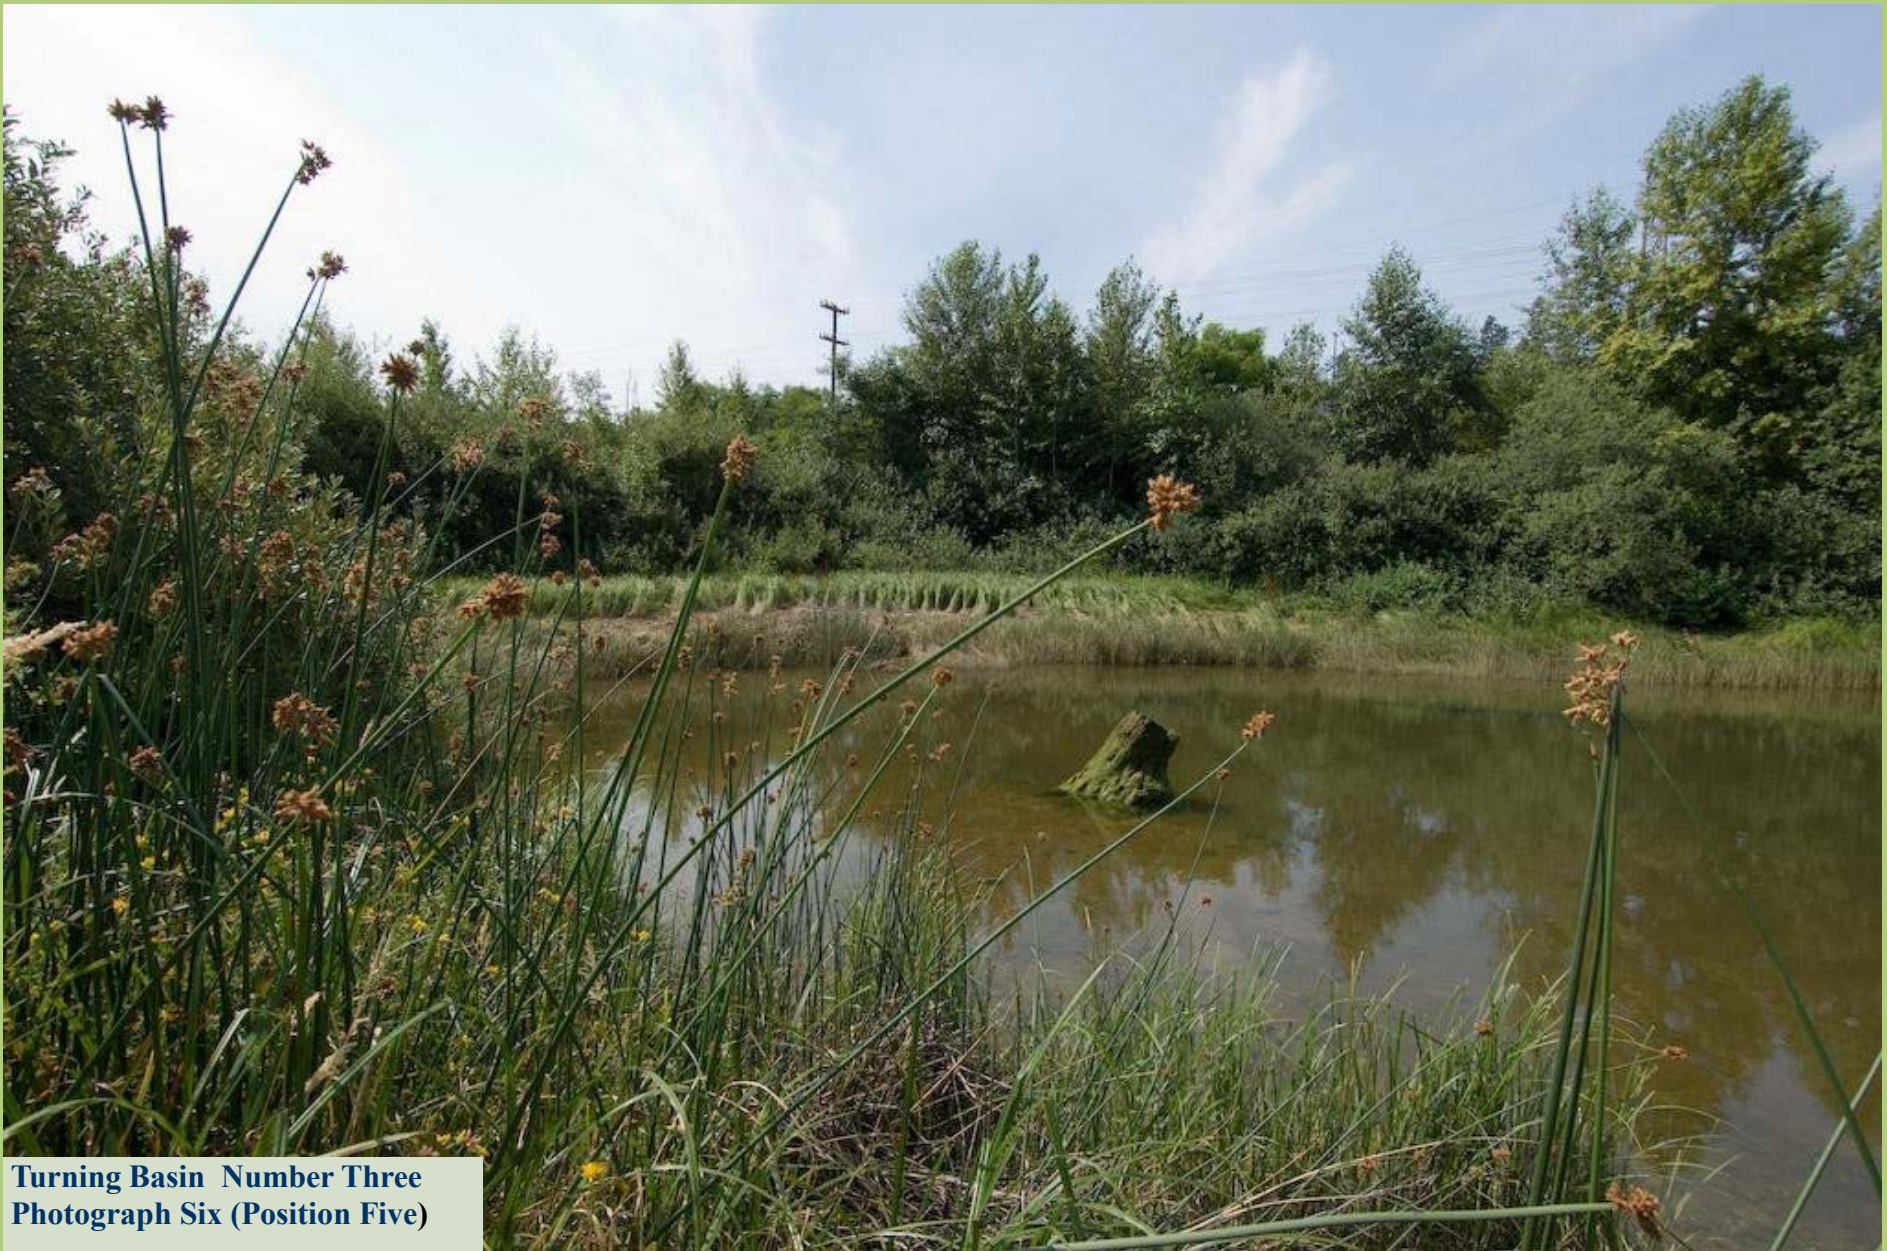
**Turning Basin Number Three
Photograph Six (Position Five)**

Turning Basin Number Three—Estuarine Fish and Wildlife Habitat (south perspective, 2008)

Illustrating marsh and riparian vegetation established at south margin of restoration site. Marsh and riparian vegetation form a continuous band at the site. Marsh vegetation in foreground planted 1999, with additional marsh plantings (background) in 2001.

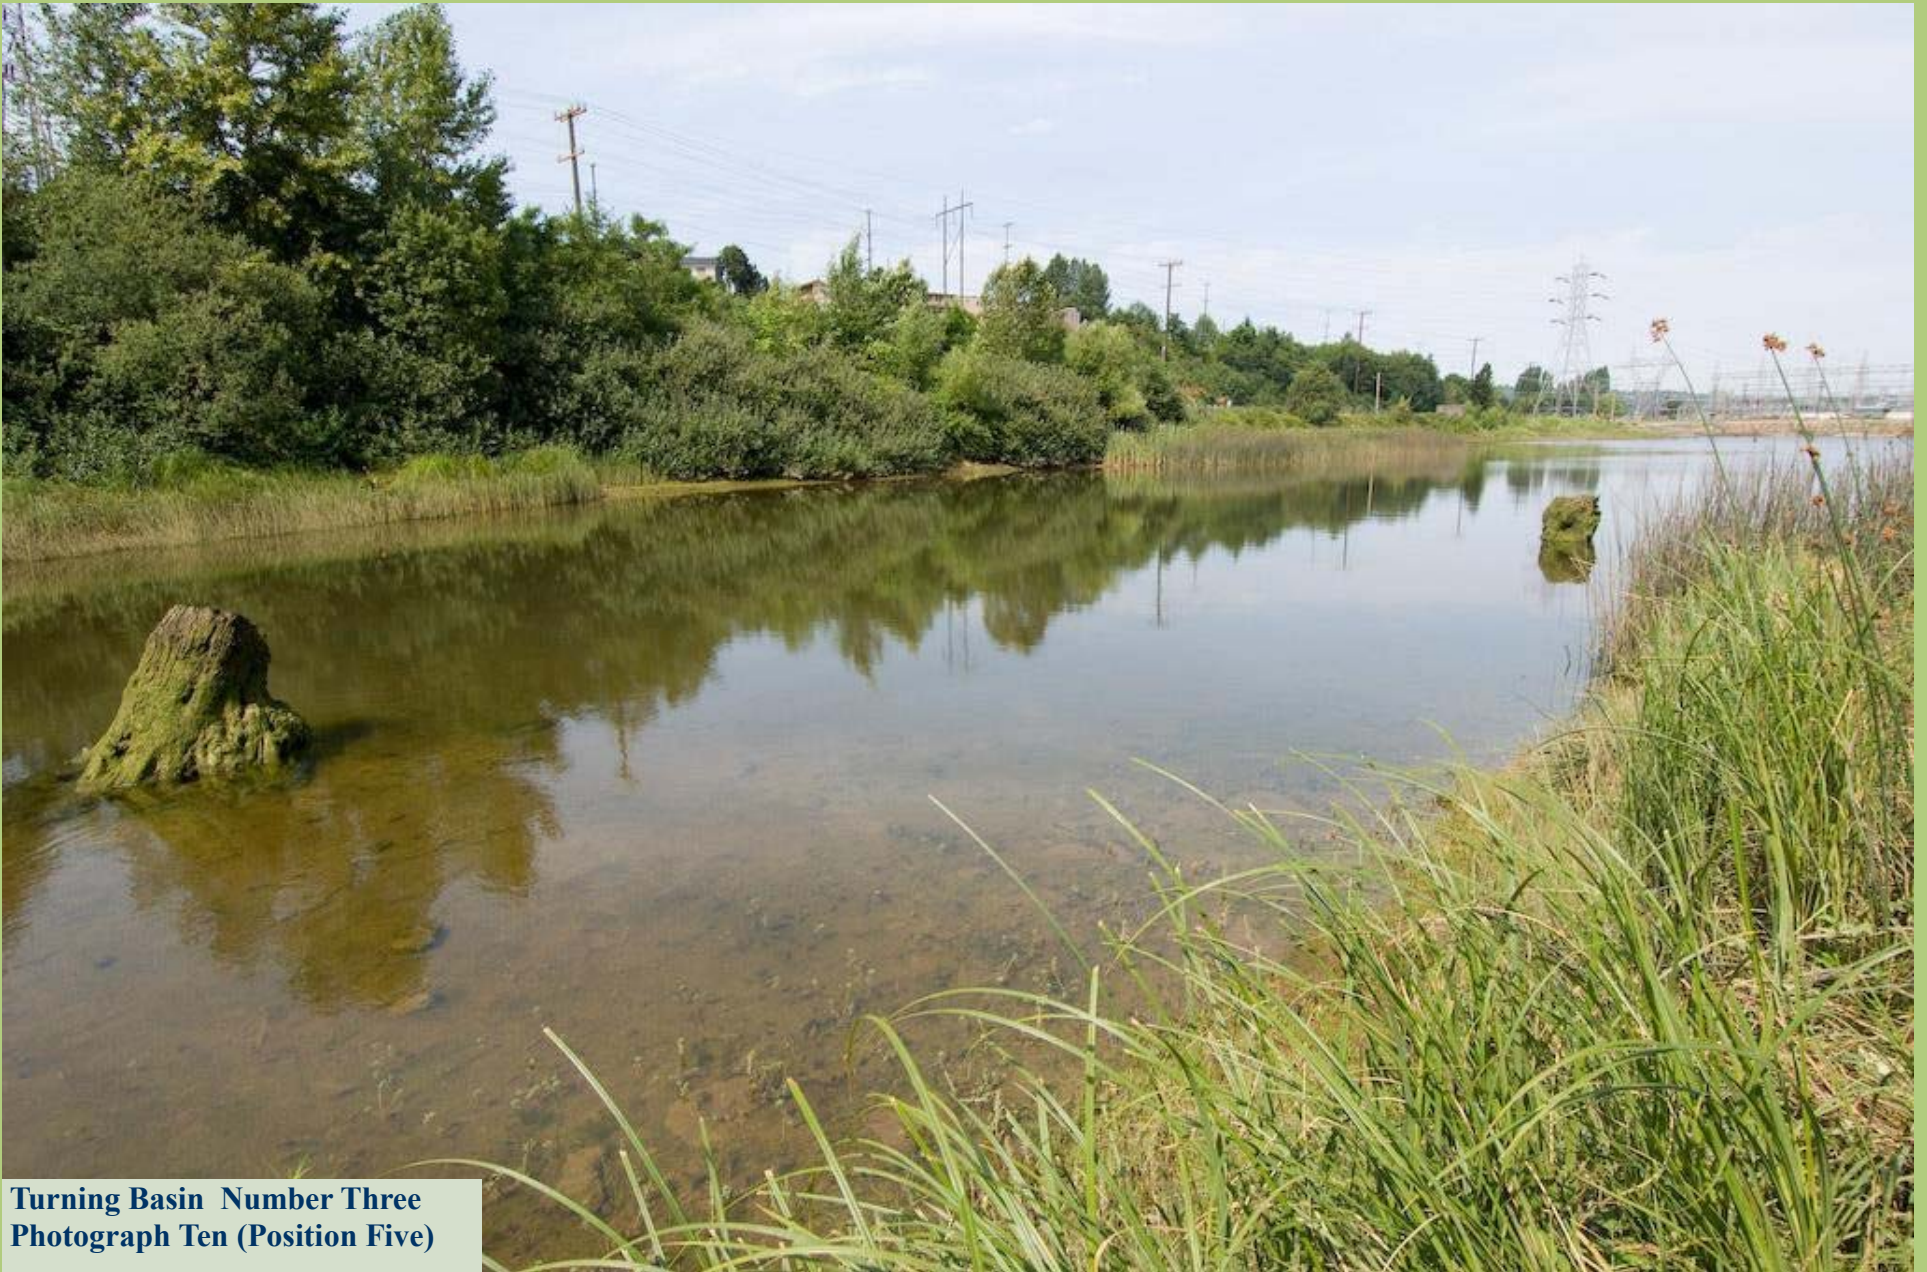
**Turning Basin Number Three
Photograph Ten (Position Five)**

Turning Basin Number Three—Estuarine Fish and Wildlife Habitat (northwest perspective, 2008)

Illustrating stable marsh and exposed fine-grained, low slope substrate. Tidal elevation approximately plus nine to ten feet MLLW.

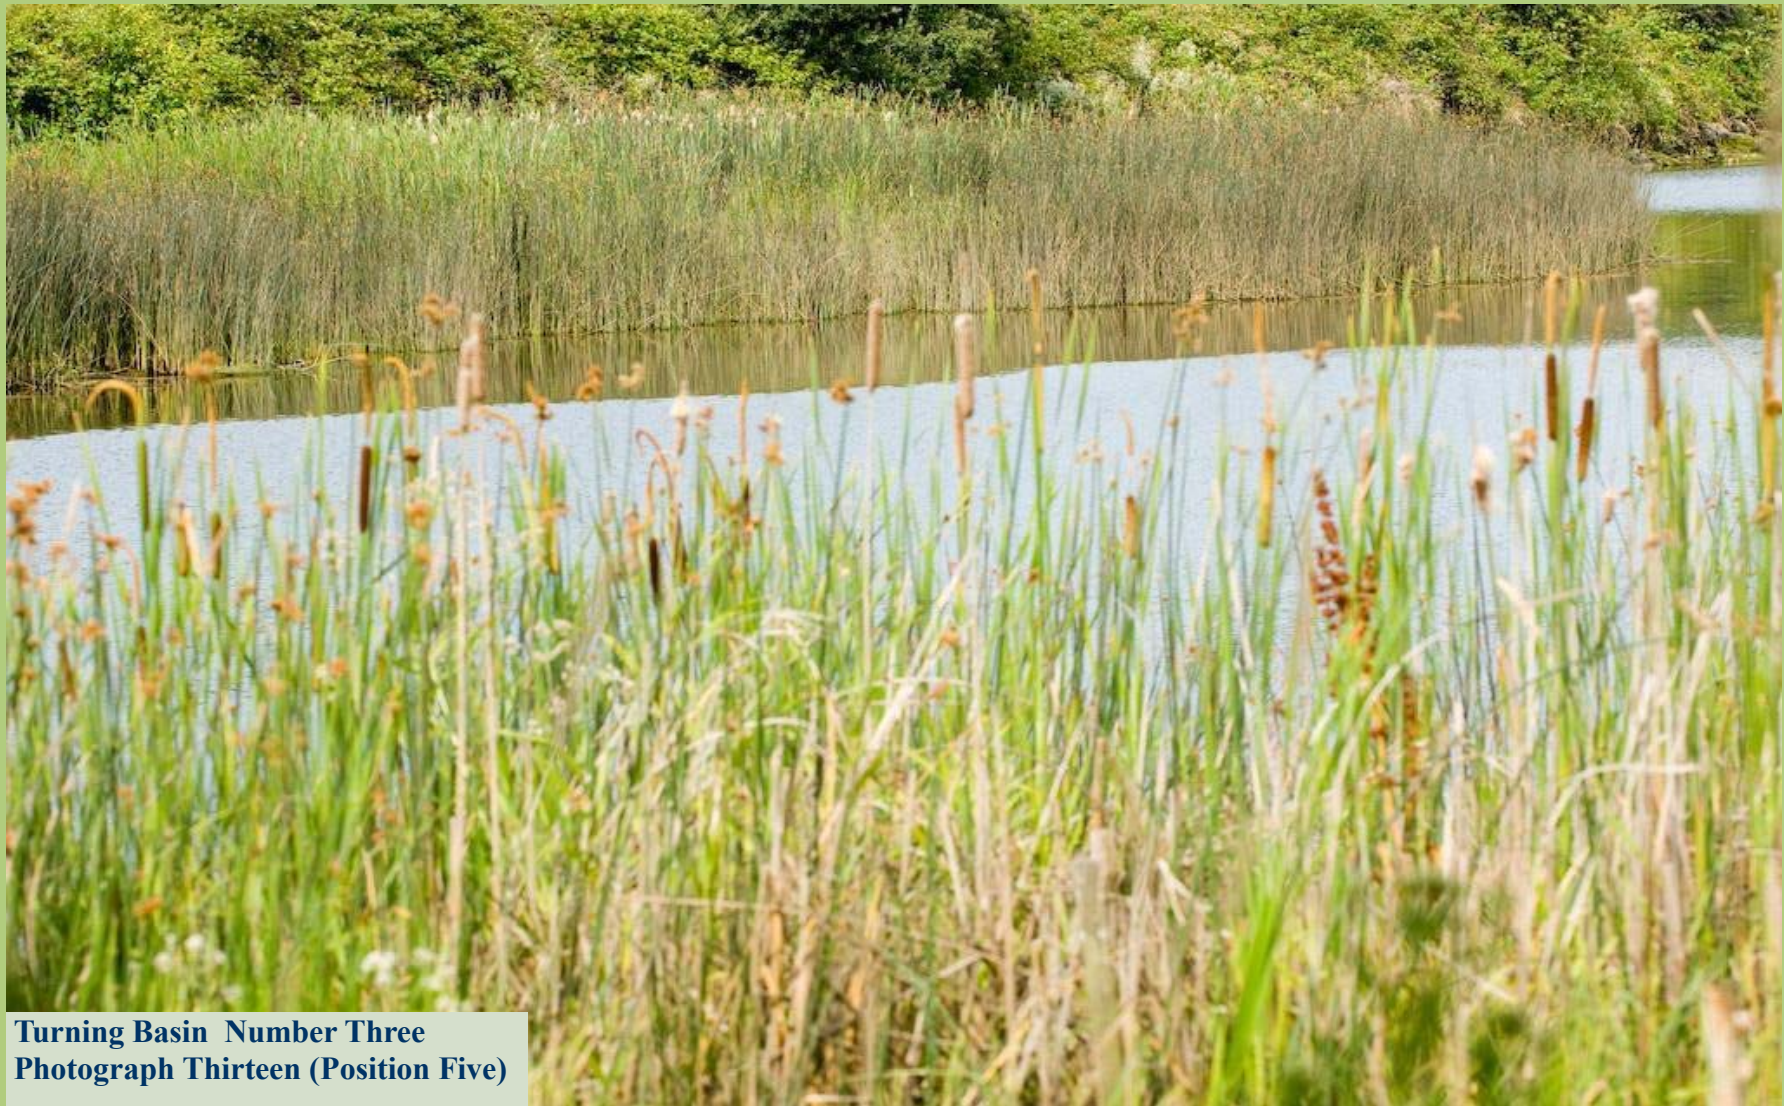
**Turning Basin Number Three
Photograph Thirteen (Position Five)**

**Turning Basin Number Three—Estuarine Fish and Wildlife Habitat
(northwest perspective—detail, 2008)**

This image also illustrates successful establishment of emergent vegetation at the restoration site. All marsh vegetation depicted is the result of the restoration project planting. Please note the continuous band of riparian vegetation immediately adjacent up-slope of the emergent planting areas. The riparian vegetation complements marsh plantings, ensuring stable bank line conditions and inhibiting Canada geese from feeding in the marsh vegetation, since the geese are prevented from entering the marsh areas from up-slope locations.

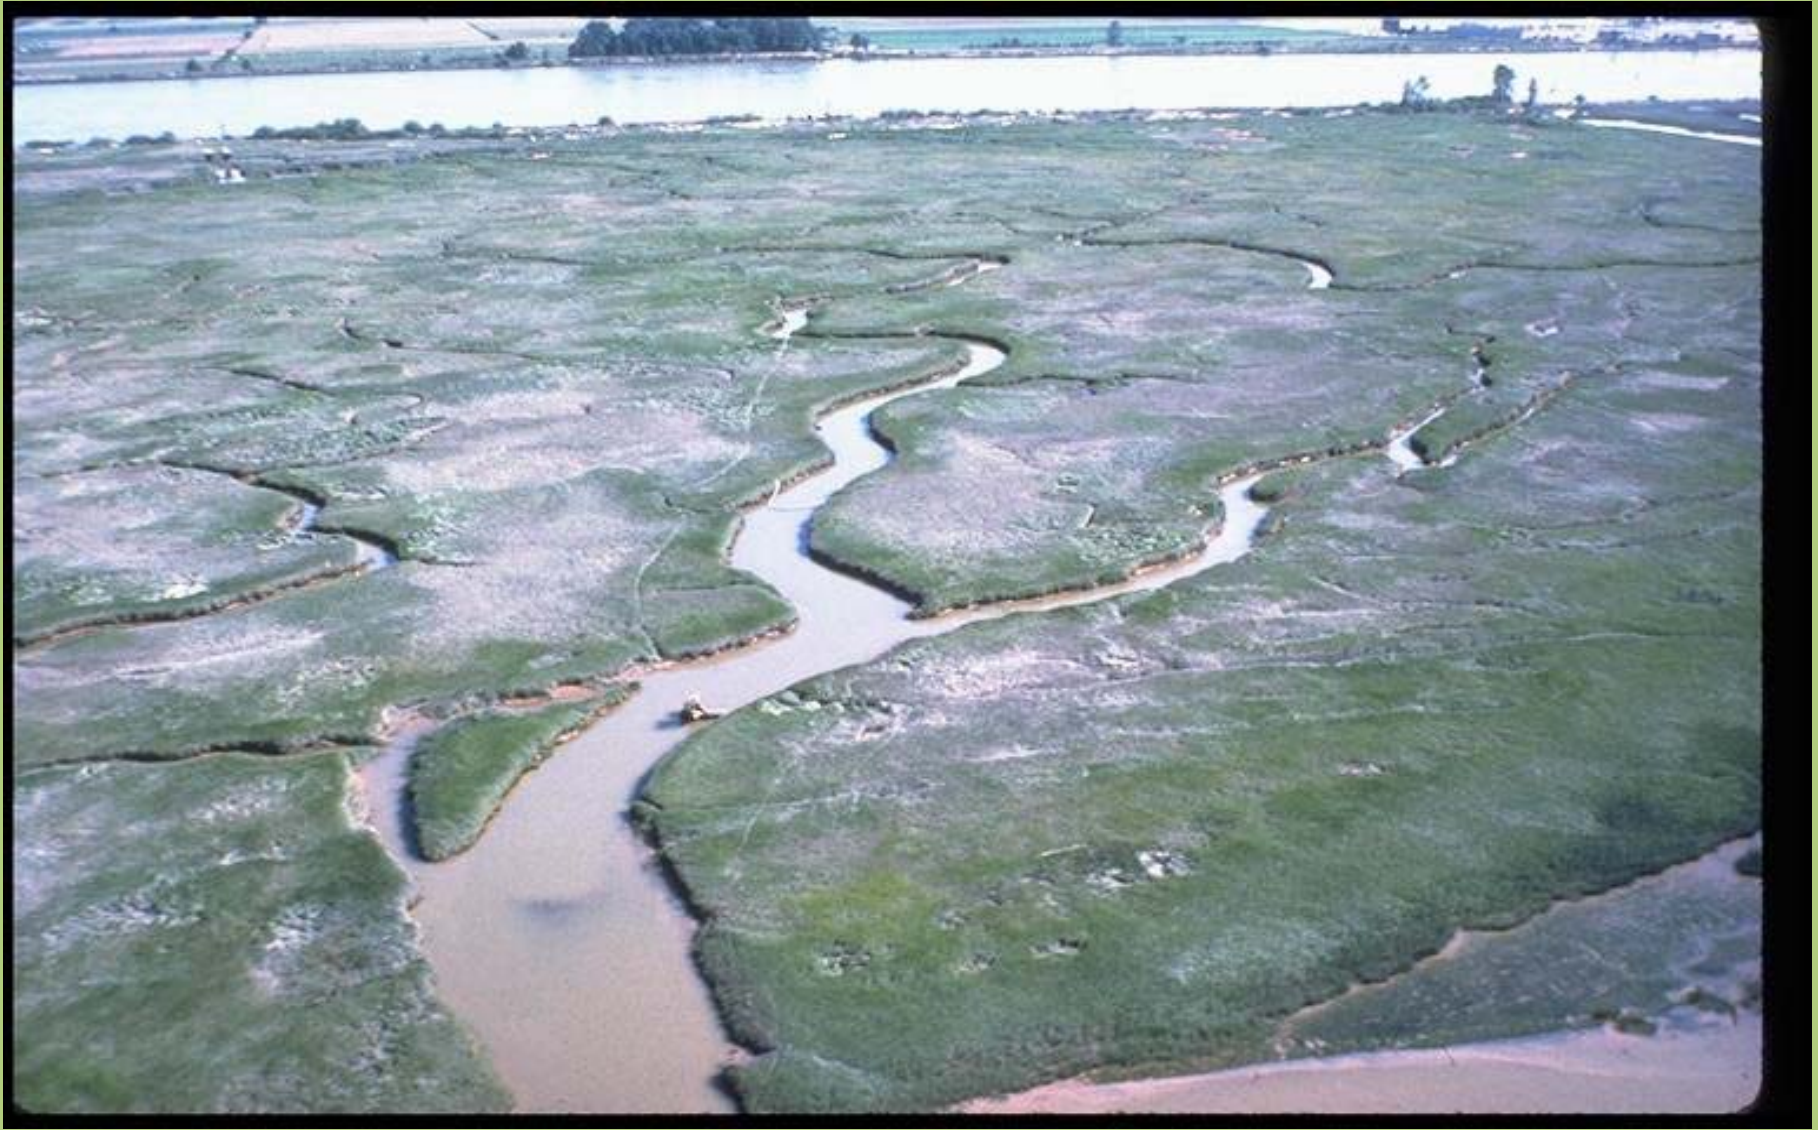
Photograph illustrating native estuarine marsh, with side channel features

Historically, marsh habitat in the Duwamish estuary included conditions similar to the photograph above. Marsh area is now utterly rare in the Duwamish estuary and side channels penetrating marsh area, once abundant, are now entirely absent. Working with federal agencies, the port designed a demonstration project as a means to re-introduce similar marsh and side channel habitat to the estuary.

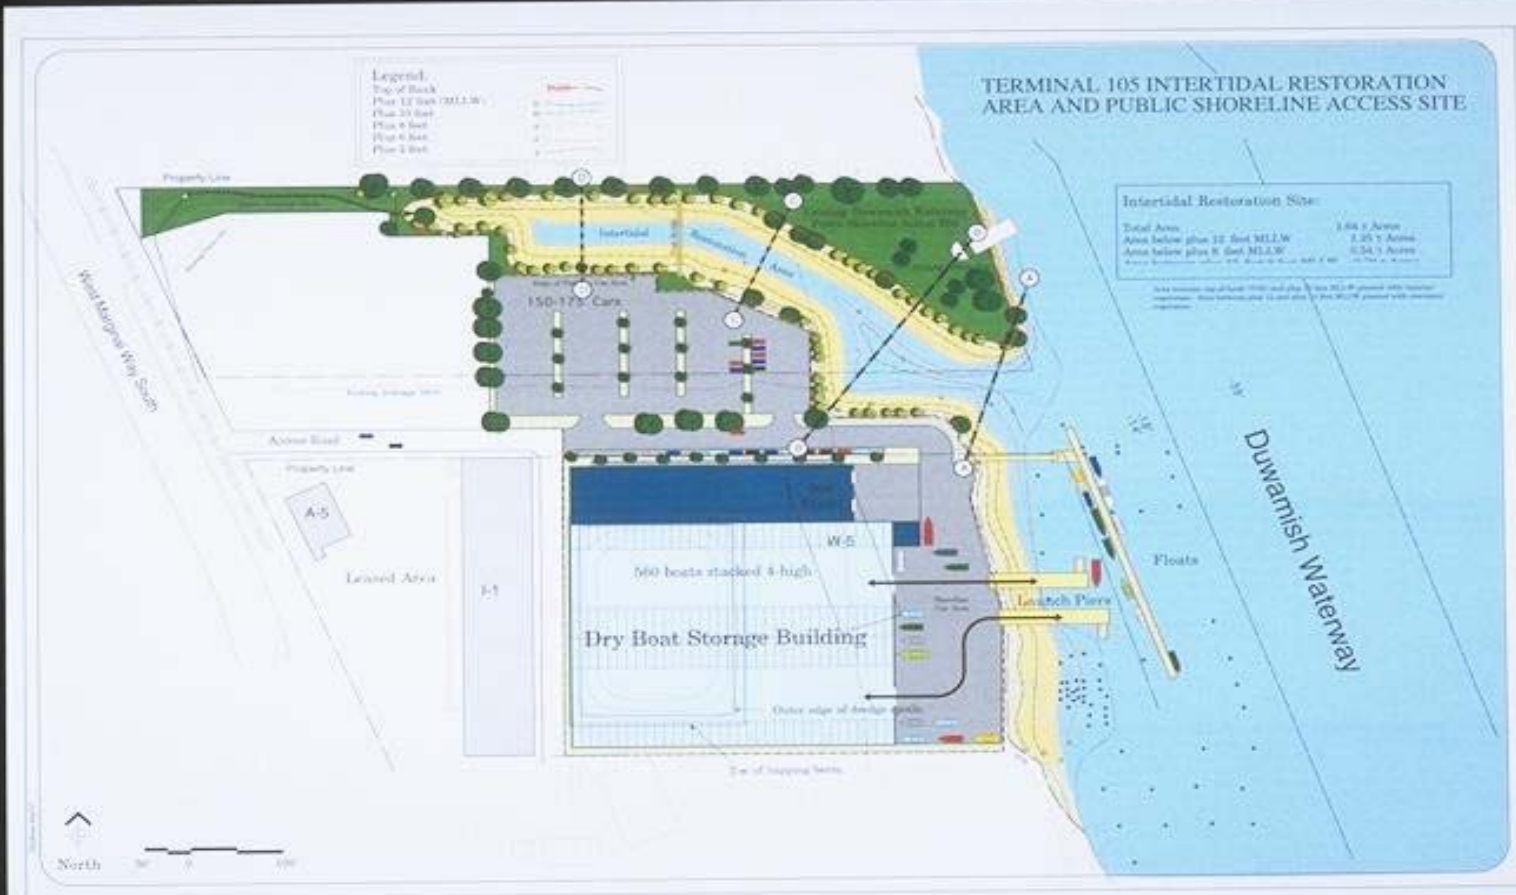
Preliminary Concept for Terminal 105 Demonstration Site

This graphic illustrates an early design concept for constructing a side channel intertidal habitat area at Terminal 105. It is important to note that the environmental objective was to restore a former habitat feature to the estuary. In addition, the demonstration project tested how restored estuarine habitat areas could be configured to be compatible with industrial shoreline areas, without impeding important waterway access. Habitat restoration area oriented perpendicular to the shoreline would provide essential environmental attributes and not foreclose industrial access to adjacent shoreline areas.
