Urban-industrial shoreline restoration techniques: Duwamish Waterway and Elliott Bay

George Blomberg

Estuarine Restoration

Urban Industrial Context

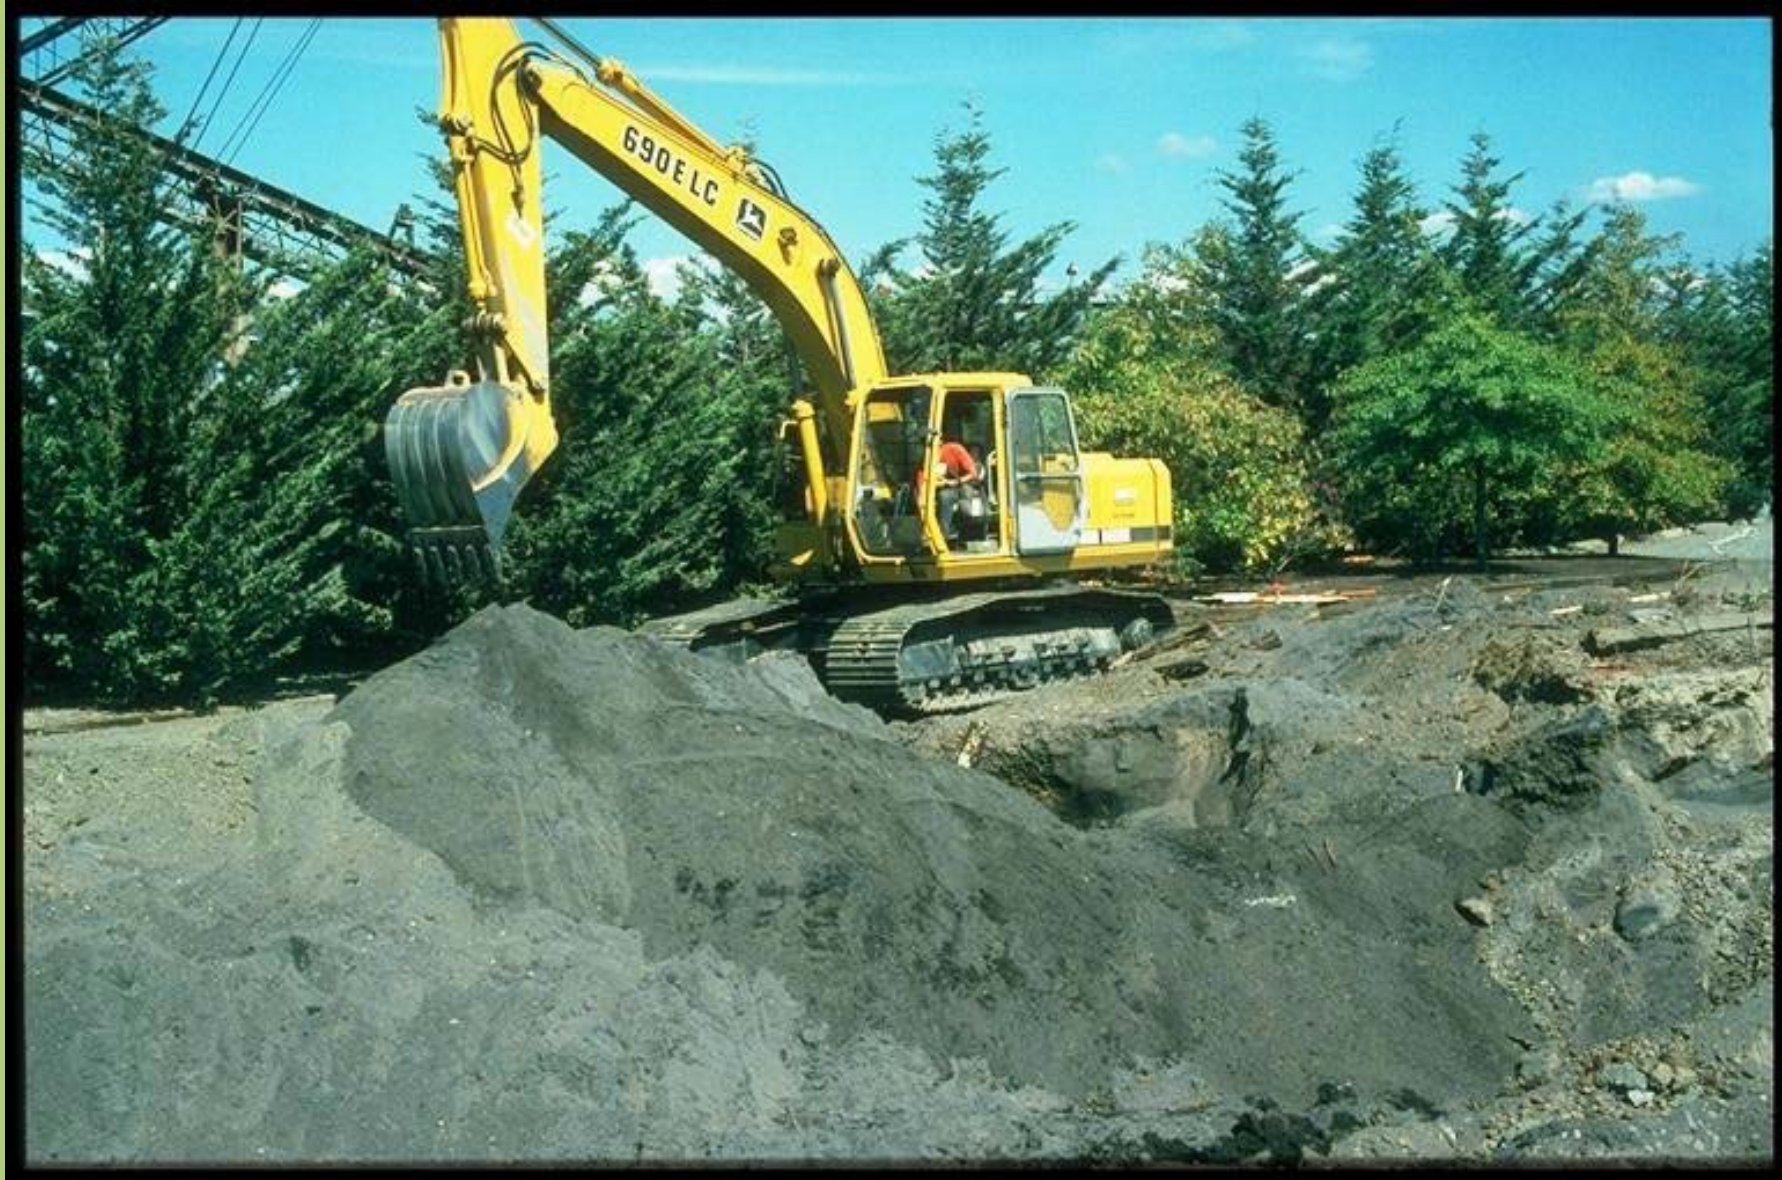
Terminal 105, Estuarine Fish and Wildlife Habitat (construction 1996-1997)

Approximately 9400 cubic yards of previously placed fill was removed to create a 0.6 acre intertidal channel approximately 1300 feet in length. During construction a buried vault, filled with paint and solvent wastes was discovered, adding substantial project costs for cleanup and confirmation testing of newly exposed intertidal sediments.

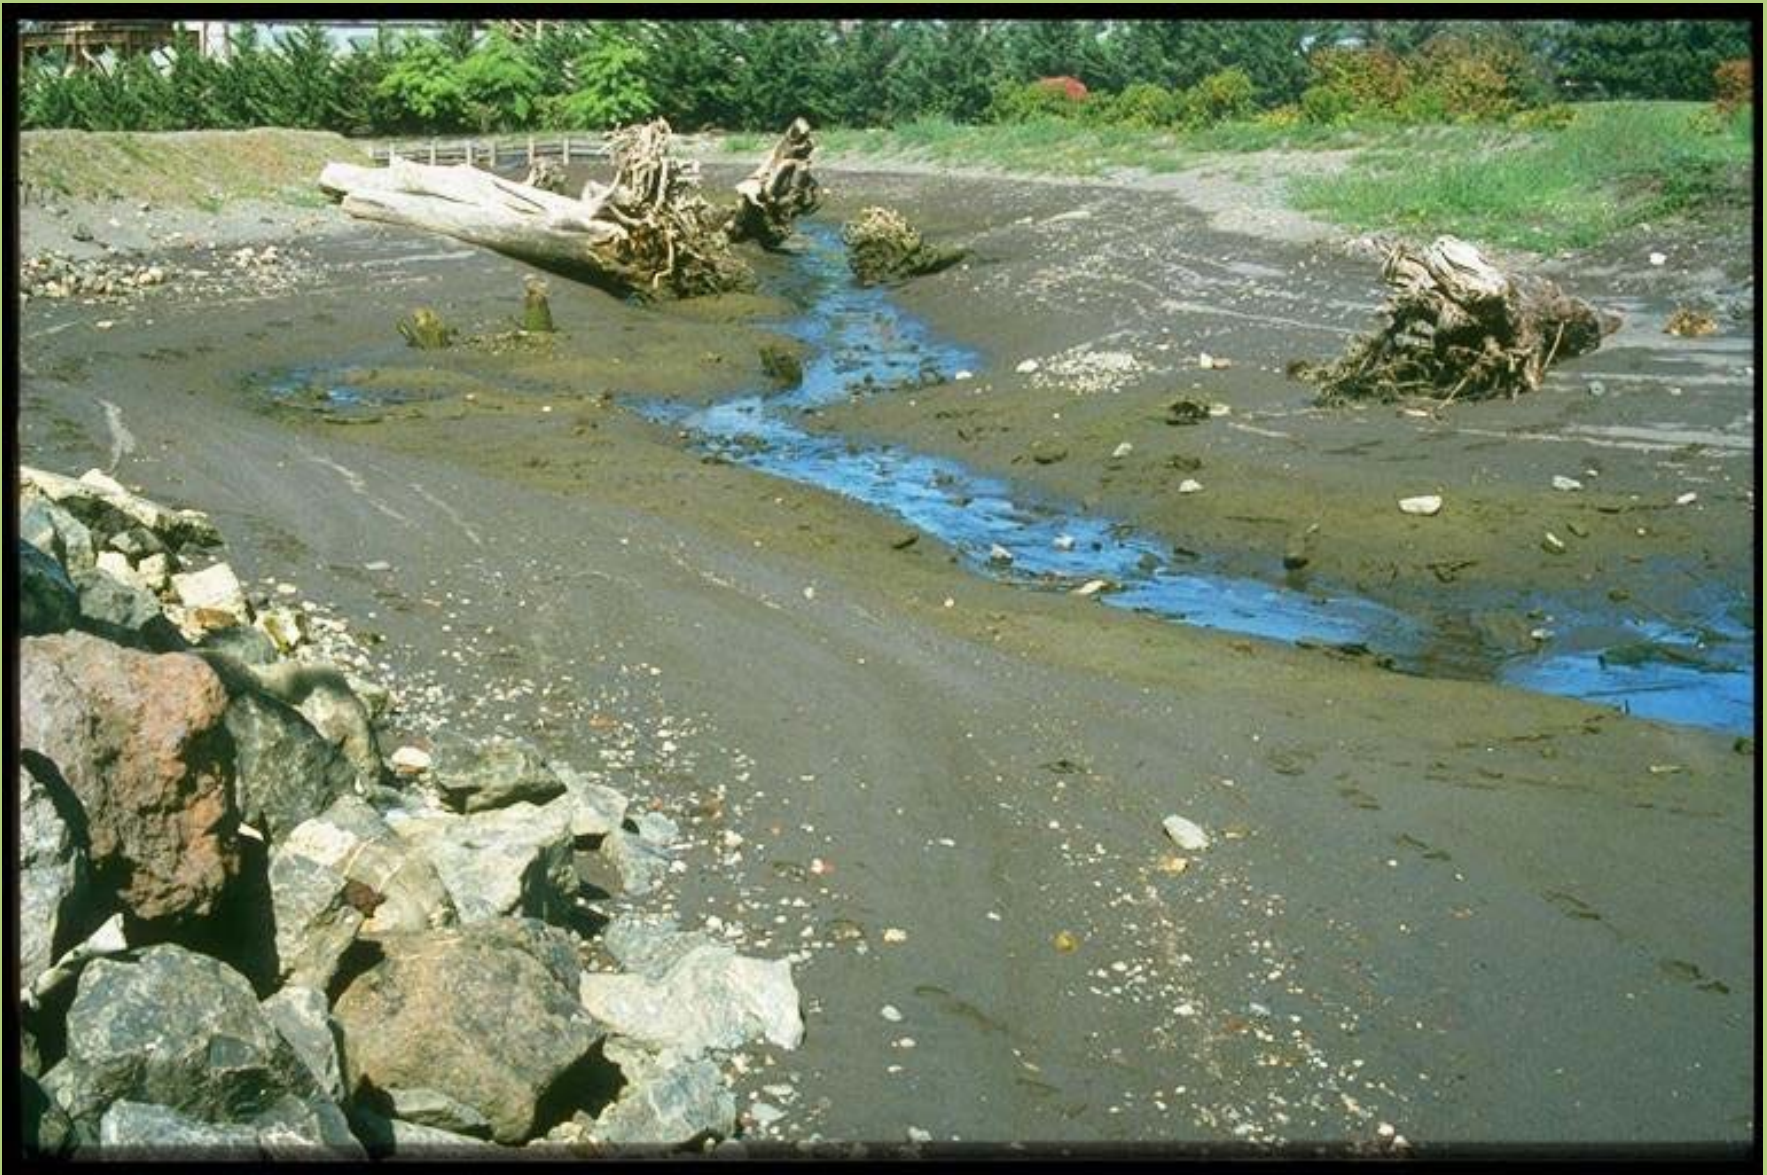
Completed Terminal 105 demonstration project site, 1997

The restoration project is illustrated at low tide – note the extent of tidal influence indicated by the wetted bank line. The site is inundated twice daily by tidal water up to five feet in depth. Following grading, the restoration site received 0.3 acres of native riparian trees and shrubs and more than 1100 marsh plants. All site vegetation work was accomplished by community participants.

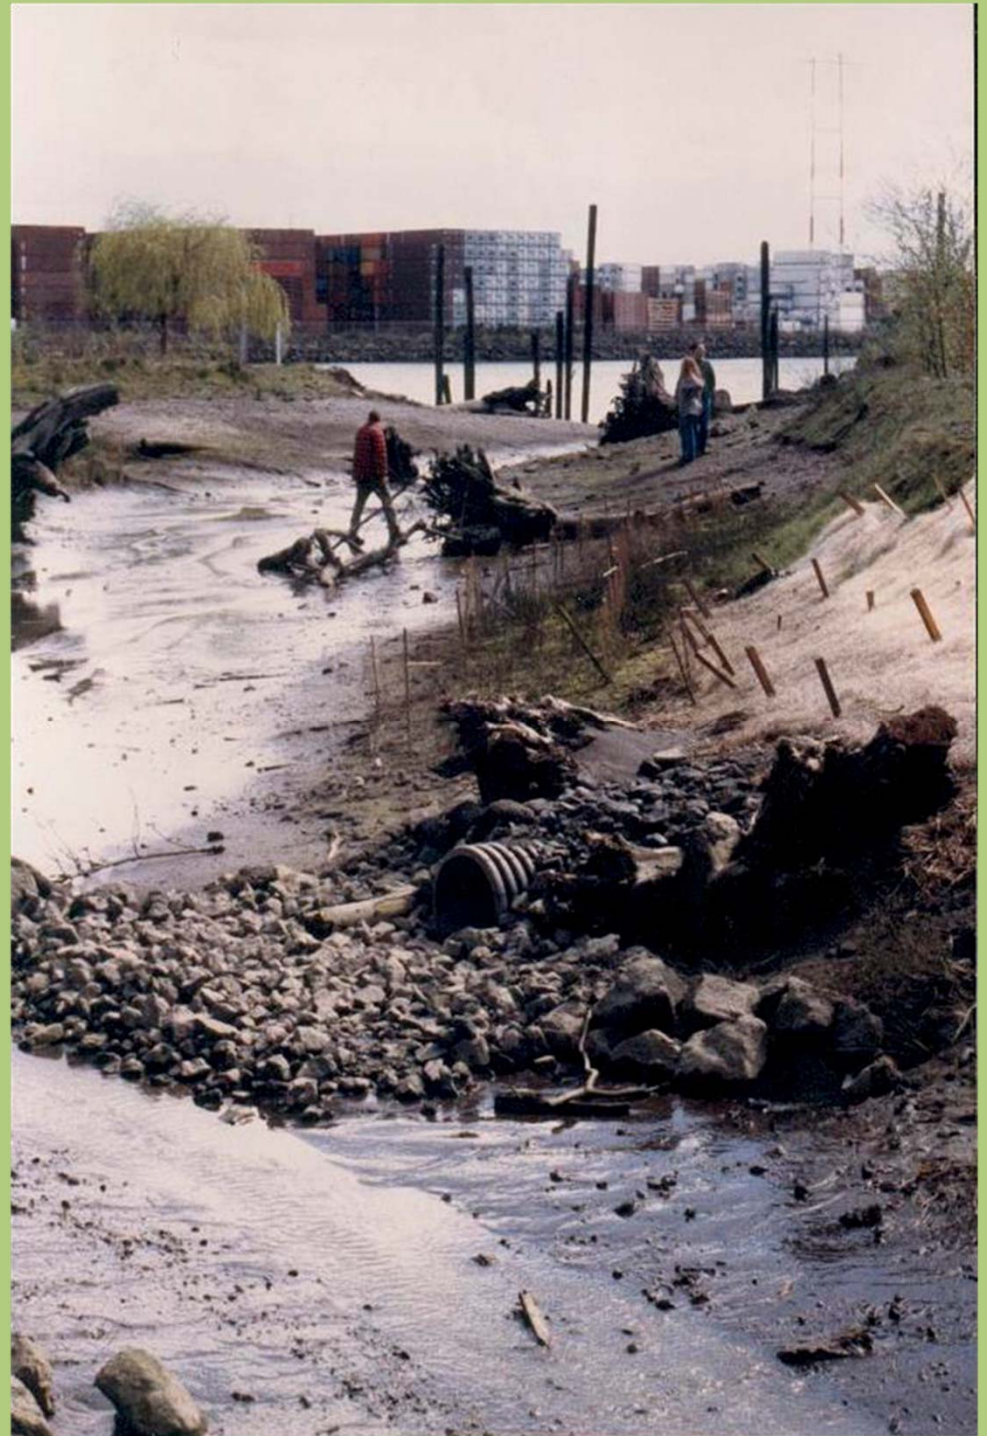
Terminal 105 demonstration project site, 1998

Illustrating intertidal channel following construction in 1998. Note erosion control fabric and emergent vegetation plantings. Riparian vegetation has been installed.

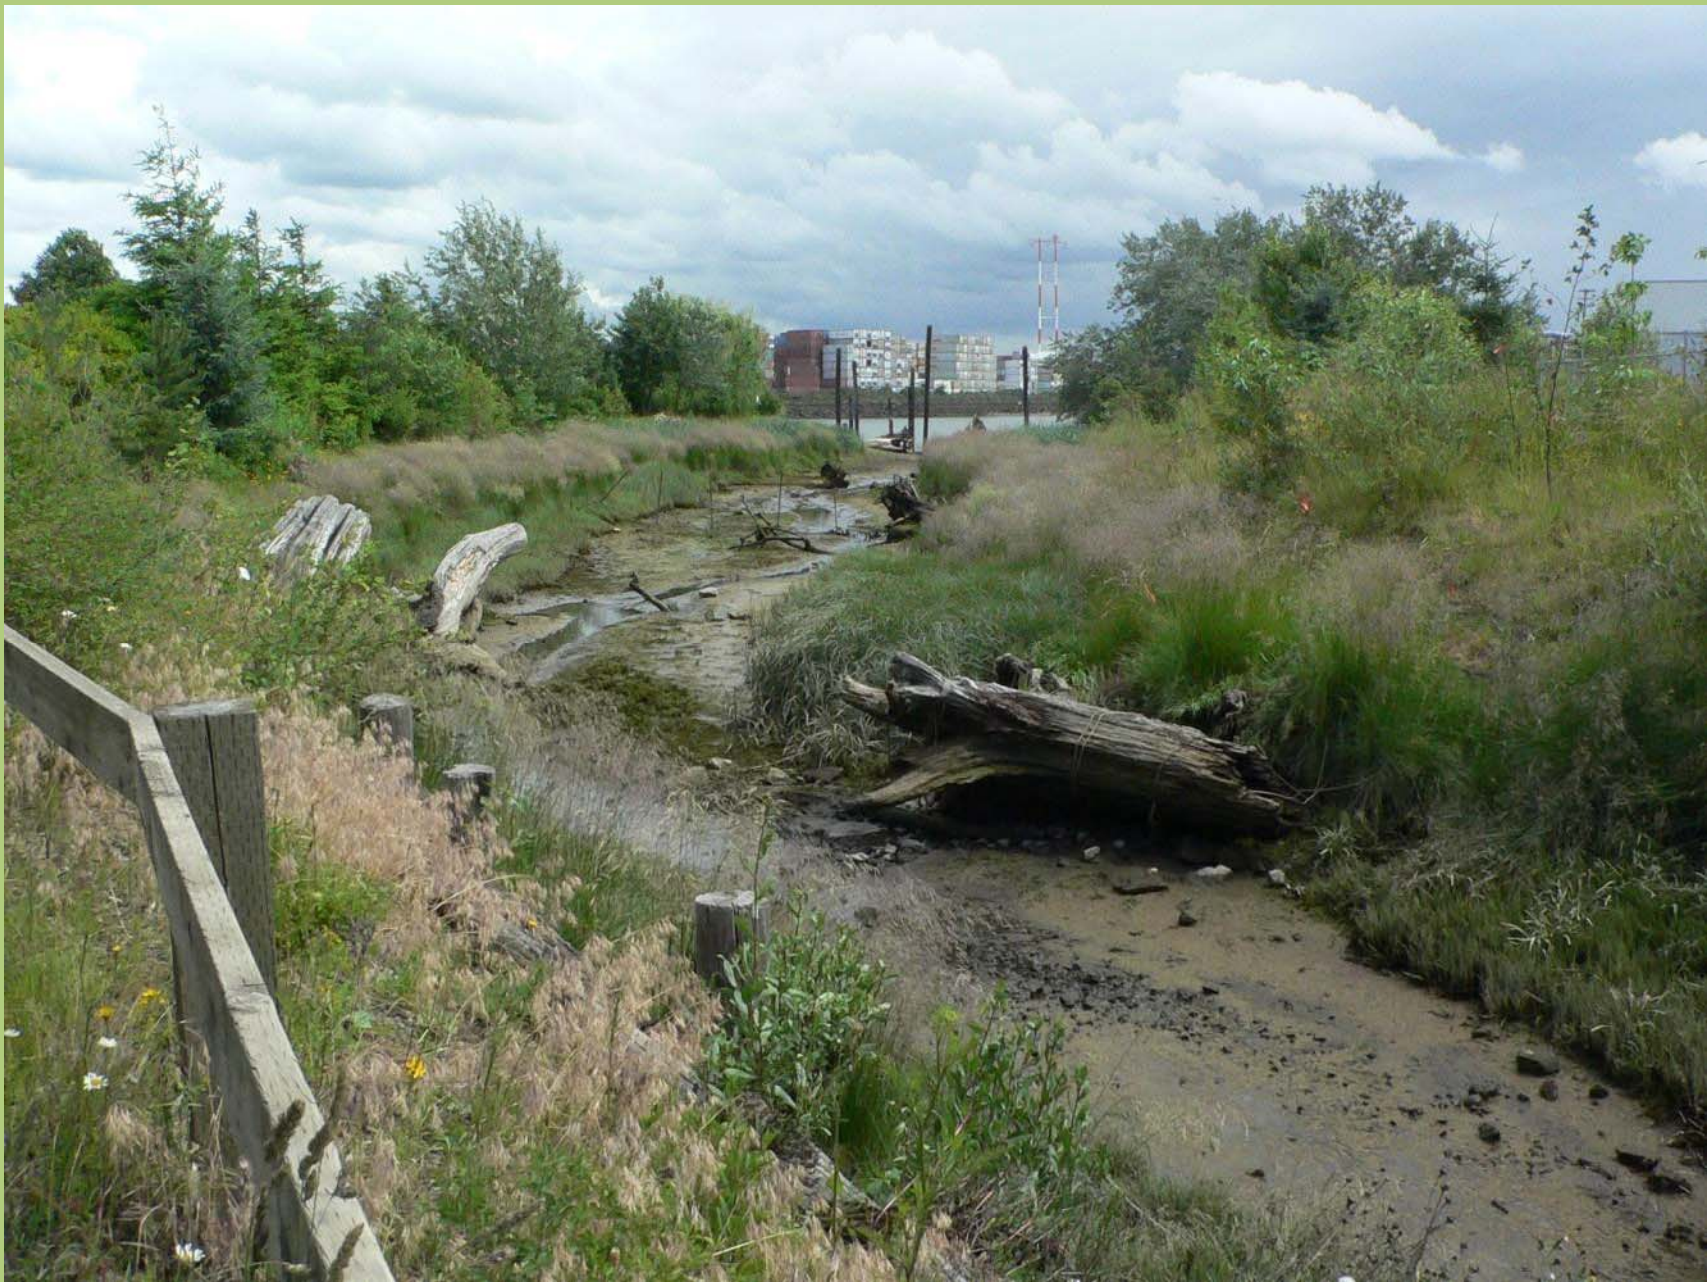
Completed Terminal 105 demonstration project—2006

The intertidal channel substrate is stable, with robust, sustained native marsh and riparian vegetation.

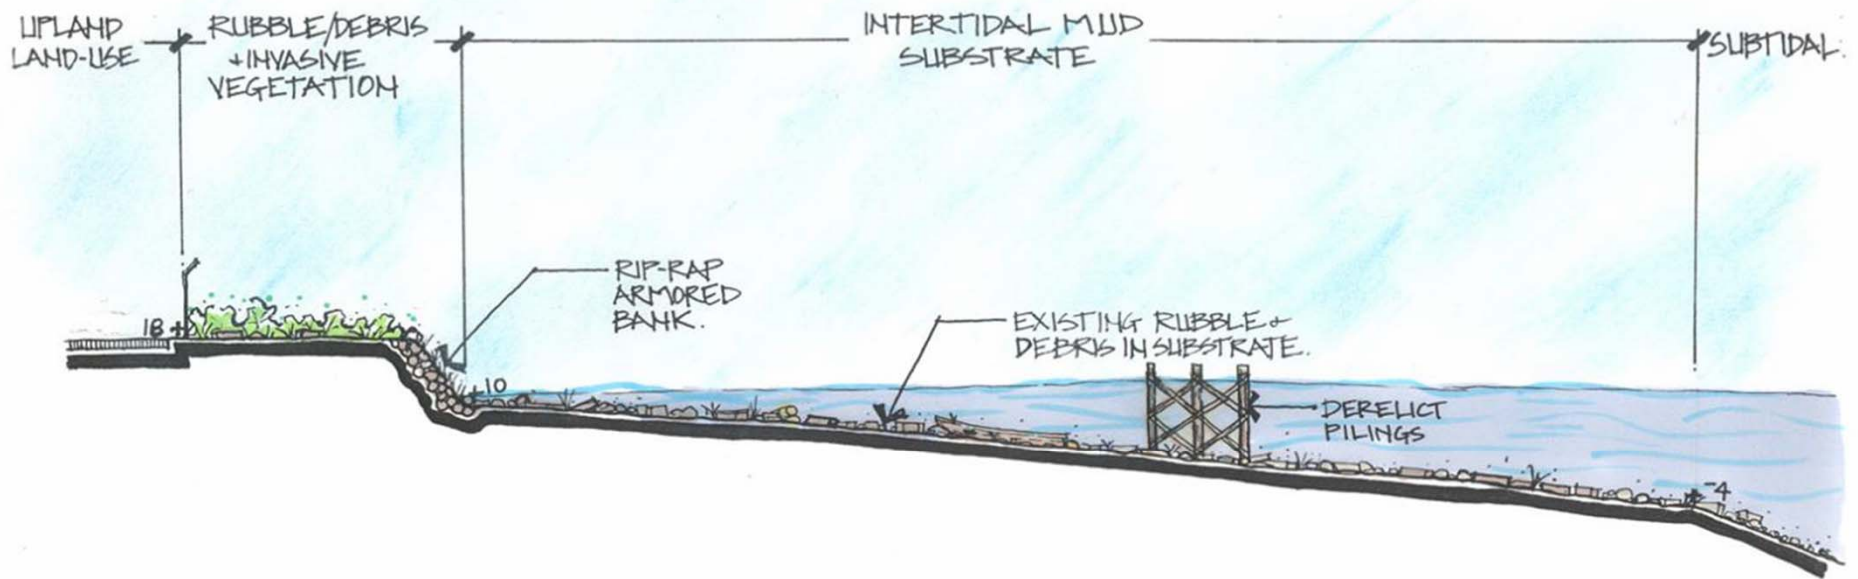
A EXISTING CONDITION SECTION A: POTENTIAL MARSH BENCH CREATION

Duwamish Waterway, Corridor Fish and Wildlife Habitat--Concept

Illustrating industrial bank line and adjacent intertidal and shallow subtidal aquatic area impeded by past industrial uses and activities

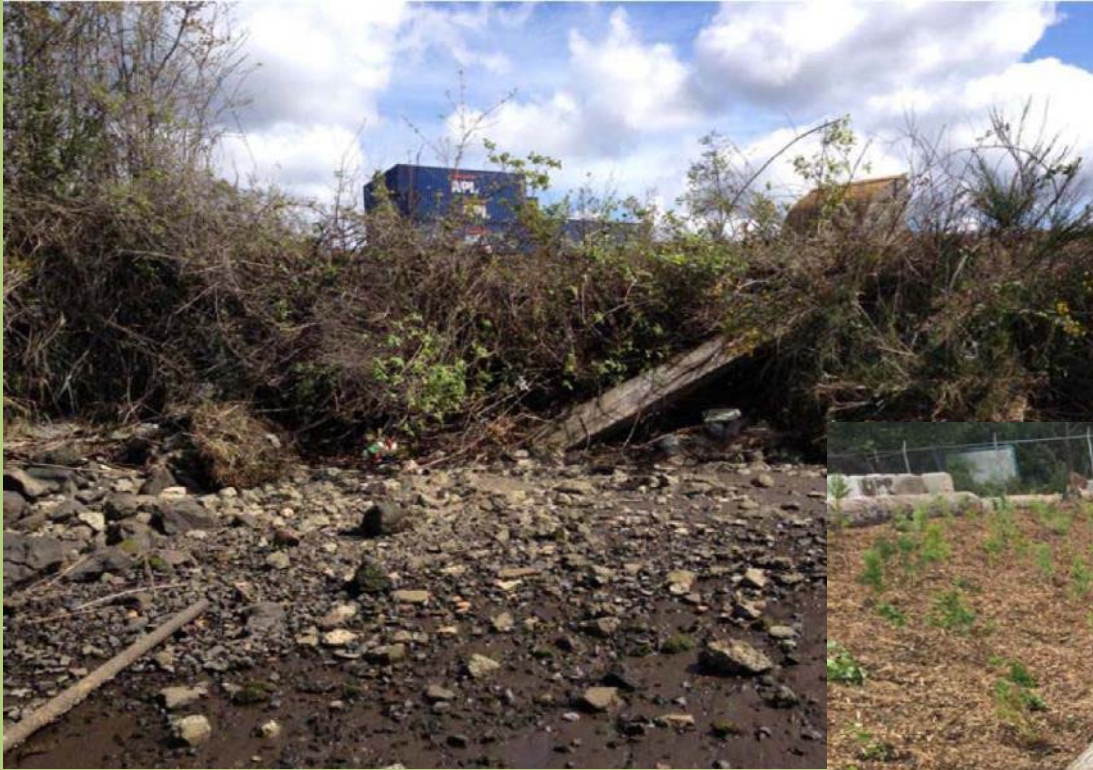
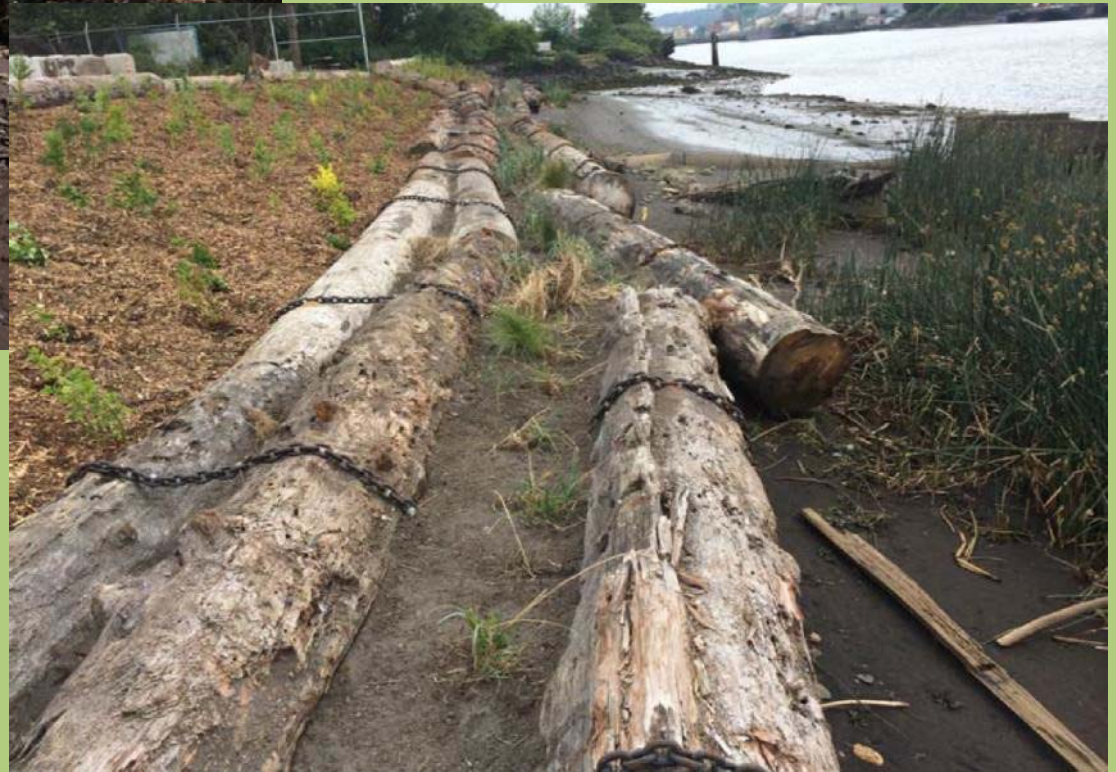
Terminal 108, Corridor Fish and Wildlife Habitat Demonstration Project (2015)

Illustrating eroding, formerly armored marine industrial bank line (upper left). Approximately 285 linear feet unstable bank line replaced with regraded riparian slope and anchored large woody debris.

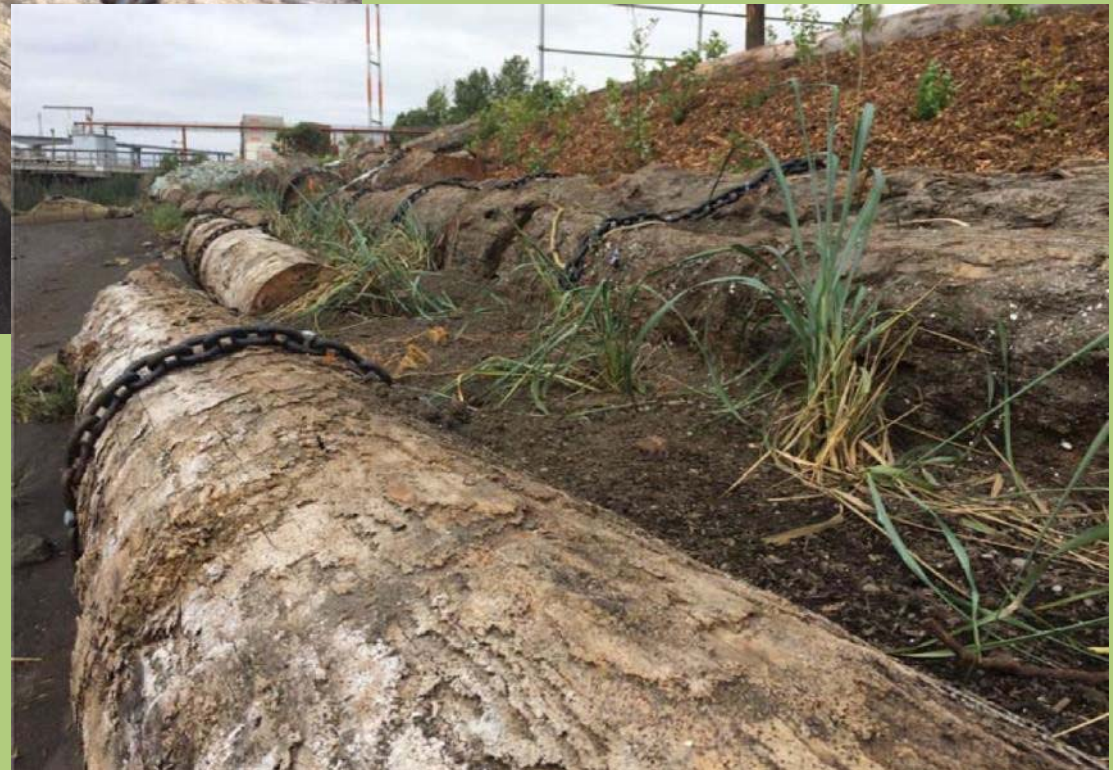
Terminal 108, Corridor Fish and Wildlife Habitat Demonstration Project (2015)

Anchored large woody debris, protecting toe-of-slope. Stable bank line conditions protect marine industrial asset while providing coincident fish and wildlife natural resource benefits.

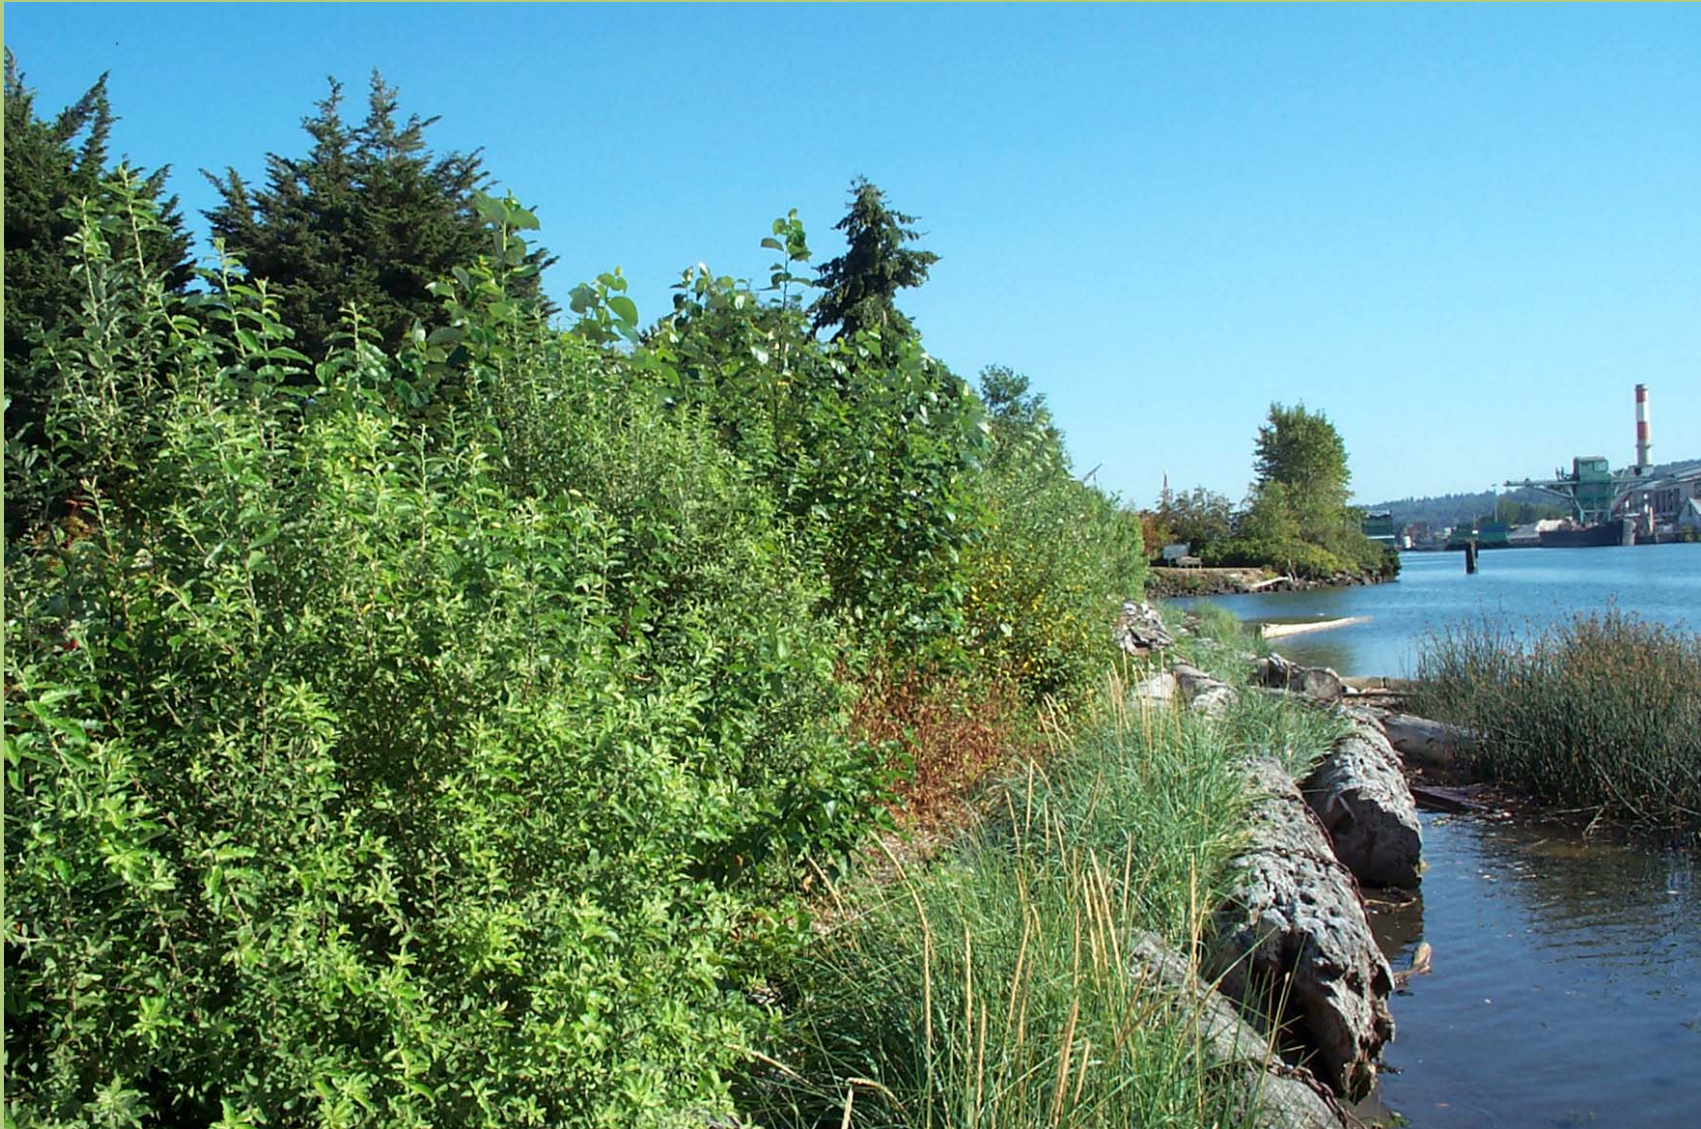
Terminal 108, Corridor Fish and Wildlife Habitat Demonstration Project (2016)

Anchored large woody debris and native riparian vegetation, following first year riparian and upper inter-tidal vegetation growth.

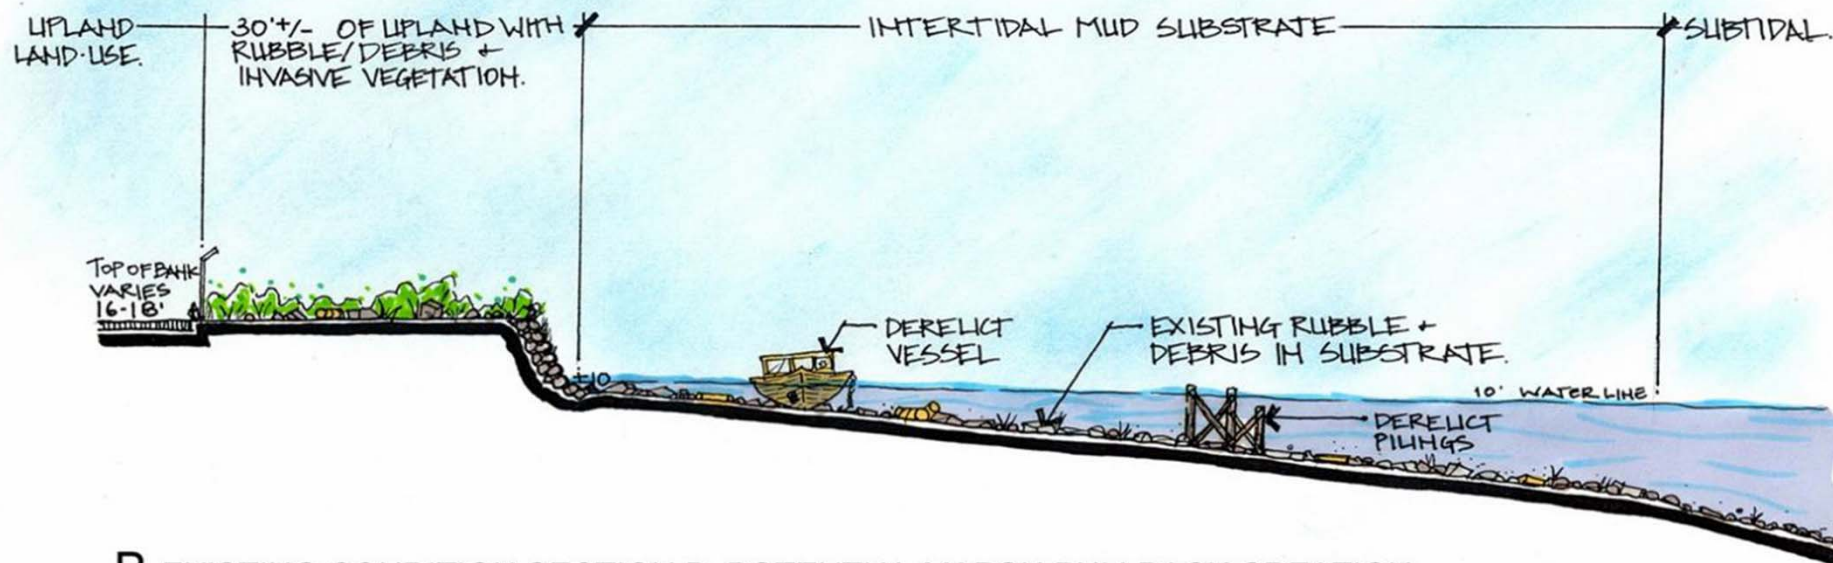
B EXISTING CONDITION SECTION B: POTENTIAL MARSH PULLBACK CREATION

Duwamish Waterway, Corridor Fish and Wildlife Habitat--Concept

Illustrating potential for removal of derelict waterway debris and regrading eroding, rubble-filled bank line.

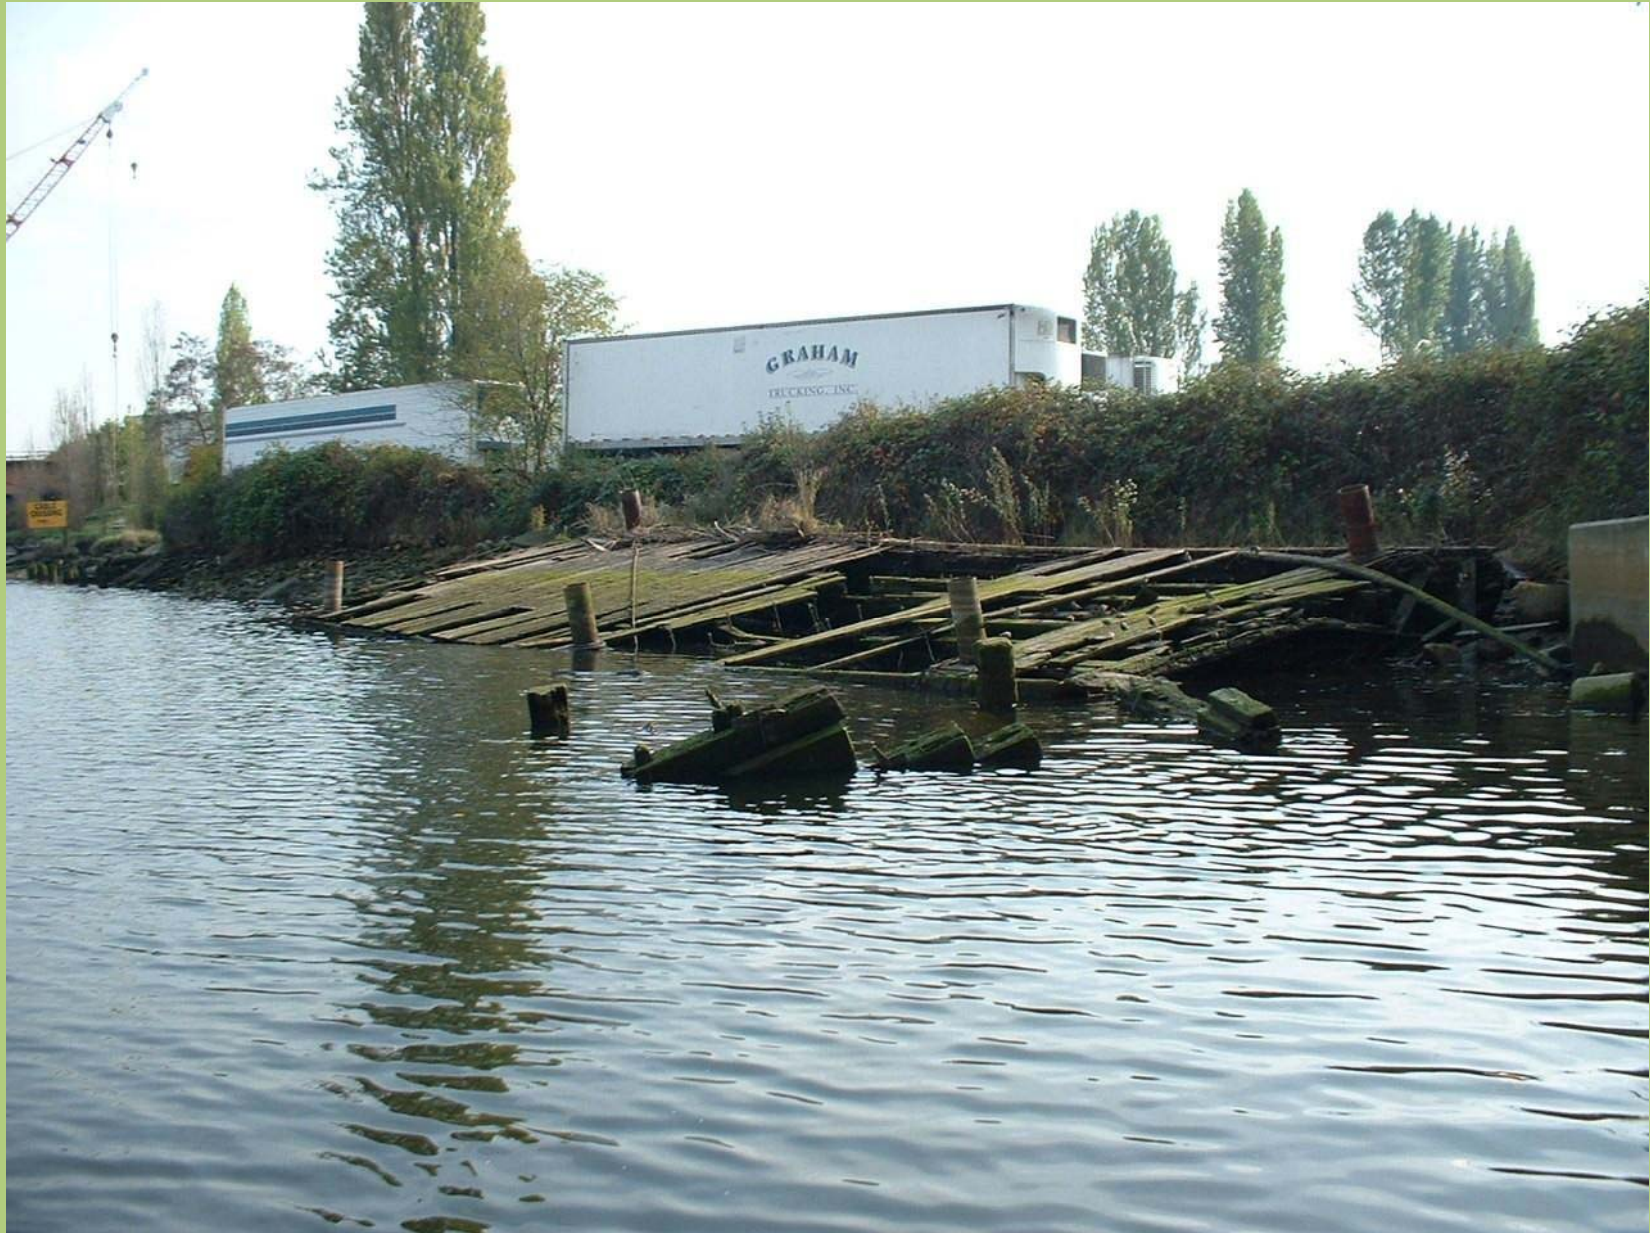
South Riverside Drive, Corridor Fish and Wildlife Habitat Restoration—existing conditions

Illustrating derelict waterway vessel and materials, eroding rubble fill bank line, and invasive plants. Port-owned bank line, with adjacent upland public right-of-way in use with commercial parking.

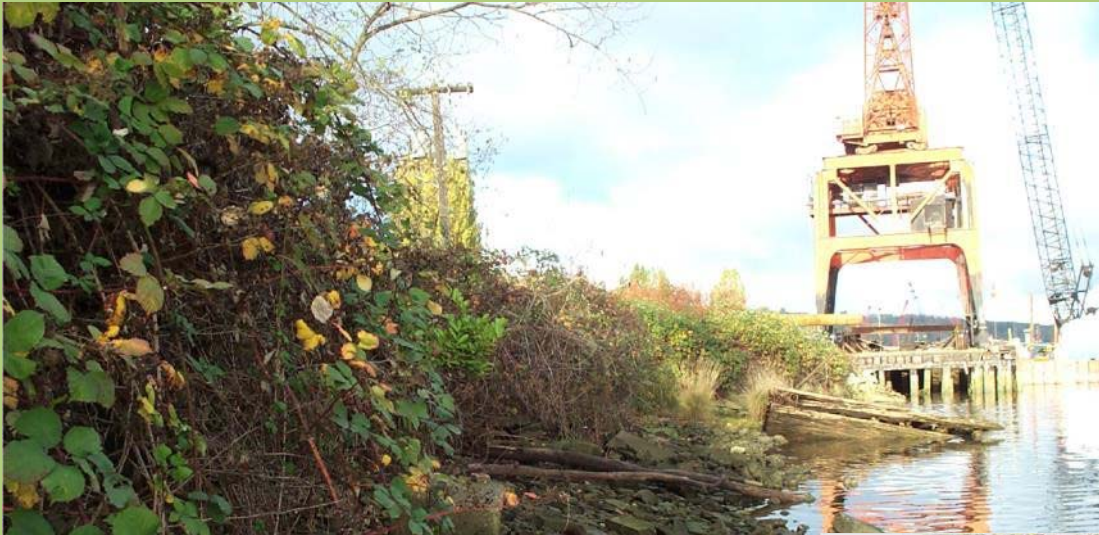
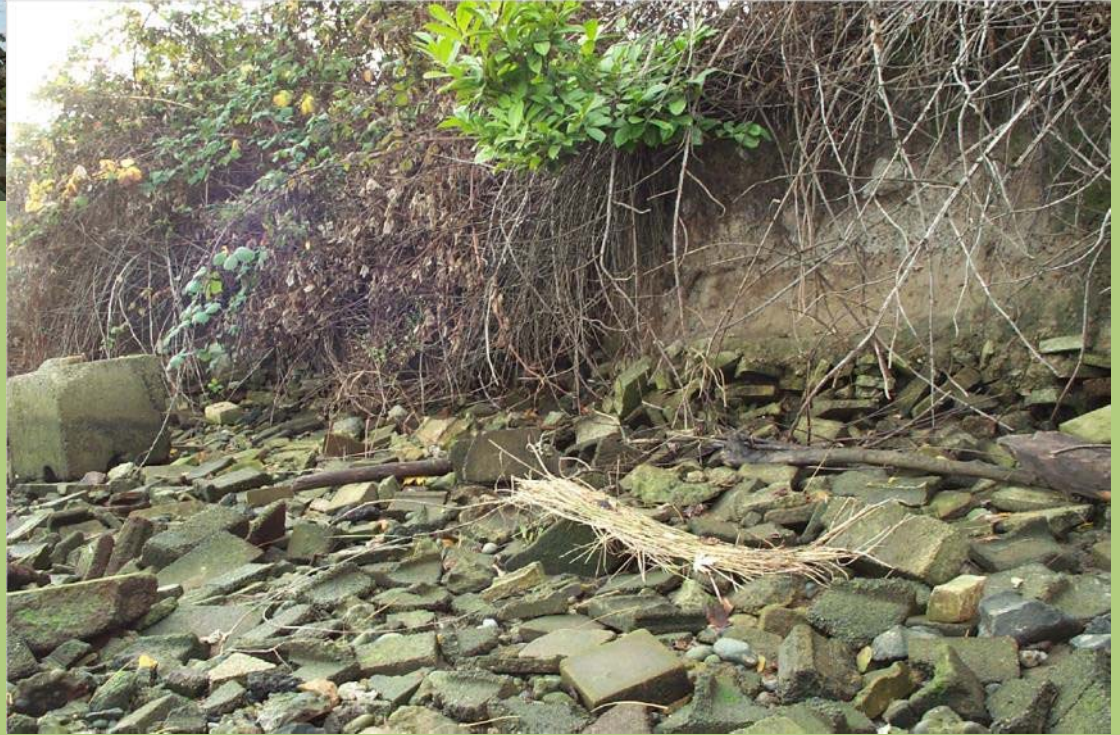
Duwamish Waterway, Corridor Fish and Wildlife Habitat--Concept

Illustrating elements of bank line restoration in publicly-owned Duwamish Waterway.

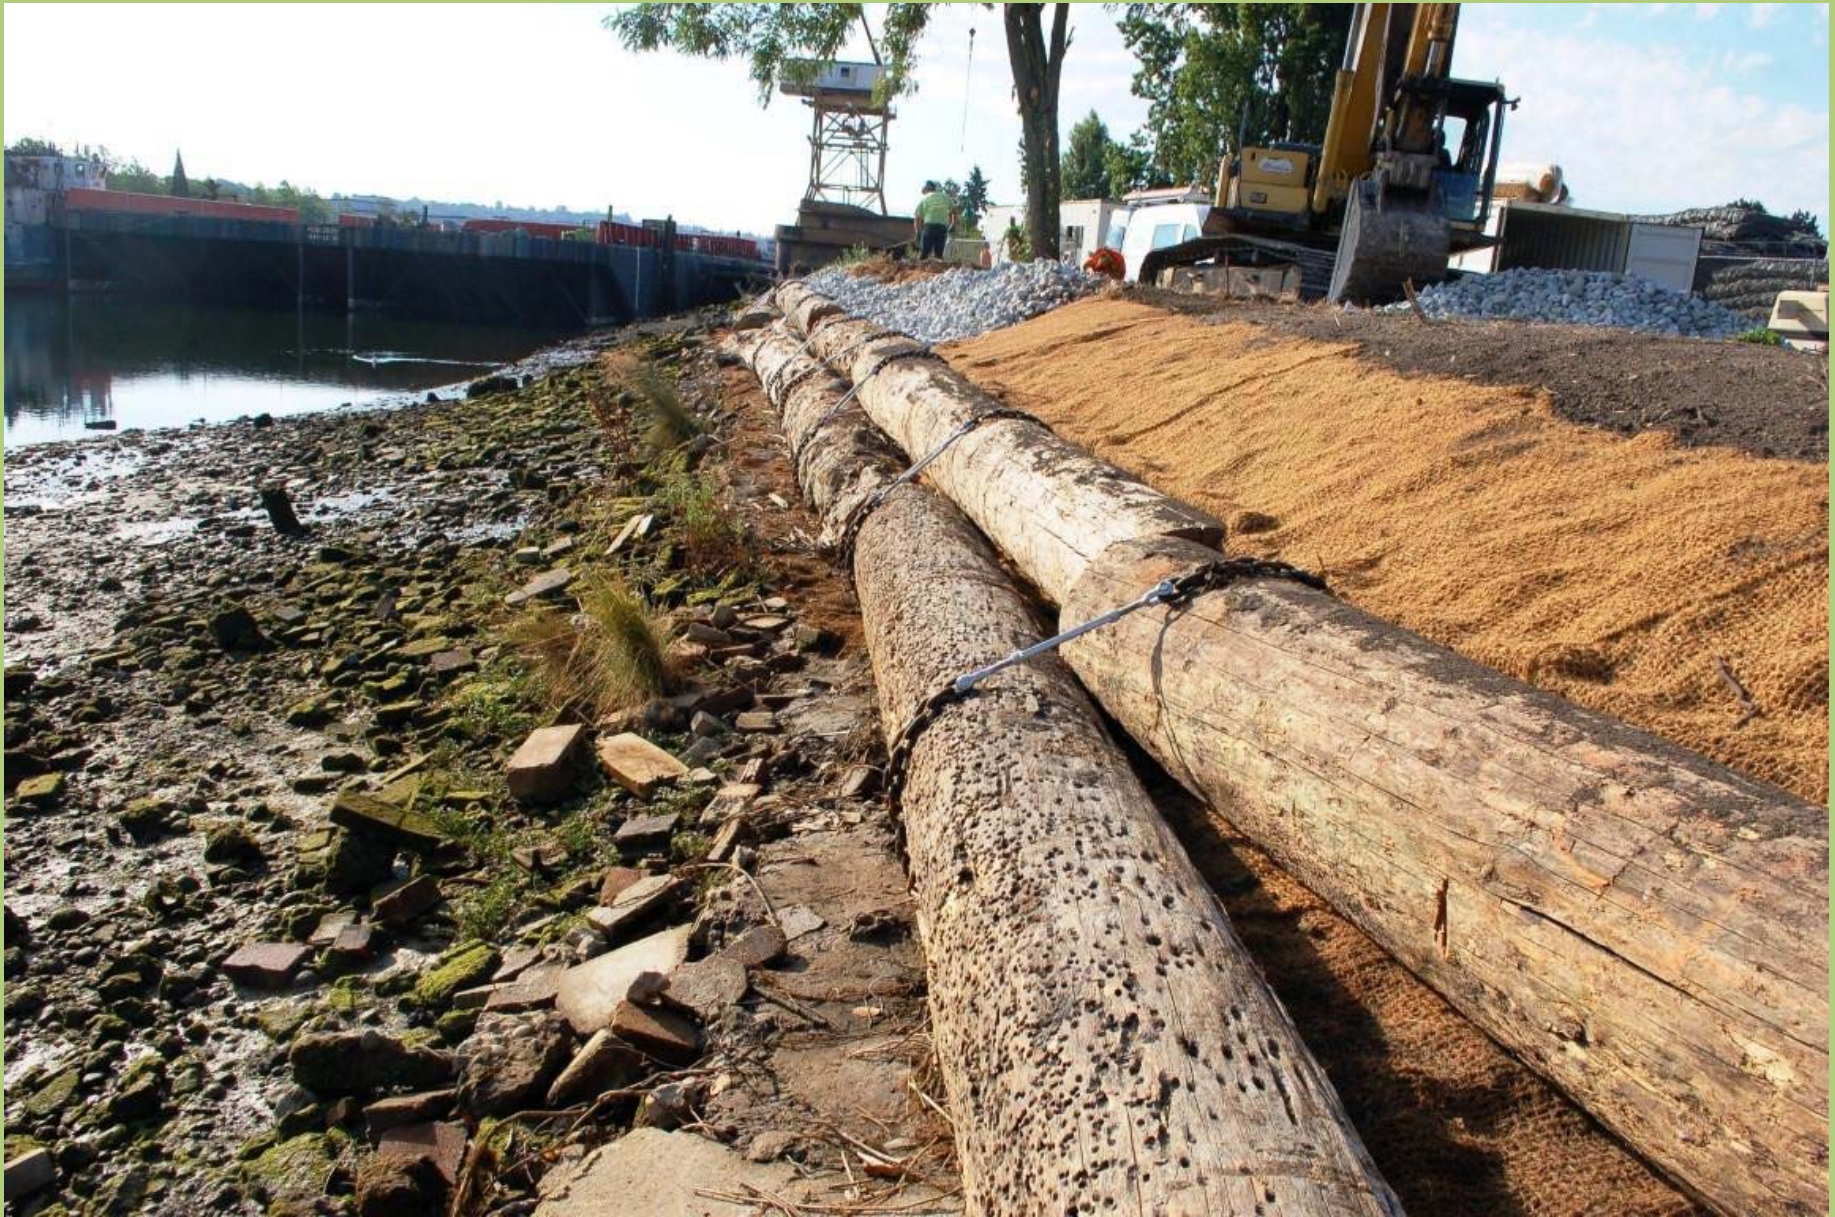
South Riverside Drive, Corridor Fish and Wildlife Habitat Demonstration Project (2014)

Illustrating eroding, rubble-filled bank line and industrial debris impeding intertidal area.

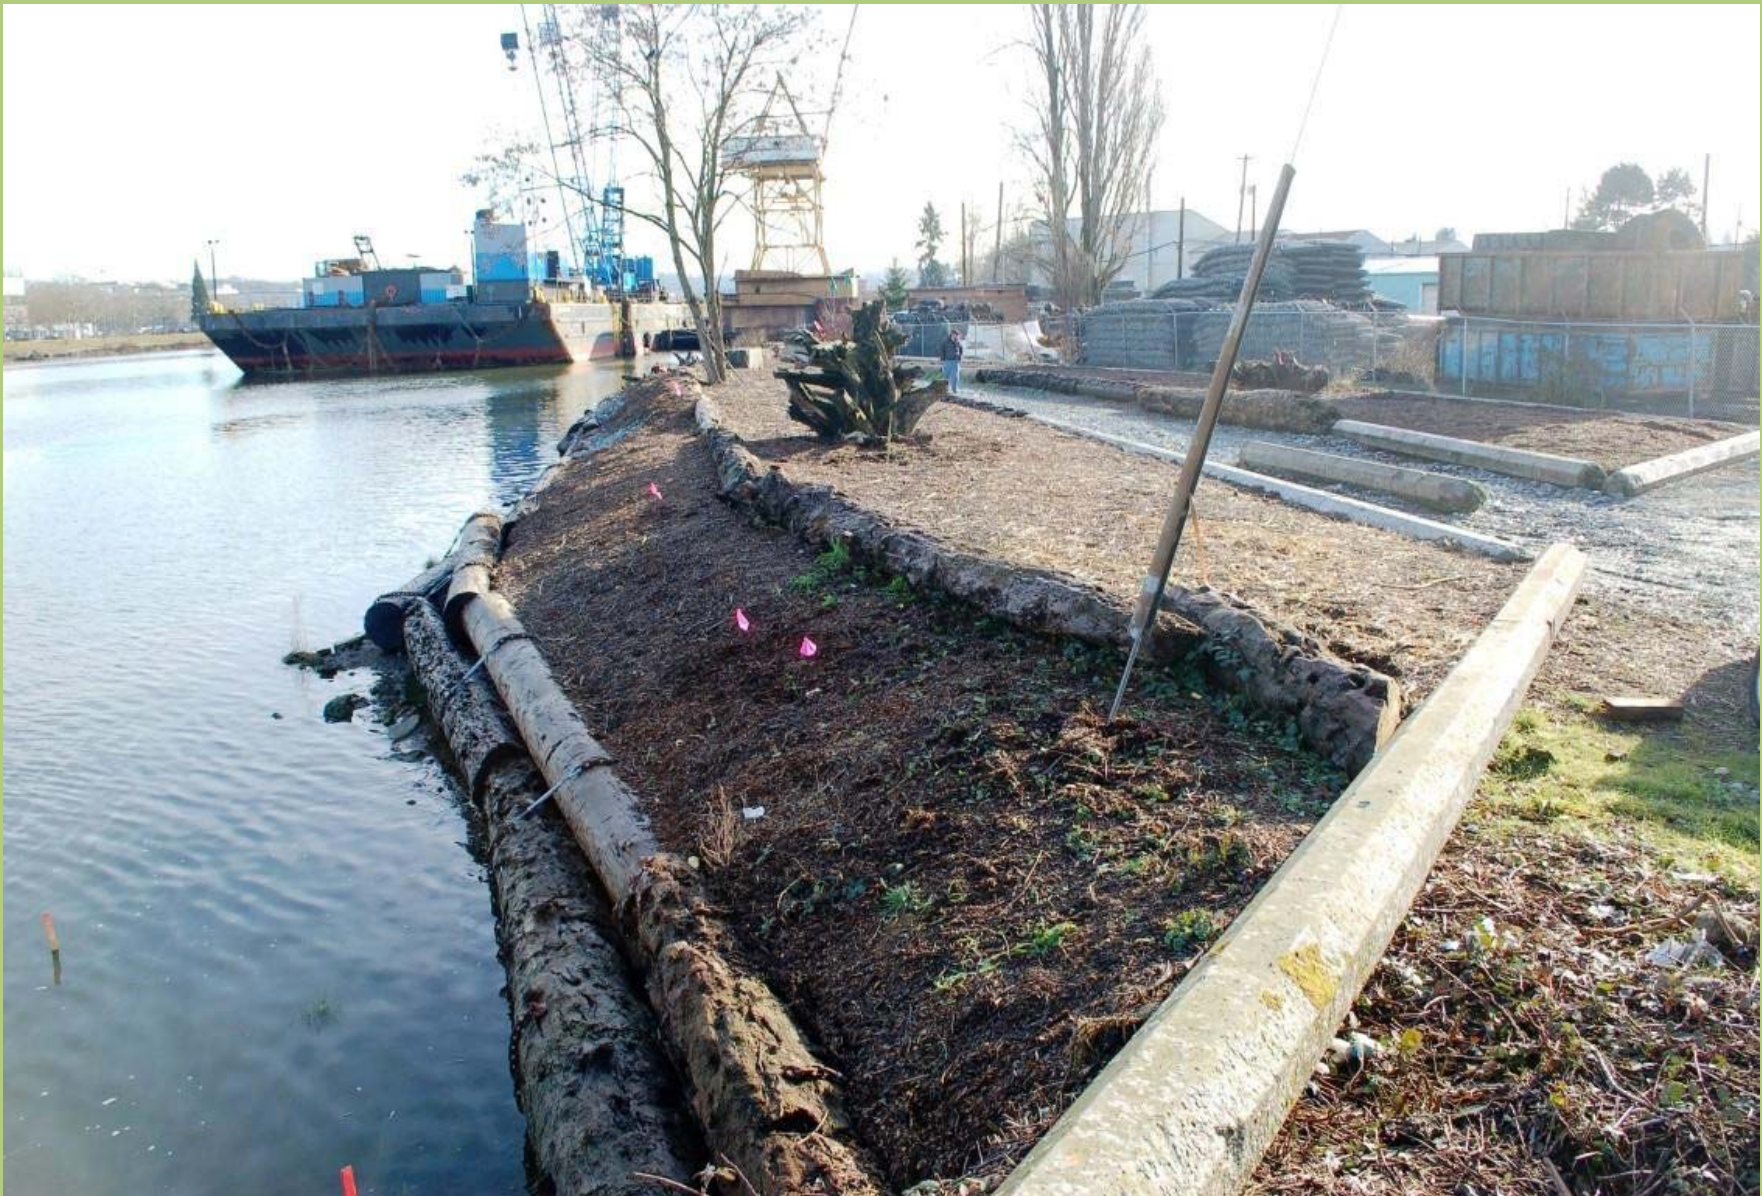
South Riverside Drive, Corridor Fish and Wildlife Habitat Demonstration Project (2015)

Waterway debris removal (approximately 75 tons) and bank-line regrading underway. Note toe-of-slope anchored large-woody-debris installation, coir fabric, and preparation of riparian slope planting area.
