Urban-industrial shoreline restoration techniques: Duwamish Waterway and Elliott Bay

George Blomberg

Estuarine Restoration

Urban Industrial Context

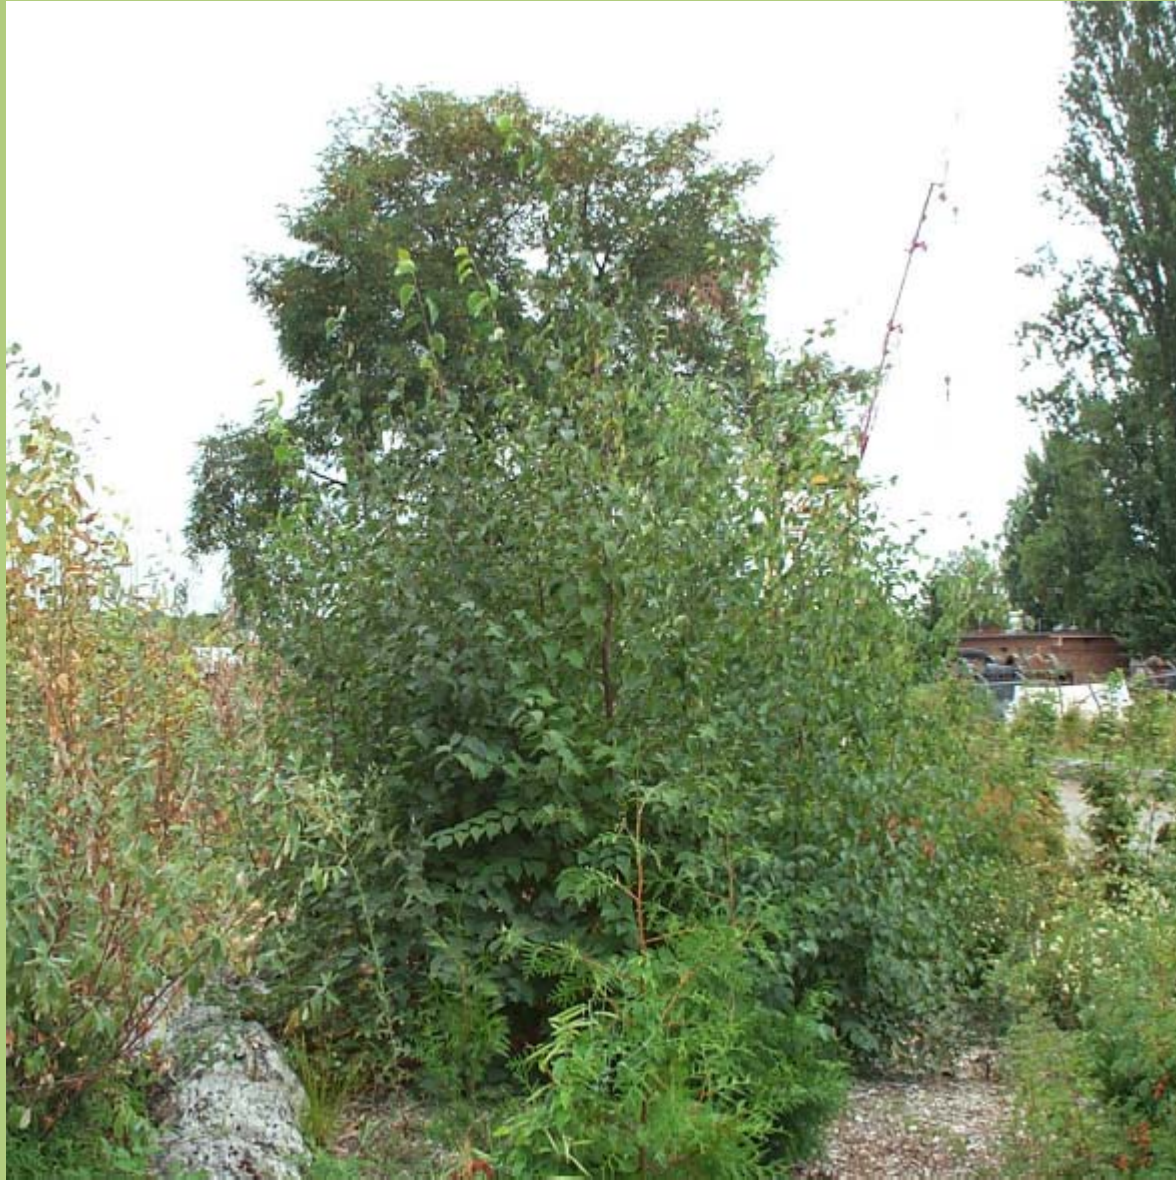
South Riverside Drive, Corridor Fish and Wildlife Habitat Demonstration Project (2015)

Approximately 310 linear feet of bank line rehabilitation completed. Approximately 6500 square feet riparian and upland native planting area prepared. Former truck parking area includes shoreline pathway connecting to adjacent port-constructed public shoreline access site. Upland area improved with passive stormwater controls.

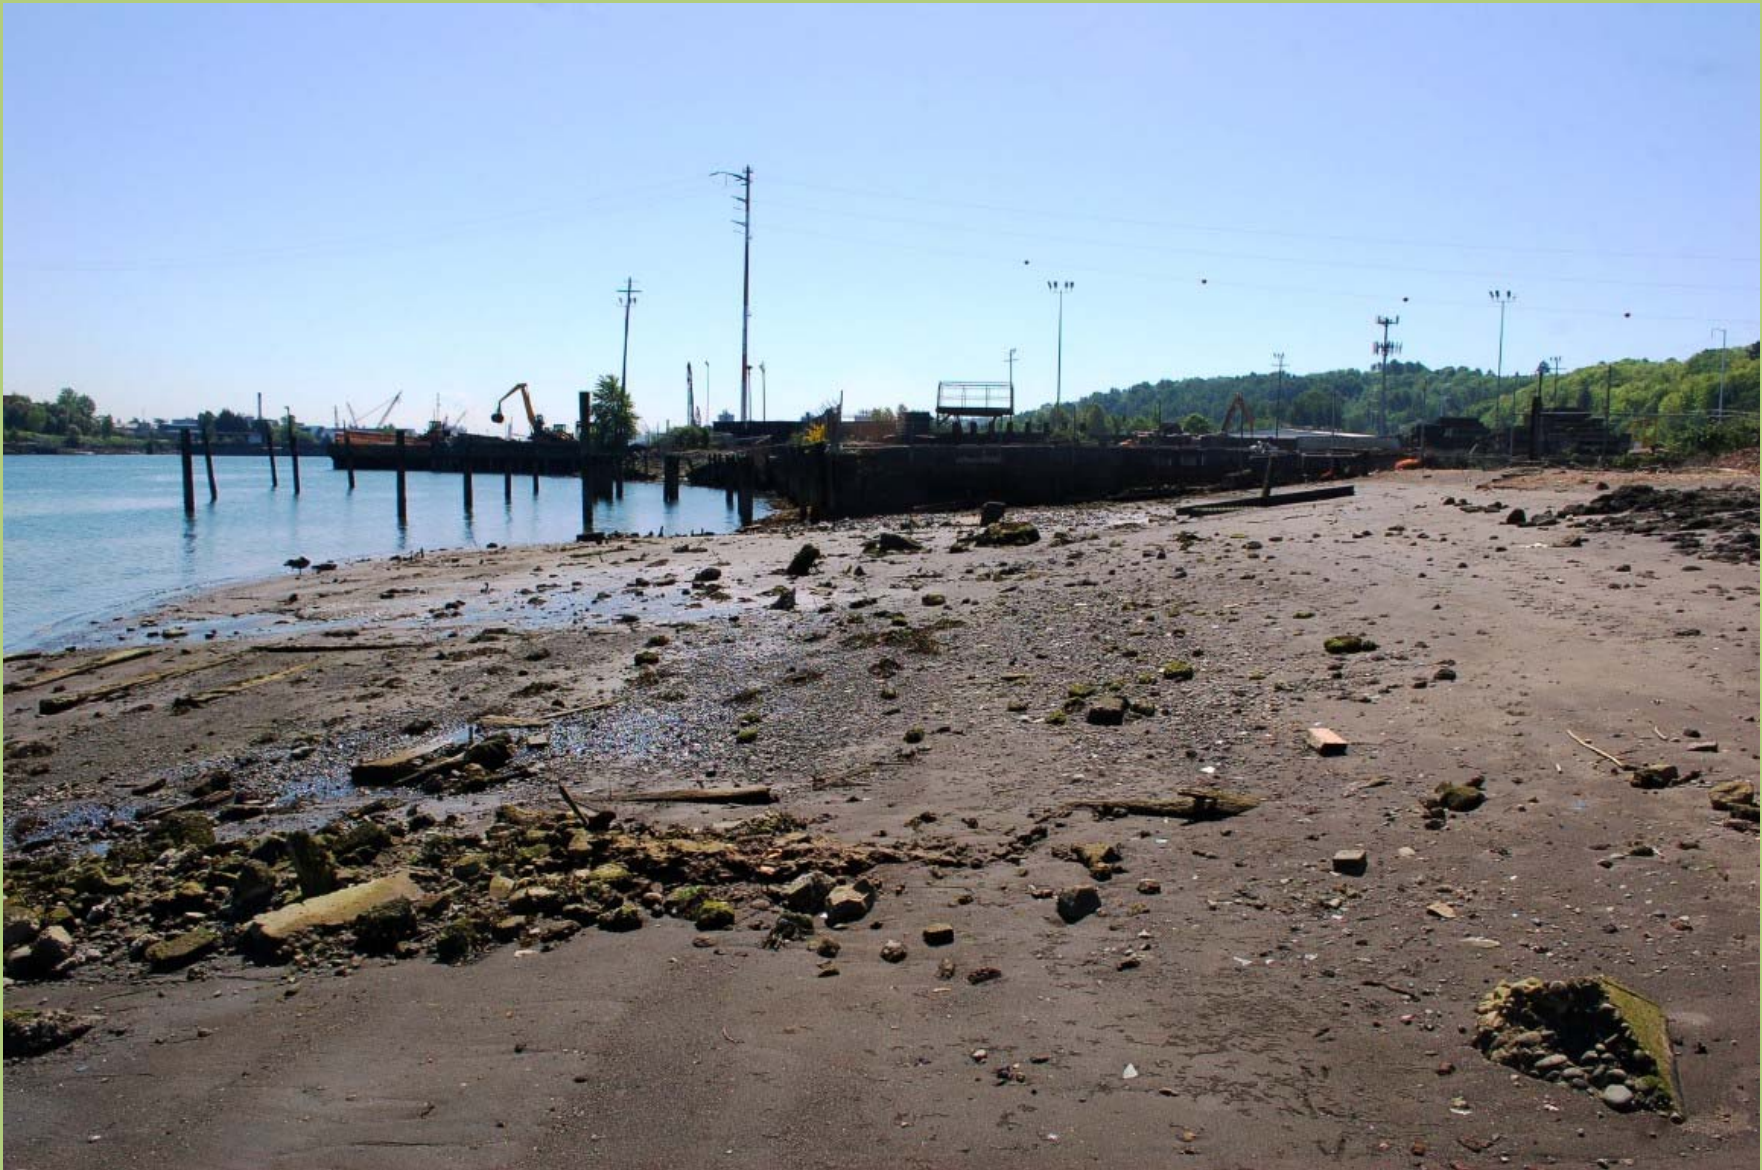
Terminal 105, Aquatic Area and Shoreline Stabilization Project (2016)

Illustrating approximately 0.5 acres aquatic area impeded with derelict creosote piling and marine industrial debris.

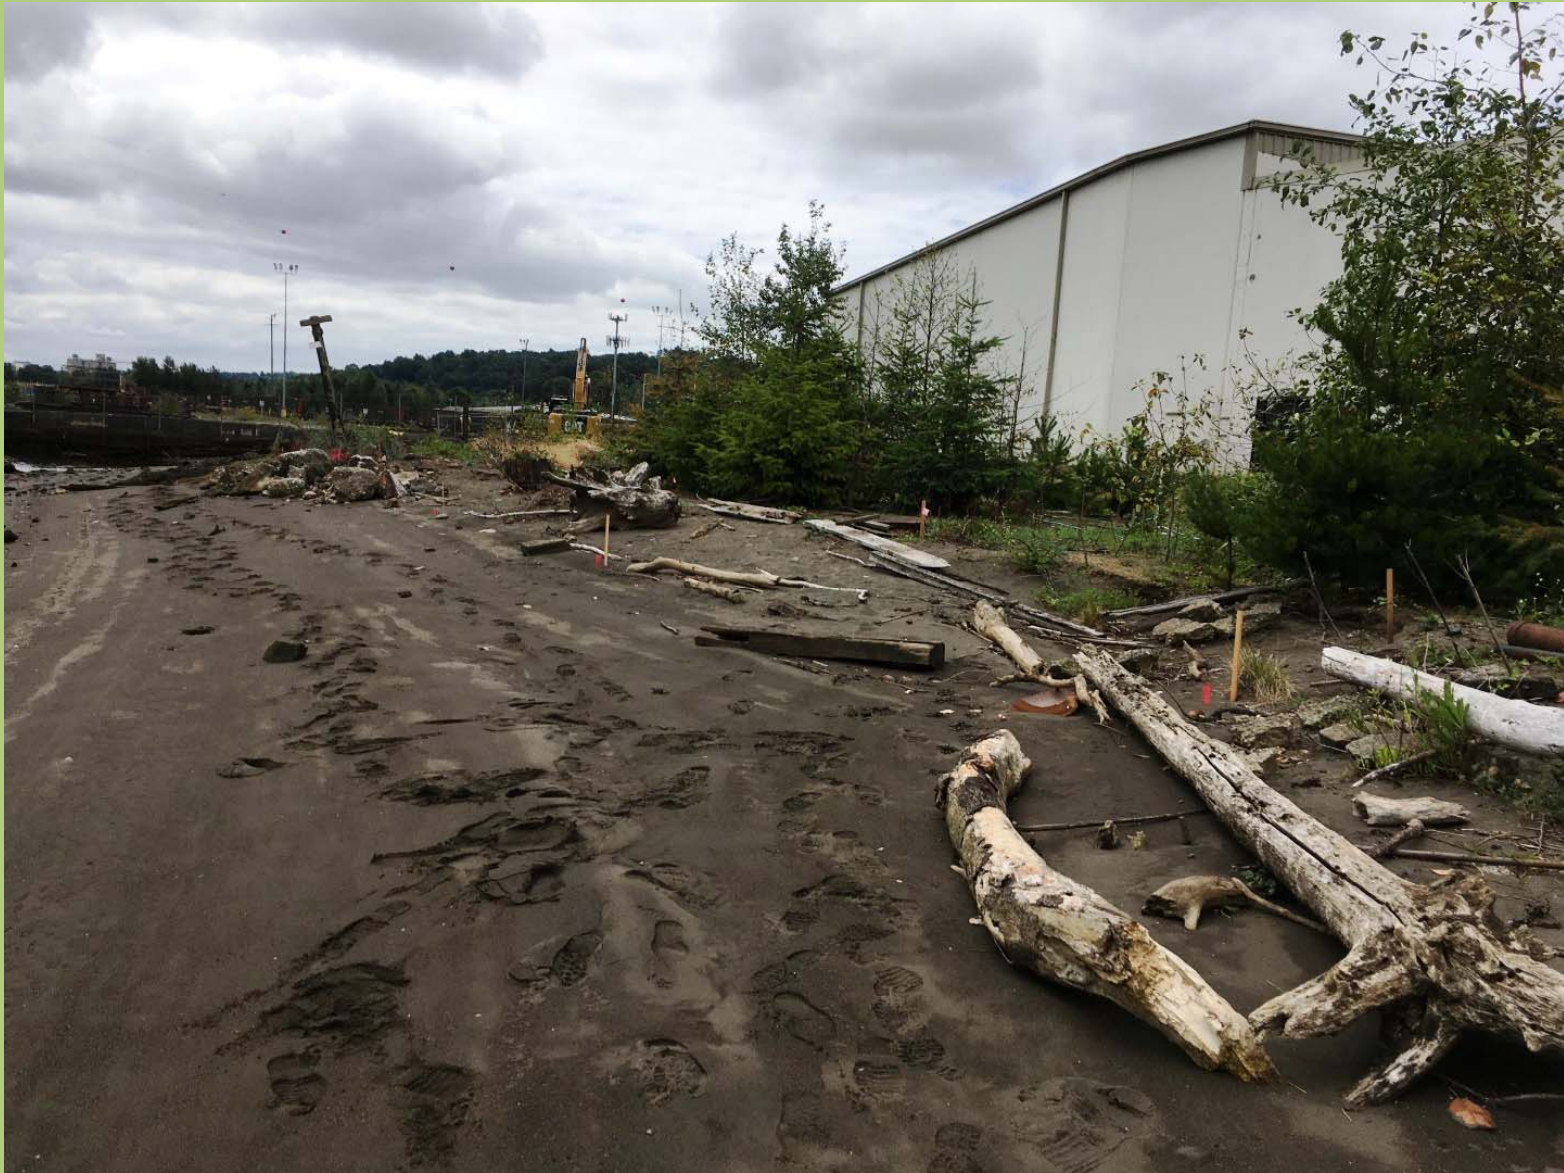
Terminal 105, Aquatic Area and Shoreline Stabilization Project (2016)

Illustrating aquatic area following removal of approximately 410 creosote piling and associated industrial debris, totaling approximately 475 tons. Aquatic area received approximately 65 tons of clean sand cover.

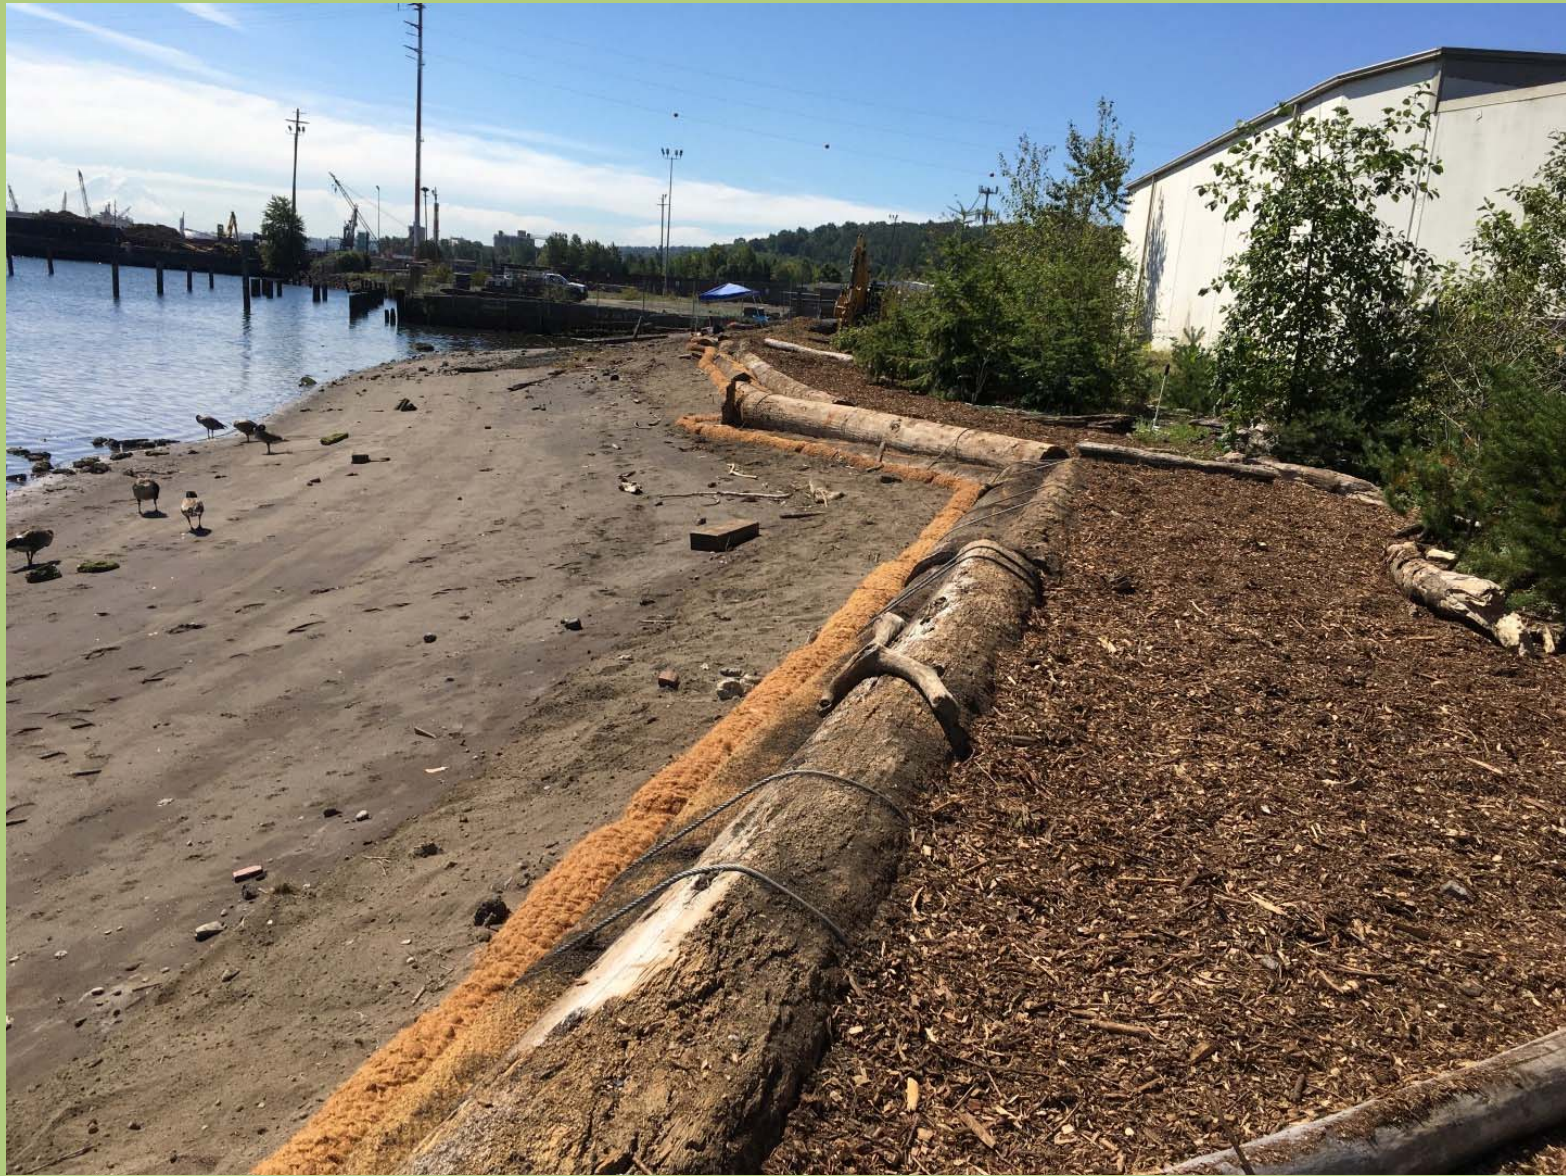
Terminal 105, Aquatic Area and Shoreline Stabilization Project (2016)

Illustrating approximately 0.3 acres, 285 linear feet, instable eroding bank-line adjacent to piling/debris removal area.

Illustrating eroding, formerly armored marine industrial bank line (upper left). Approximately 285 linear feet unstable bank line replaced with regraded riparian slope and anchored large woody debris.

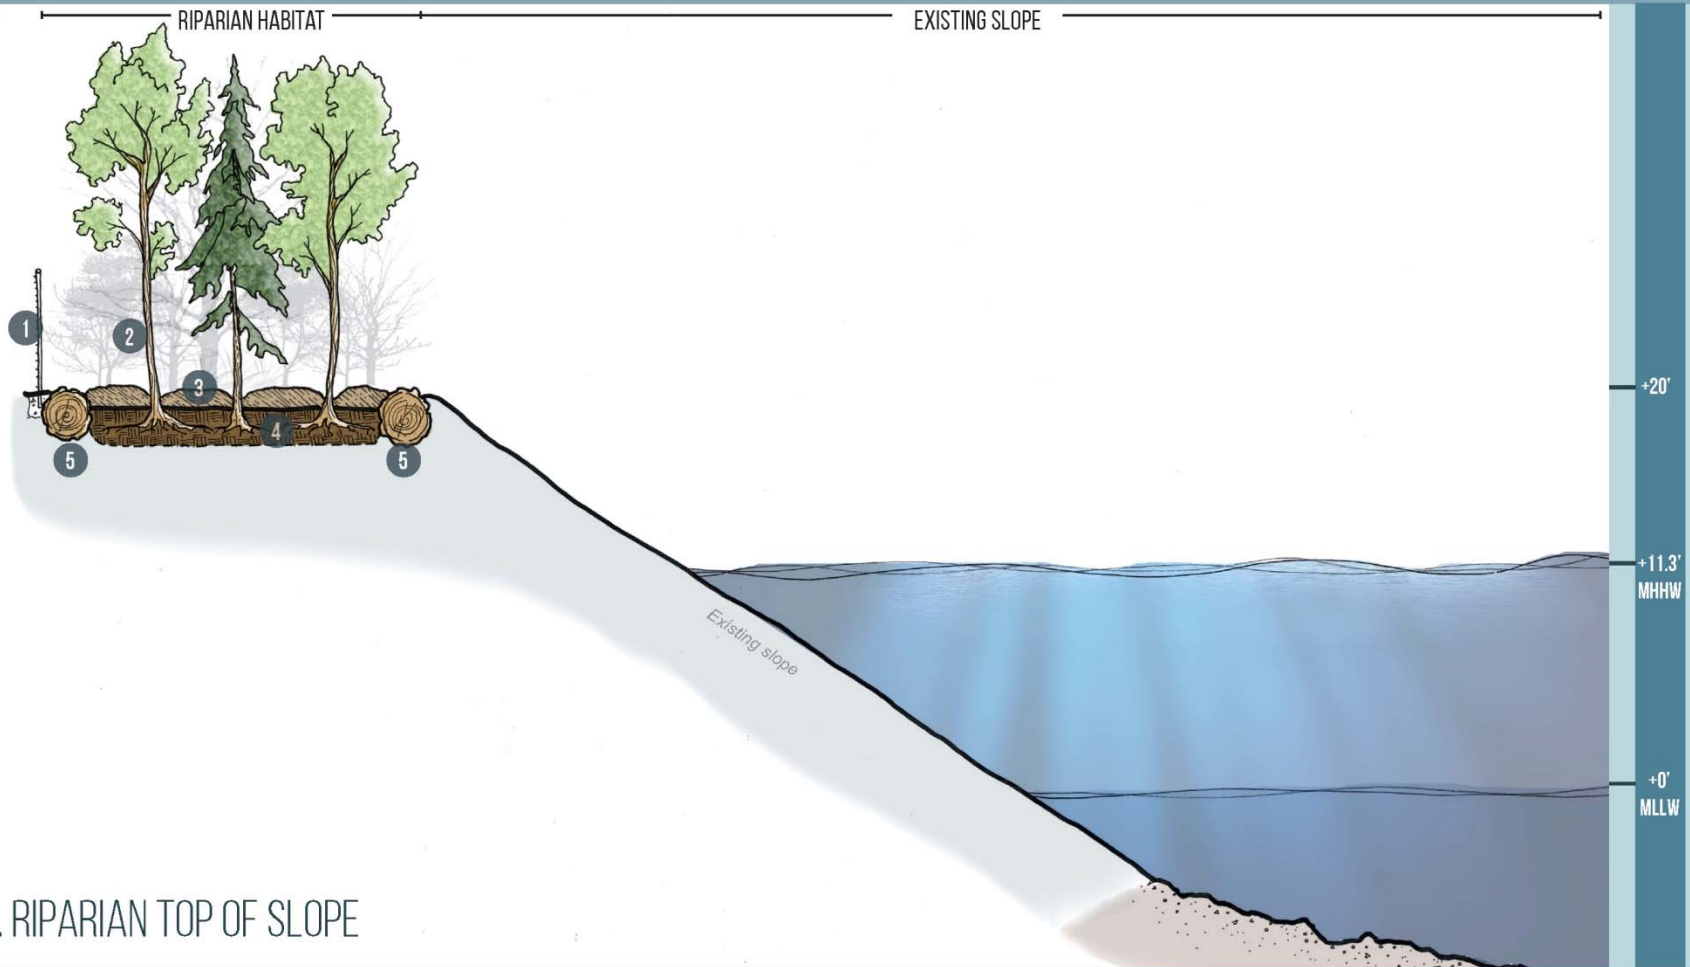
Terminal 105, Aquatic Area and Shoreline Stabilization Project (2016)

Rehabilitated bank-line, with anchored large woody debris, composted soil, and mulch cover. Large woody debris included approximately 90 logs, imbedded as “triple bundles”, secured with “duck-billed” anchors ten to 15 feet below grade. Shoreline planted in winter/spring 2017, including 600 native trees, shrubs, and upper-intertidal plants.

Anchored large woody debris, protecting toe-of-slope. Stable bank line conditions protect marine industrial asset while providing coincident fish and wildlife natural resource benefits.

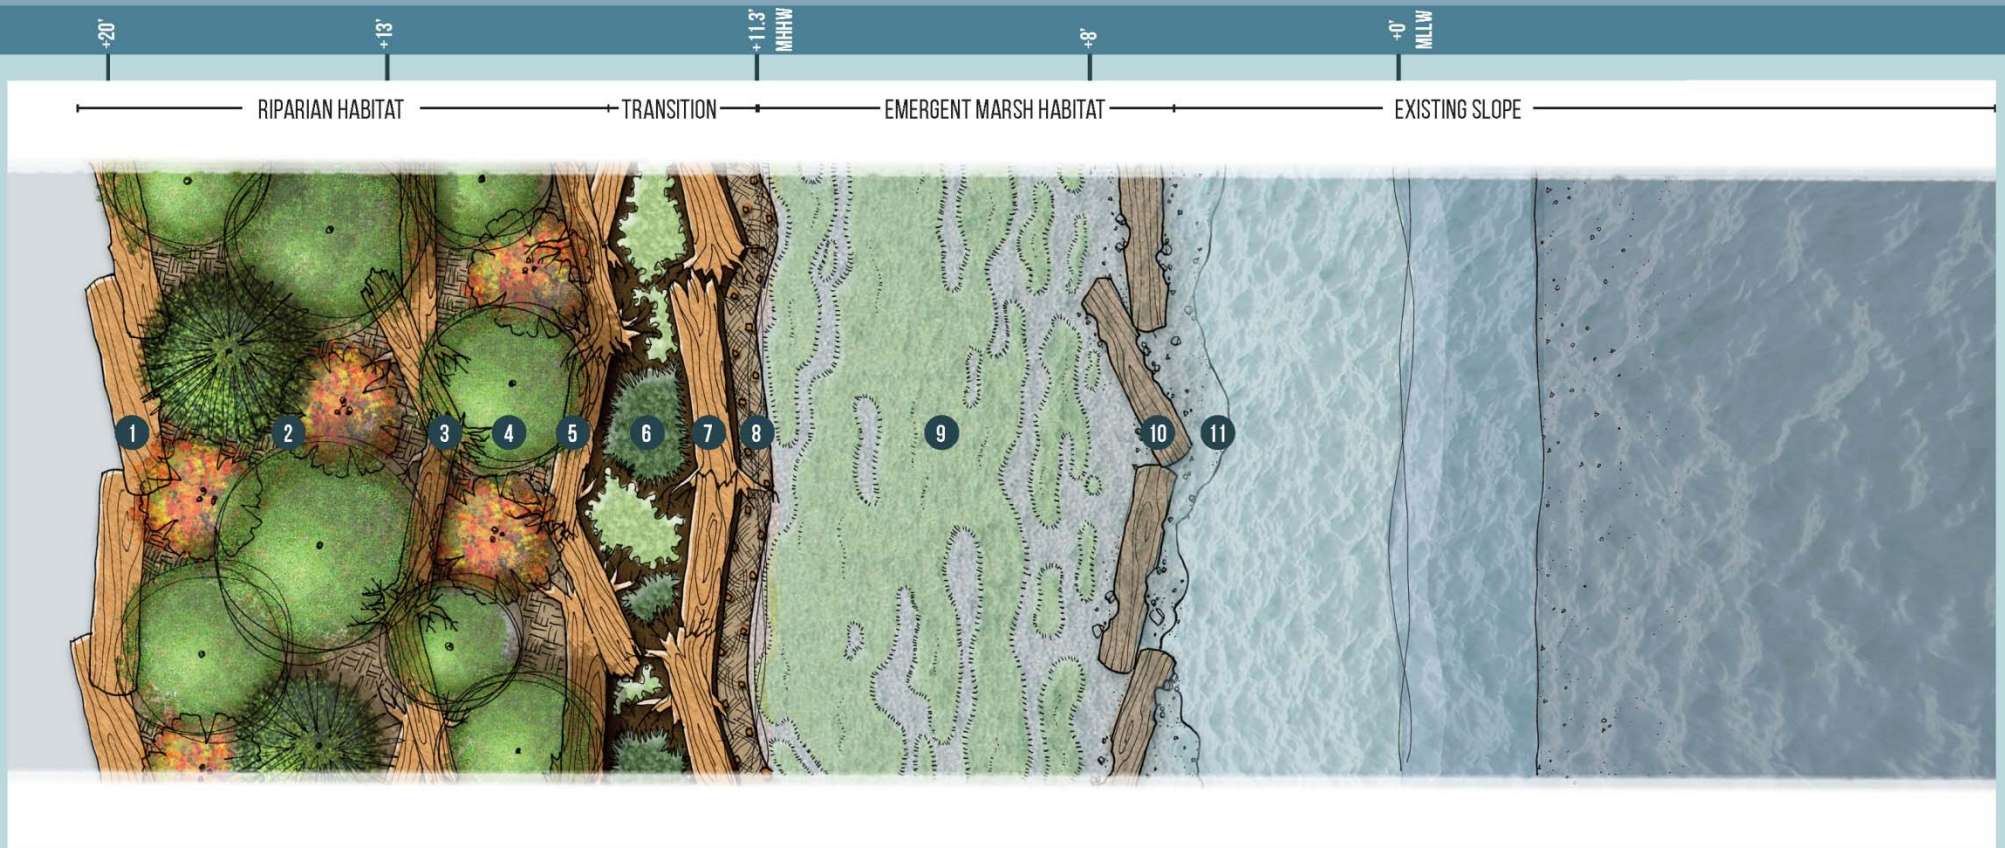
3. SLOPED RIPARIAN AND EMERGENT MARSH

- 1 Large woody debris
- 2 Dense riparian plantings with irrigation - 2:1 to 4:1 slope
- 3 Twelve-inch mulch layer
- 4 Two feet of imported topsoil over geotextile fabric
- 5 Large woody debris defines slope transition
- 6 Dense riparian plantings with irrigation - 4:1 or flatter slope
- 7 Anchored large woody debris on rock bolster defines waterward edge of riparian habitat
- 8 Earth anchor system to secure log
- 9 Emergent plants in biodegradable geotextile fabric pillow filled with two feet of fine grain sediment
- 10 Anchored sacrificial toe log on rock bolster
- 11 Staked fiber roll (wattle)
- 12 Emergent marsh planted in biodegradable geotextile fabric pillow - 4:1 to 10:1 slope
- 13 Twelve-inch import topsoil layer in pillow
- 14 Two-foot fine grain sediment layer in pillow
- 15 Anchored buried log with rock bolster
- 16 Fine grain sediment veneer

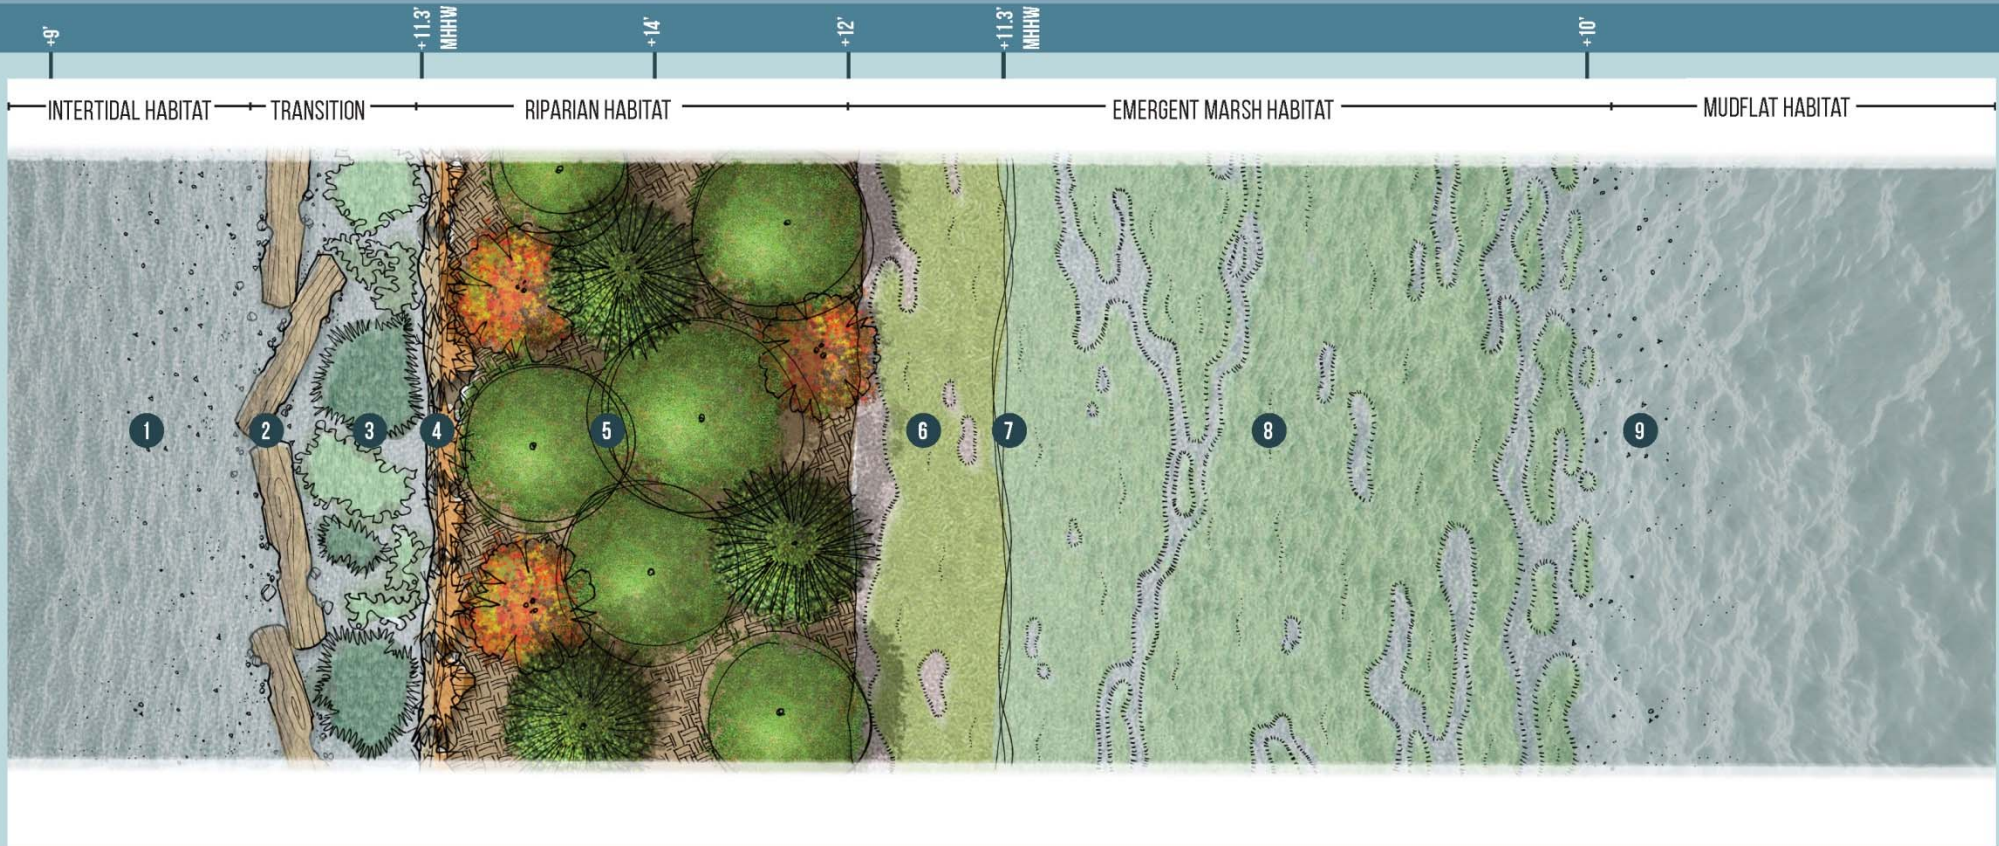
6. -TYPICAL BERM: RIPARIAN AND EMERGENT MARSH

- 1 Unvegetated intertidal habitat
- 2 Anchored large woody debris on rock bolster defines waterward edge of riparian habitat
- 3 Earth anchor system to secure log
- 4 Emergent plants in biodegradable geotextile fabric pillow filled with two feet of fine grain sediment
- 5 Large woody debris cross log
- 6 Anchored large woody debris footer log with rock bolster
- 7 Dense riparian plantings with irrigation - 3:1 slope
- 8 Twelve-inch mulch layer
- 9 Two-foot imported topsoil layer over geotextile fabric
- 10 Emergent marsh planted in biodegradable geotextile fabric pillow - 10:1 slope
- 11 Slope transition point - continues as 25:1 slope
- 12 Twelve-inch layer fine grain sediment
- 13 Unvegetated mudflat
