Analysis of Southern Segment of Sumatran Fault Monitoring Bench Mark as Preliminary Approach in Updating Earthquake Hazard Map

Satrio Muhammad Alif¹, Arliandy Pratama¹

¹ Geomatics Engineering Department, Institut Teknologi Sumatera, Lampung Selatan, Lampung

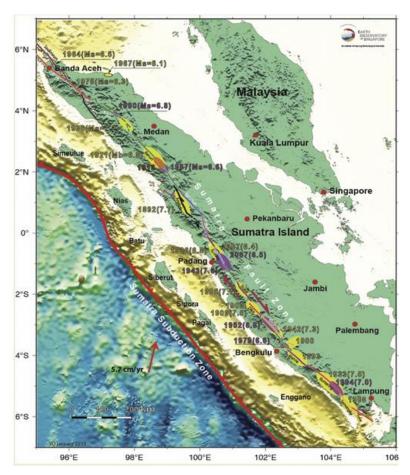
Figure 1. Sumatran Fault [1]

Sumatran Fault generate many great earthquakes in past shown in **Figure 1** [1]. Sixteen great earthquakes with magnitude more than 5 was occurred in southern segment of Sumatran Fault in last two years [2]. Monitoring of Sumatran Fault is focused on northern segment of Sumatran Fault especially after the occurrence of the 2004 Aceh earthquake which triggers activity of Sumatran Fault. Southern Segment of Sumatran Fault Monitoring is rarely conducted compared to northern segment since slip rate of northern segment is higher [3]. It makes monitoring bench marks around southern segment especially in Lampung Province is in low numbers. Fault monitoring bench marks is measured using geodetic technique to get coordinate values difference over time that generate fault parameters such as slip rate, locking depth, and segmentation [4].

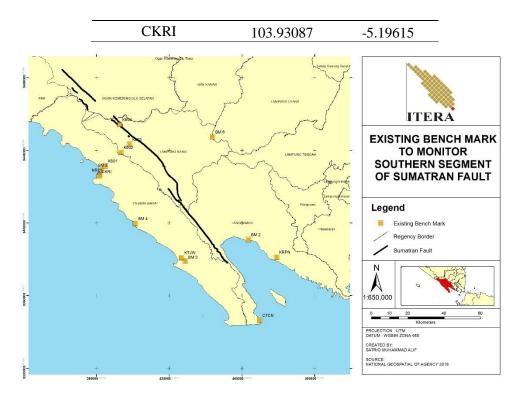
Figure 2. Existing bench mark to monitor southern segment of Sumatran Fault

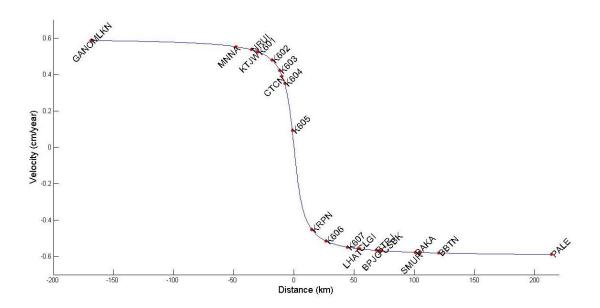
Figure 3. Sumatran fault slip model [7]

Figure 3 shows the velocity trend changes due to Sumatran fault distance value in 15 kilometres from Sumatran fault. It means threshold between bench mark which classified as high class bench marks and low class bench marks is in 15 kilometres from Sumatran fault. Bench mark with perpendicular distance less than 15 km is classified as high class bench marks, while the other bench marks classified as low class bench marks. Separation of those existing bench marks can be seen on **Figure 4**. High class bench marks means those bench marks is in high priority to be used to monitor the fault since the distance is closer to fault.

Classification based on perpendicular distance between existing bench marks and Sumatran Fault using Sumatran Fault function with certain fault parameter from Alif [7] shown in **Figure 3**, with slip rate is 1.4 cm/yr and locking depth is 16 km.

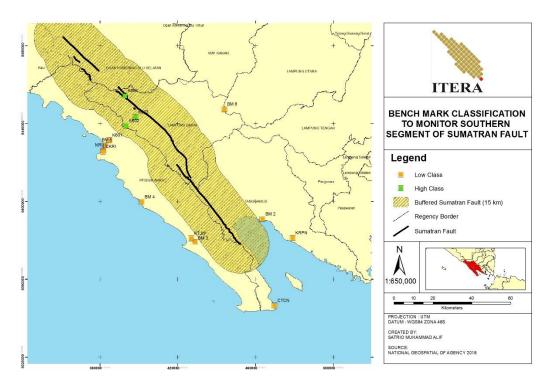
Figure 4. Bench mark classification

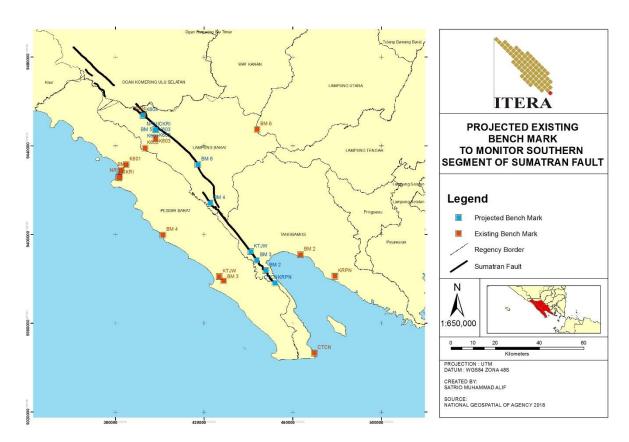
Figure 5. Existing bench marks and its projected points on Sumatran fault

Classification of segment of Sumatran fault which bench marks monitor is resulted by projecting bench mark perpendicularly method. The result is shown on **Figure 5.** The classification of each segment is shown on **Figure 6.** Red lines are segments with no monitoring bench marks. The length of those segments is 96.018 km or 58.54% of total segments with 164.020 km long. The possible location to monitor those segments with no monitoring bench marks is shown on **Figure 7**,

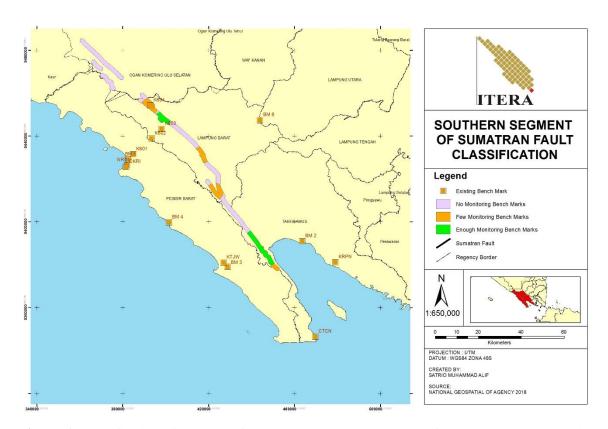
Figure 6. Classification of Sumatran fault segment based on number of bench marks projected in it

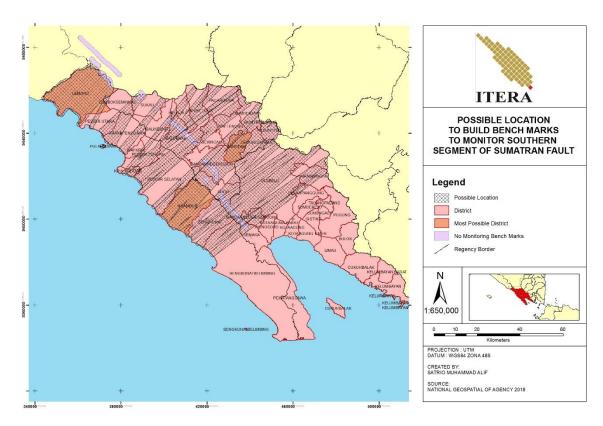
Figure 7 shows possible location related to districts in three regencies: Tanggamus, West Lampung, and West Pesisir. Based on area percentage of possible location in district, the prioritized district to build bench mark is Airhitam, Lemong, and Ngambur. The summary of the area percentage of possible location in district is shown on **Table 2**.

Figure 7. Possible location to monitor segments with no monitoring bench marks
