# CARBON FIBER-REINFORCED POLYMERS AS A TENSILE REINFORCEMENT OF THE *Pinus elliotti* AND *Manilkara huberi* WOOD SPECIES

In wood structures, the elements subjected to bending stresses, such as the beams, present a fracture initiated in the tensile region, and under these conditions, the use of laminated composite materials is presented as an alternative solution in the form of repair or reinforcement. This research aimed to evaluate the influence of the use of carbon fibers laminated composites in tensile reinforcement in the direction parallel to grain of *Pinus elliotti* and *Manilkara huberi* wood species. The Viapol two-component epoxy adhesive was used in the lamination and fixation of the unidirectional carbon fiber in the wood species. Ten specimens with no defects (reference) and 10 specimens were prepared for each crack length (25 and 50mm) with and without the reinforcement (60mm × 50mm) by the laminated composite. The tensile tests were performed in accordance with the requirements of the Brazilian standard ABNT NBR 7190 (1997). From the results of the statistical analysis, the use of the carbon fiber composite was able to restore the tensile strength of the cracked sa

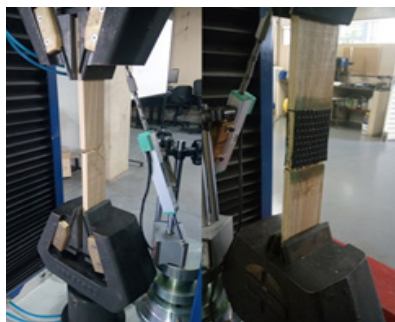
**Figure 1:** Tensile test for determination of tensile strength in the parallel direction in wood specimen of *Pinus elliotti var. elliotti* partially cracked.

The apparent density ( $\rho_{ap}$ ) and the tensile strength parallel to the fibers ( $f_{t0}$ ) were obtained according to the assumptions and methods of calculation of the referred Brazilian standard, and it should be noted that the geometry of the specimens was considered rectangular ( $1 \times 5$  cm) and 40 cm in length, with the length of the contact of each pair of claws (apparatus for the tensile test) with the specimens being 8 cm. The tensile tests (Figure 1) on the test specimens were performed with the aid of an EMC® test machine with 100 kN load capacity.

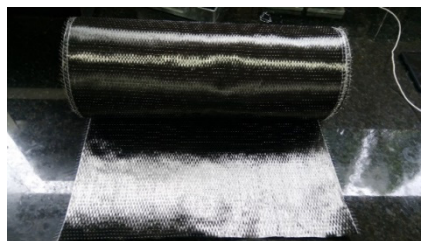
**Figure 3:** Unidirectional carbon fiber Viapol Carbon CFW 300.

The unidirectional carbon fiber fabric (Figure 3) used in the lamination and fixation in the specimens came from the manufacturer Viapol (Viapol Carbon CFW 300), recommended for structural reinforcements, with the fibers of the fabric being oriented parallel to the fibers of the wood. This unidirectional carbon fiber fabric has grammage of  $0,300 \text{ kg/m}^2$ , thickness of  $0,166 \text{ mm}$  tensile strength of  $4900 \text{ MPa}$ , modulus of elasticity of  $230 \text{ GPa}$  and elongation at break of  $2,1\%$ .
