Limiting Structural Damage on Masonry Structures due to Foundation Movement

J. Mahachi

University of Johannesburg, South Africa

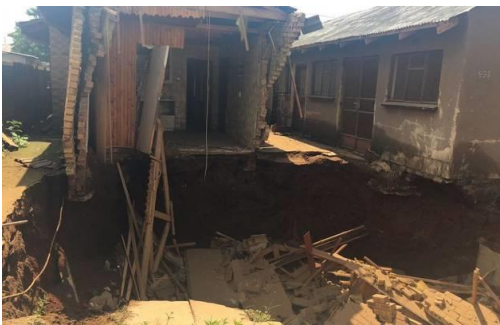
Figure 1: Sinkhole formation on dolomites

The weakly carbonic acid groundwater moves through the joints, fractures and faults in the dolomite and as a result the rock is slowly dissolved over years. Dolomites underlie many of the densely populated areas of South Africa. Approximately 2.5 to 3 million people in South Africa live on dolomites. The result of water infiltration in the dolomites is the formation of sinkholes which subsequently compromises the structural integrity of the houses. A typical sinkhole in a dense township is shown in Figure 1. The risk of formation of sinkholes is not only for integrity of the top-structure, but also for the safety of the occupants, children in the playground and neighbours.

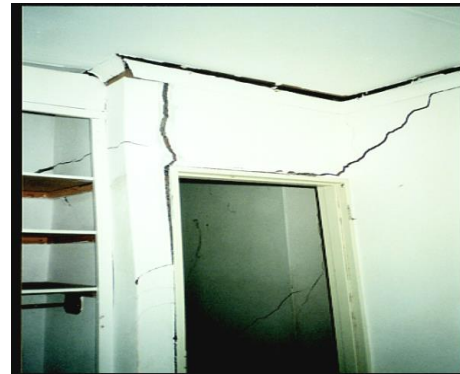
Figure 2: Superstructure failure

Mahachi et.al. (2004) also reported that a number of failures of the super-structures are a result of poor workmanship and not paying particular attention to construction detail. However, as mentioned earlier, super-structure failure may also be caused by failure of the foundation system. Example of super-structure failure caused by foundation settlement is shown in Figure 2. This house was part of a housing complex development in which 20 houses were constructed on a backfilled brick quarry. Densification of the upper 2 m of the soil profile using an impact roller was inadequate resulting in severe structural distress on the

super-structure of all the houses. All the houses in this development had to be demolished and the area was condemned for residential development.

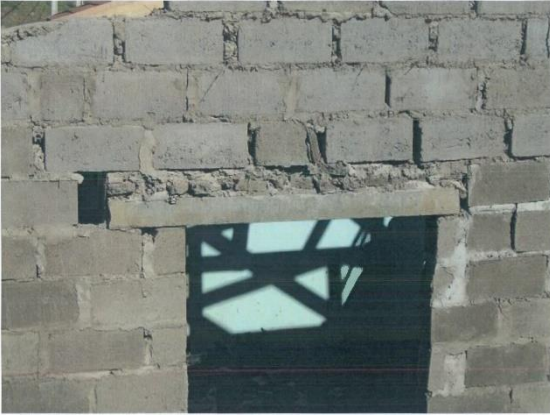
Figure 3: Poor installation of lintel

research conducted was to investigate the suitability of the HeliBeam for improving the structural strength of low-income houses; where unacceptable sag of blockwork wall sections occurs over doors or windows. This could be as a result of foundation settlement or poor workmanship, etc. A typical example where a lintel over a door opening was incorrectly installed and also suffered foundation settlements, is shown in Figure 3.

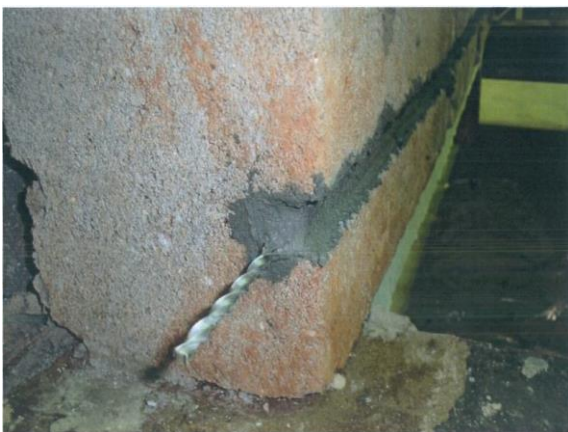
Fig. 4: HeliBeam system

The HeliBeam system (Helifix, 2004) is a proprietary helical reinforcement which is embedded into the bedjoint of existing masonry buildings using a special grout (the “HeliBond”). The effect of the reinforcement and the grout is to act compositely with existing brickwork or blockwork, and has the potential to be used to repair cracks or to form deep reinforced masonry beams. The installation of the HeliBar is illustrated in Figure 4. If these beams can span over areas suffering from ground movement, or where crack stitch is required, they can reduce the need for costly traditional underpinning. This has thus the potential of reducing differential settlement problems in housing.

curing period of 28 days was applied to all beams, which were constructed. Subsequently, the installation of 6mm galvanized carbon steel HeliBars and HeliBond grout took place and again a period of about 20 days was provided for the curing of the HeliBeam installation. Figure 4 shows a HeliBar positioned in the concrete beam.

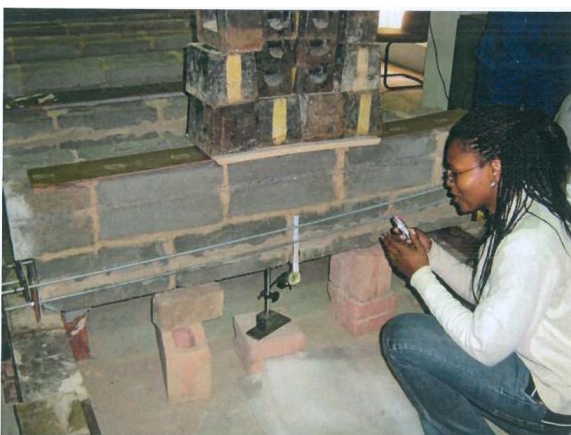
Figure 5: Loading arrangement

The loading configuration simulated a point load which was determined by considering typical loads that would act on an opening of 1.5 m, i.e. Dead Load (G_k) from the roof and uniformly distributed load (Q_k) of 0.5 kN/m^2 . Although this load seemed high, it was considered appropriate for low-income subsidy houses as *additional loads are often positioned on top of the roofs* to prevent the uplift of roof sheeting. The ultimate concentrated load, based on SANS 10160 (2011) load combination of $1.2G_k + 1.6Q_k$ was 4.25 kN. The vertical loads were applied via a 50mm wide wooden spacer.

This approach thus led to the adoption of the most conservative situation of one roof-beam placed centrally over the lintel-beam and carrying the loads from a contributory area of 1.5 metres wide. A typical test set-up is shown in Figure 5. The mid-span deflections were measured by means of a dial gauge, and observation of any cracks were noted.

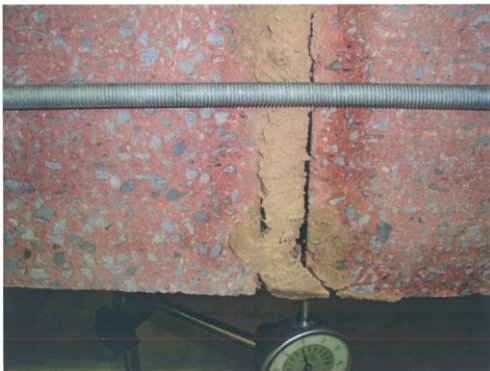
Figure 6: Cracking of unreinforced block beam

Upon the release of the supporting shutters on the beams, all unreinforced beams deflected instantly under their own self-weight, with a visible sag of between 4 and 5.5 mm. This was accompanied by several horizontal and vertical cracks developing in the mortar, with crack widths between 1 mm and 2 mm, as is evidenced in Figure 6.

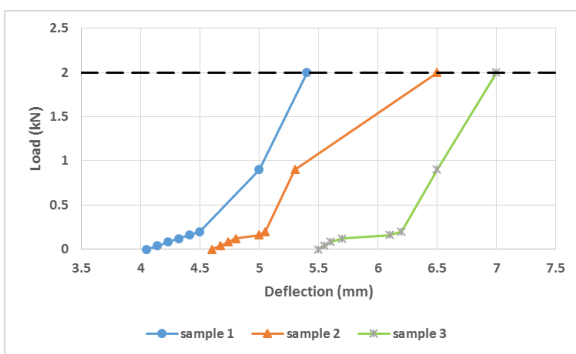
Figure 7: Load-deflection for Unreinforced Beam

The results of the loading tests are presented in Figure 7, where the load is plotted against mid-span deflection. The loading of the beams introduced an additional sag of between 1.5 mm and 2 mm. The HeliBeams could not carry a load greater than 2 kN as this was accompanied by large deflections and further opening of the cracks. The resultant, total mid-span deflections (under a load of 2 kN) was between 5.5 mm and 7 mm, which are above the performance limit of 4.3 mm. It was therefore concluded that unreinforced beams clearly fail to fulfil their functional requirements. The variability of the results, as is evidenced in Figure 7, is also indicative of the variability in quality of the concrete blocks.

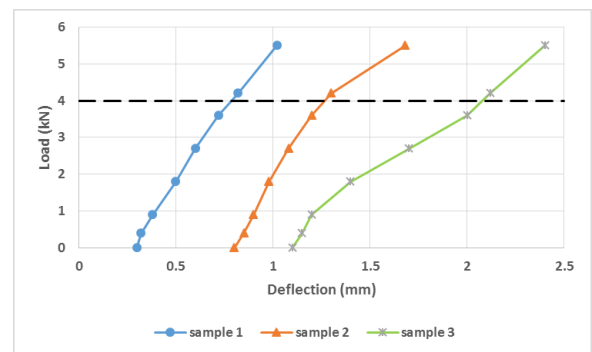
Figure 8: Load-Deflection (Bottom layer Heli-Bar)

The results for this group of tests are presented in Figure 8 for beams reinforced with bottom layer of HeliBars and Figure 9 for beams reinforced with both bottom and top layers of HeliBars. It can be seen that both graphs indicate better performance of beams fitted with HeliBars. A slightly better performance corresponded to beams fitted with the double layer of HeliBars (Figure 9). In Figure 9, the initial sag, upon the removal of the supports to shutters, was only about 0.5 mm, with a final deflection of about 0.9 mm under a load of 4 kN. In comparison, the initial deflection of the beams with a single HeliBar was of the order of 0.4-1.2 mm and a total deflection of between 1 to 2 mm. The scatter of the results is much less reduced for two layer reinforcement compared to single layer reinforcement, indicating the enhancement effects of the HeliBars. The apparent similarity between both situations, shown in Figures 8 and 9, indicate a situation in which the resistance offered by the bottom HeliBar may be sufficient to cope with the imposed level of the loading and does not require the engagement of the compression top-bars.

Four sets of three beams each were tested from different sites. Like the Group 2 samples, these tests were carried out with a load of up to 5.5 kN which exceed the required ultimate design load of 4.3 kN by 30%. The results of the tests showed a behavior similar to that shown in Figure 8 and a summary of the test results is presented in Table 2.
