# SEARCH AND RESCUE – DEVELOPMENT AND VERIFICATION OF A MODERNIZED PASSIVE FLOATING SYSTEM FOR PAYLOAD SEA RECOVERY

For most suborbital space flights, the successful recovery of the experimental payload is a critical point at the very end of the mission. Beside land based recovery, particular missions require a sea recovery in the Arctic Ocean. Therefore, a variety of passive floating systems have been developed and used by DLR's Mobile Rocket Base (MORABA).

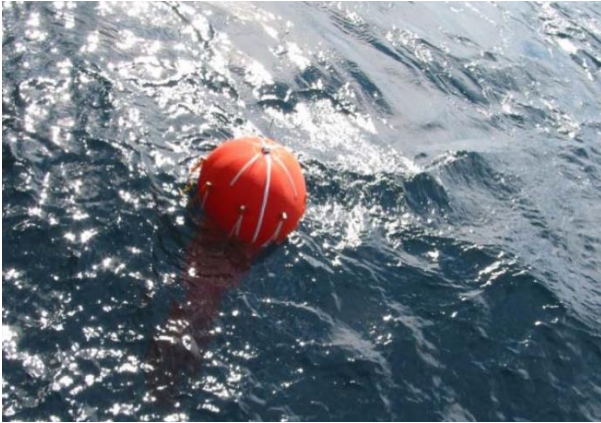
Because of its two chamber design, the floater still generates buoyancy even if there is a rupture on the outer shell. The size of the floater body can vary, depending on the mass of the payload. For localisation a GPS/Iridium transceiver, a VHF radio beacon transmitter and a strobe light for visual detection are installed in a watertight box that is mounted on the floater's apex. After visual detection the floater can be hooked at a salvage line and hoisted off the water together with the parachute and the payload. Those kind of floating recovery systems have been used for multiple missions during the last 50 years.

Figure 2 Previous passive floating system

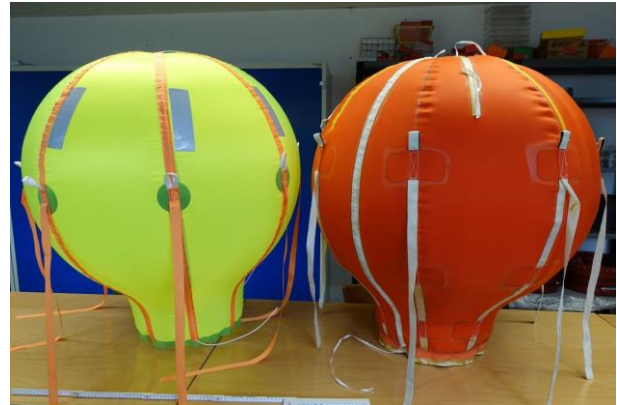
distinctive and bright colour of the material meets the requirement of a better visibility. Different to the previous design the single strips are not bonded but connected by ultrasonic welding and high frequency welding. This technique provides more reliable, homogenous and tight joints. A first prototype of the redesigned floater was manufactured and completed after one day. In comparison the production of the previous floater took multiple days. The final mass of the floater body prototype is 0.89kg, which results in a mass reduction of 40% compared to the previous design (1.53kg).

Figure 3 New (left) and previous (right) floater design

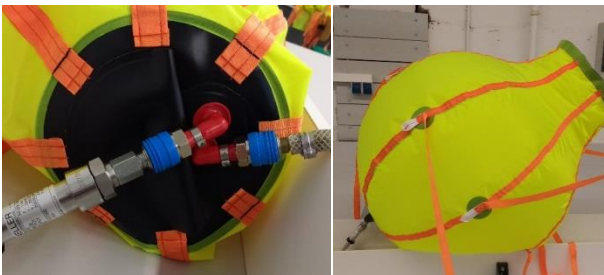
For the burst tests the floater was inflated via a pressure port at the apex of the floater body. Additionally, the inner pressure was measured via a second port at the apex.

Figure 5 Burst test assembly

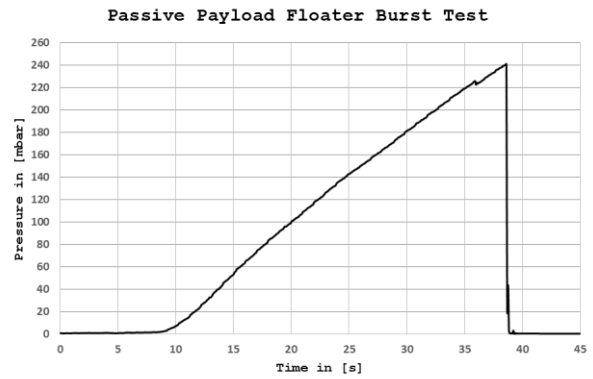
The result of the burst test of prototype 4 is exemplarily showed in Figure 6. At this test the joint between the duckbill valve and the membrane was sufficiently reinforced with heat welded tape.

Figure 6 Result of burst test 4

The floater failed at a burst pressure of 240mbar [4]. For the comparison of the tensile stresses the boiler formula (Eq. 2-4) is used again. For the burst pressure of 240mbar the tensile stress leads to 4,89N/mm<sup>2</sup>, which is close to the minimum reached tear strength of the joints' tensile tests. A safety factor of 8 compared to the determined flight loads is reached. The results of the burst tests correspond to the results of the tensile test and verify the design as well as the test results.

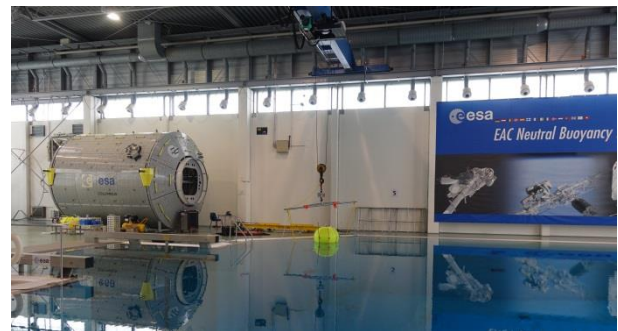
In addition to successful dimensioning of the modernized passive payload floater, the functionality in use has to be proven. The offered diving pool of ESA's NBF provides a controlled environment to perform different recovery scenarios.

Figure 7 Neutral Buoyancy Facility

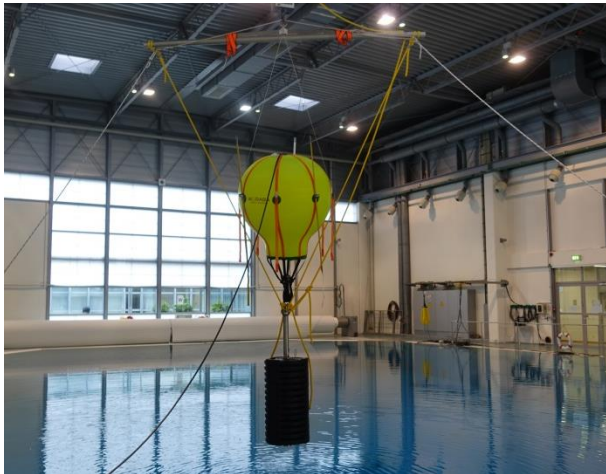
to a dummy mass carrier (net mass 21kg) that can be equipped with a variable amount of rubber insulated weight plates á 25kg. Furthermore a GoPro camera was mounted to the harness to record the behaviour of the duckbill valve during operation. To keep the floater unloaded while lifting it into the water a load beam construction was developed. It is shown in Figure 8.

Figure 8 Load beam construction

When the floater is set down on the water surface the suspension ropes of the load beam are released and the dummy payload mass is finally carried by the floater. Buoyancy tests were performed with three different payload masses (100kg, 200kg and 350kg). For all tests the floaters were inflated with the same initial pressure of 30mbar. The test duration for each test level was 60min. All tests were performed for the new and the old floater. During the buoyancy tests the differential pressure and the temperature was measured. Furthermore draft marks were placed around the payload floater to observe the sinking level of the floater over time.

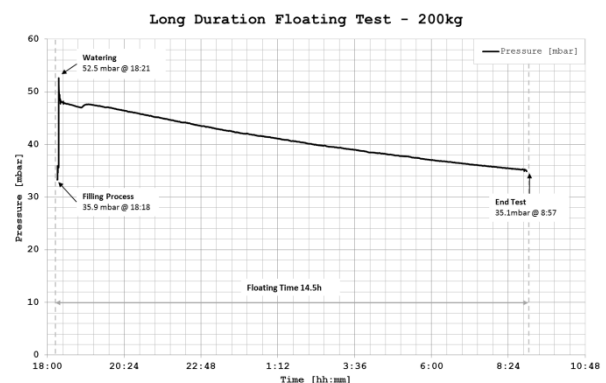
At the long duration buoyancy test the endurance of the modernised floater system was further investigated. The test was performed with a 200kg payload mass for 14,5h. The pressure plot is shown in Figure 10.

Figure 10 Pressure measurement long duration buoyancy test

Similar to the previous buoyancy tests the floater was inflated to a pressure of approximately 30mbar. When the floater was set down on the water surface the pressure increased to 51mbar as the floater was compressed by the surrounding water. After 14,5h the pressure level decreased to 35mbar. The draft marks showed that the floater sunk about 30mm and just some

water puddles accumulated in the floater. A closer look to Figure 10 reveals that the course of the plot is not proportional over time but the gradient of the pressure loss decreases. A trend line analysis displayed that after 48h the pressure inside the floater still would have been 17mbar. The buoyancy performance of the modernized passive payload floater has been satisfying. The improvement compared to the previous floater system was clearly proven.

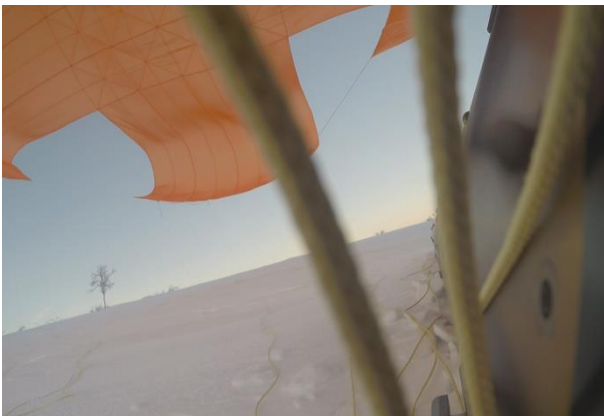
Figure 14 Parachute sinking to the ground

A video analysis showed that the parachute usually hits the ground or water surface with velocities between 1-3m/s [5].

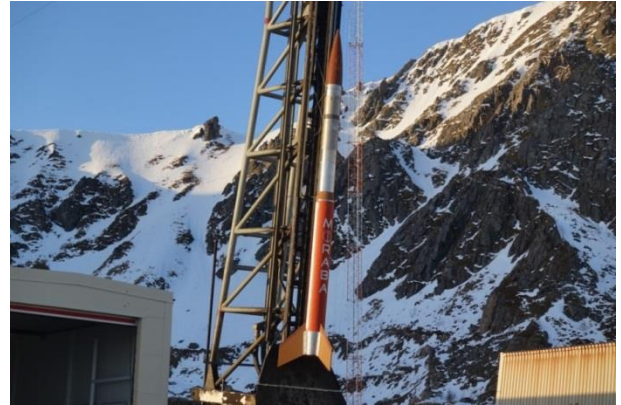
Both rockets were boosted by an Improved Malemute motor and were equipped with the modernized passive floating recovery system. The payload masses in recovery configuration were 161.3kg (PMWE 1) and 159.3kg (PMWE 2) [6].

Figure 15 PMWE 2 vehicle at the launcher

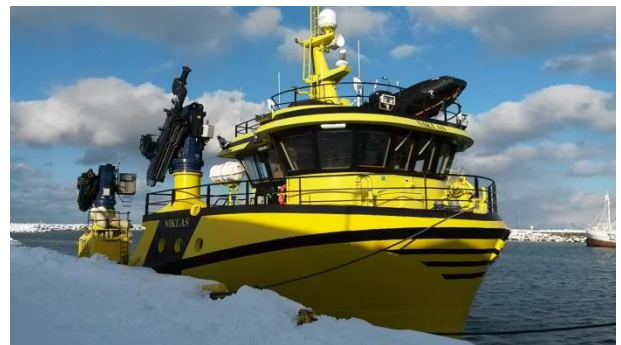
For the recovery operation the service and off-shore work boat MS Niklas from FDA (Finnsnes Dykk & Anleggsservice AS) was hired, which is equipped with two 20m cranes that facilitate payload recovery from 10m below the sea surface [7]. Prior to the campaign a VHF direction finder has been installed on board to receive the signal of the radio beacon transmitter. Three crew members of MS Niklas and one member of MORABA finally performed the recovery operation on deck.

Figure 16 Recovery vessel MS Niklas
