IR thermography for lightning-strike damage monitoring in composite materials

by J.-M. Roche*, F. Passilly*, P. Beauchêne*, C. Zaepffel**, R. Sousa Martins**, D. Balageas***

* ONERA, Materials and Structures Department, Châtillon, 92320, France, jean-michel.roche@onera.fr

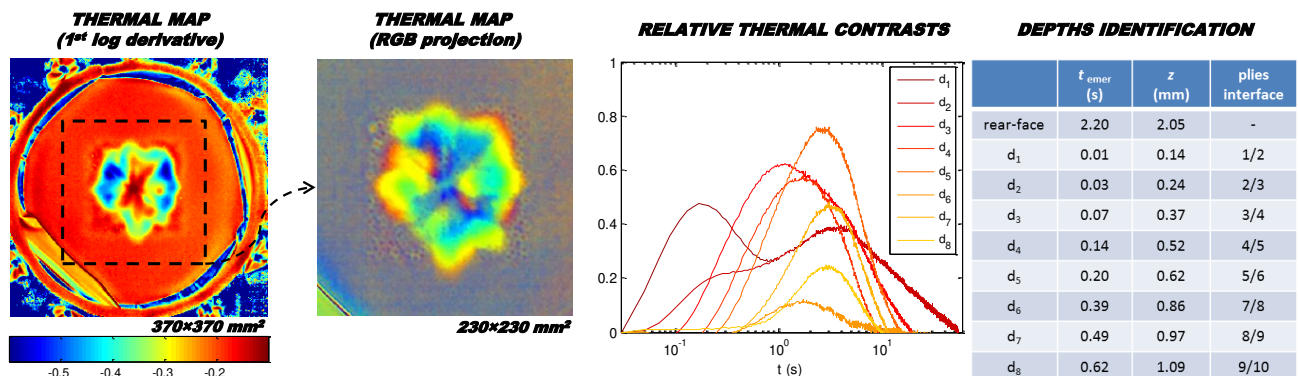
The resulting thermal maps make it possible to assess the global extent of the delaminated areas, the depths of which can be deduced from the occurrence times of their emerging contrasts. An example is given in Fig. 2 for a 2.05 mm thick coupon for which the lightning-strike damage has generated delamination up to the interface between the 9th and 10th plies (counting from the rear-face).

Fig. 2: Pulse thermography inspection of lightning-strike induced damage. 1st logarithmic derivative (left), RGB projection (middle) centered around the impact zone, time-evolution of the relative thermal contrasts (middle) and identification of the depths of the delaminated areas based on the occurrence times of the emerging contrasts (right).

The helical-like damage patterns induced by lightning-strike (Fig. 2) are quite similar to those generated by low-velocity mechanical impacts on unidirectional carbon/epoxy composite materials [5].

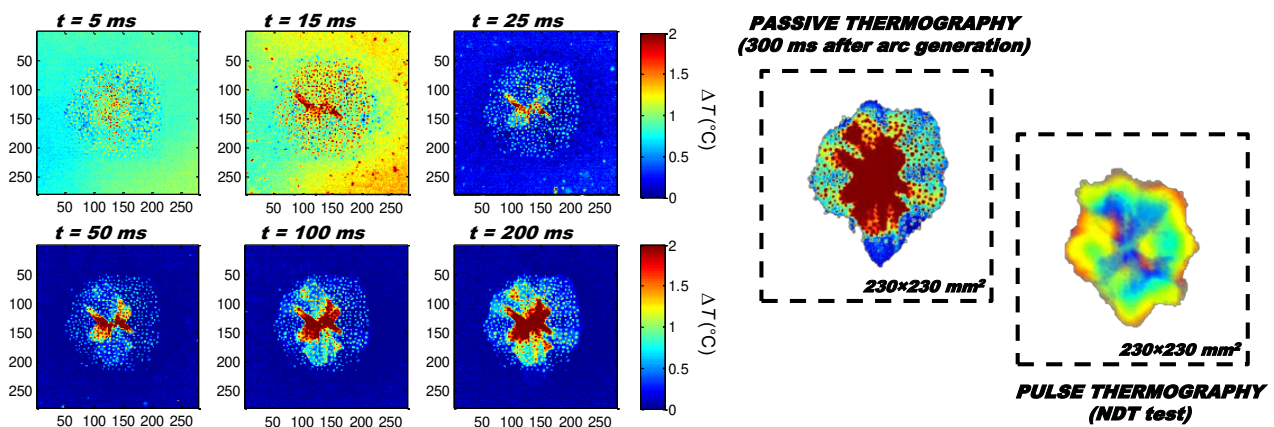
The real-time thermal damage monitoring of the lightning-strike test is carried out with a frame rate of 200 images per second. The successive inter-ply delamination is checked over the first 300 ms following the arc generation (Fig. 3).

Fig. 3: Passive thermography for *in situ* damage monitoring of the lightning-strike induced damage. Time-evolution of the heating maps over the first 200 ms after the arc generation (left). Comparison of the thermal map at $t=300$ ms and the pulse thermography map from the inspection after the test (right).

The global damage pattern observed from such this real-time monitoring turns out to be in excellent agreement with the non-destructive inspection carried out after the test. This tends to validate the relevance of passive thermography as a tool for lightning-strike damage monitoring.
